DOCKET 50-301
LICENSEE EVENT REPORT 96-001
REACTOR TRIP DUE TO SPURIOUS CLOSURE OF TURBINE STOP VALVES
POINT BEACH NUCLEAR PLANT, UNIT 2

LICENSEE EVENT REPORT (LER)

Point Beach Nuclear Plant, Unit 2

Reactor Trip Due to Spurious Closure of Turbine Stop Valves

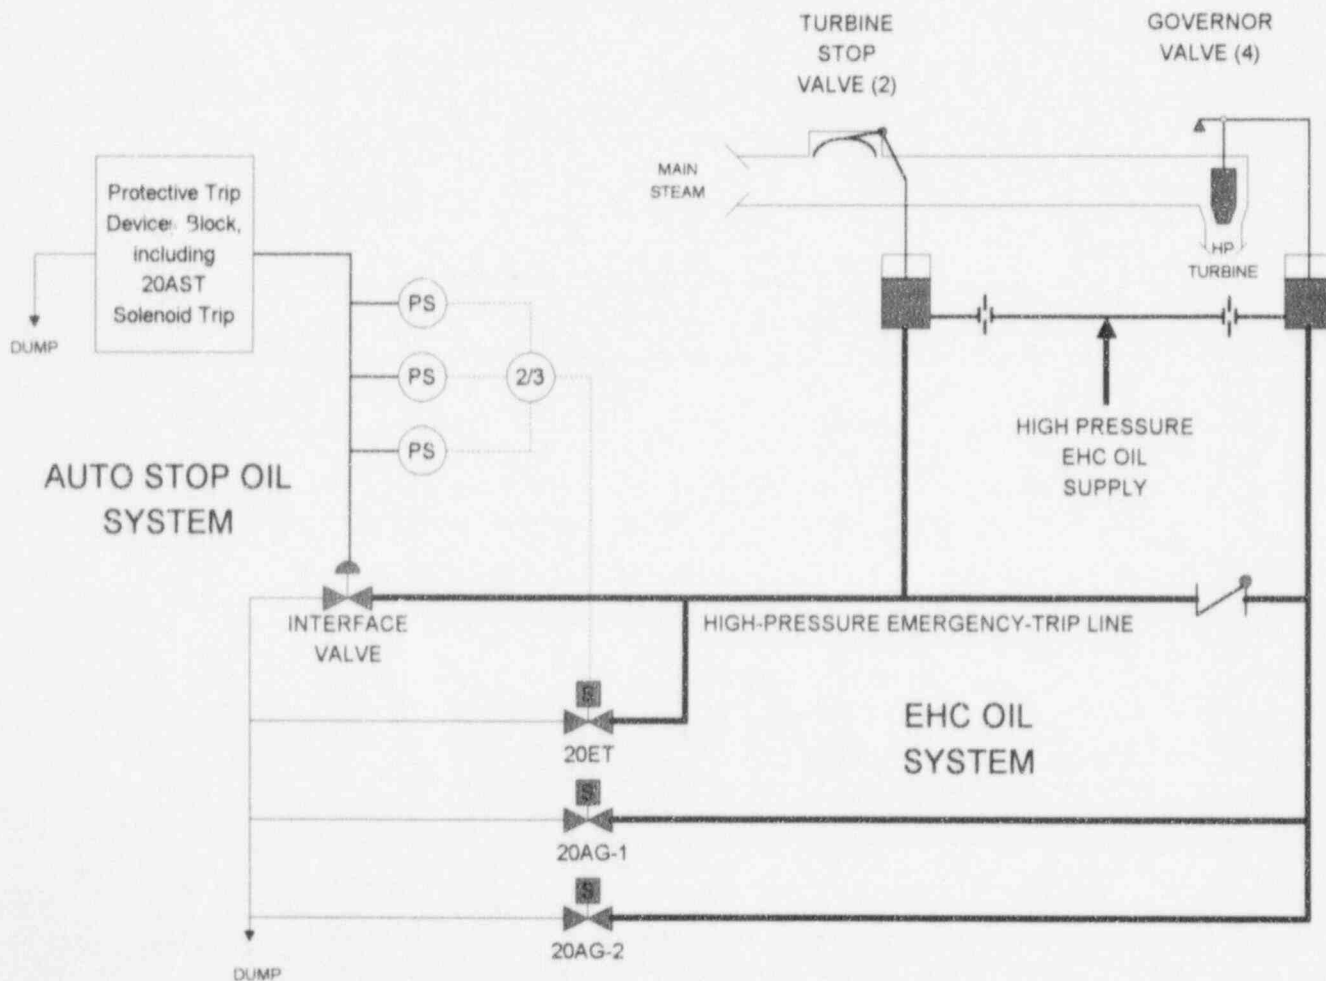
SIMPLIFIED SKETCH OF APPLICABLE SECTIONS OF THE EHC AND AUTO STOP OIL SYSTEMS

By design, the high-pressure emergency-trip line is common to both turbine stop valves and all four (4) governor valves. Several different valves are provided to automatically dump the pressure in this line (or a portion of this line) to effect the closure of the turbine stop and/or governing valves. These valves include: (1) the Interface Valve, (2) the 20ET (Emergency Trip) Valve, and (3) the 20AG (Auxiliary Governor overspeed protection) Valves. Automatic or spurious actuation of any of these valves would cause some combination of turbine stop and governing valve closure. To a certain degree, check valves and orifices in the hydraulic lines are designed to preserve the integrity of the system such that an internal hydraulic leak or malfunction in any valve operator would be limited and not result in complete EHC system failure.

The Interface Valve and the EHC Emergency Trip Solenoid Valve (20ET) function similarly in that the opening of either valve will dump the high-pressure emergency trip line; resulting in the shutting of both turbine stop valves and governor valves. The Interface Valve is hydraulically actuated by a separate auto stop oil system. Auto stop oil pressure keeps the Interface Valve closed. If auto stop oil pressure is released due to mechanical overspeed, solenoid 20AST actuation, low vacuum, low lube oil, or thrust bearing wear trip, the Interface Valve will open and dump EH fluid; causing the turbine stop and governor valves to close. Alternatively, the high-pressure emergency trip line may be dumped when the 20ET solenoid valve trips directly from one of the following events:

The investigation focused on the two valves that each provide a single barrier to prevent dumping the EHC high-pressure emergency-trip line. These two valves are the Interface Valve and the 20ET valve. To spuriously fail without detection, the Interface Valve operating diaphragm would have had to have failed and external leakage would have been detectable. Upon physical examination, no degradation was noted. Upon startup, with the turbine latched for rollup, temperature and flow measurements verified that there was no internal through-leakage in the system. Solenoid valves 20AG-1 and -2 were tested to verify the integrity of the adjacent check valve.

Therefore, the investigation ultimately led to the EHC Emergency Trip Solenoid Valve (20ET), which had just been replaced in the Fall of 1995 with a new valve design. The valve was examined and removed. Westinghouse and the new valve vendor were contacted to identify the operating history of this valve design. Neither the examination nor the vendor's experience with operational valves indicated a likelihood for this valve to spuriously fail to the open position. A spurious, undetected control signal to the solenoid or a spurious voltage would have had to have been applied to the solenoid to cause the valve to open. However, based on the lower probability of other failures, it was

Extensive troubleshooting was performed. The operator and valve of the failed component (20ET) was examined in place, removed, and replaced with a valve of an identical model. Troubleshooters found no fluid leaks or other visible evidence of a loss of functionality. Electrical circuits to the 20ET solenoid were monitored for stray electrical signals. Upon startup, with the turbine latched for rollup, temperature and flow measurements verified that there was no internal through-leakage in the system. Solenoid valves 20AG-1 and -2 were tested to verify the integrity of the adjacent check valve. In addition, EHC oil sample analyses indicated no abnormalities in the hydraulic fluid.

Electrical testing is being planned for the control and power circuitry of the 20ET valve during the next Unit 2 shutdown. Various plant conditions will be simulated to identify any potential for generation of a control signal or power oscillation which could cause the solenoid to energize, and therefore open.
