LETTER REPORT

EVALUATION OF CRACKS ON THE JOSEPH M. FARLEY UNIT #1
MAIN STEAM ISOLATION VALVE (MSIV) SHAFT

Materials Technology Division
Department of Nuclear Energy
Brookhaven National Laboratory
Upton, New York 11973

AUGUST 1984

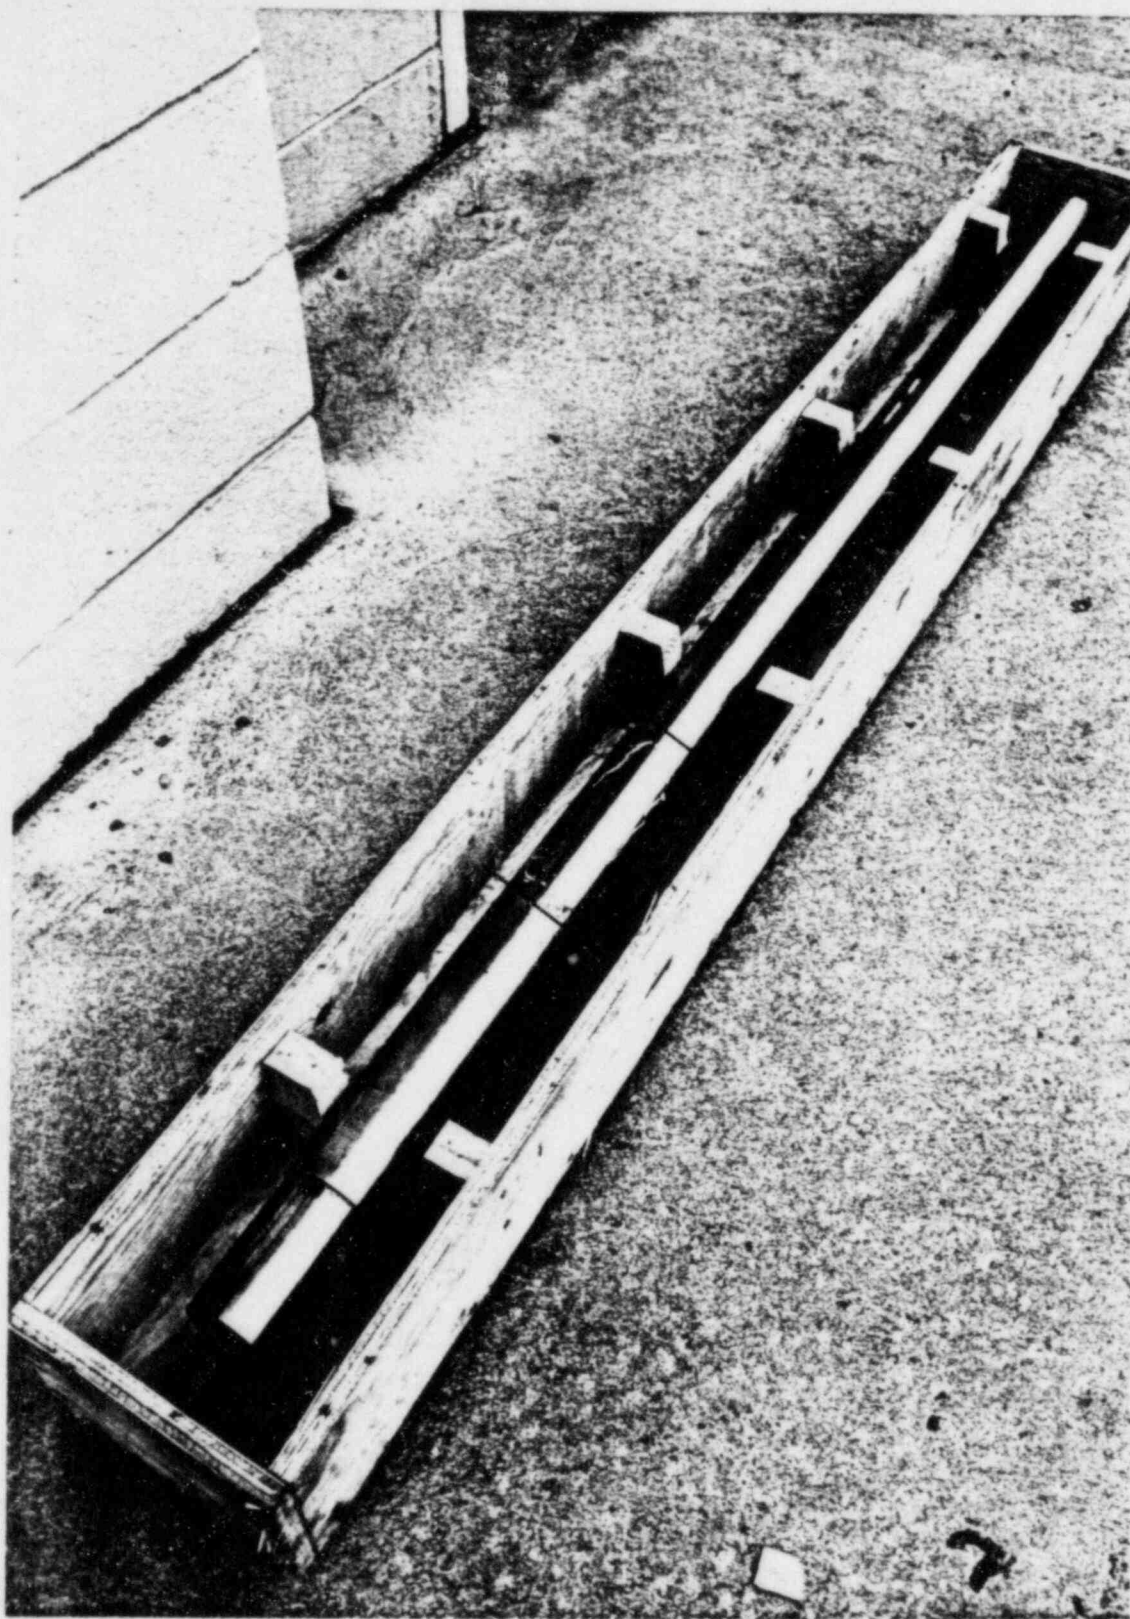
The MSIV shaft sent to BNL was #69C. The shaft "as received" was 77 inches long (195.6 cm) by 3.5 inches diameter (8.89 cm) and weighed approximately 400 lbs. The linear indications were located at the approximate halfway point on the shaft (Figure 1). The indications (cracks) encompassed a total length of approximately 6.6 inches (16.7 cm) axially along the shaft (Figure 2).

FIGURE 1. Photograph of 77" MSIV shaft from Joseph M. Farley Unit #1. Outlined area is location of cracking.

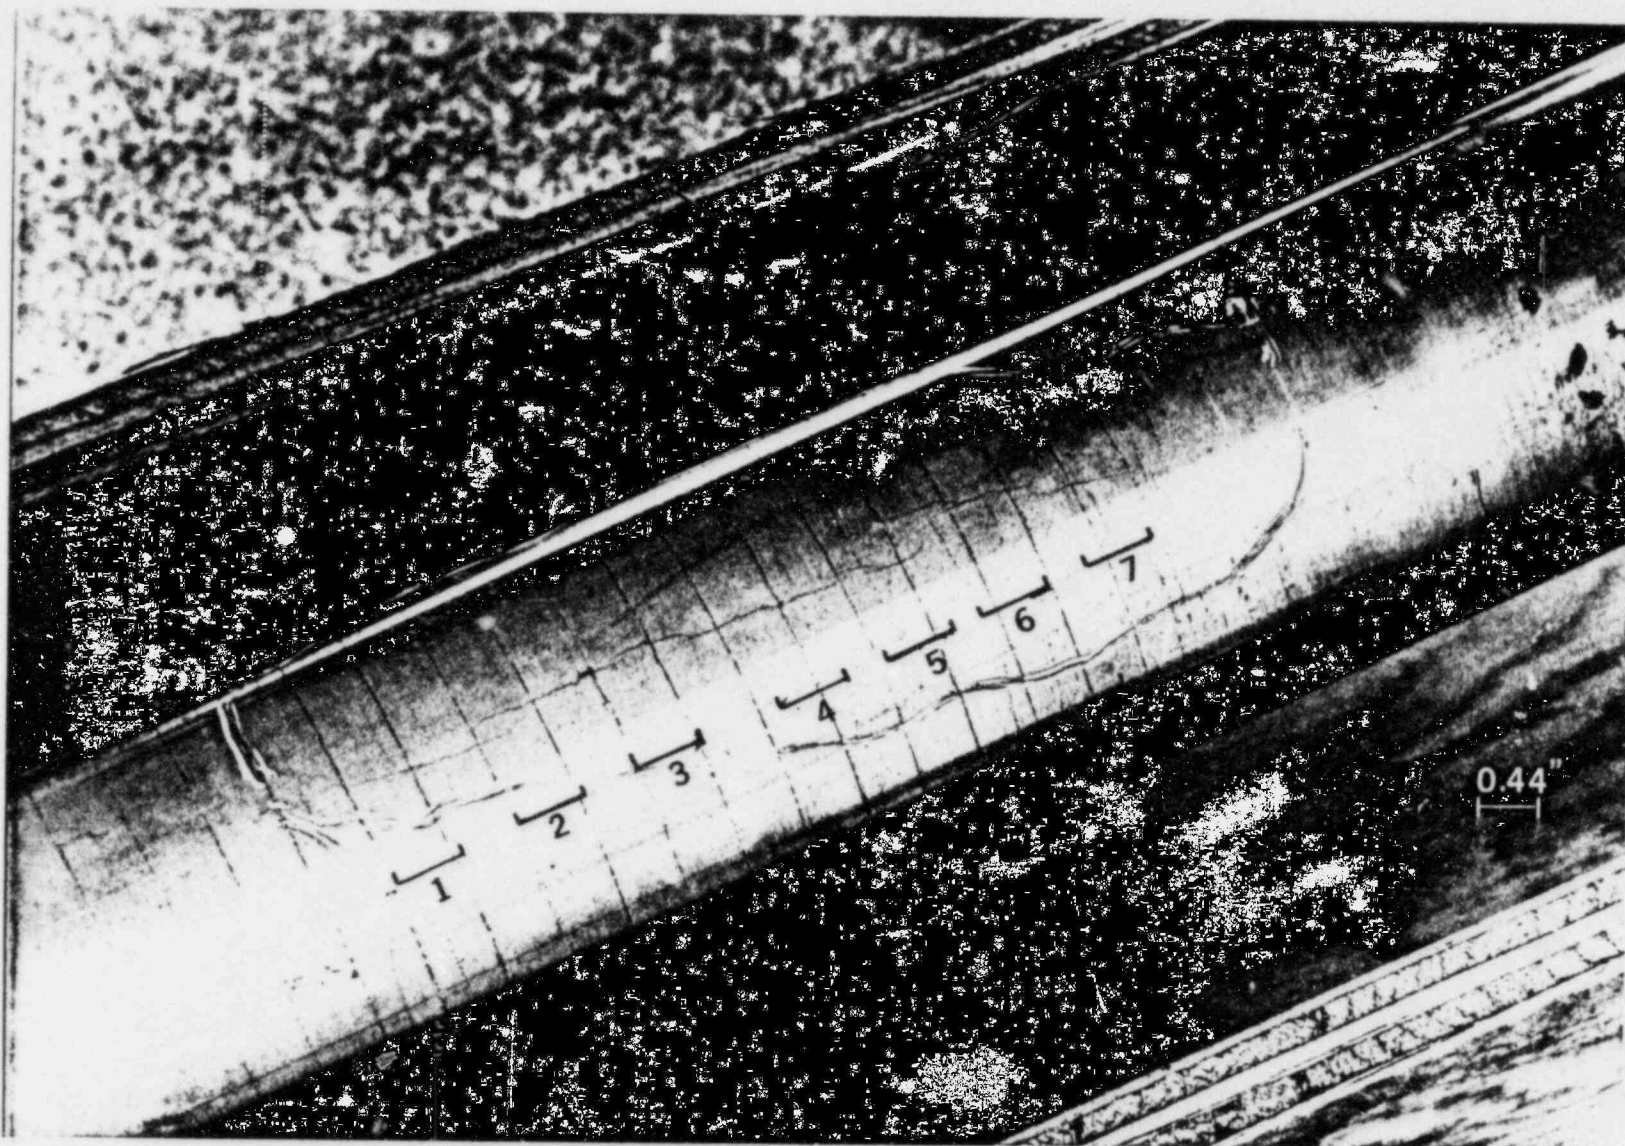
Seven discs were cut from the shaft (Figure 2) in the area of the cracks. All cuts were made dry in order to keep contamination to a minimum. The specimens cut were numbered 1-7. Specimens 2, 6 and 7 were used for SEM/EDS examination and specimens 4 and 5 were polished for optical metallographic examination. Specimen 1 had hardness measurements performed on it and then had half of the disc sectioned for chemical analysis.

FIGURE 2. Photograph of cracks on MSIV shaft. Numbered areas are approximate locations of specimen cuts.

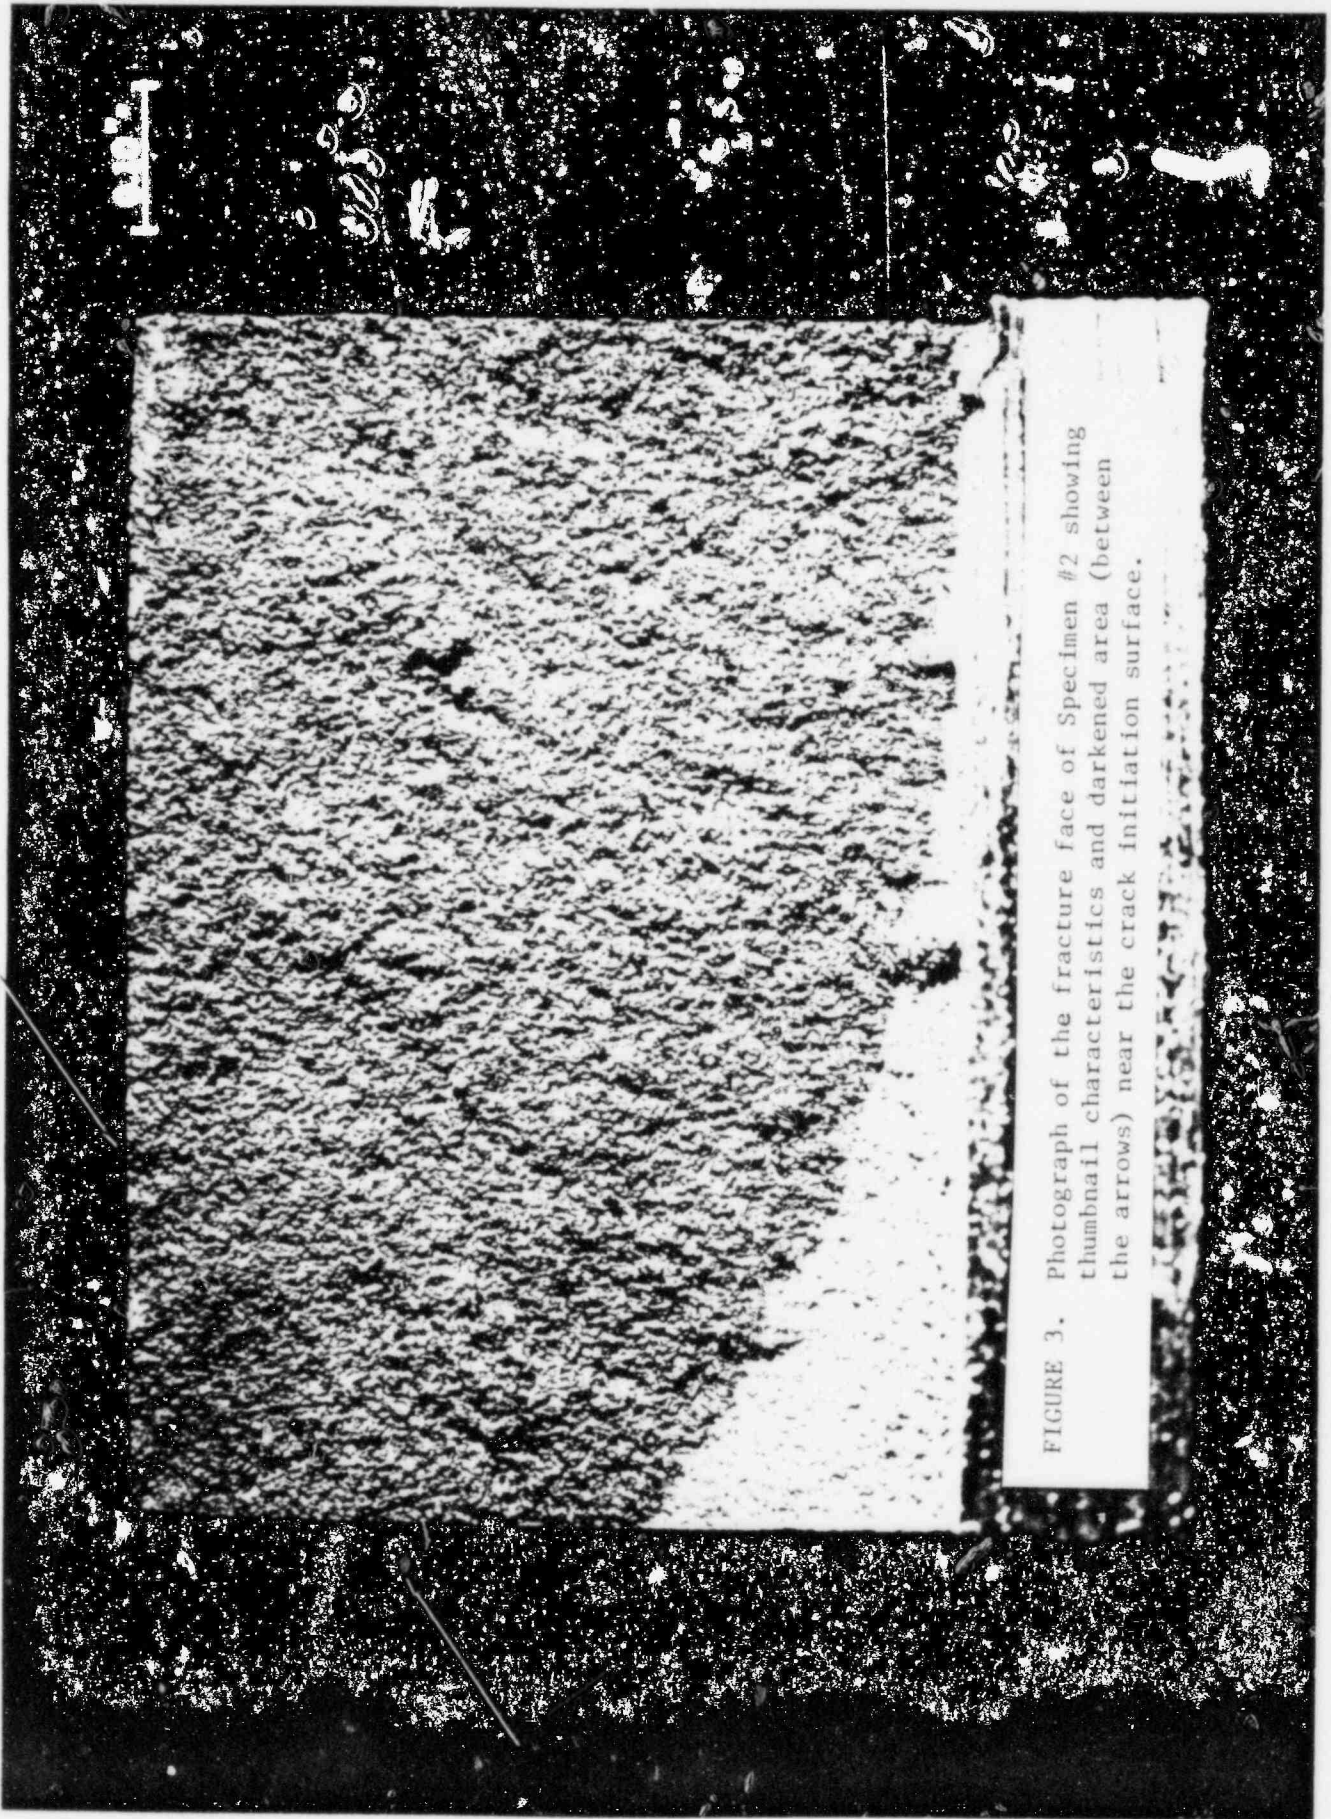
FIGURE 3. Photograph of the fracture face of Specimen #2 showing thumbnail characteristics and darkened area (between the arrows) near the crack initiation surface.

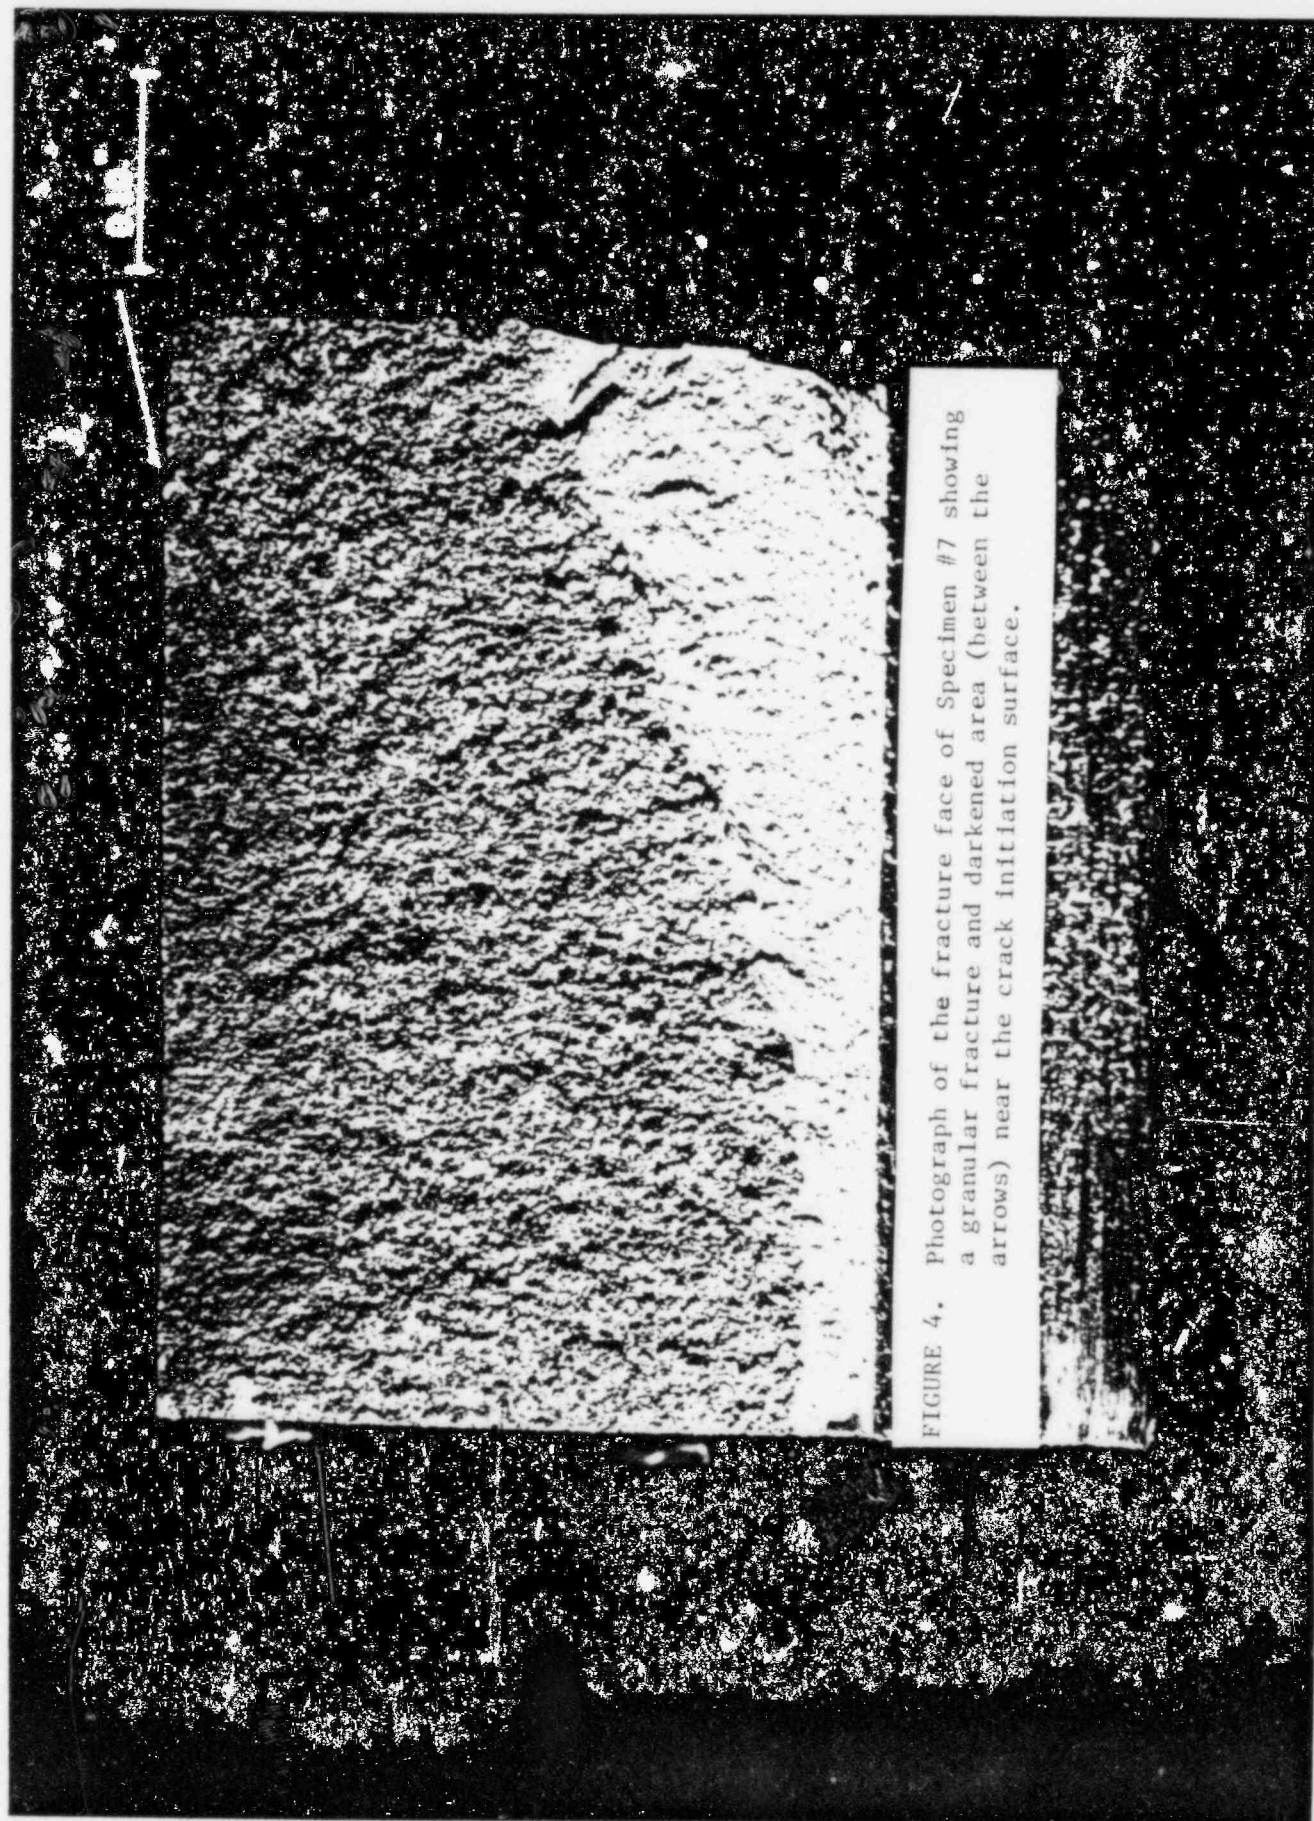
FIGURE 4. Photograph of the fracture face of Specimen #7 showing a granular fracture and darkened area (between the arrows) near the crack initiation surface.

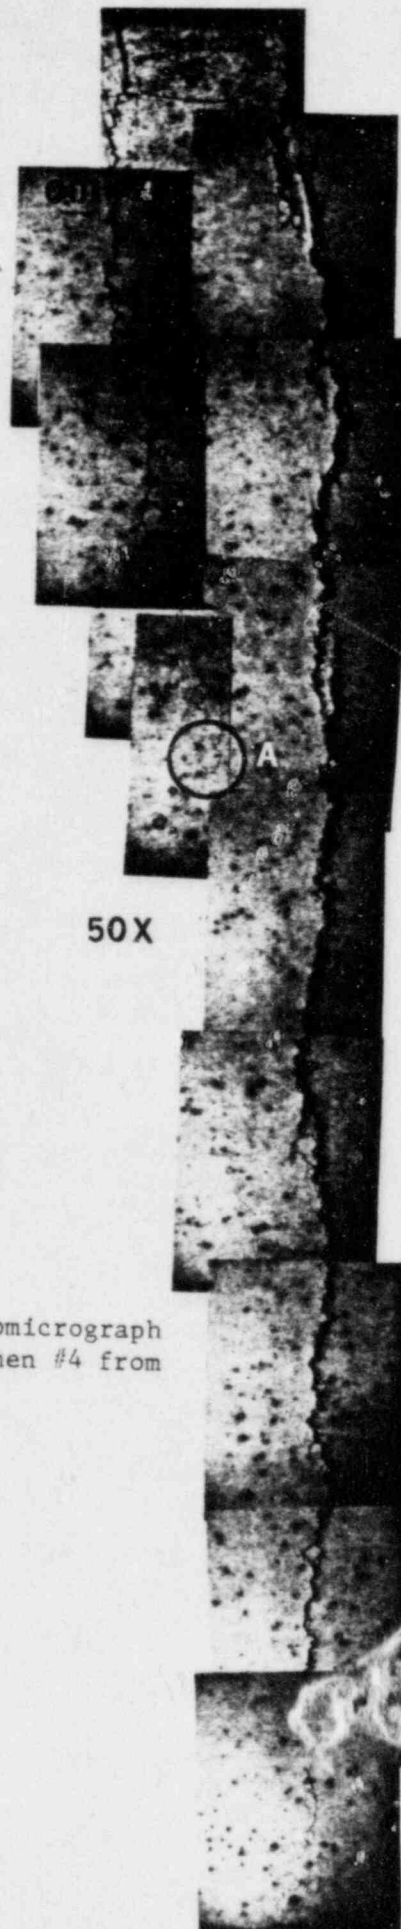
Specimens 4 and 5 were ground, metallographically polished, and then etched lightly in Vilella's reagent. It is clearly seen in the two photomicrographs (Figures 5 and 6) that the cracks are quite straight with very little branching in evidence. A higher magnification photomicrograph (Figure 7) of the circled area "A" of Figure 5 gives the intimation of an intergranular crack which is further emphasized in the more etched structure in Figure 8. The crack in this photomicrograph appears to be intergranular (along prior austenite grain boundaries) in a basically tempered martensite matrix. Two other photomicrographs of the structure after full term etching (Figures 9 and 10) display the tempered martensitic structure which was common to both specimens.

FIGURE 5. Low magnification photomicrograph of the cracks on Specimen #4 from the Farley MSIV.

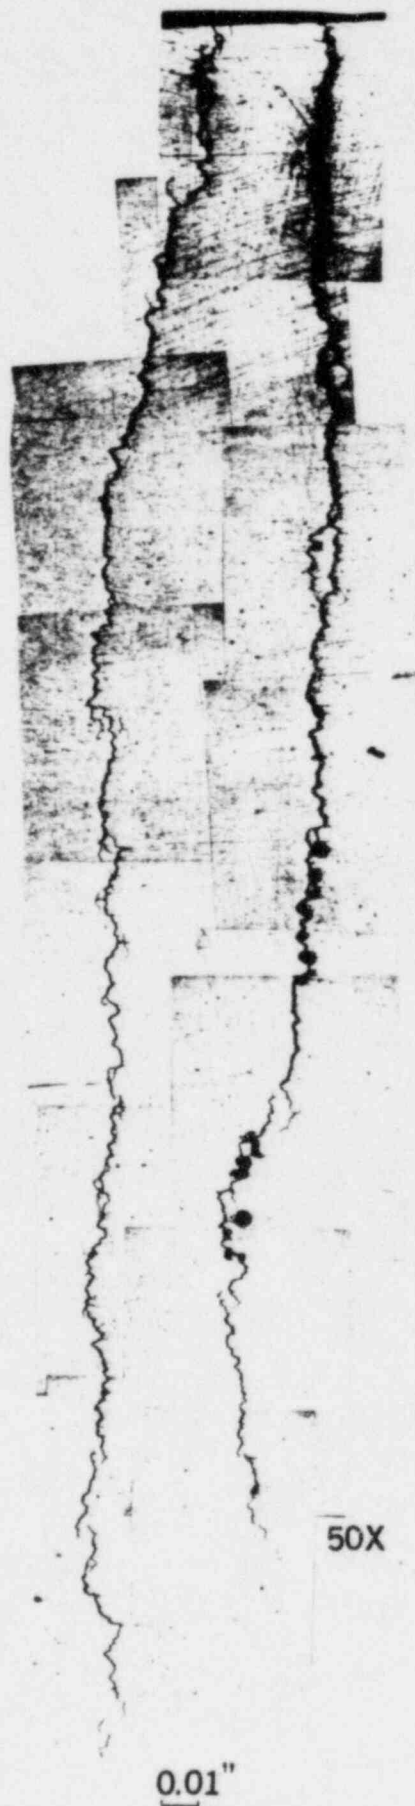
FIGURE 6. Low magnification photomicrograph of the cracks in evidence on Specimen #5 from the Farley MSIV.

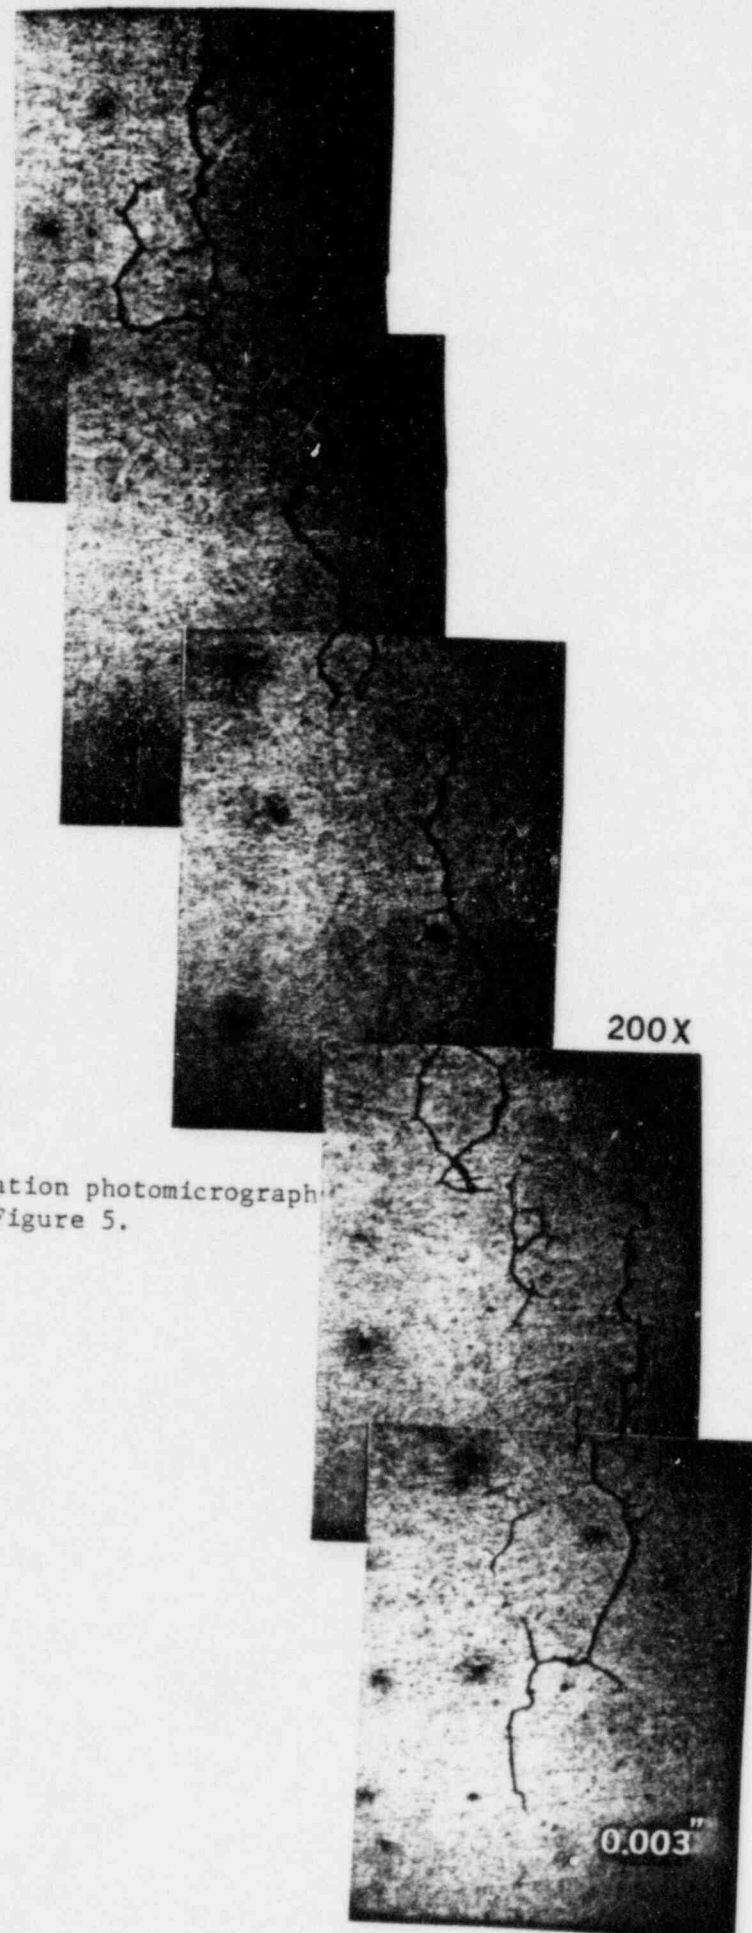
FIGURE 7. Higher magnification photomicrograph of Area "A" in Figure 5.

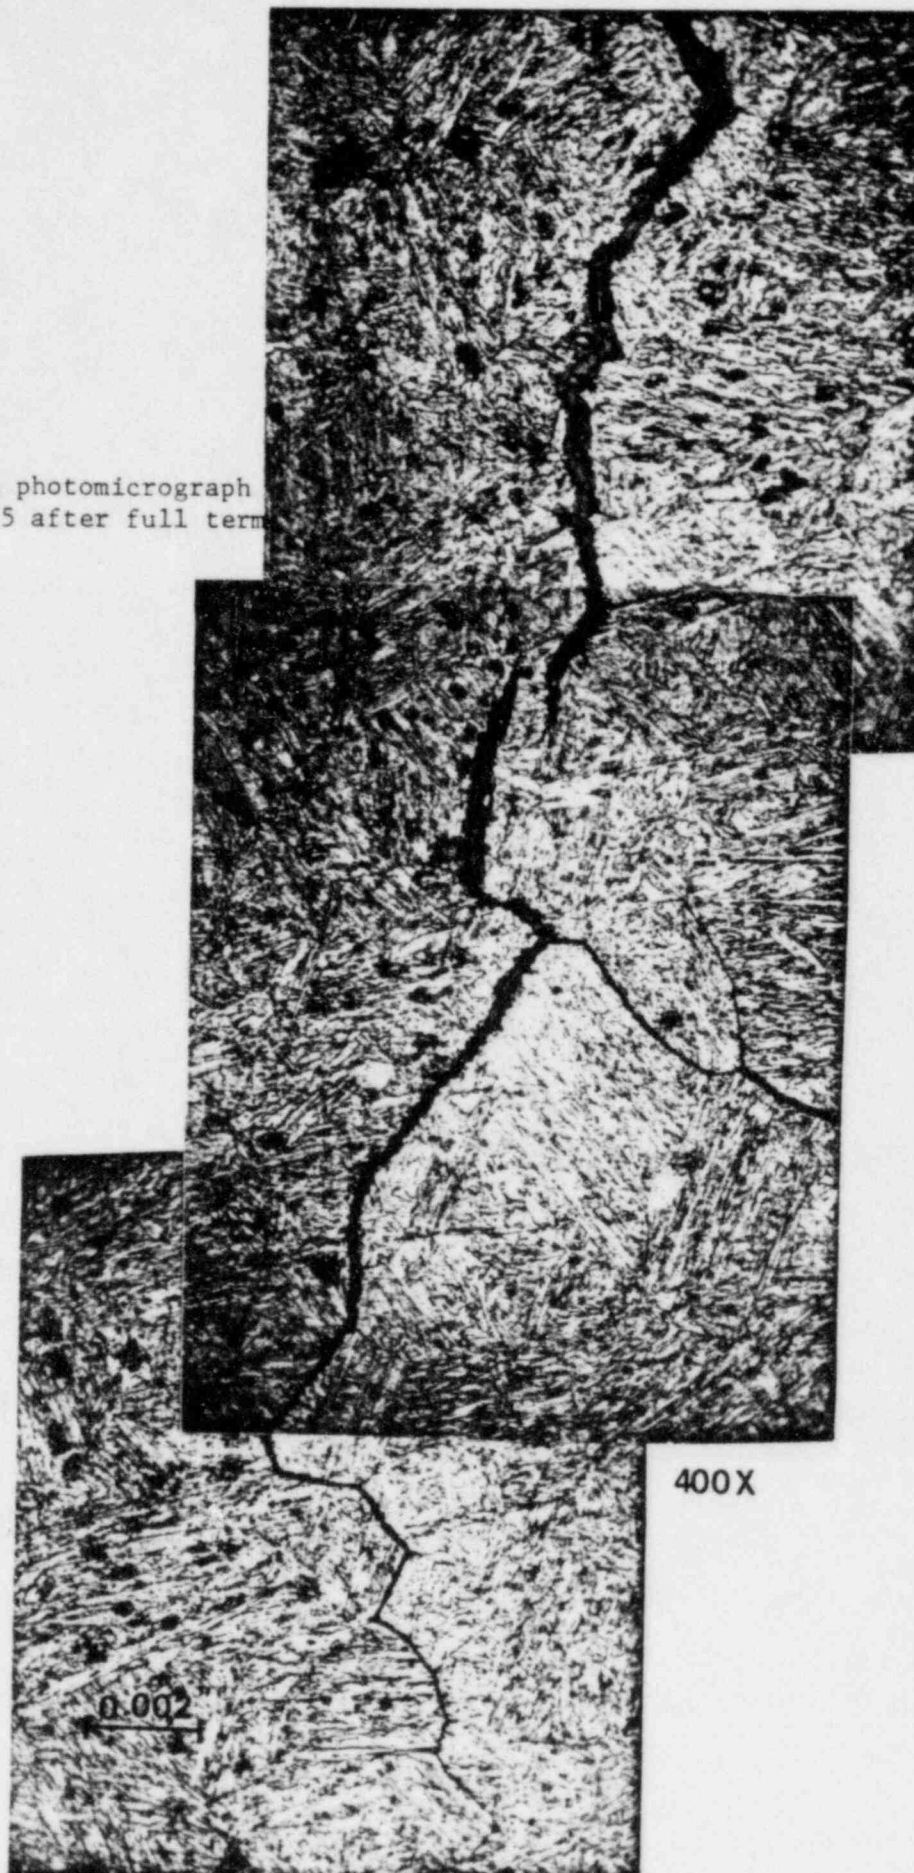
FIGURE 8. High magnification photomicrograph of crack on disc #5 after full term etching.

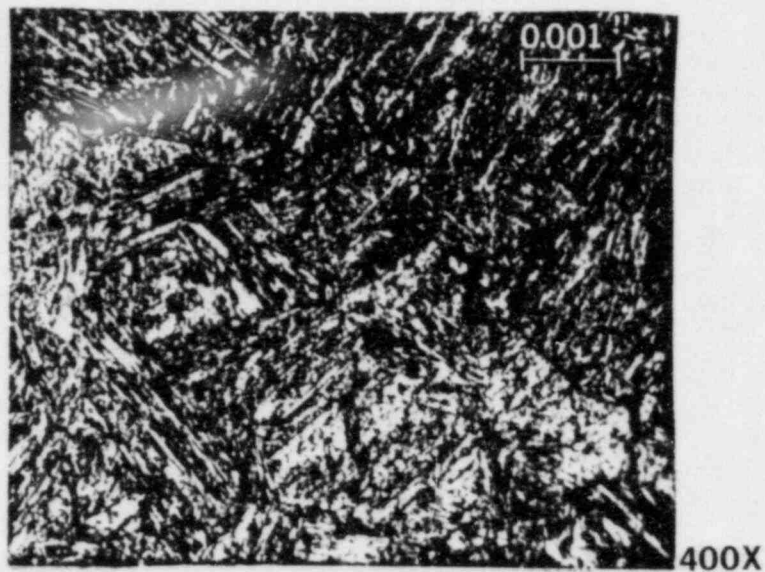
FIGURE 9. Photomicrograph showing structure of disc #4 as tempered martensite.

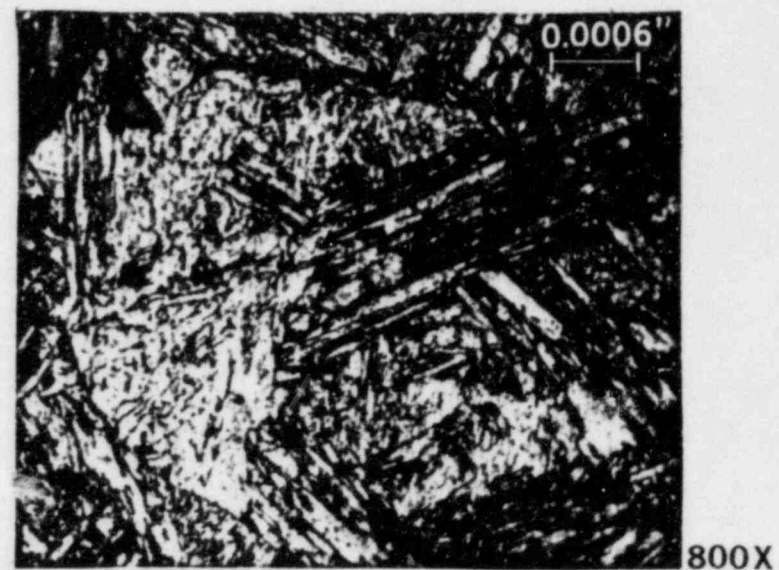
FIGURE 10. High magnification photomicrograph of disc #5 showing structure.

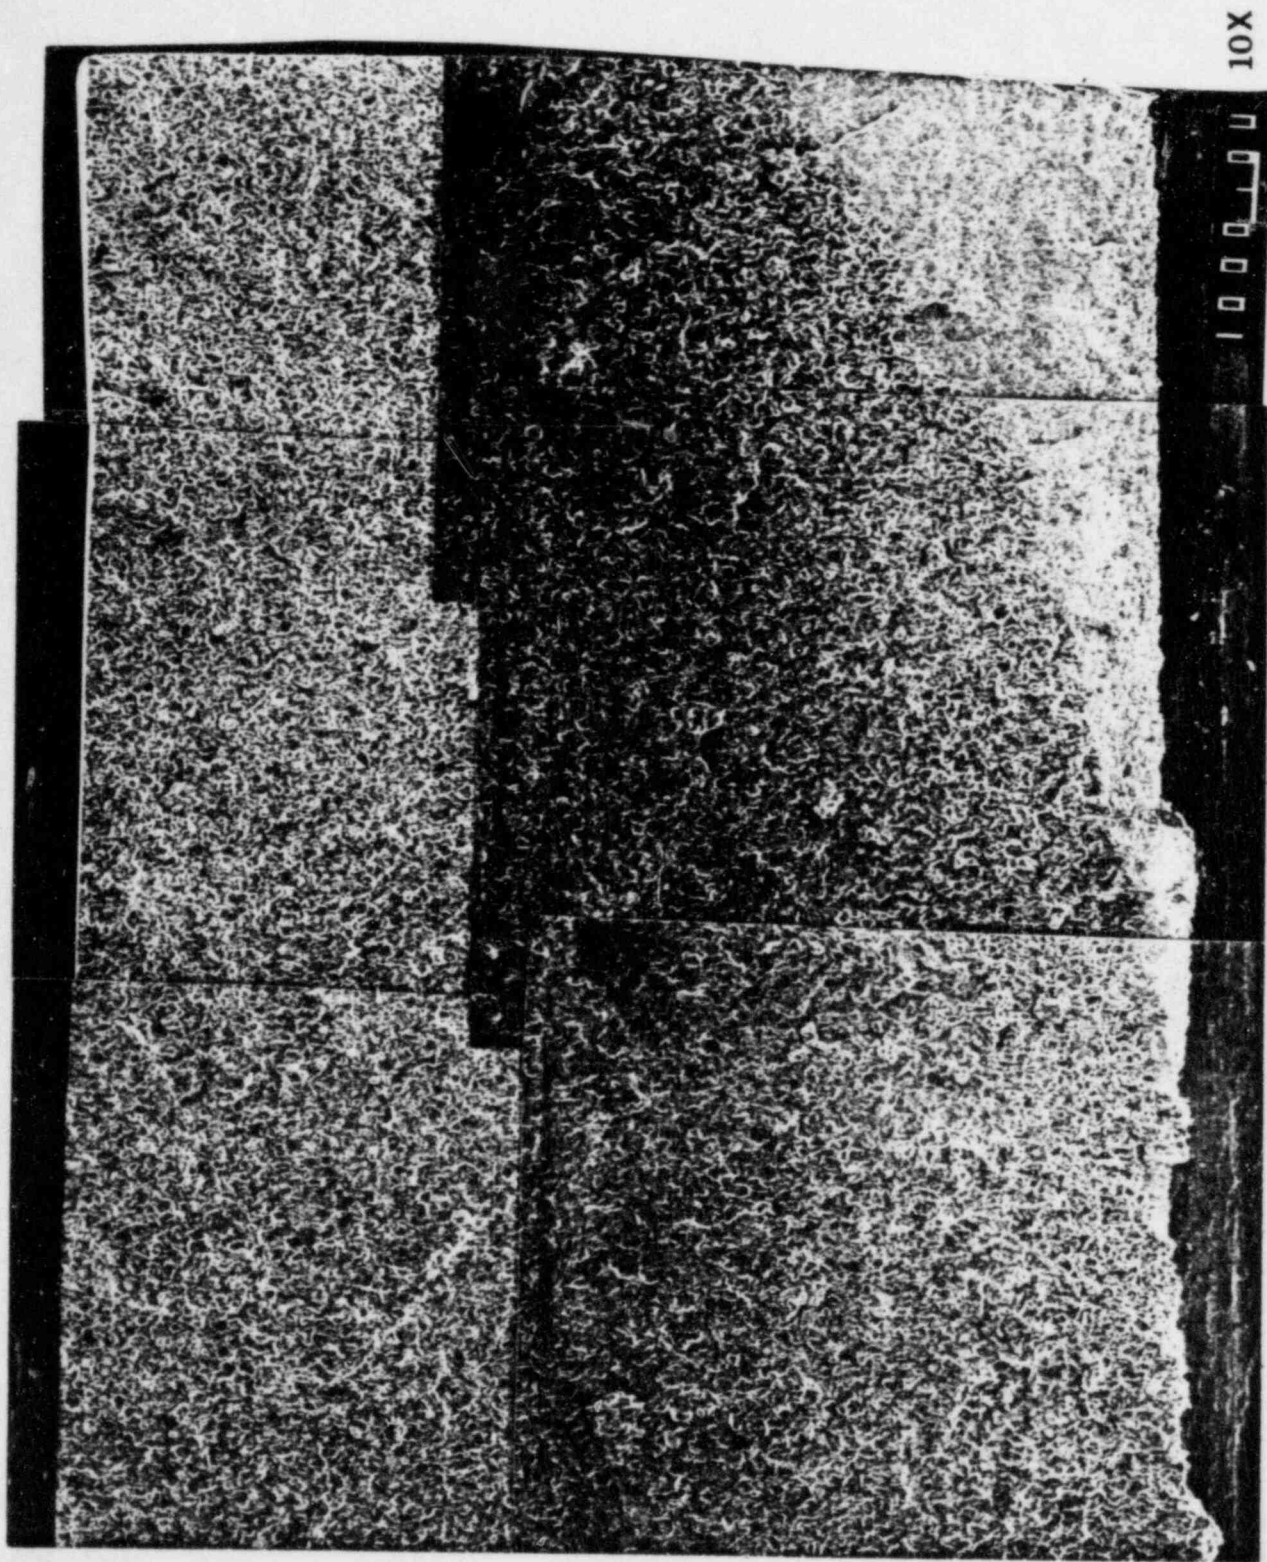
The fracture face of disc #2 was examined by SEM/EDS. The low magnification fractograph (Figure 11) shows a "thumbnail-like" fracture, granular in appearance and covered with oxide scale. Three EDS scans were made across the fracture face (Figures 12 - 14a) prior to a deoxidizing treatment. The oxide film varied from crystalline to powdery in appearance. All of the scans had Fe and Cr present, while many of the scans had a Zn peak associated with them. One scan (Figure 12) also had Al and Si present. The appearance of Zn on the fracture face could not be explained, unless a Zn-based lubricant was used somewhere on the valve near the packing gland area. It appeared that the further the scan moved away from the initiation surface, the lower the Zn peak, until near the leading edge of the crack (Figures 14, 14a) no Zn was detected.

FIGURE 11. Low magnification fractograph of disc #2 fracture face showing granular appearance.

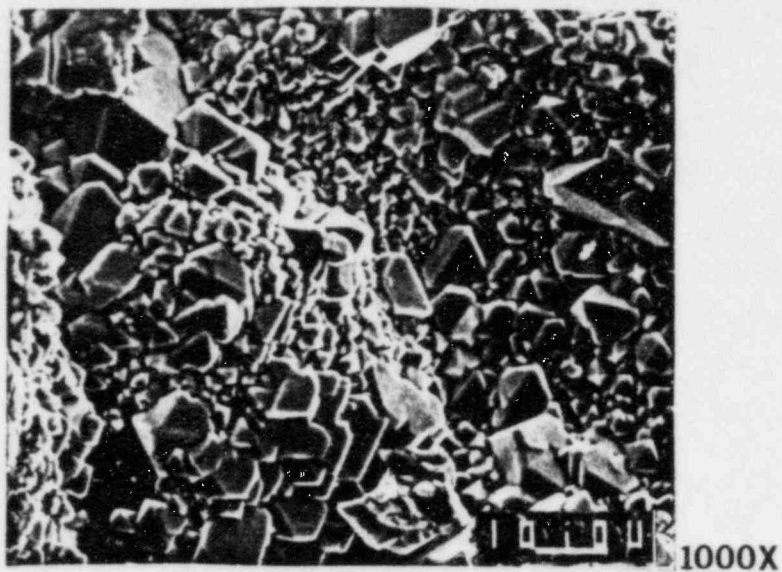
FIGURE 12. Fractograph of dark oxide area of disc #2.

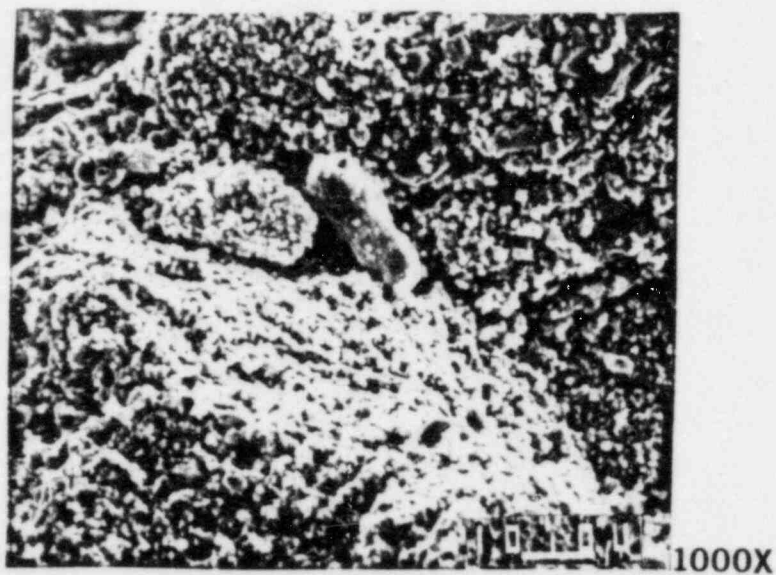
FIGURE 13. Powder like oxide is seen on the second fractograph of disc #2.

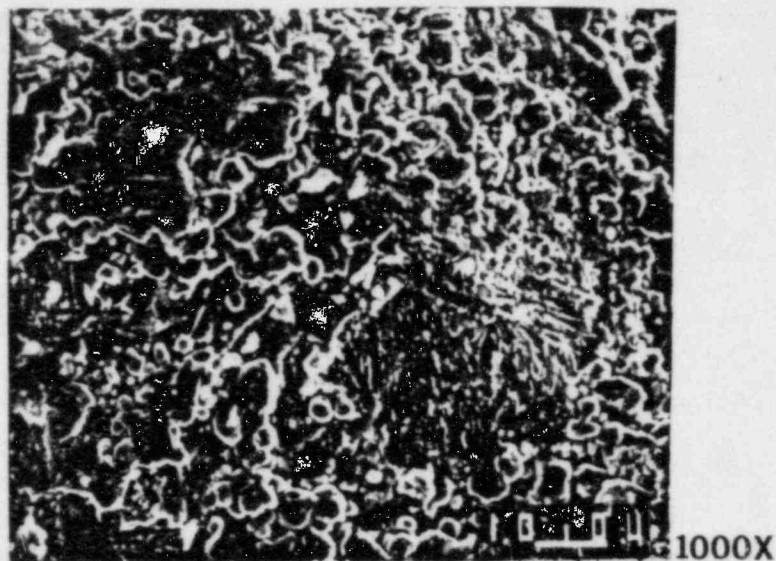
FIGURE 14. SEM photo of third scan on disc #2 — farthest scan away from initiation surface.

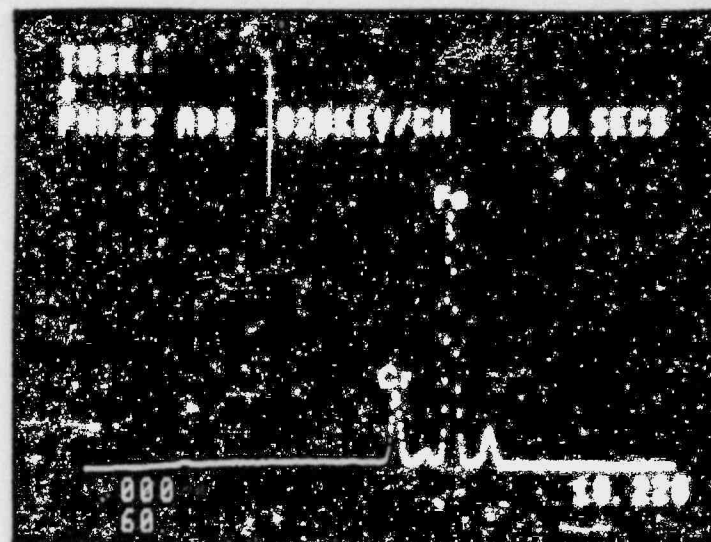
FIGURE 14a. EDS scan of area for constituents — note the absence of Zn.

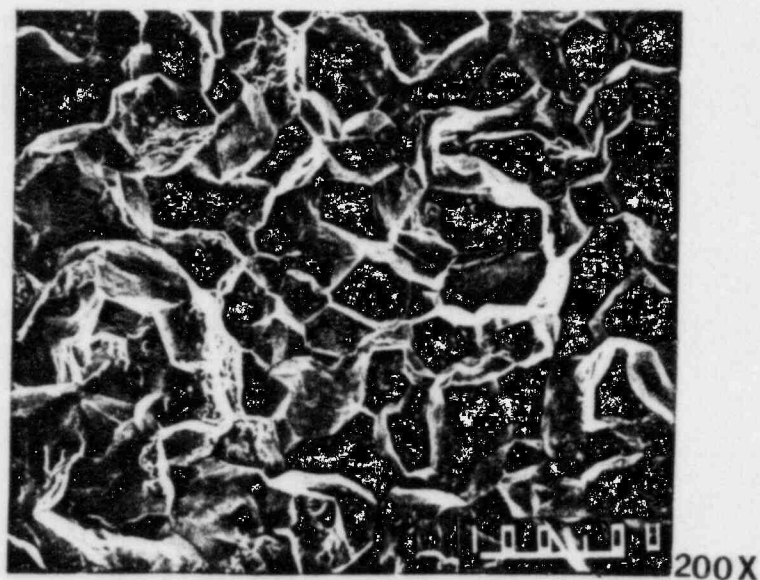
The resultant fracture appearance after the deoxidizing treatment is displayed in Figure 15. It is clearly evident that the fracture is predominantly intergranular in appearance. Complete examination of the fracture disclosed no indication of fatigue interaction.

FIGURE 15. Intergranular structure of disc #2 fracture surface is evident after deoxidizing treatment.

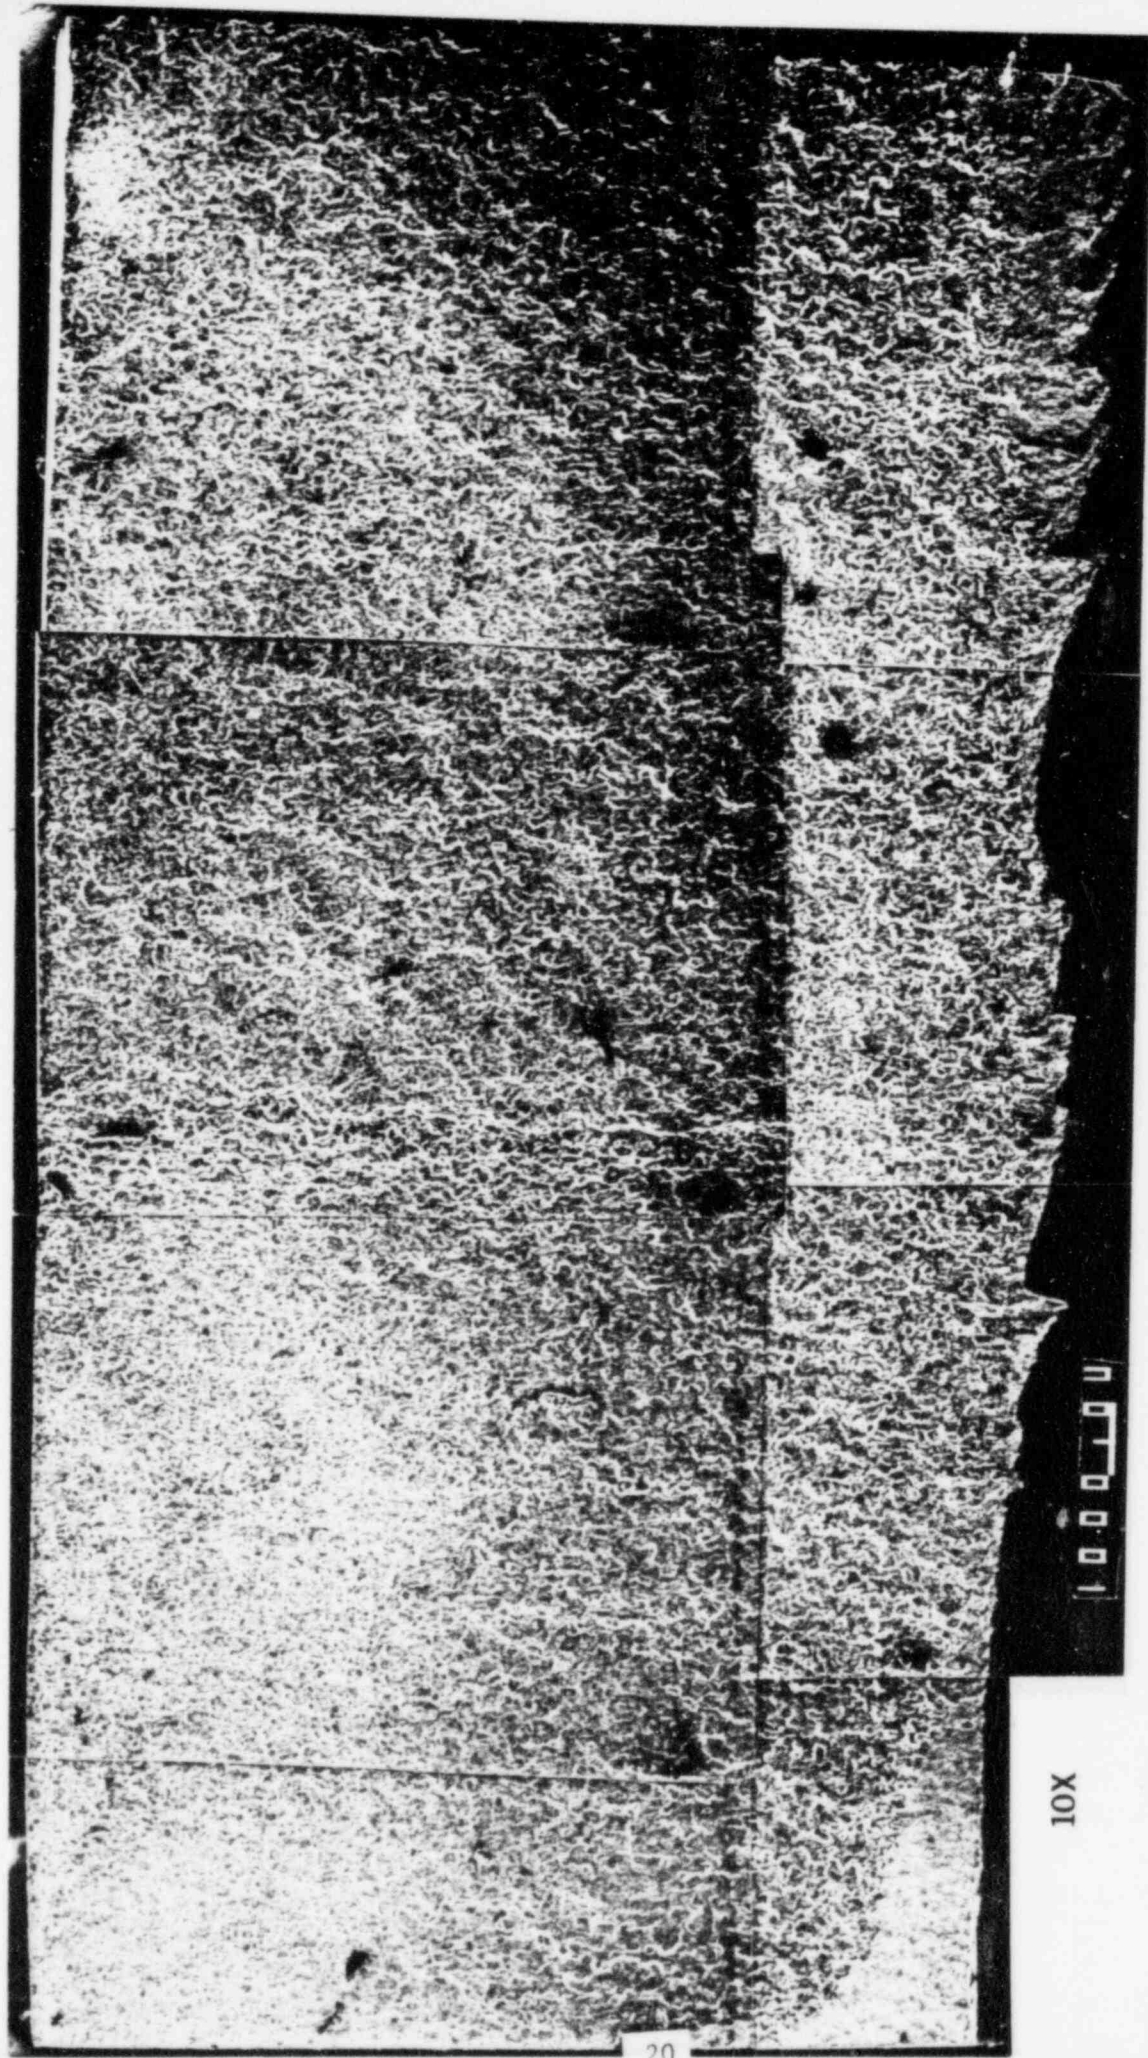
The fracture face of disc #6 was also examined (Figure 16) by SEM. The fracture face was also granular in appearance with no areas of fatigue interaction. Both EDS scans (Figures 17-18a) had Cr, Fe and Al associated with them. The scan furthest away from the initiation surface had no Zn associated with it, while the more heavily oxidized (darker) area near the initiation surface had both Zn and Si present in the scan.

FIGURE 16. Low magnification SEM photo of the fracture on disc #6.

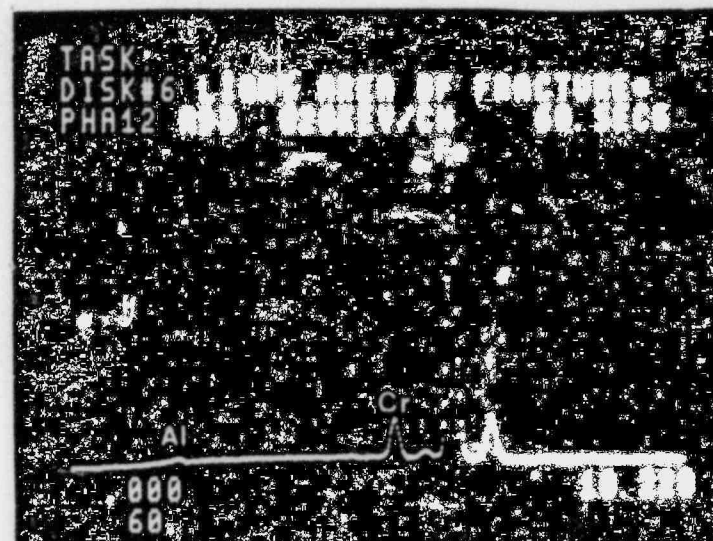
FIGURE 17a. EDS scan of area for constituents — note the absence of Zn.

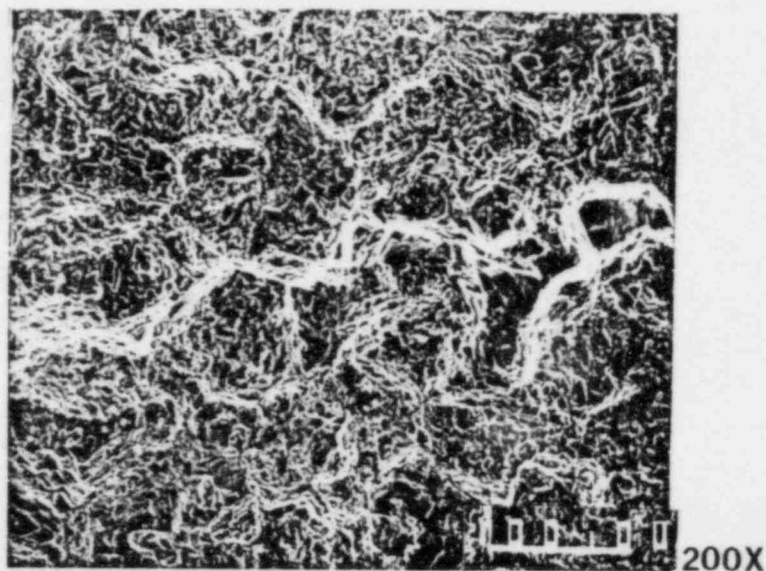
FIGURE 18. Fractograph of dark oxide area of disc #6.
