LETTER REPORT

EVALUATION OF CRACKS ON THE JOSEPH M. FARLEY UNIT #1
MAIN STEAM ISOLATION VALVE (MSIV) SHAFT

Materials Technology Division
Department of Nuclear Energy
Brookhaven National Laboratory
Upton, New York 11973

AUGUST 1984

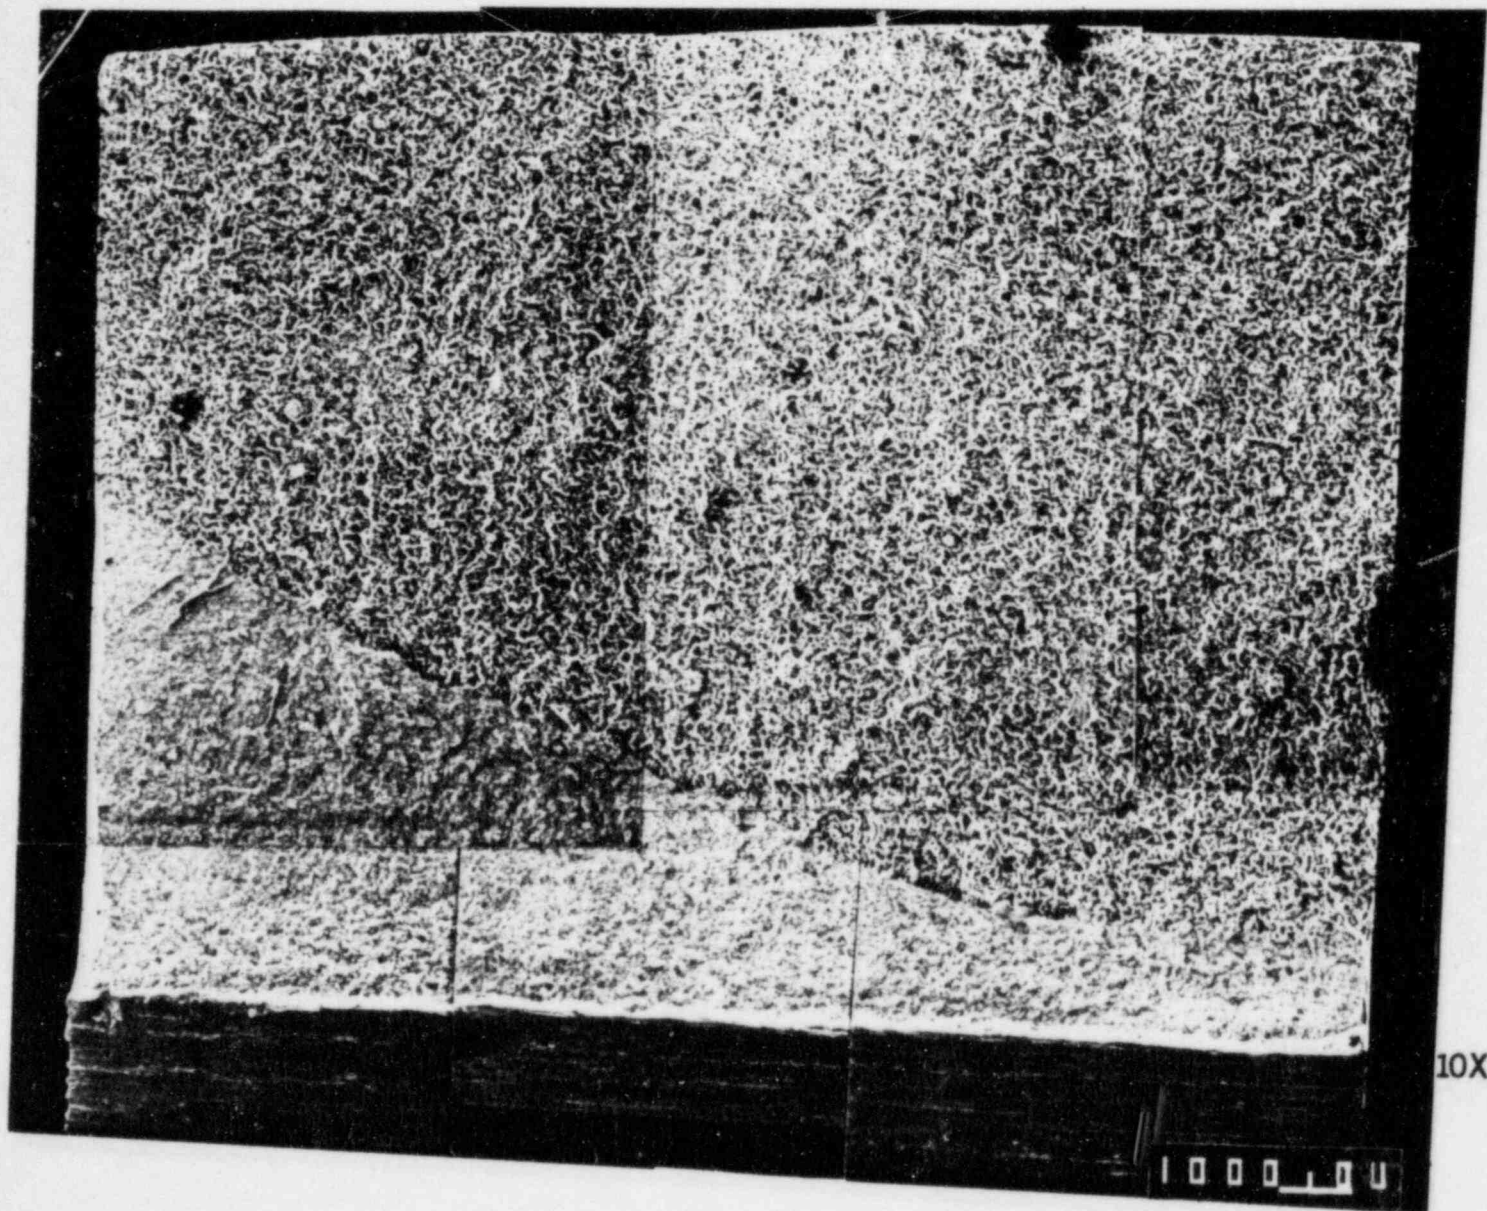
The final fracture face examined was from disc #7 (Figure 19). The fracture was also granular and had a thumbnail appearance. EDS scans were performed across the fracture surface (Figures 20-22b). All of the scans had Cr, Fe, Zn and Al in common, with three of the four scans exhibiting a Si peak.

FIGURE 19. Low magnification fractography of the fracture face from disc #7.

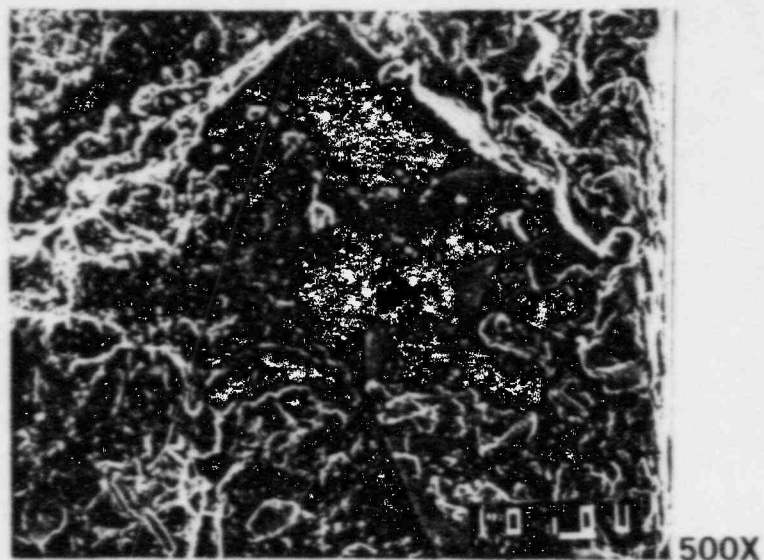
FIGURE 22. SEM photo of an intergranular facet on disc #7.

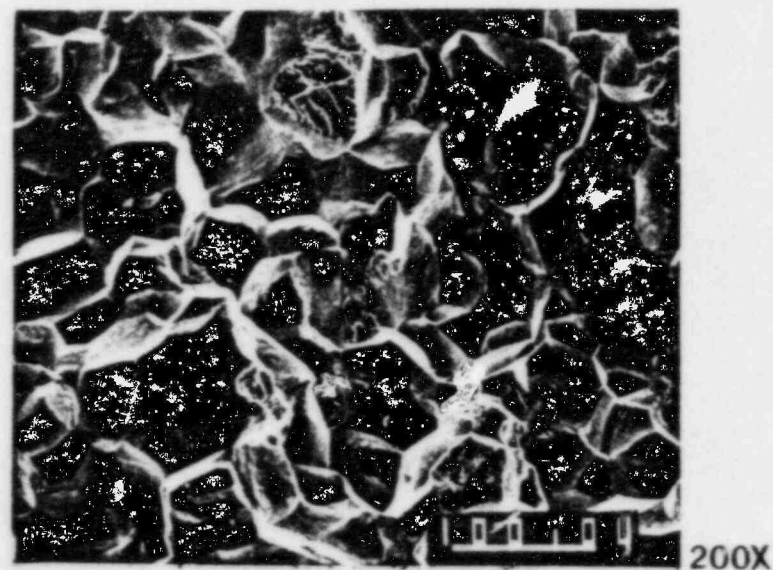
After examination by EDS the fracture face was deoxidized and examined by SEM. Figure 23 is a fractograph which shows the intergranular facets that were typical on this fracture.

FIGURE 23. Fractograph of intergranular nature of disc #7 fracture after deoxidizing treatment.
