LETTER REPORT

INVESTIGATION ON A FEEDWATER REDUCER FROM FARLEY UNIT 1

Brookhaven National Laboratory
Department of Nuclear Energy
Upton, New York 11973

JULY 1984

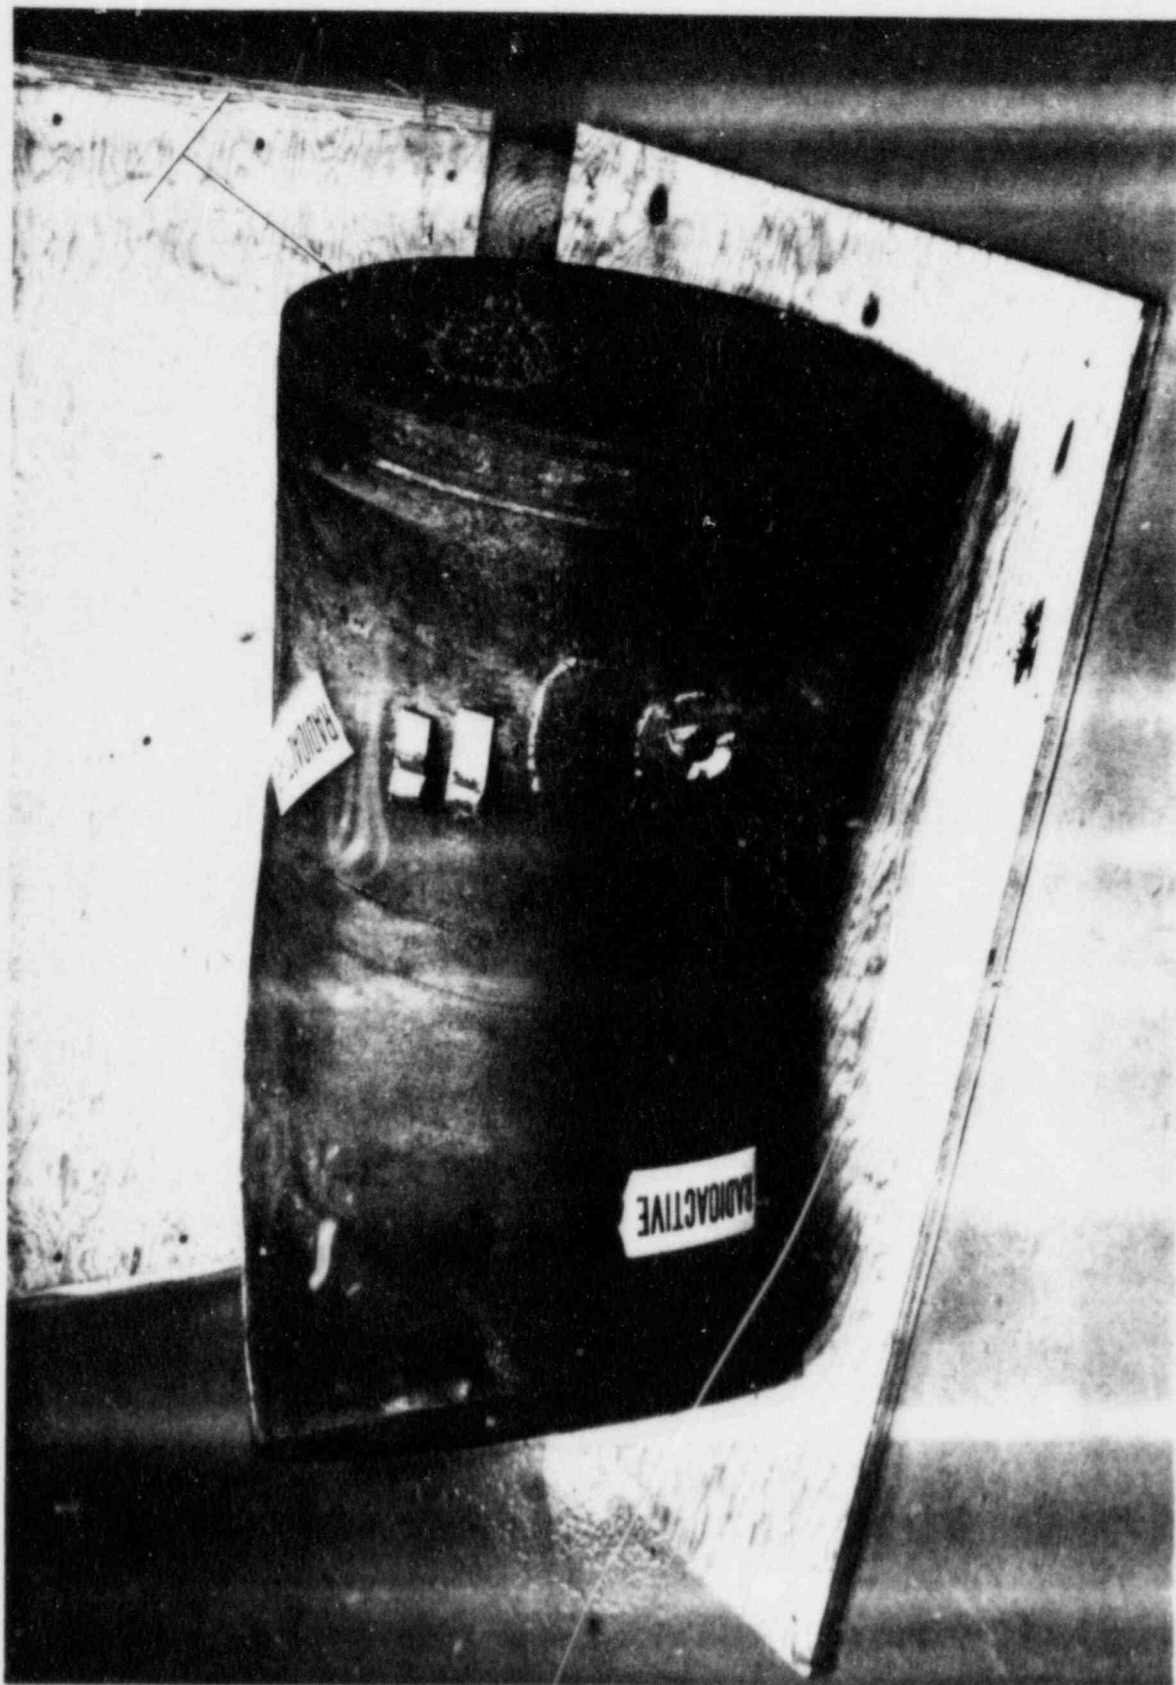
Visual examination of the extrados end of the reducer revealed no linear indications so a dye penetrant examination was performed using spotcheck brand (all Formula B) penetrant Type SKL-HF/SKL-S, developed type SKD-NF and cleaner/remover type SKC-NF. After two applications of the process with no indications revealed, it was concluded that the indications had probably been inadvertently removed during the reducer's removal from the nozzle.

Figure 1 Photograph of feedwater reducer 1B from Farley Unit 1.
Arrow points to extrados end of reducer.

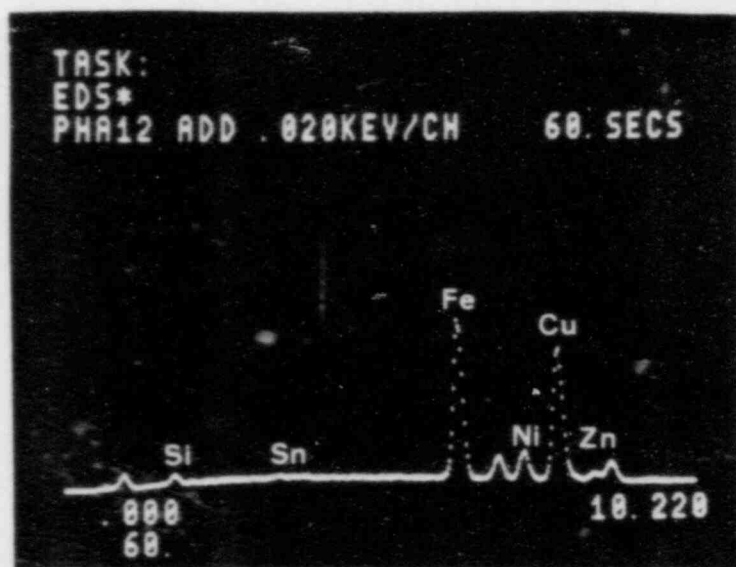
The scrappings were evaluated by Energy Dispersive Spectroscopy (EDS) for chemical analysis. It can be seen on Figures 2 and 2A that the scrappings consisted of Fe, Ni, Cu, Zn, Sn with Si present on one scan.

Figure 2a EDS scan of scrapings for constituents.

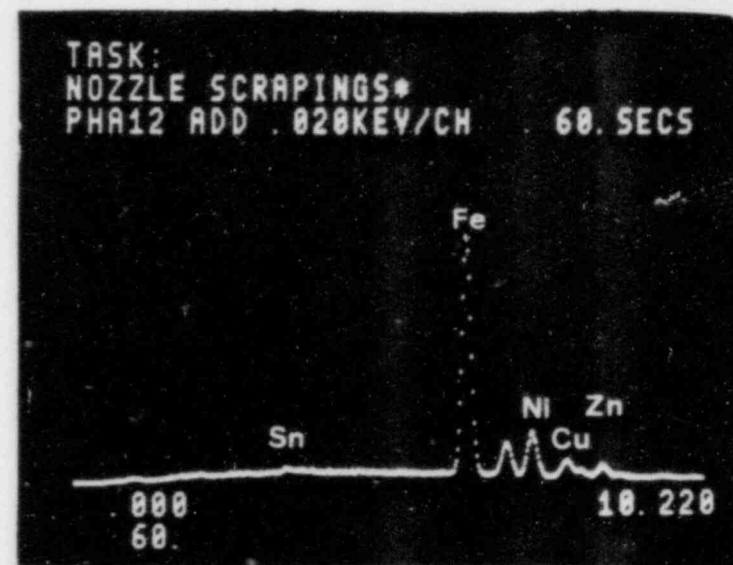
Figure 2b Second EDS scan for chemical analysis of scrapings.
