# NORTHEAST UTILITIES

September 15, 1991  
MP-92-997

Reference: Facility Operating License No. NPF-49  
Docket No. 50-423  
Licensee Event Report 92-016-01

Attachment: LER 92-016-01

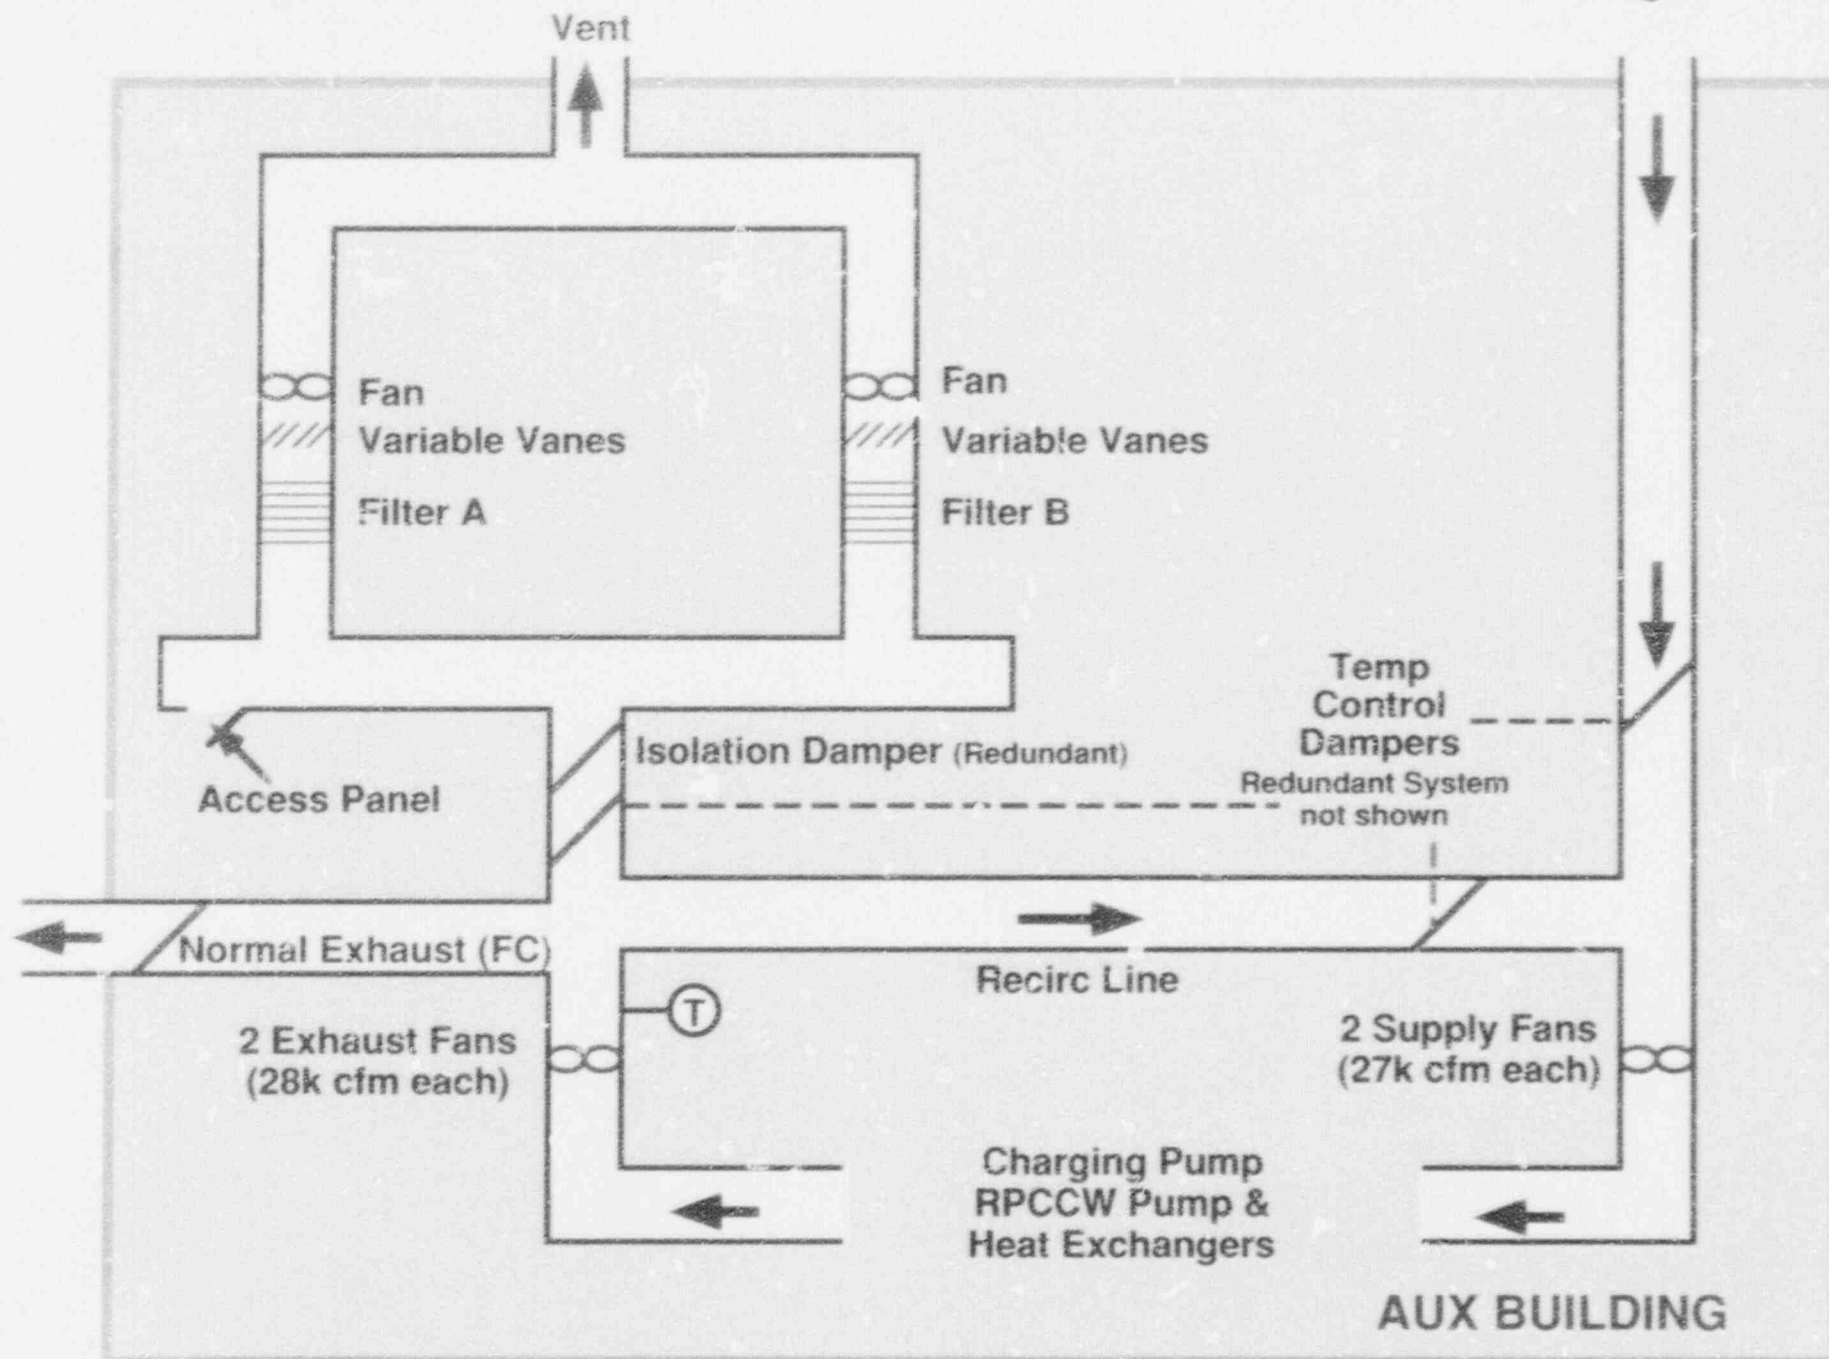
- filter the air in the Auxiliary Building before discharge to the atmosphere. This is accomplished by passing the discharge of the Charging Pump and Component Cooling Water Area Ventilation exhaust fans (see attached drawing) through the filters.
- assist the Supplemental Leak Collection and Release System (SLCRS) in maintaining a negative pressure in the Auxiliary Building. This is accomplished by exhausting more air than is brought into the building by the Charging Pump and Component Cooling Water Area Ventilation supply fans (see attached drawing).

The open access door is assumed to have a non-conservative effect on the amount of air removed by the Auxiliary Building Filter System. The section of duct where the access door is located is pressurized in the accident alignment. Opening the access door may reduce the inlet pressure to the Auxiliary Building Filter System fans with a subsequent reduction in flow. A simplified sketch of the Auxiliary Building Filter System is included in this report.

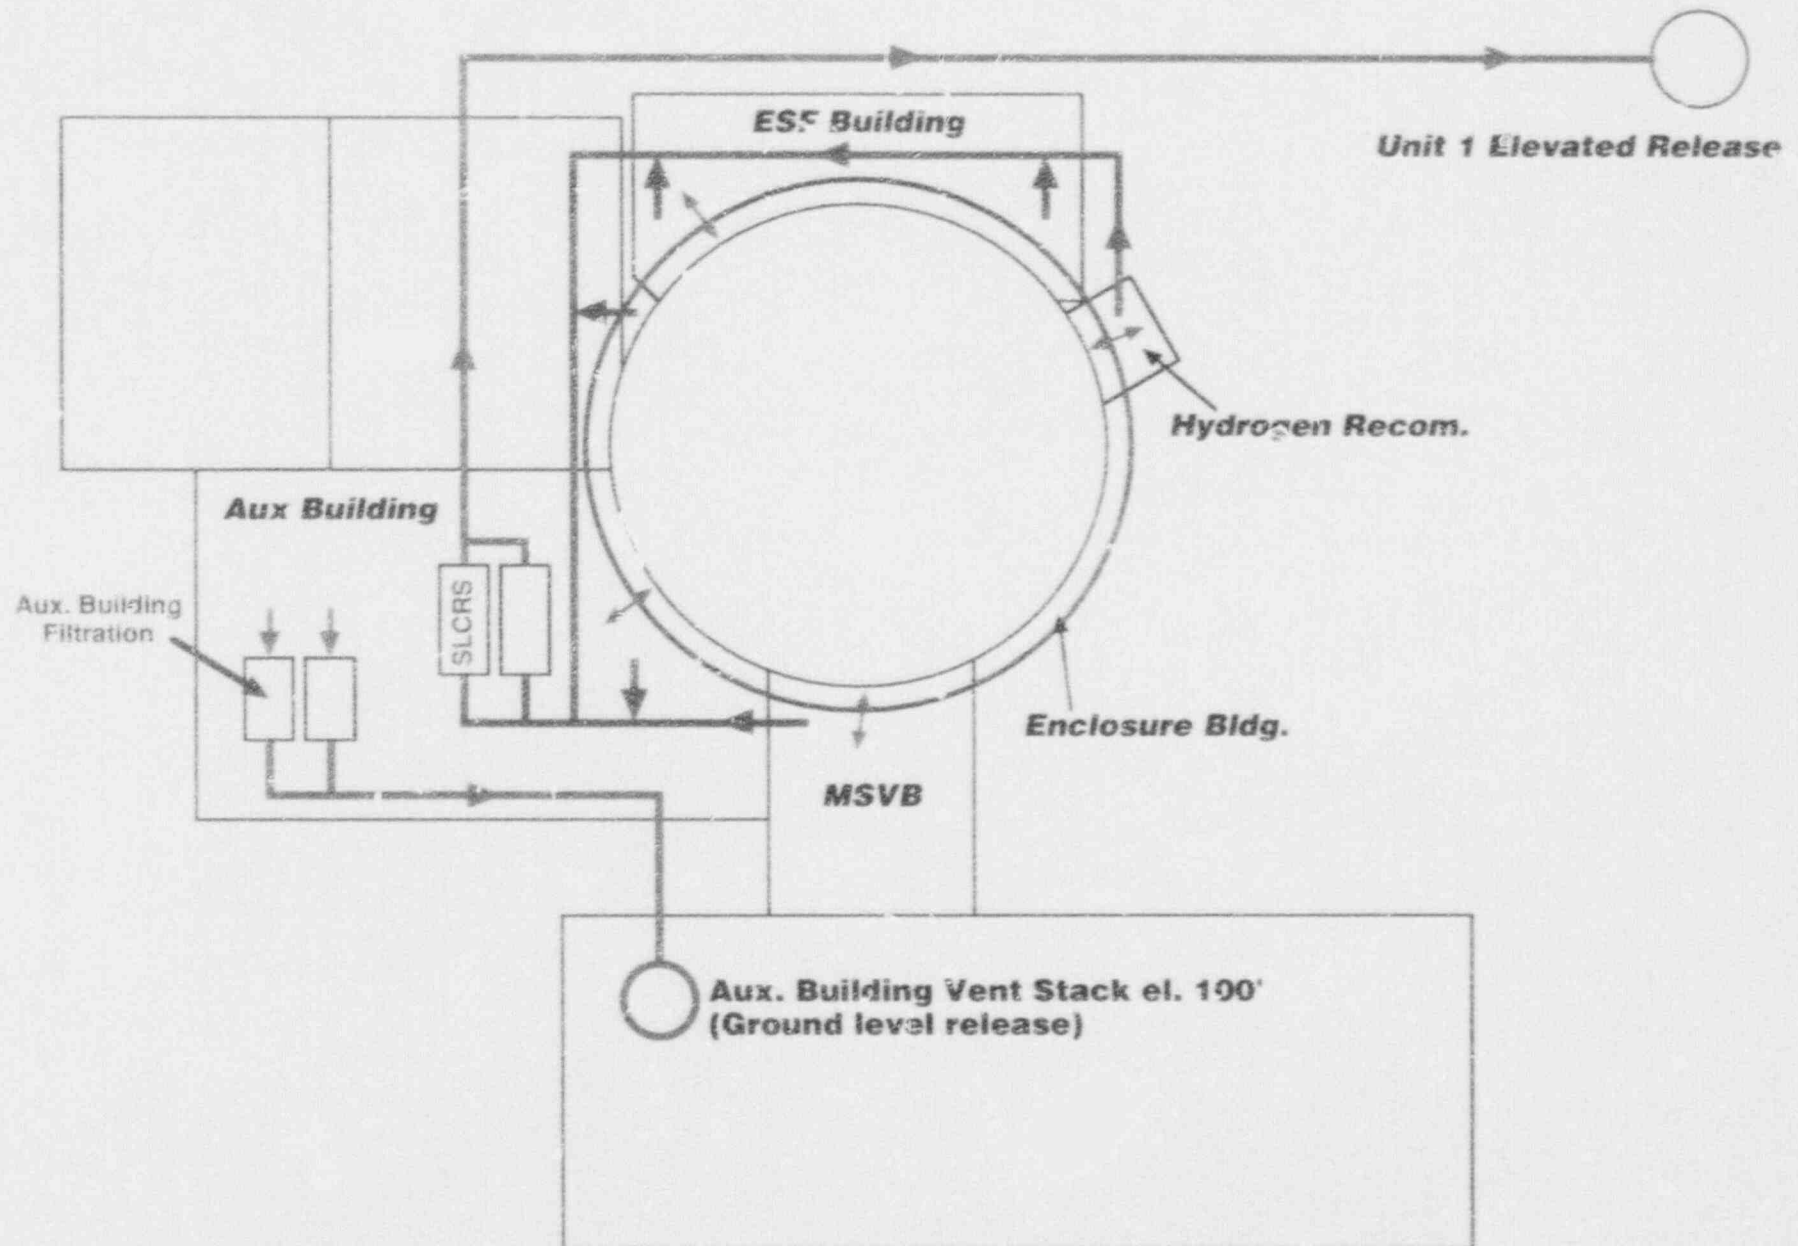
## Secondary Containment Drawdown

The two systems, Auxiliary Building Filter System and SLCRS, work together to establish the negative pressure. A simplified drawing of the secondary enclosure is included in this report. The two systems are tested together to demonstrate the ability to achieve the negative .25 inches water gage pressure within 1 minute inside the secondary containment enclosure during the 18 month secondary enclosure drawdown surveillance.
