SUBJECT: Calvert Cliffs Nuclear Power Plant
Unit No. 2; Docket No. 50-318; License No. DPR 69
Licenses Event Report 92-006

LICENSEE EVENT REPORT (LER)

Reactor Trip on RPS when MSIV Shut Due to Hydraulic System Malfunction

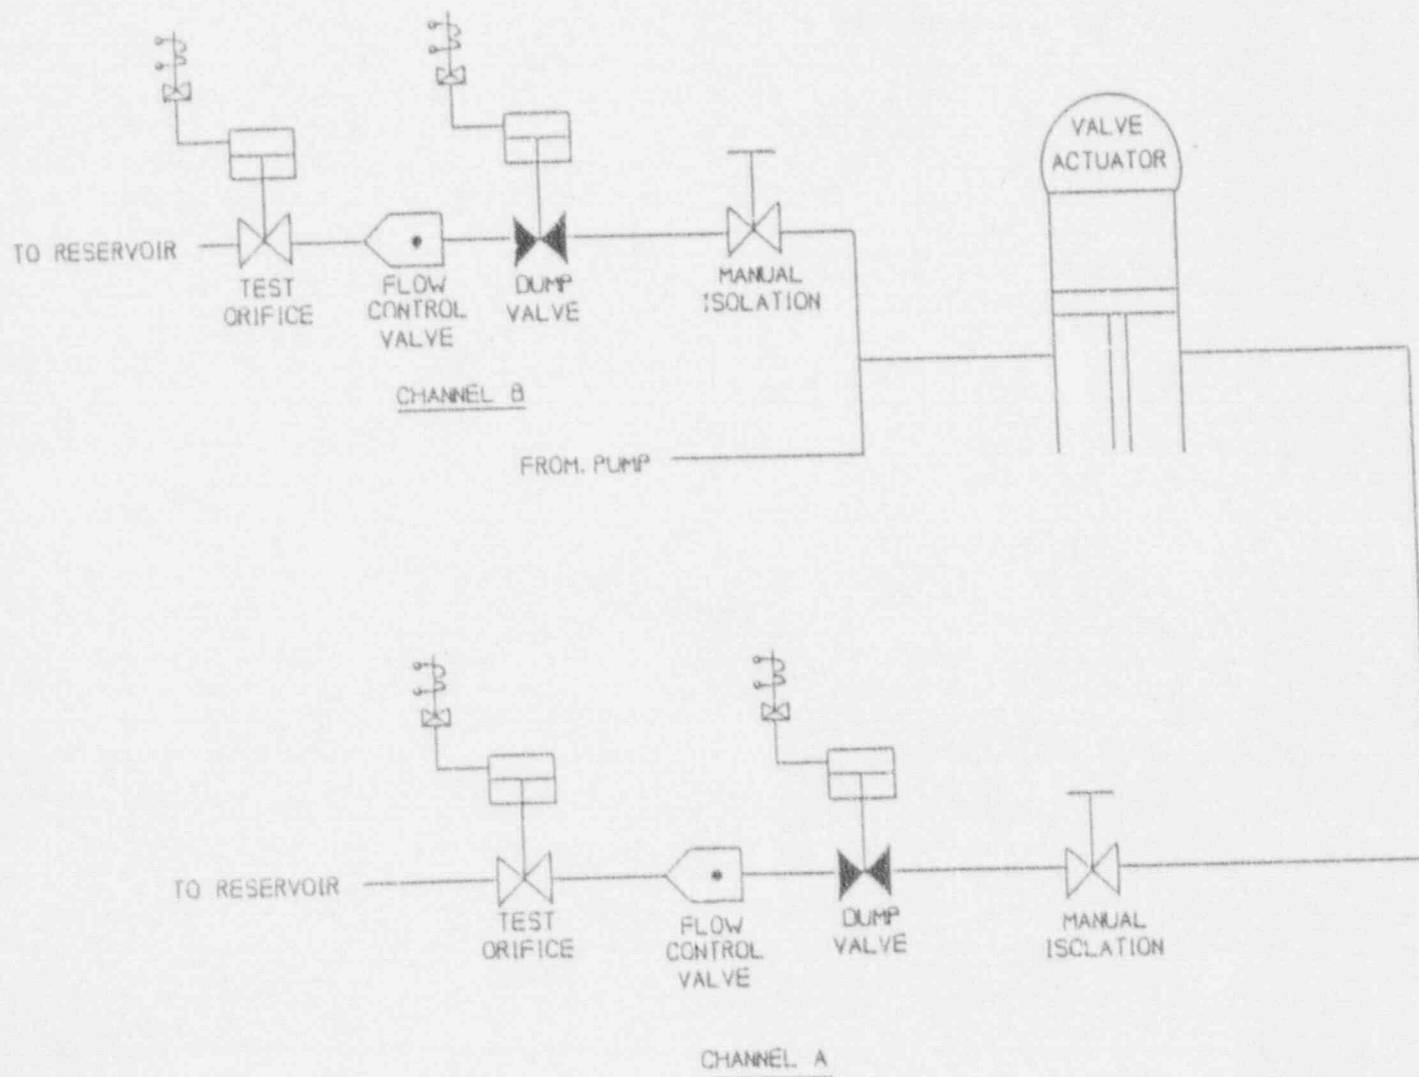
SIMPLIFIED MSIV HYDRAULIC DIAGRAM

STP O-47B-02 was scheduled to be performed on the evening of August 17, 1992, on both Unit 2 MSIVs, 21 and 22. The hydraulic system for opening and closing the MSIVs is arranged as shown in Attachment 1. Hydraulic pressure is maintained by an air driven hydraulic pump cycling on and off as necessary. The hydraulic pressure in the system is used to open and keep open the MSIVs. When the pressure is relieved, the MSIVs shut. There are two parallel hydraulic relief paths, channel A and channel B, that lead to a common reservoir. Each path contains a main dump valve and an exercise piston containing an orifice in series. The valve and exercise piston are controlled by solenoids that port hydraulic fluid in the appropriate direction. In MODE 1, the dump valve is normally shut. The exercise piston contains an orifice to slow the rate of hydraulic fluid flow through the line. In MODE 1, the exercise piston is normally retracted. The exercise piston is only extended when performing the partial stroke test. When the dump valve is open, there is a relief path to the reservoir and the MSIV shuts. When the exercise piston is extended, the orifice slows the rate of hydraulic fluid flow and thus slows the rate at which the MSIV shuts when the dump valve is opened.

The immediate cause of this event was that the MSIV 22 dump valve did not shut before the exercise piston was retracted. With the exercise piston removed, MSIV 22 started to shut at a faster speed. Before the valve completely shut, the dump valve shut and MSIV 22 stopped shutting. MSIV 22 stroked correctly during follow-up testing.

This event was most likely caused by a hydraulic problem or mechanical binding in the dump valve assembly.

A hydraulic problem could prevent establishment of hydraulic pressure to shut the MSIV 22 channel B dump valve. Hydraulic fluid samples in December 1991 and subsequent to the trip are inconclusive, however, the post-event samples did indicate increased levels of particulates. Normal monthly samples were not available due to inoperability of the sample valve. The MSIV technical manual recommends changing out the fluid annually, but because this requires the MSIV to be fully shut, the MSIV hydraulic fluid is changed out every refueling cycle during MSIV overhaul. It was last changed out in October, 1990, and exposed to high temperatures starting in May, 1991.

All the hydraulic fluid in the MSIVs 21 and 22 was changed out and the systems were flushed.

The MSIV 22 hydraulic fluid sample valve was replaced.

The MSIV 21 and 22 dump valve solenoids will be replaced.
