NORTHEAST UTILITIES

Reference: Facility Operating License No. NPF-49
Docket No. 50-423
Licensee Event Report 92-020-00

LICENSEE EVENT REPORT (LER)

FACILITY NAME (1) Millstone Nuclear Power Station Unit 3	DOCKET NUMBER (2) 0501042392	LER NUMBER (6)			PAGE (3) 02 OF 07
		YEAR 92	SEQUENTIAL NUMBER 020	REVISION NUMBER 00

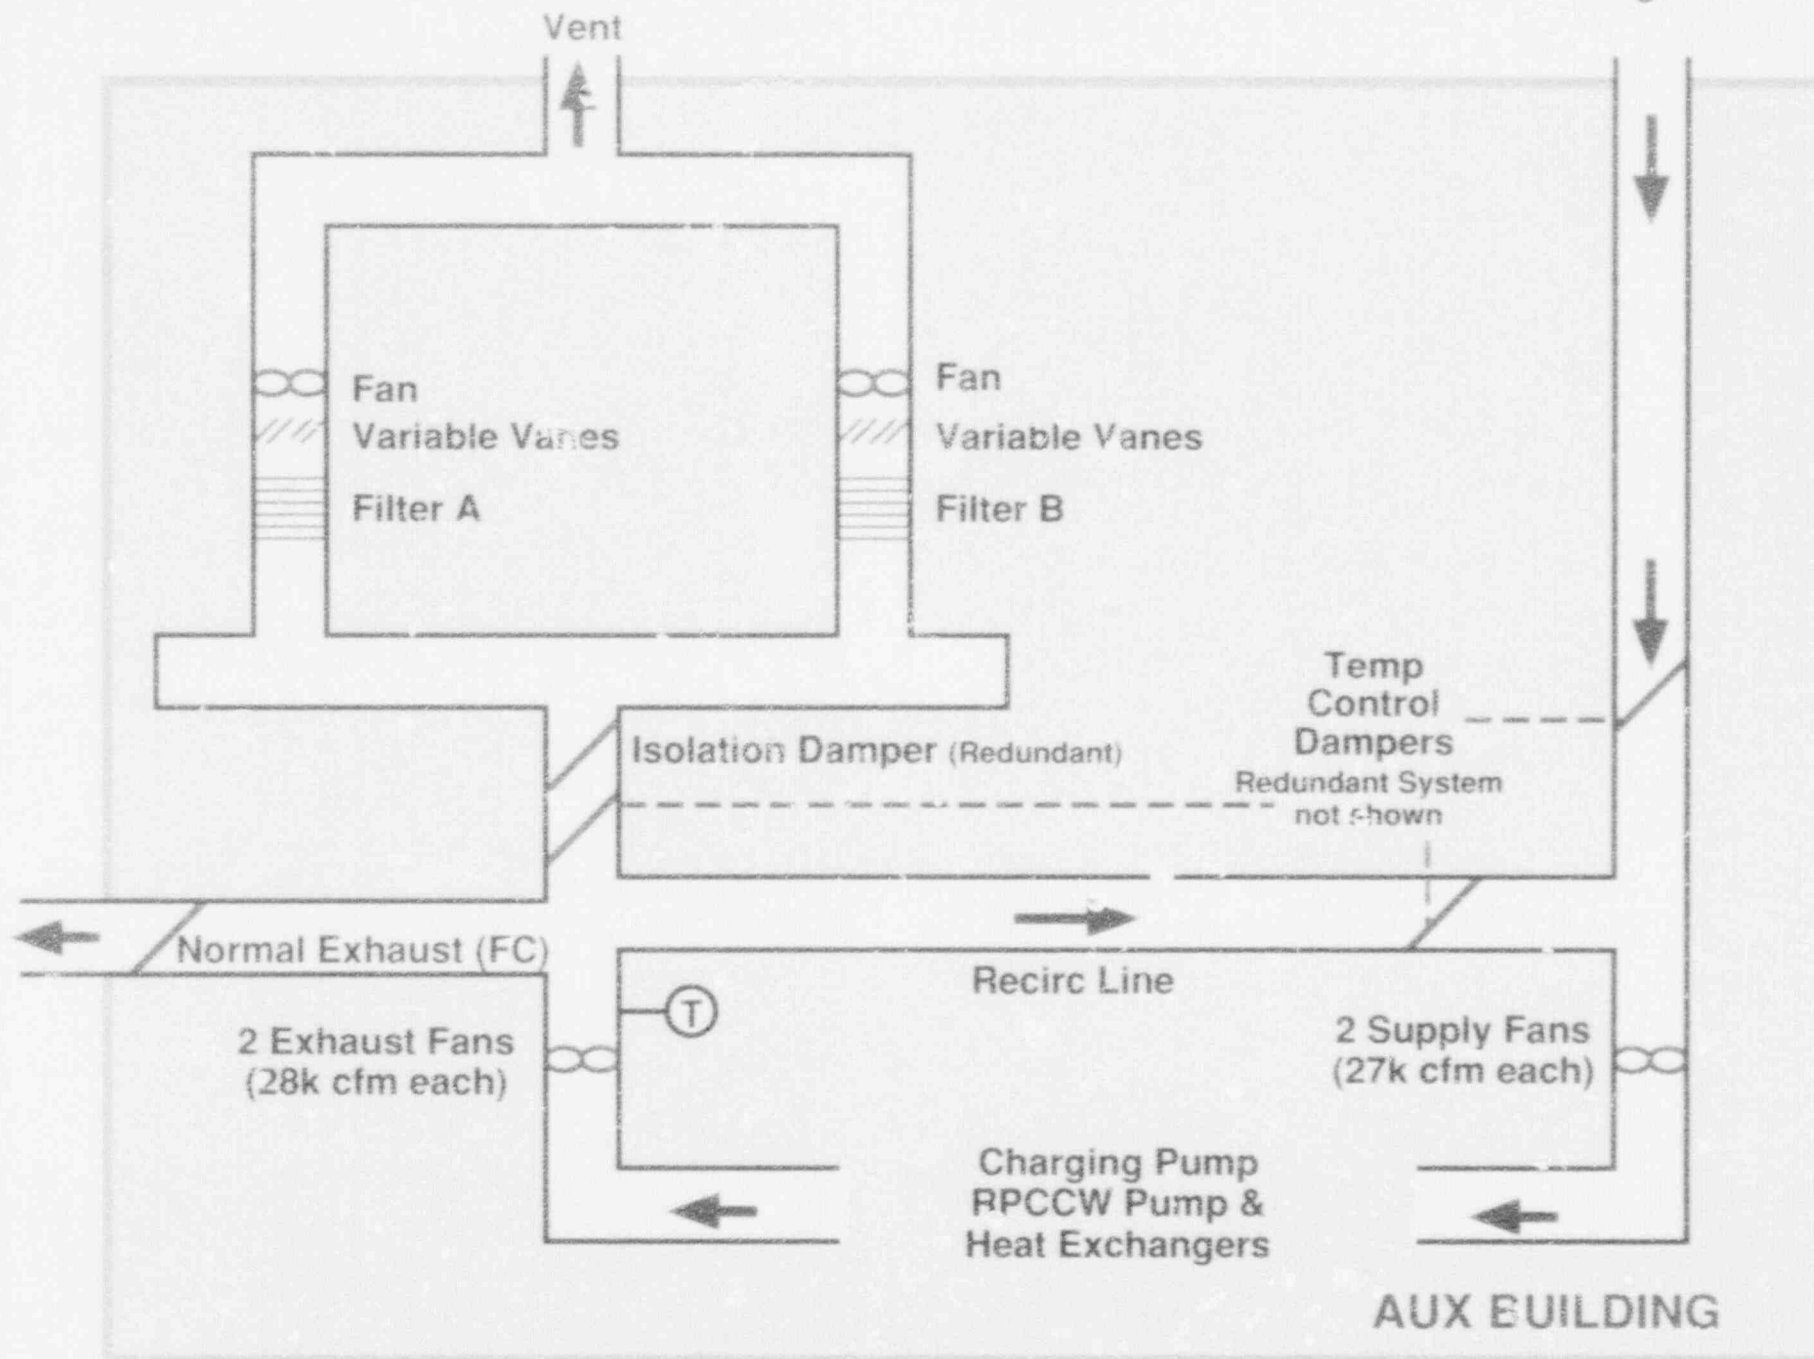
- filter the air in the Auxiliary Building before discharge to the atmosphere. This is accomplished by passing the discharge of the Charging Pump and Component Cooling Water Area Ventilation exhaust fans (see attached drawing) through the filters.
- assist the Supplemental Leak Collection and Release System (SLCRS) in maintaining a negative pressure in the Auxiliary Building. This is accomplished by exhausting more air than is brought into the building by the Charging Pump and Component Cooling Water Area Ventilation supply fans (see attached drawing).

The two systems, Auxiliary Building Filter System and SLCRS, work together to establish the negative pressure. A simplified drawing of the secondary enclosure is included in this report. The two systems were tested together to demonstrate the ability to achieve the negative 2.2 inches water gage pressure within 1 minute inside the secondary enclosure during the 18 month secondary enclosure draw down surveillance.
