James A. FitzPatrick  
Nuclear Power Plant  
P.O. Box 41  
Blycoming, New York 13093  
315 342-3840

SUBJECT: DOCKET NO. 50-333  
LICENSEE EVENT REPORT: 92-035-00 - ESF ACTUATION AND  
LOSS OF EFFLUENT MONITORING  
DUE TO TRANSFORMER FAILURE

FACILITY NAME (1) James A. FitzPatrick Nuclear Power Plant										DOCKET NUMBER (2) 0 5 0 0 0 3 3 3				PAGE (3) 1 of 0 7												
TITLE (4) ESF Actuation and Loss of Effluent Monitoring Due to Transformer Failure																										
EVENT DATE (5)			LER NUMBER (6)				REPORT DATE (7)			OTHER FACILITIES INVOLVED (8)																
MONTH	DAY	YEAR	YEAR	SEQUENTIAL NUMBER	REVISION NUMBER	MONTH	DAY	YEAR	FACILITY NAMES				DOCKET NUMBER(S)													
0	9	2	4	9	2	9	2	—	0	3	5	—	0	0	0	9	2	2	9	2					0 5 0 0 0	
OPERATING MODE (9)			THIS REPORT IS SUBMITTED PURSUANT TO THE REQUIREMENTS OF 10 CFR 5. (Check one or more of the following) (11)																							
POWER LEVEL (10)			20.402(b)				20.405(a)				<input checked="" type="checkbox"/> 50.73(a)(2)(iv)				73.71(b)											
0 0 0			20.405(a)(1)(i)				50.36(a)(1)				50.73(a)(2)(v)				73.71(a)

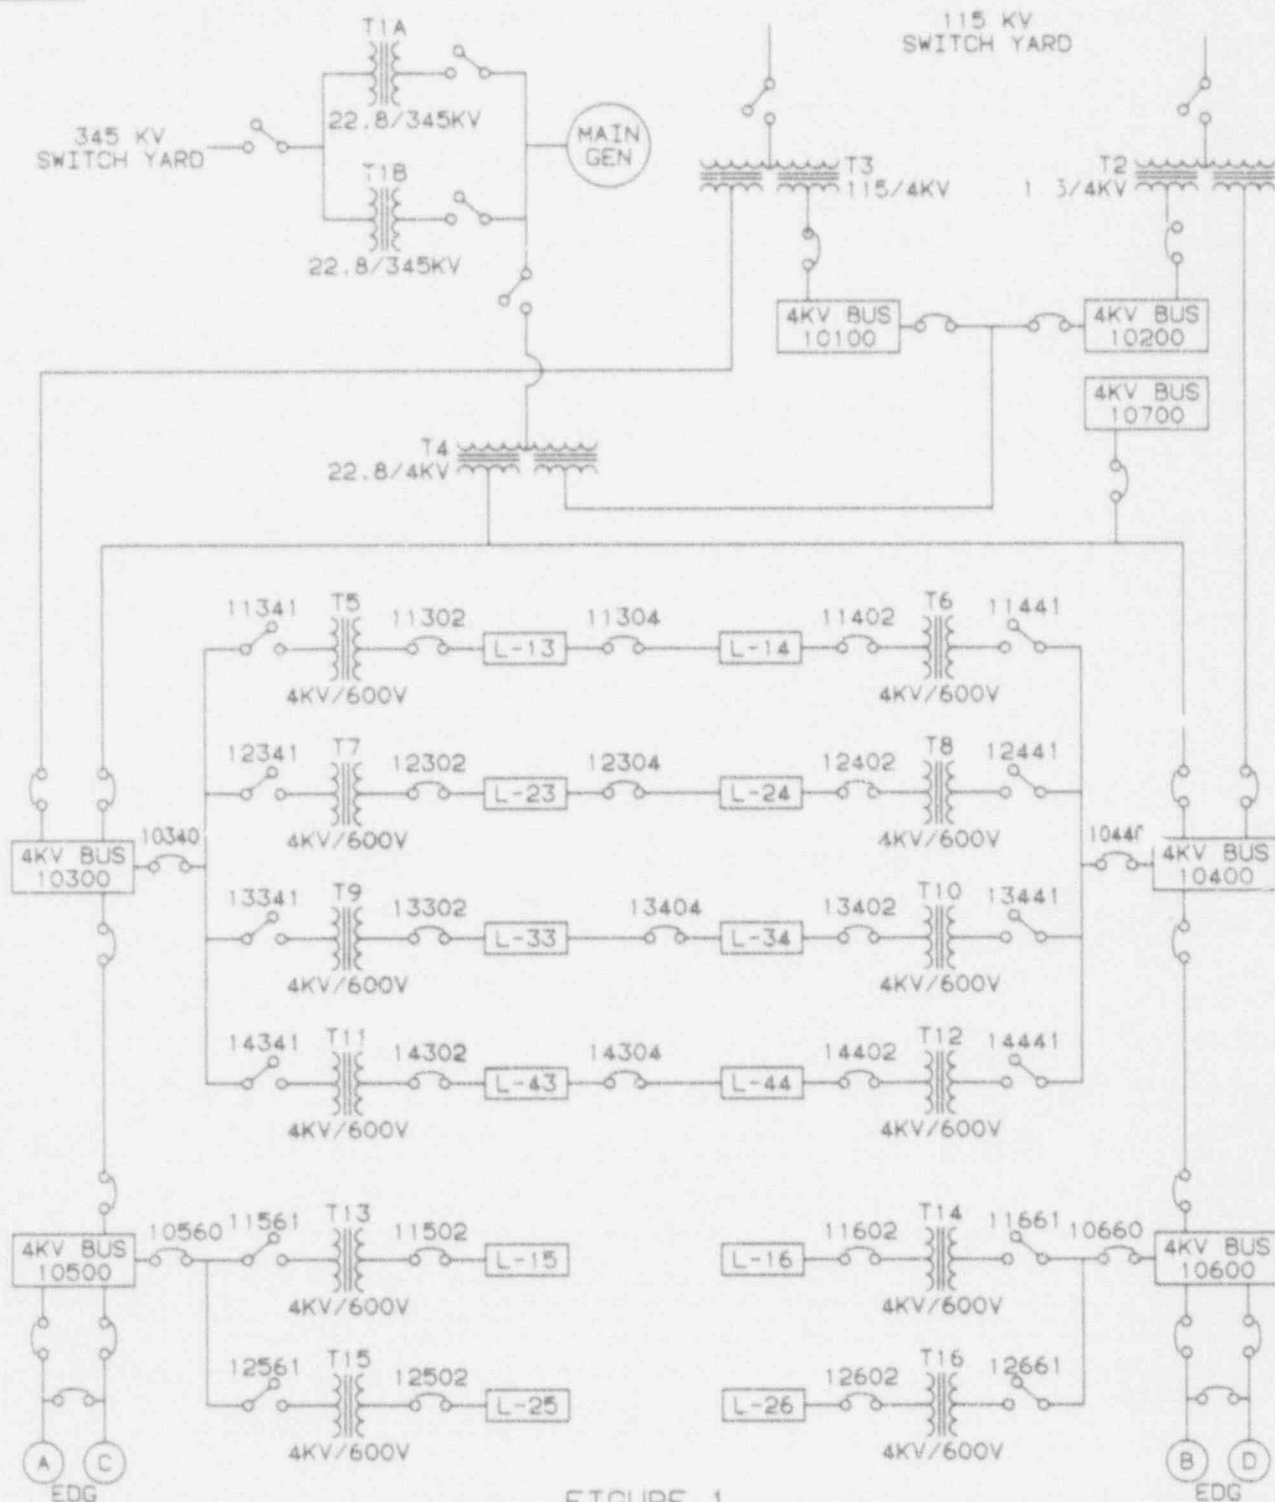
On August 15, 1992 non-safety related 4160 volt (4KV) bus 10300 [EA] and safety related 4KV bus 10500 [EB] were deenergized for planned maintenance. Non-safety related 600 VAC [EC] Load Centers L-13, 23, 33 and 43 had been aligned to power the load centers from bus 10400. Safety related 600 VAC [ED] Load Centers L-15 and 25 were deenergized along with buses 10300 and 10500 because, by design, no alternate power source is provided from the other safety division (bus 10600). See Figure 1.

The 120 VAC uninterruptible power supply (UPS) [EE] system motor-motor generator was also out of service for maintenance. The normal alternative power source for the UPS instrumentation bus is from a motor control center that is provided with power from bus 10500 via Load Center L-25. Since Load Center L-25 was to be deenergized temporary alternate power was provided from a motor control center powered from Load Center L-33 (which in turn was powered from bus 10400) during the planned maintenance work. See Figure 1.

FIGURE 1  
SIMPLIFIED POWER DISTRIBUTION SKETCH
