Hope Creek Generating Station

HOPE CREEK GENERATING STATION
DOCKET NO. 50-354
UNIT NO. 1
LICENSEE EVENT REPORT 92-008-00

TITLE: Operation prohibited by Technical Specification 3.6.1.1,
 Containment Penetration test valve opened due to procedural
 inadequacy.

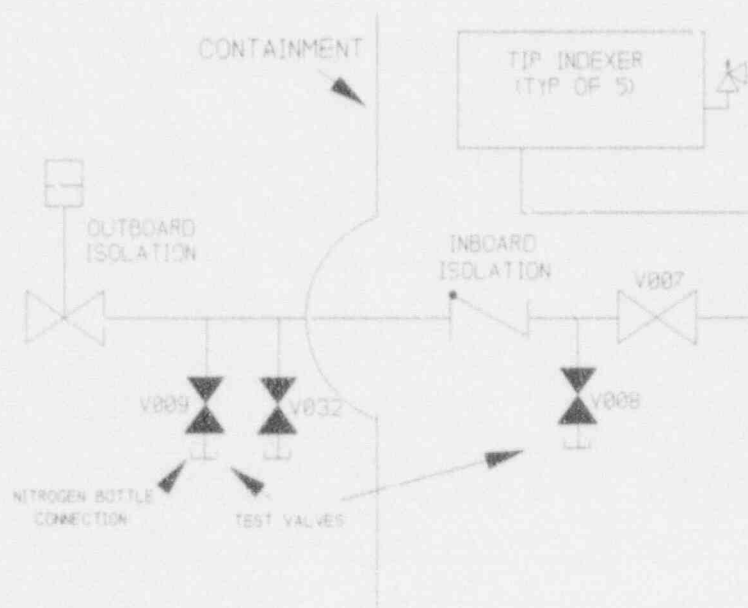
The Containment Instrument Gas System provides the dry purge gas required to keep the TIP system clean and dry. The purge line is 3/8" O.D. tubing which penetrates containment and connects to the TIP indexer mechanism inside containment. The line is configured with an outboard air operated isolation valve and an inboard check valve. The system does not communicate directly with containment atmosphere during normal operation; however, during accident conditions a pressure/relief valve mounted to the indexer housing will open to allow containment pressure and the pressure in the housing to equalize. For this reason the line requires both inboard and outboard automatic isolation capability. The penetration also has several 3/8" valves inside of the isolation valve boundary for leak testing of the containment isolation valves during outages. The test valves are locked closed under administrative control during reactor operation.
