September 22, 1992

- REF: 1. Your letter to me dated September 1, 1992
2. Draft report dated August 19, 1992 regarding examination of 4 x 4 x 1/2" ASTM-500 Grade B tubing by John Fox, Metallurgical Engineer
Restart Eng. Mechanical/Nuclear Department

This report covers the evaluation of a 4" x 4" x 1/2" wall section of ASTM A-500 Grade B steel tubing heat number T42510 from coil number 924544. This sample was found to have a cracked weld by your customer, TVA/Bechtel at the Browns Ferry Nuclear Plant in Alabama. This tubing was supplied to Consolidated Power Supply on P.O. #S65-17742.

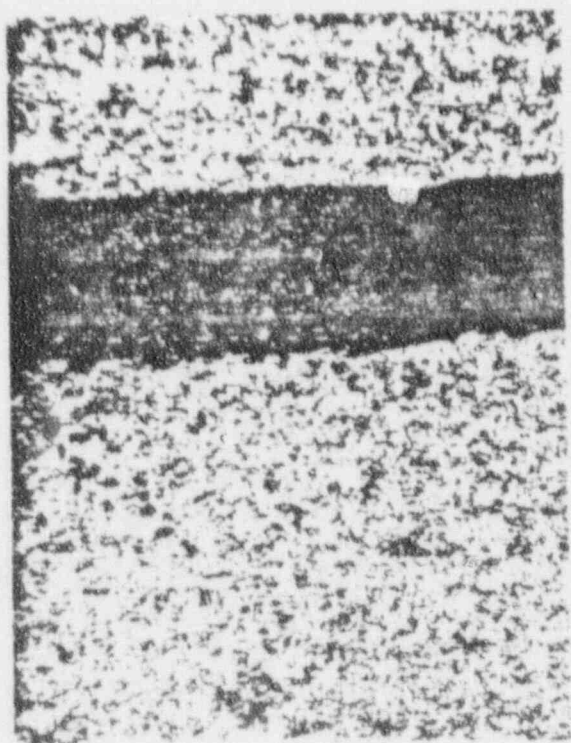
NEAR
O.D.

This sample represents a portion of a defective tube which in turn represents a portion of the overall 0.65% customer rejection rate due to poor weld for this size and thickness of tubing. The lack of fusion was due to incorrect mill set-up and is not heat or material related.

The corrective action requested by your letter will take the form of re-instructing the mill operator, mill foreman and other mill personnel on the importance of weld quality. If the operator is making an adjustment which could affect weld quality, he is to immediately advise the Quality Control inspector so that weld quality can be examined. This meeting will take place within the next 30 days.
