Homestake Mining Company of California

24 April 2020

RE: Homestake Mining Company, Grants Reclamation Project, License Source Materials License SUA-1471, Docket Number 40-8903; NMED Discharge Permit DP-200: 15-Day/30-Day Corrective Action Report for the Unauthorized Discharge from Clarifier #2 Blowdown Pump

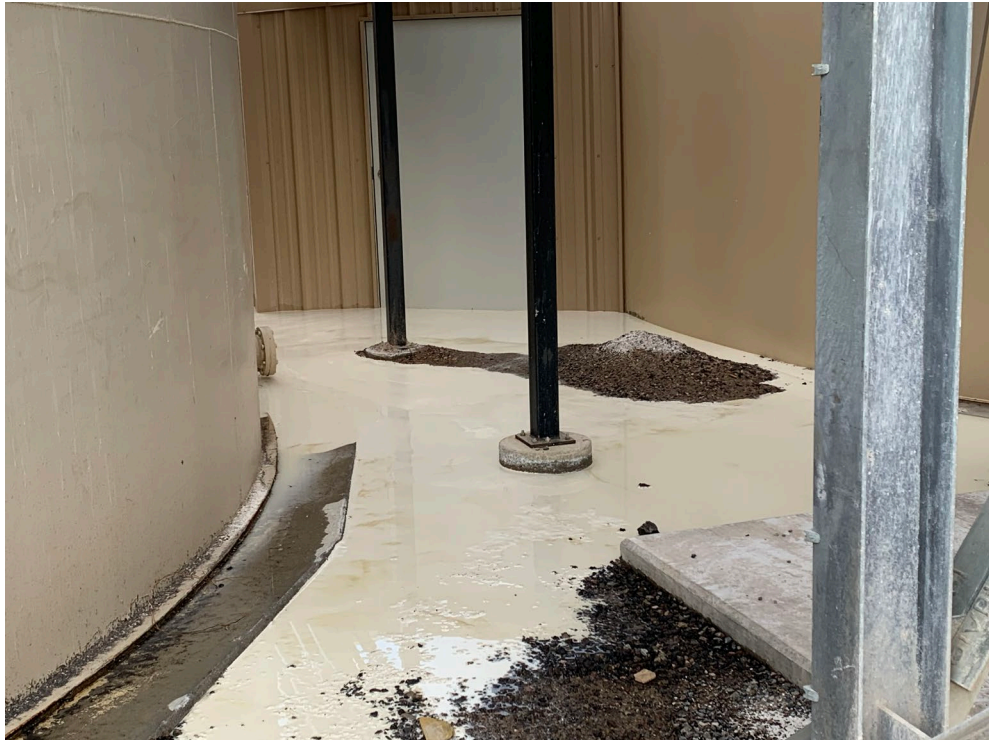
Upon arriving at the Reverse Osmosis Water Treatment Plant (RO WTP) on Friday morning (March 27th), workers immediately noticed the release of sludge from the clarifier. Further inspection showed that the sludge was being released through the blowdown pump seal. This seal is the same one that failed in September 2019. At that time, HMC ordered replacement parts and received a generic part which was installed since original equipment parts were not available for several weeks. This generic seal is the one that failed. It should be noted that the sludge release was limited to the site adjacent to the clarifier and did not migrate offsite.

The failure resulted in the release of approximately 3-4 cubic yards of sludge consisting of spent lime from clarifier #2 (see photographs). The release occurred immediately adjacent to the clarifier, was contained onsite, and was cordoned off by site personnel pending remediation efforts. Sludge concentrations were estimated from existing data from sludge samples collected in the collection ponds. The pond samples exhibited a uranium concentration of 3,090 milligrams/kilogram, radium 226 concentration of 0.3 picoCuries/gram-dry (pCi/g-dry), and thorium 230 concentration of 0.3 pCi/g-dry.

Photograph 1 showing sludge release adjacent to Clarifier #2

Once the area was redressed, the failed seal was removed and replaced with an original equipment part on Monday, April 13th. Upon replacement, the RO WTP was brought back online on Tuesday, April 14th. System startup included flushing the micro-filtration break tank, performing enhanced flux maintenance on skids A and B of the micro-filtration system, balancing the pH level in the Flash Mix Tank, and closely monitoring Low Pressure RO 1 (LPRO1) during startup (i.e. pressures, conductivities, recovery, etc.). The RO WTP is currently treating water at 300 gallons per minute.

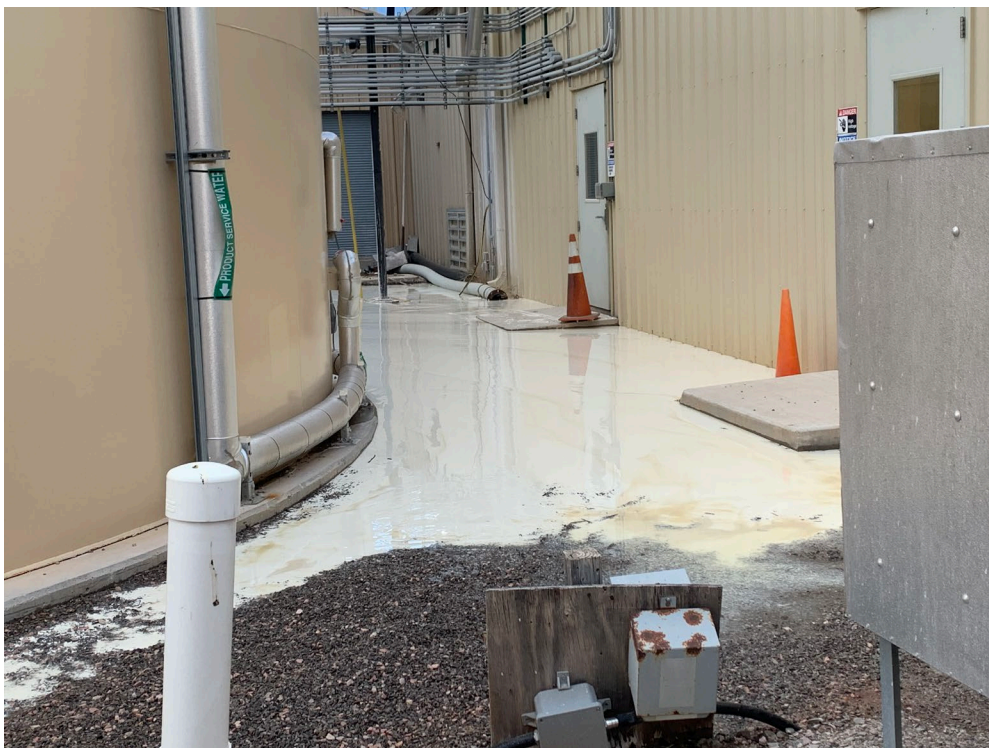
Photograph 2 showing another view of sludge release adjacent to Clarifier #2

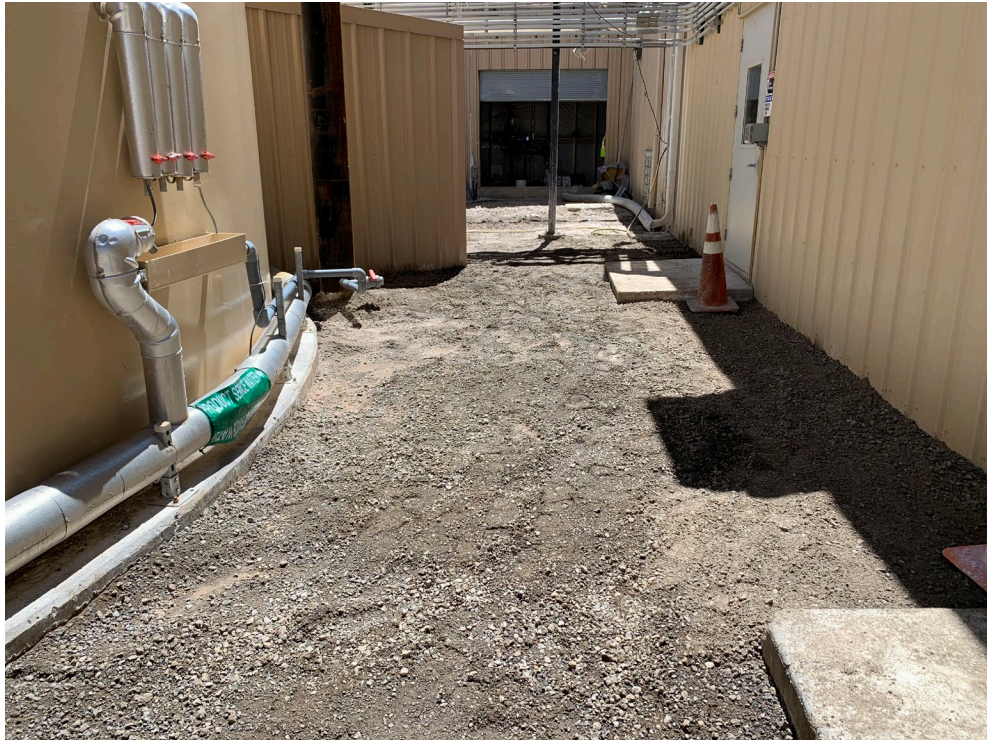
Photograph 3 showing similar view as Photograph #2 after cleanup of sludge release

RE: 15/30-Day Notification of Unauthorized Discharge from Clarifier #2 Blowdown Pump
employees. Prior to other employees returning to work, HMC provided COVID-19 testing to non-symptomatic employees and performed a hyper-cleaning of the office and RO WTP control room. On April 9th, a contractor was brought in to perform the work. The work was performed under a radiation work permit (RWP) overseen by site personnel. The sludge was loaded into a front-end loader by hand for disposal in Evaporation Pond #1 (EP-1). In addition to the sludge removal, underlying impacted soil and gravel cover was over-excavated and placed into EP-1 along with the sludge. An estimated total of 8-10 cubic yards of material was removed and placed into EP-1 and the area was redressed with imported material and fresh gravel. Photographs showing the area after remediation are attached.

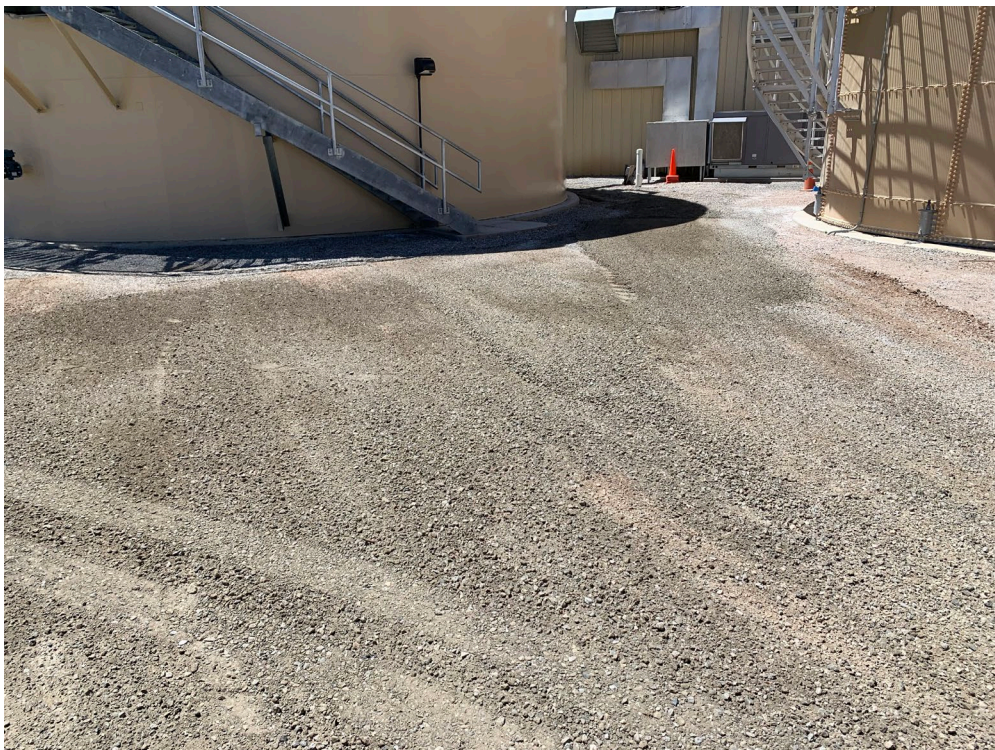
Photograph 4 showing another view of area after sludge cleanup
