RADIOLOGIC AND ENGINEERING ASSESSMENT

DOE ID NO.: GJ-07866-RS
ADDRESS: 134 MIRIAM AVENUE

MAY 1985

BENDIX FIELD ENGINEERING CORPORATION
P.O. Box 1569
Grand Junction, Colorado 81502

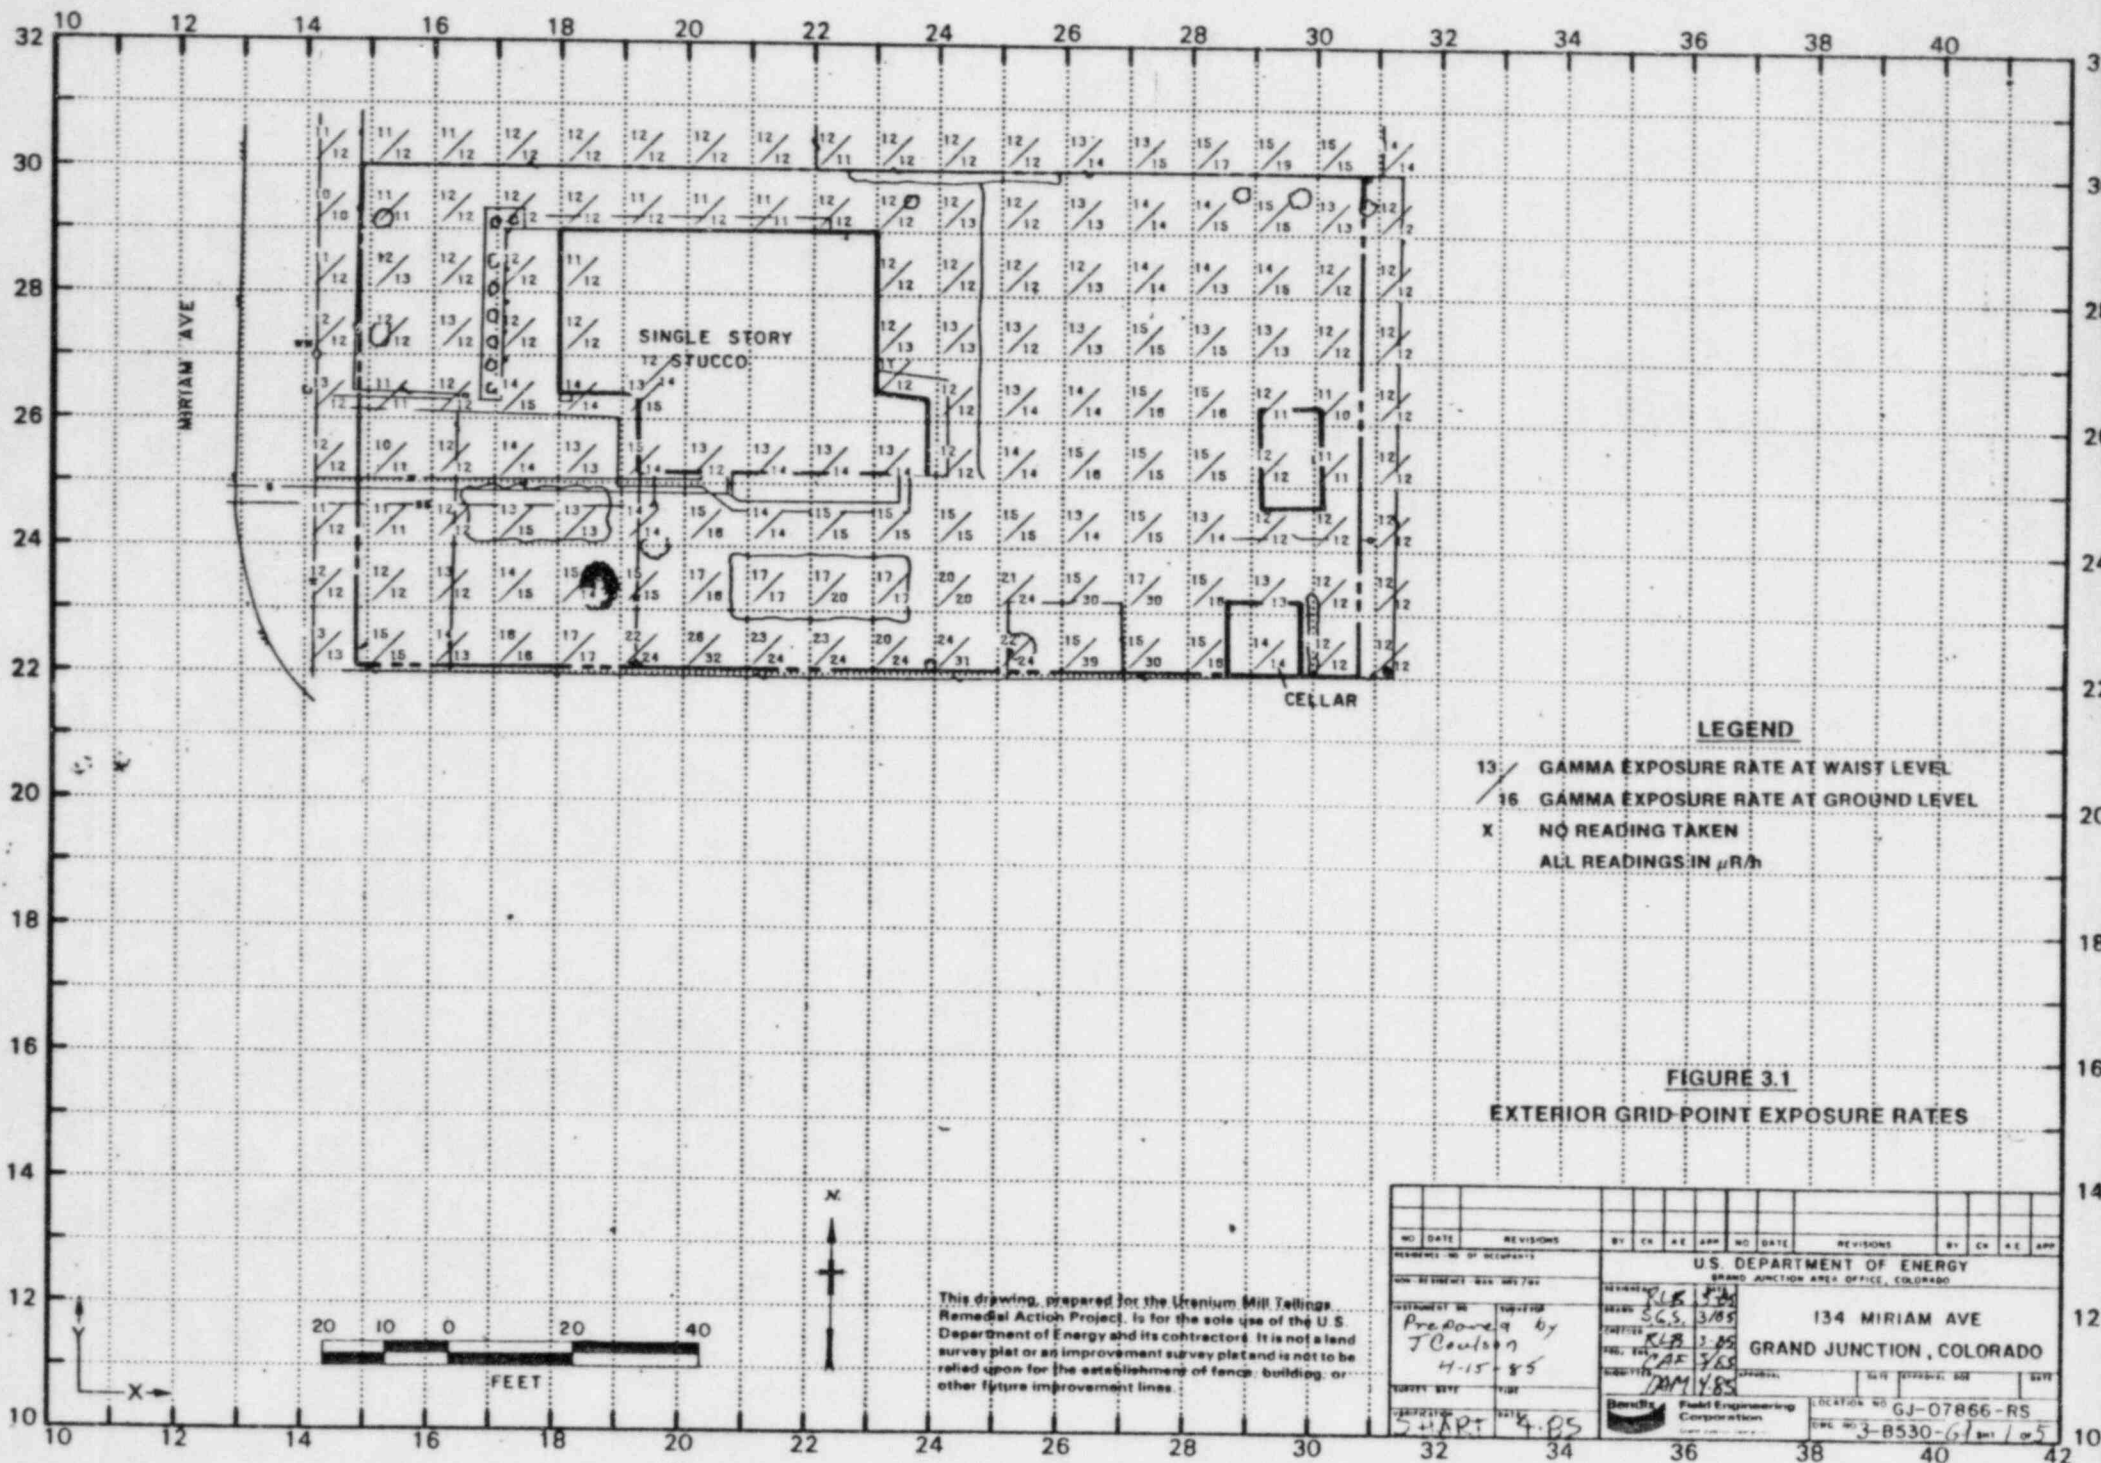
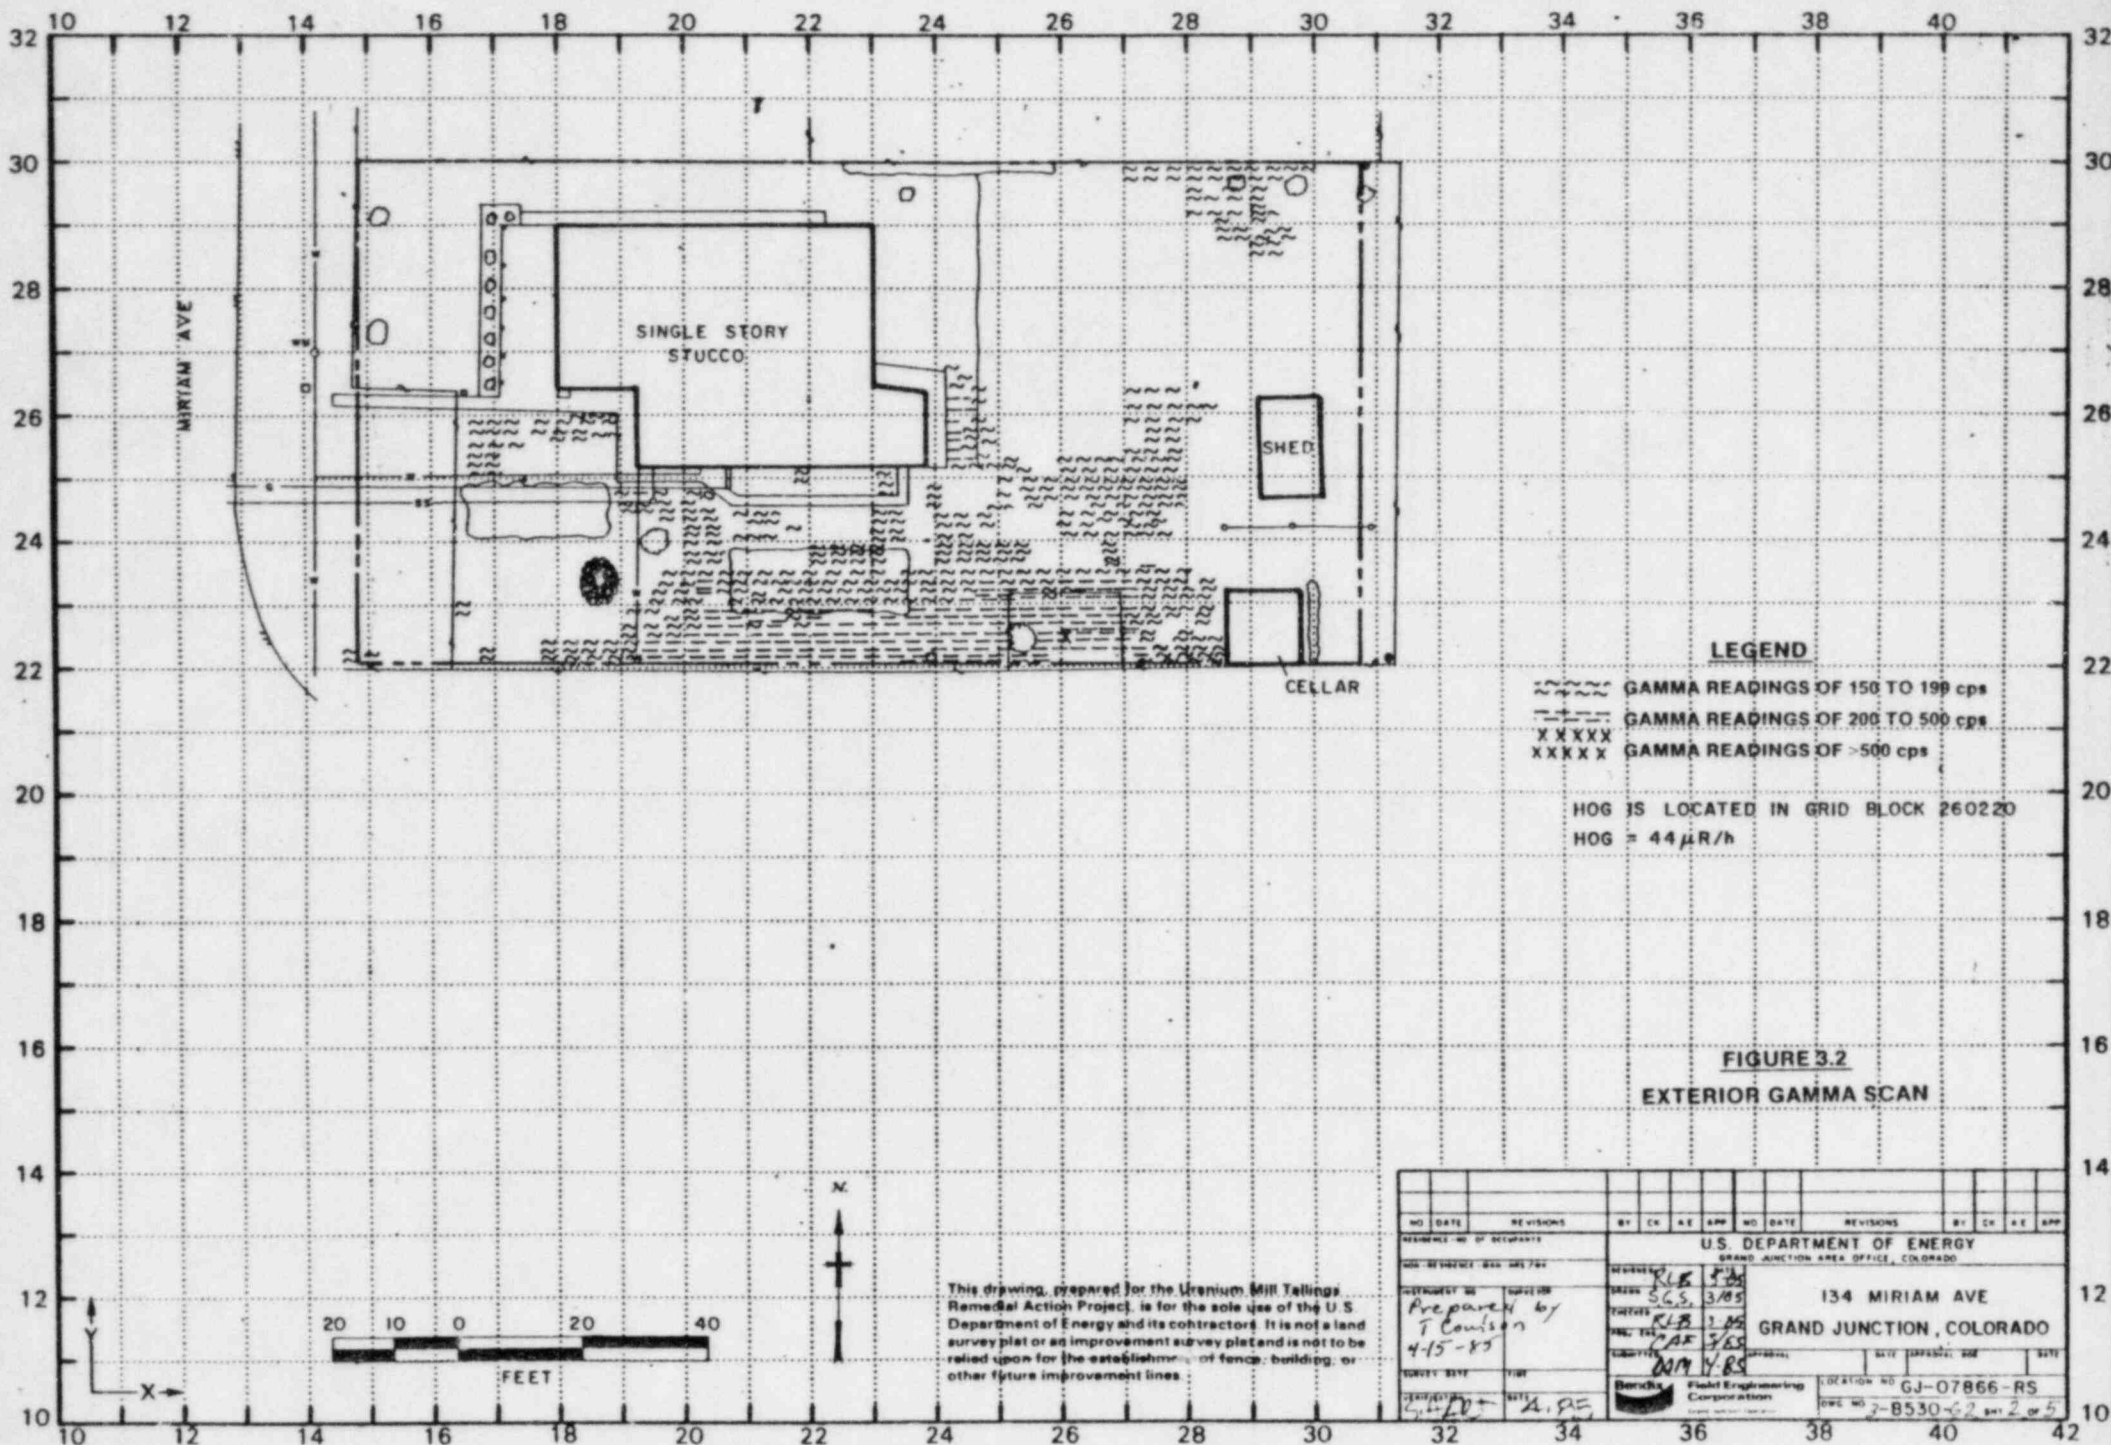
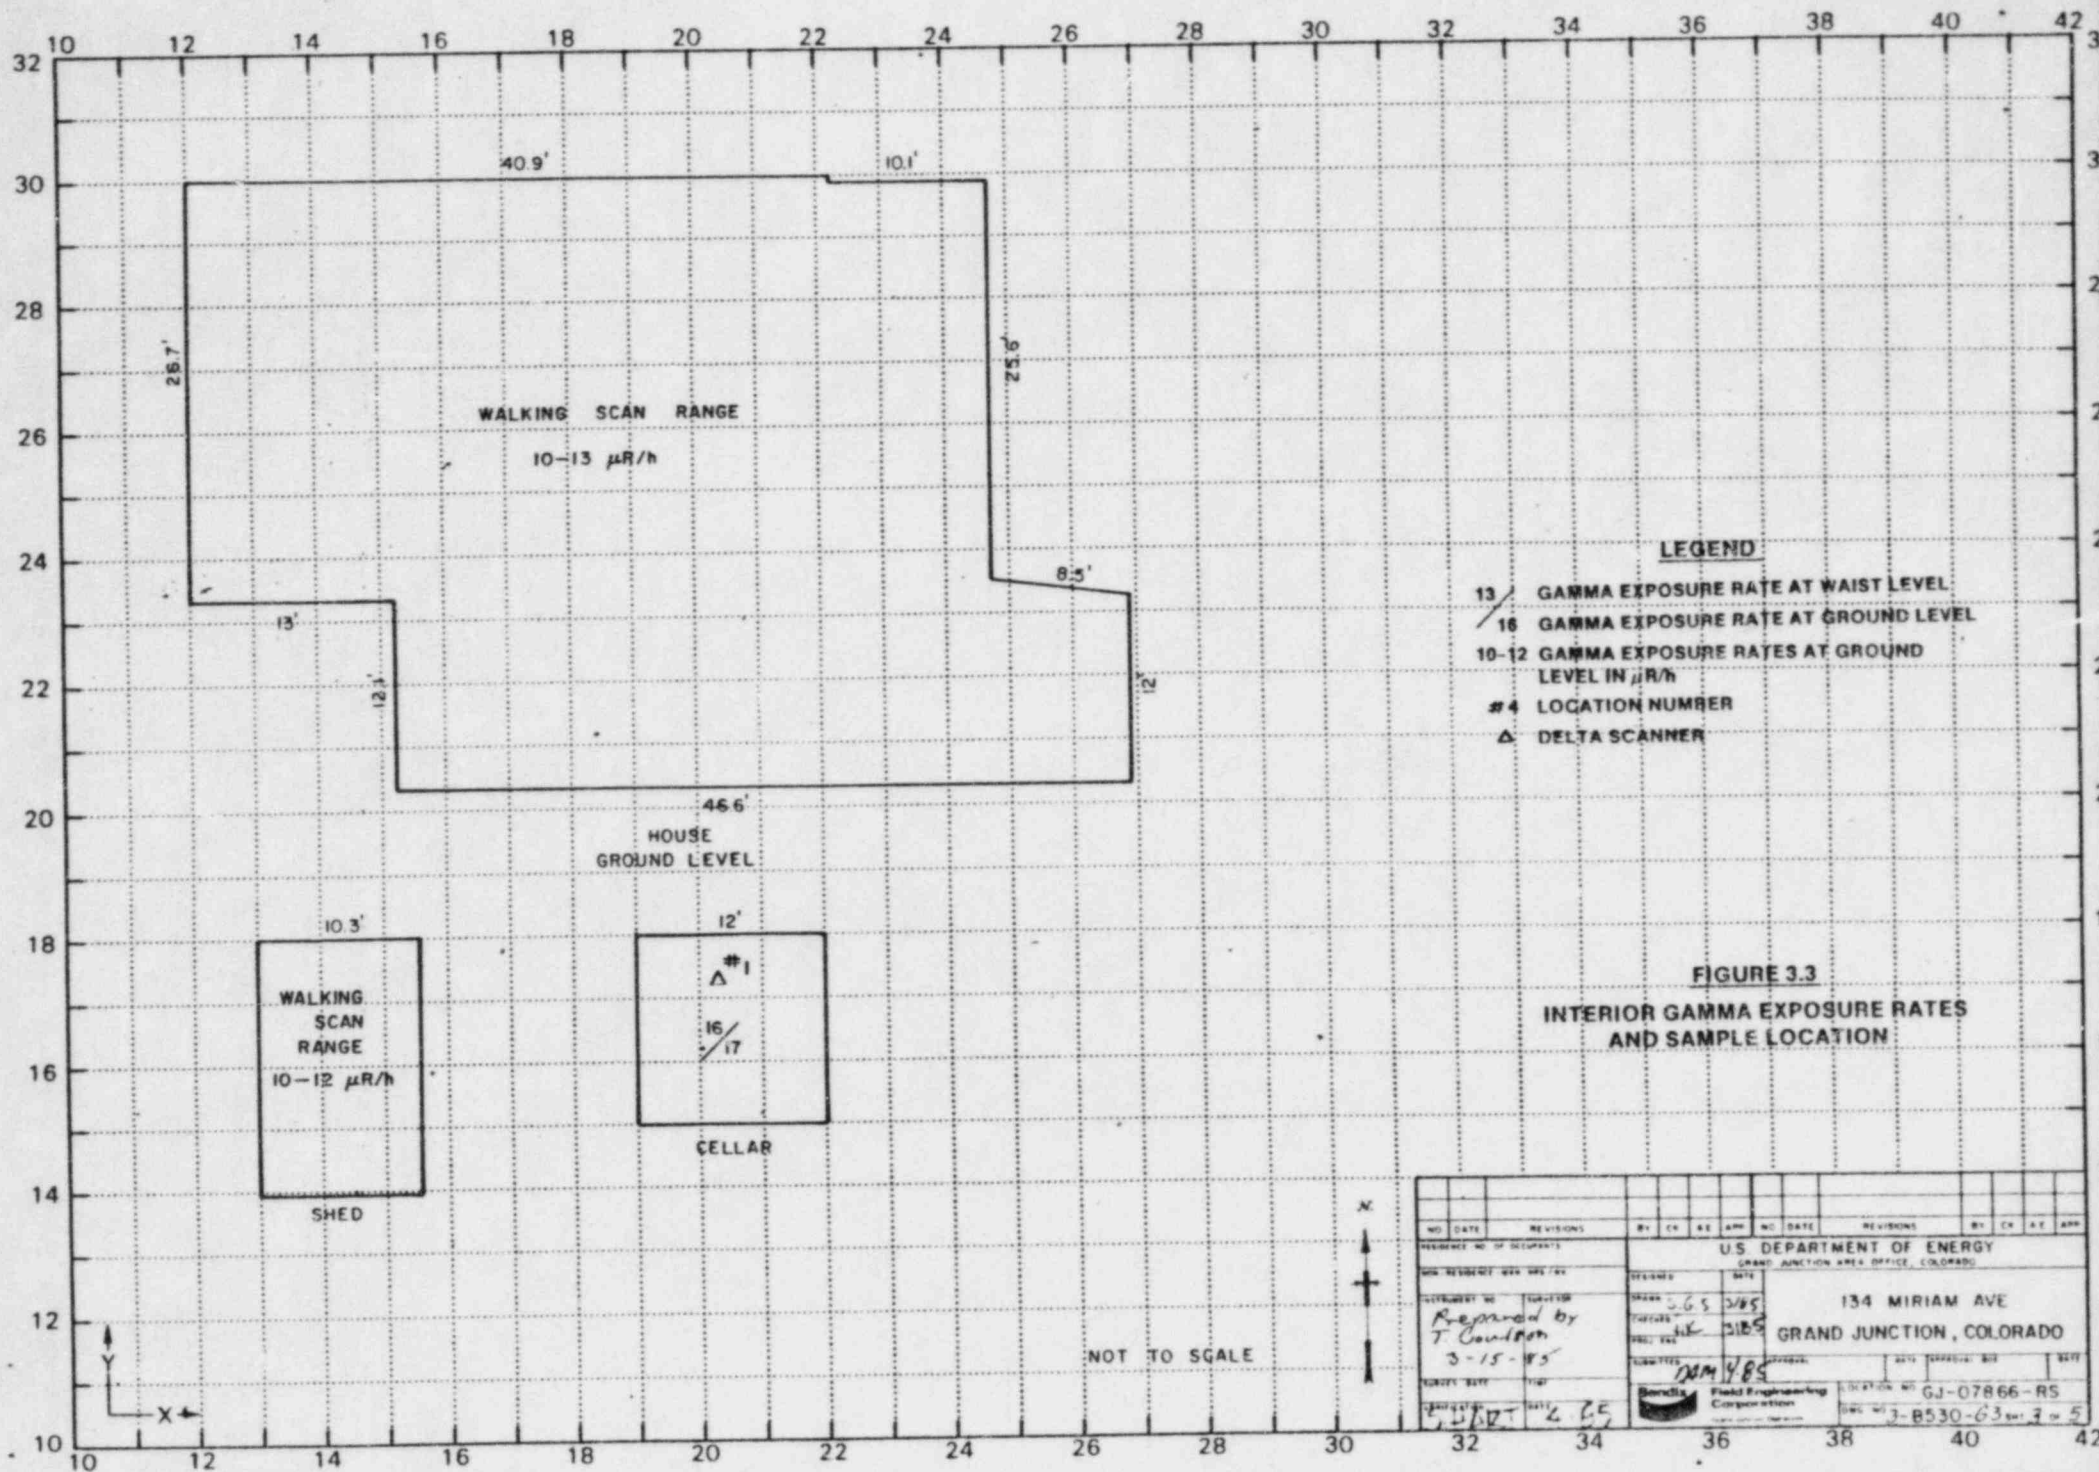
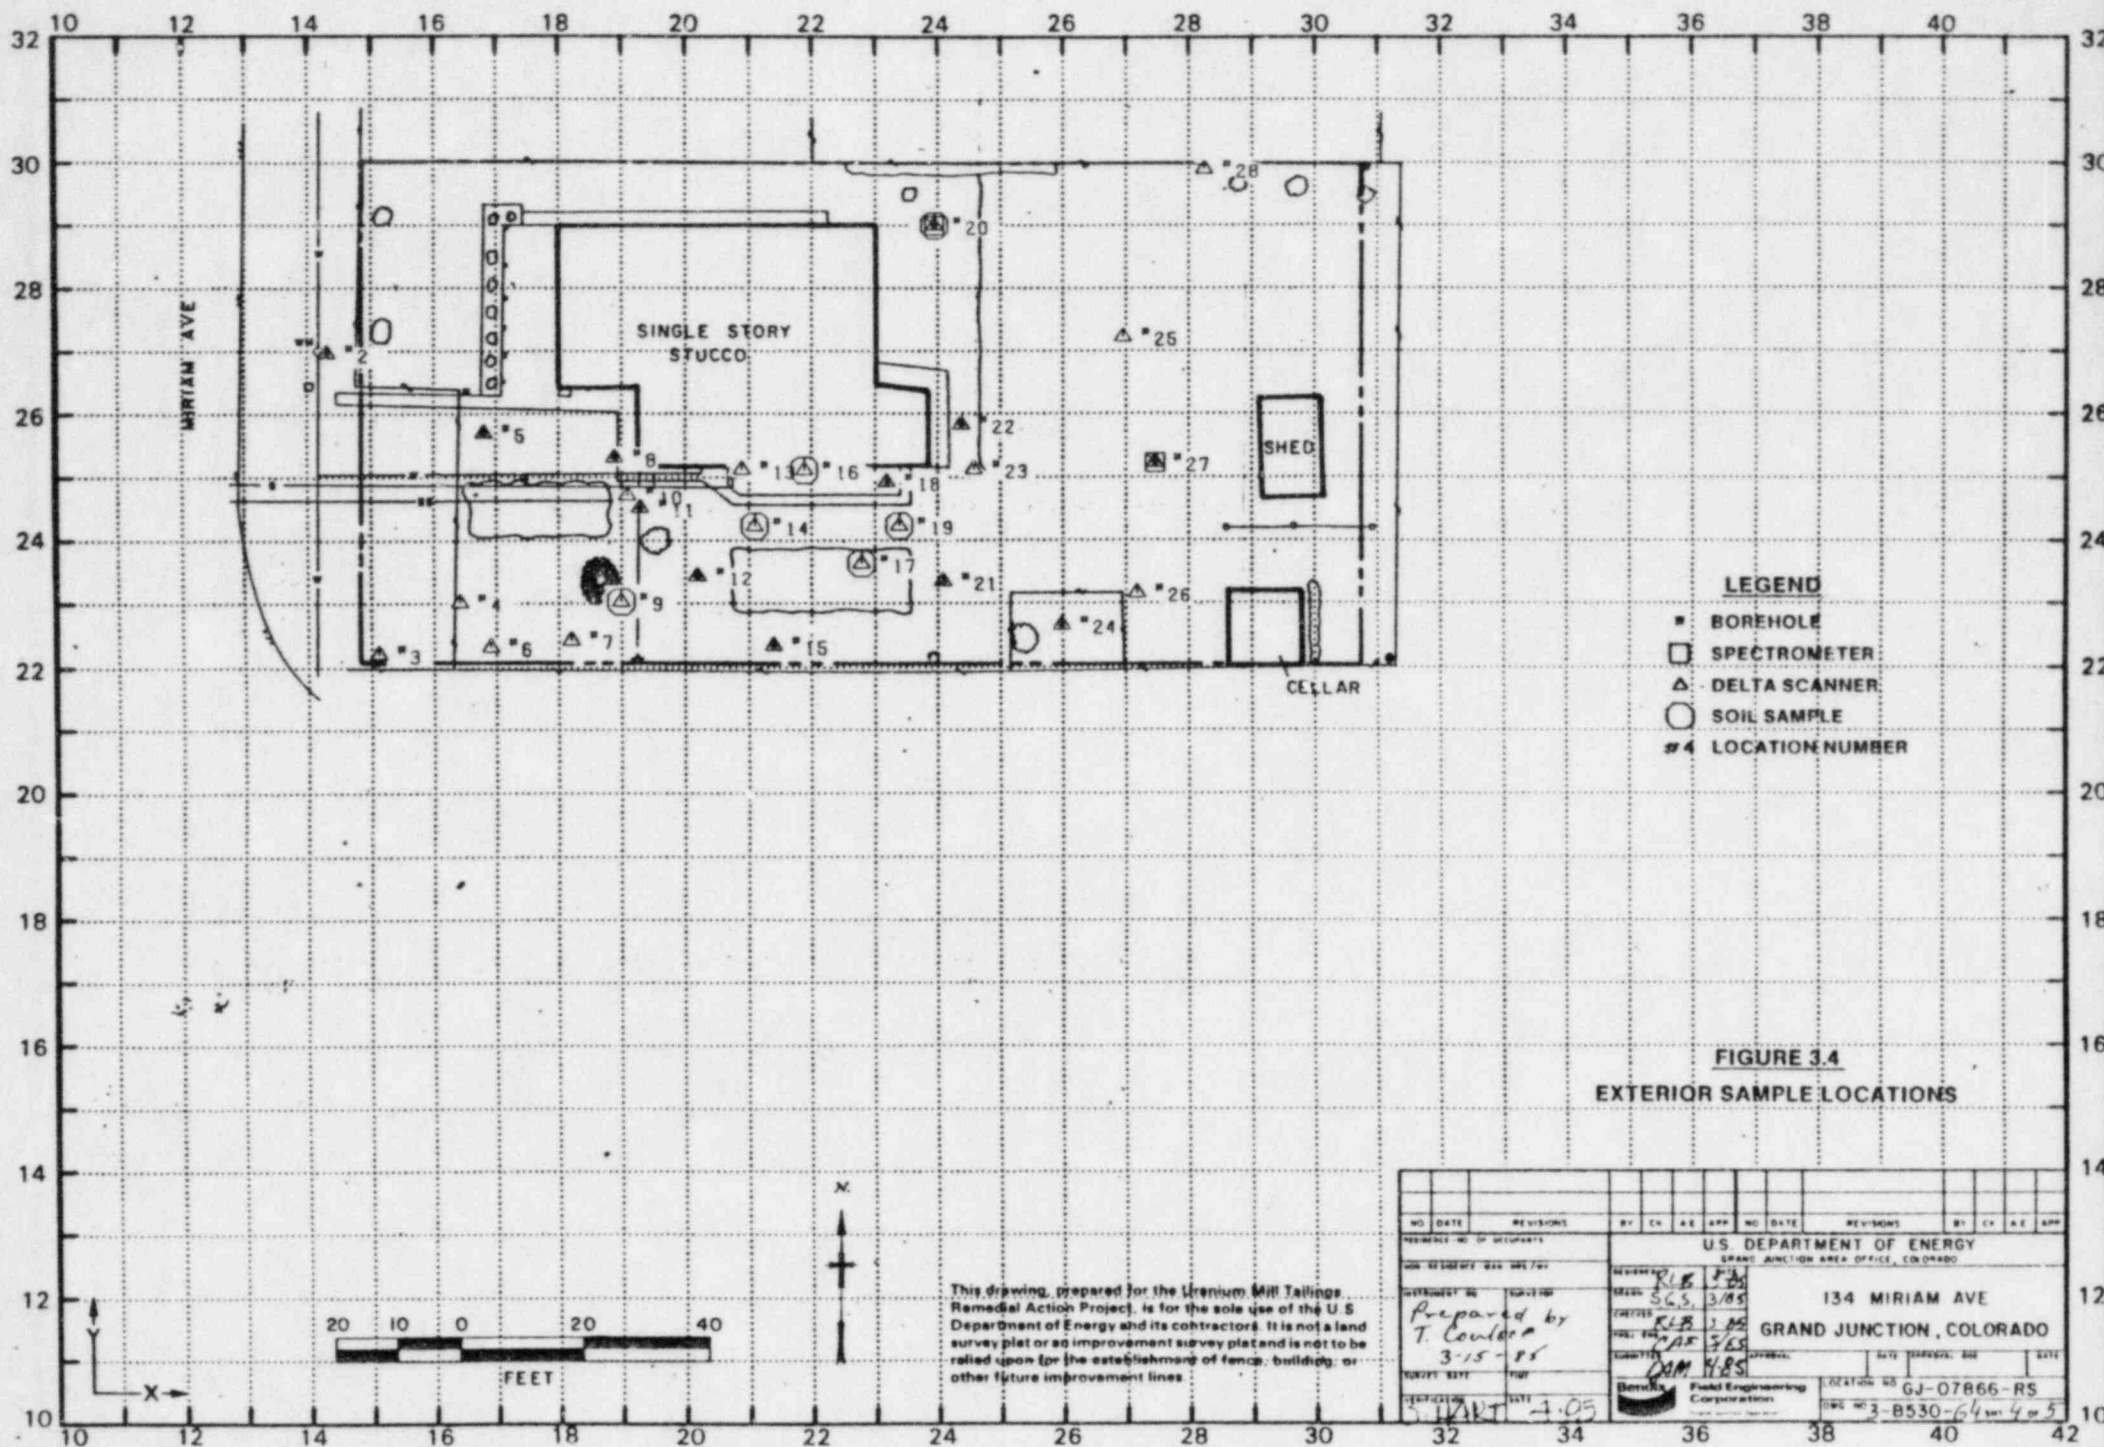
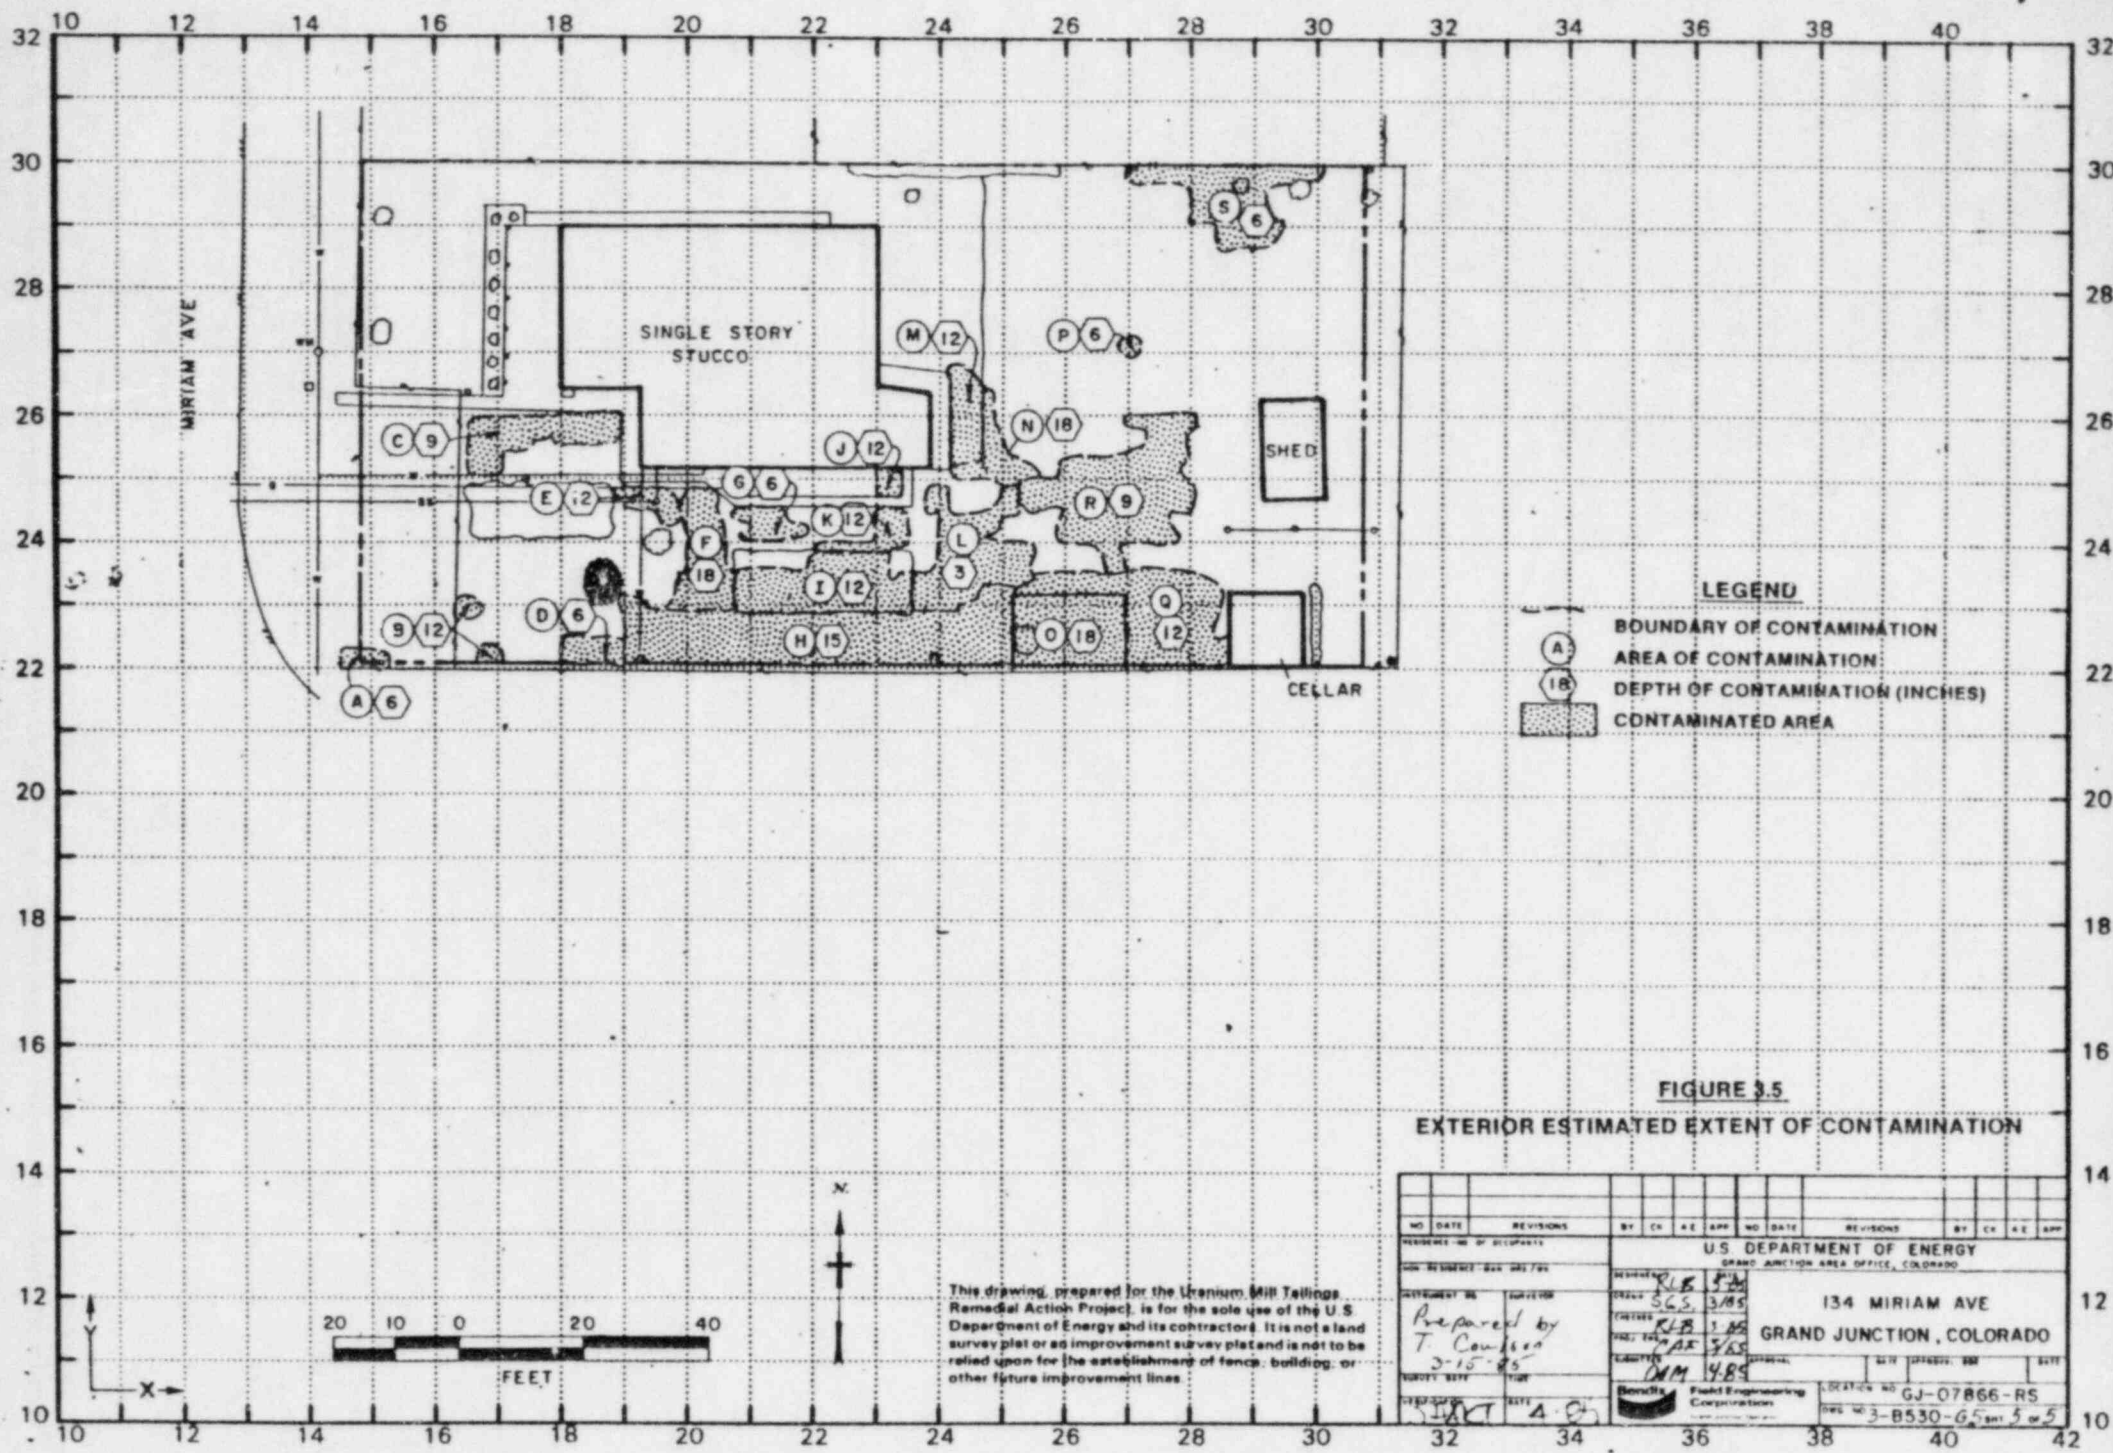
Appendix Figure 3.5 shows identified areas and estimated depths of contamination on this property, based on assessments of all measurements taken. As noted in this figure, areas recommended for remedial action that contain identified residual radioactive materials are:

- (AREA A) An isolated deposit in the southwest corner of the property is contaminated to a depth of 6 inches (approximately 21 sf).
- (AREA B) On the south and west fence lines there are two spots of contamination. The depth of contamination is 12 inches (approximately 24 sf).

- (AREA C) Midway along the west fence line contamination extends to a depth of 9 inches (approximately 140 sf).
- (AREA D) Adjacent to the south property line contamination extends to a depth of 6 inches (approximately 50 sf).

- (AREA E) Southwest of the primary structure the depth of contamination is 12 inches (approximately 40 sf).
- (AREA F) South of the south sidewalk, contamination in the lawn extends to a depth of 18 inches (approximately 160 sf).

- (AREA G) A small deposit of contamination exists between the south sidewalk and south garden. The depth of contamination is 6 inches (approximately 50 sf).

- (AREA H) The middle portion of the south yard, adjacent to the fence line, there is contamination to a depth of 15 inches (approximately 586 sf).
- (AREA I) The majority of the garden in the south yard is contaminated to a depth of 12 inches (approximately 235 sf).

- (AREA J) Near the southeast corner of the primary structure, contamination extends to a depth of 12 inches (approximately 16 sf).
- (AREA K) Near the southeast corner of the sidewalk, contamination extends to a depth of 12 inches (approximately 45 sf).

- (AREA L) The lawn in the southeast portion of the yard is contaminated to a depth of 3 inches (approximately 255 sf).

- (AREA M) East of the primary structure, contamination in the lawn extends to a depth of 12 inches (approximately 75 sf).
- (AREA N) East of the primary structure, a deposit is contaminated to a depth of 18 inches (approximately 78 sf).
- (AREA O) The soil in the fenced dog yard is contaminated to a depth of 18 inches (approximately 204 sf).
- (AREA P) In the middle of the garden a point source is contaminated to a depth of 6 inches (approximately 4 sf).
- (AREA Q) Near the southeast corner of the property there is contamination to a depth of 12 inches (approximately 304 sf).
- (AREA R) The soil in the garden, east of the primary structure, is contaminated to a depth of 9 inches (approximately 400 sf).
- (AREA S) The soil in the garden, adjacent to the northeast corner of the yard is contaminated to a depth of 6 inches (approximately 226 sf).

The recommended remedial action for this property, DOE ID No. GJ-07866-RS, includes removal of all areas identified as containing radioactive material (as discussed in Section 3.5 and shown in Appendix Figure 3.5, and transport of removed material to the disposal site.
