RE: Phased Startup of Sequoyah Facility

SEQUOYAH FUELS CORPORATION
ROOT CAUSE ANALYSIS

ROOT CAUSE ANALYSIS - DUF₆ RELEASE, 05/01/92

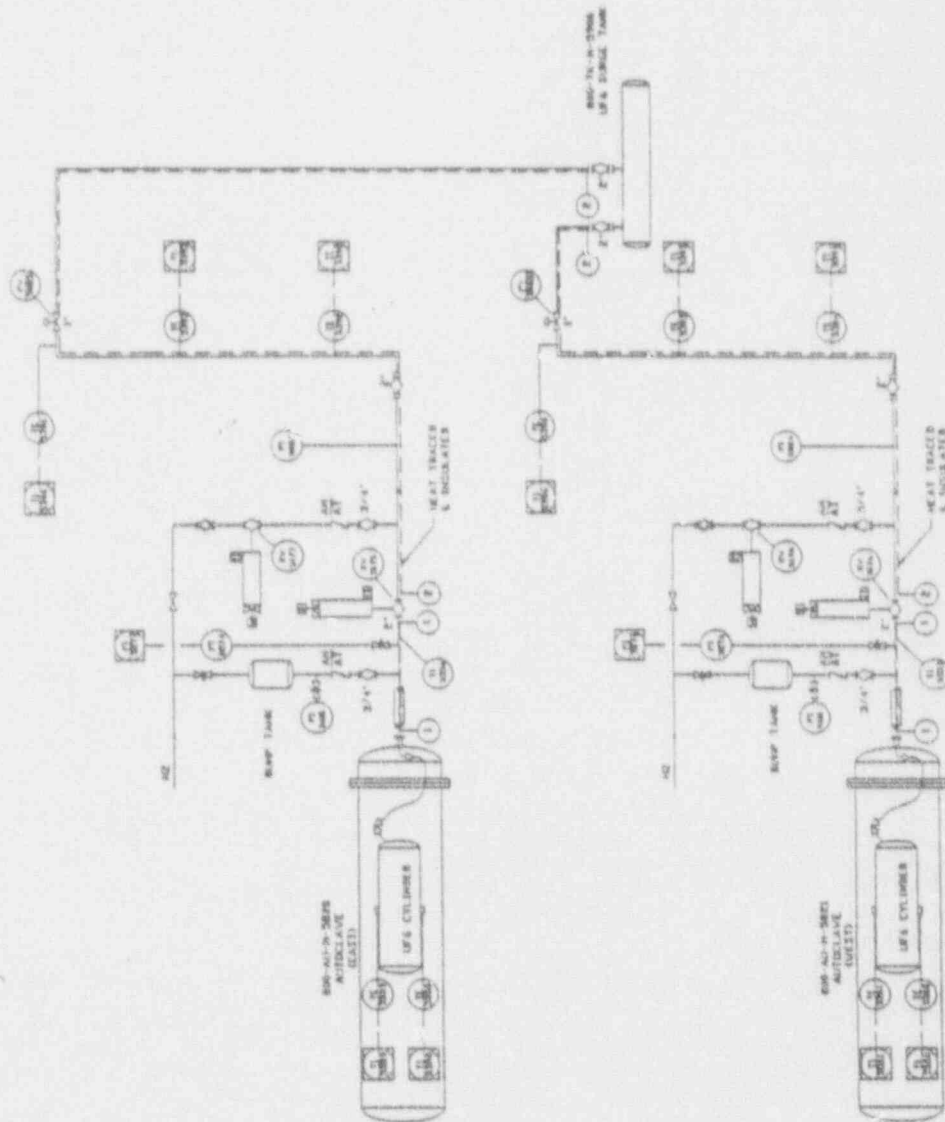
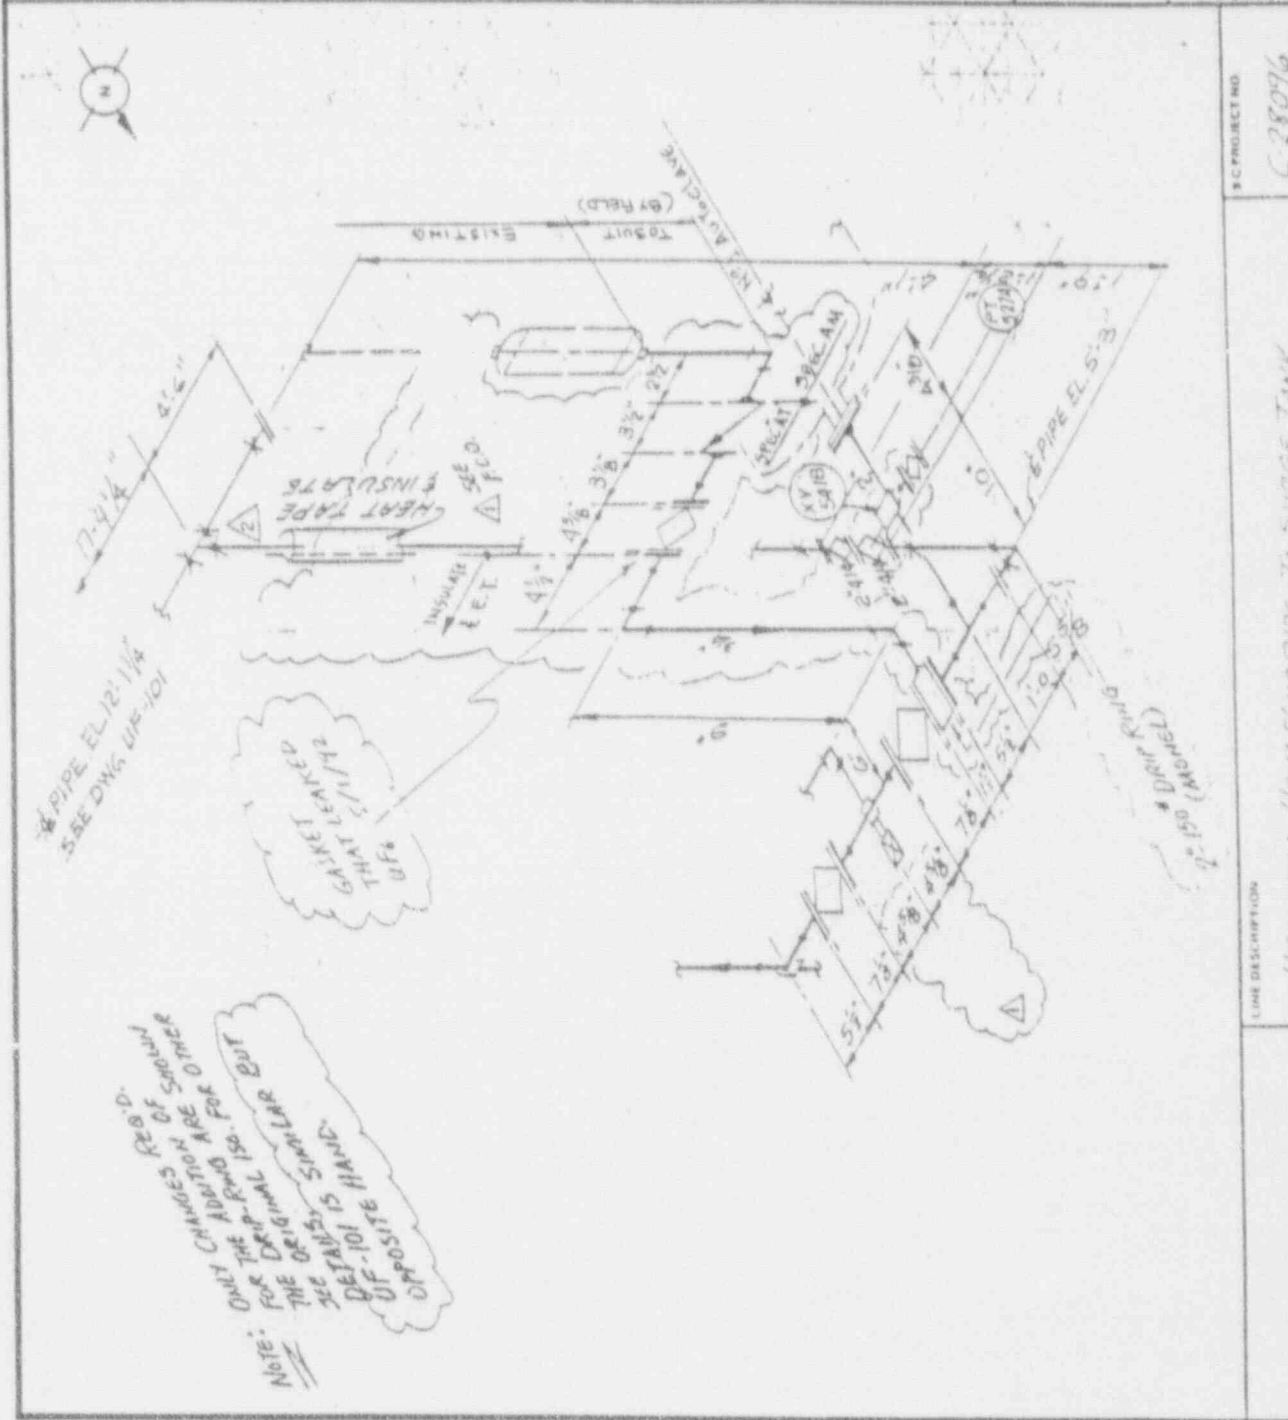
PROJECT NO. C-28096
URANIUM HEXAFLUORIDE TO DUNGE TANK

A factor that may have contributed to the leakage of UF₆ at this particular gasket is that the flanges between which the nitrogen valve is installed do not appear to be parallel. The piping below the nitrogen bump tank is free to move. However, the other flange attached to the UF₆ line piping is rigid and appears to be cocked somewhat off vertical. This indicates that unequal tension would be required on the bolts in order to draw the flanges up parallel.

The failed gasket itself appears upon detailed inspection to have had an adequate sealing surface all the way around. It is difficult to determine whether it was equally compressed all the way around. The gasket was obviously elongated by the force of the escaping UF₆.

While the heating tape was off, UF_6 vapors from the hot cylinder in AU-5821 began desubliming in the piping and tubing outside the autoclave. This desublimation of UF_6 in the cool piping and tubing eventually formed a solid plug of material. When the heating tapes were turned back on, the UF_6 began liquefying and/or vaporizing inside a confined space. This was indicated by the steady rise in pigtail pressure as shown by PI-5276 between 1320 and 1350. The pressure (either gas pressure or hydraulic pressure due to expansion as solid UF_6 liquefied) eventually resulted in the failure of a flange gasket on the plug valve below the nitrogen bump tank.

- (1) Review whether a standard maintenance procedure for preparing gasketed flanges should be developed or should the training and job skills required of a mechanic be considered sufficient. The review and any proposed corrective actions should be documented.
- (2) Determine whether other gaskets in the piping system related to the event of May 1 were affected by the overpressure situation. Replace as needed and document findings.

- B.3 Disassemble lines on the 5821 system that were exposed to high pressure during the leak incident. Remove entrapped UF₆ and UO₂F₂, inspect for damage and reassemble. Replace gaskets, recalibrate pressure transmitter, test heat tape, and reinsulate lines.

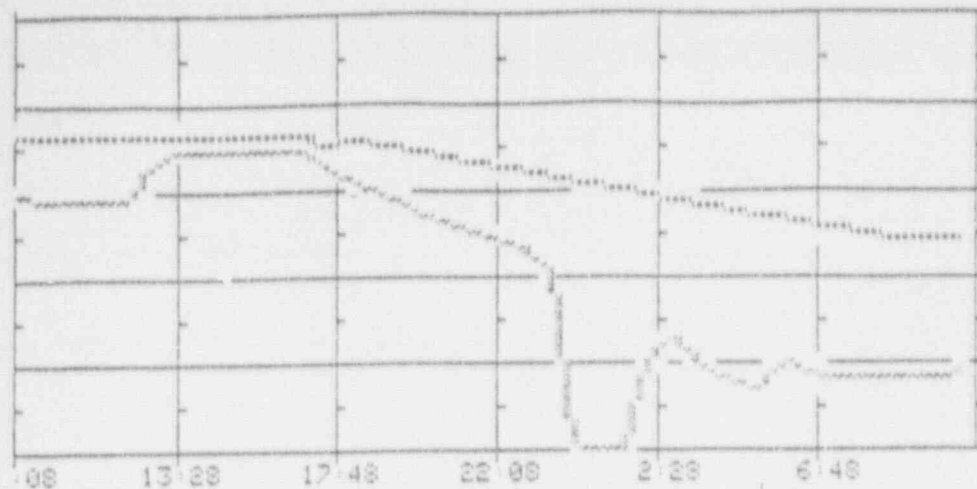
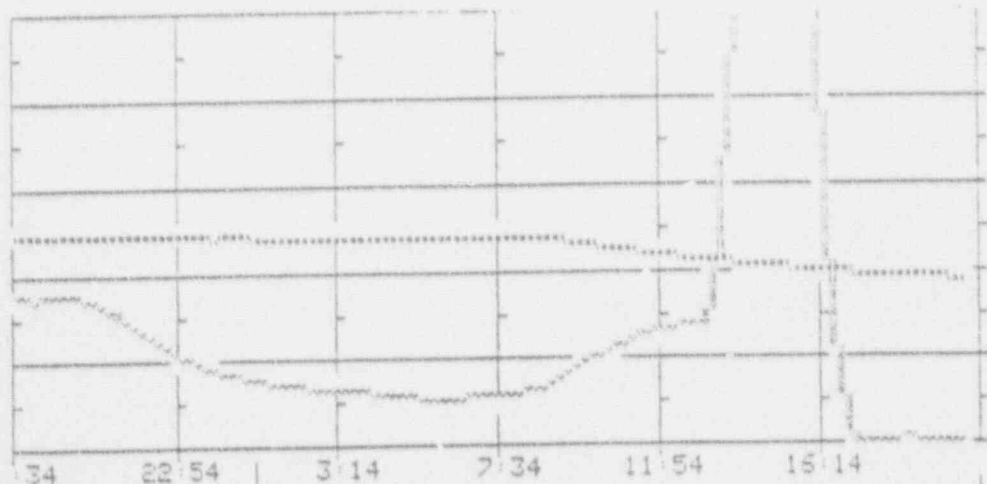
ACQUIRED TRENDS

After the event started, the OIU Operator noted that the pigtail pressure transmitter, PT-5276, on AU-5821 was in "bad quality". He was looking for a high pressure that could be the source of the leak, so he called that data up on the screen and monitored the pressure for a while. He noted that it did not decline, so he

UF_6 vapors from the hot cylinder would desublime at the point in the system where heat transfer would allow removal of the latent heat of desublimation. This would occur at a point in the system where the temperature is below the triple point temperature (147 F). The pigtail inside the autoclave would probably retain enough heat by conduction from the hot cylinder to prevent desublimation of UF_6 , even though the steam was off inside the autoclave. However, the piping outside the autoclave would be cold enough with no external heat tracing so that the UF_6 could easily desublime inside the piping and tubing between the autoclave head and valve XV-5176, which was closed. This is a very short section of piping, less than 4 feet of 2" piping. The nitrogen bump tank and the tap for the pressure transmitter, PT-5276 enter the UF_6 feed line just outside the autoclave head and in close proximity to each other. It is postulated that the pluggage of UF_6 formed so that a small isolated space was created upstream of the PT-5276 tap to the UF_6 feed line. Photos show that the UF_6 side of the plug valve below the nitrogen bump tank was jammed solid with UF_6 . As the heating tape supplied the heat necessary to melt and vaporize the solid UF_6 , the pressure rose as reflected accurately by PT-5276 (See OIU Trend Chart).

The maximum temperature shown by TC-5557 was only about 165 F, not sufficient alone to generate the pressures shown by PT-5276. The maximum pressure shown by PT-5276 of about 130 psia during the event could have been generated by a combination of UF_6 vapor pressure and inert gas in the lines that was compressed as the UF_6 expanded as it changed phase from solid to liquid.
