METROPOLITAN EDISON COMPANY

Subject: WATER IN THE INSTRUMENT AIR LINES AT THE CONDENSATE POLISHER CONTROL PANEL AND REGENERATION SKID RESULTING IN A LOSS OF FEEDWATER CONDITION IN UNIT #2 ON OCTOBER 19, 1977

Location TMI Nuclear Station
Middletown, PA 17057
Date November 14, 1977

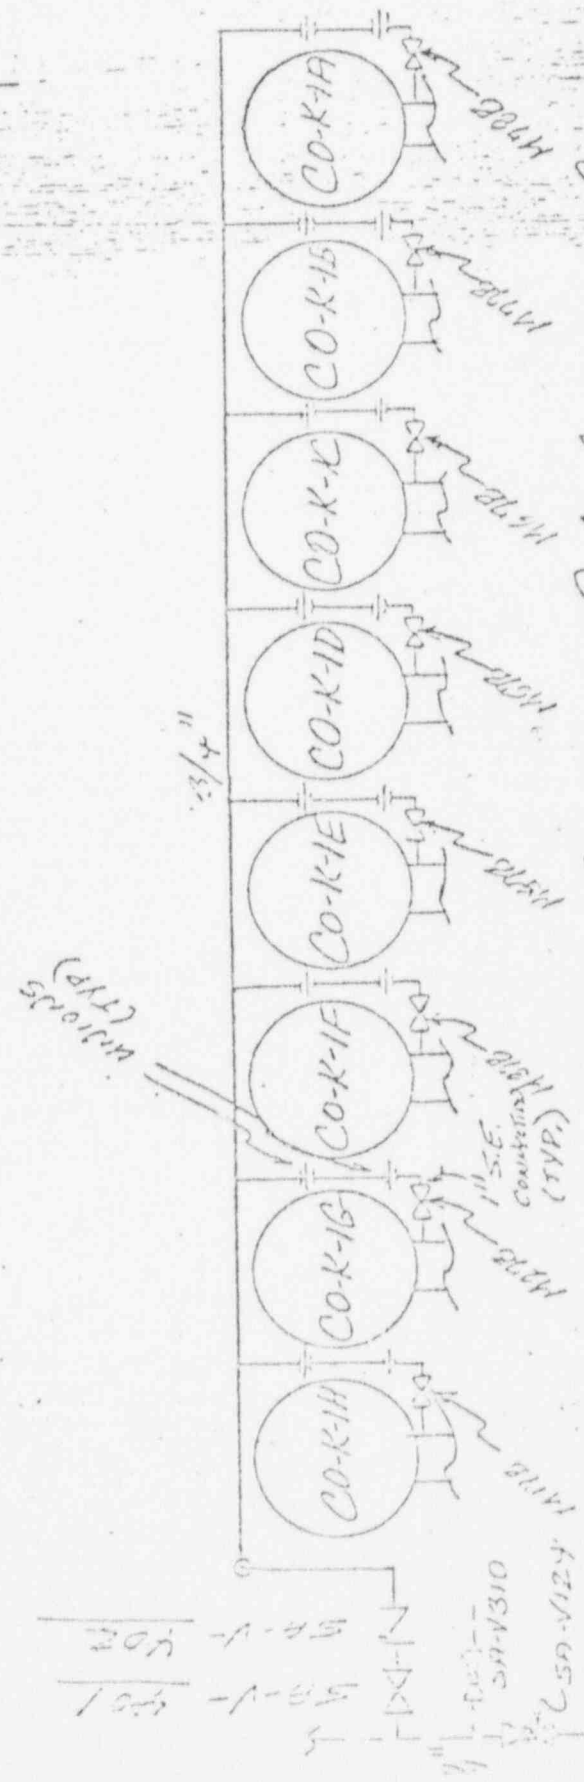
Attachment 1 of 2
 ECM No. S-4512

All Piping To Be 3/4" ISO-1
 And Field Run By UEC STARTUP

UEC START-UP TO CONNECT 3/4" Line spec.
150-1, piping at S.A. STA. NO. 12 and field
route to a 3/4" C.S. gate valve and check valve.
From the check valve field run the header
and branch lines to each Condensate Polisher
valve M17B then M87B. (see attachments
1 and 2 of 2).
