Reference: Facility Operating License No. NPF-49
Docket No. 50-423
Licensee Event Report 92-026-00

LICENSEE EVENT REPORT (LER)

FACILITY NAME (1) Millstone Nuclear Power Station Unit 3

TITLE (4) Both Trains of High Pressure Safety Injection Inoperable

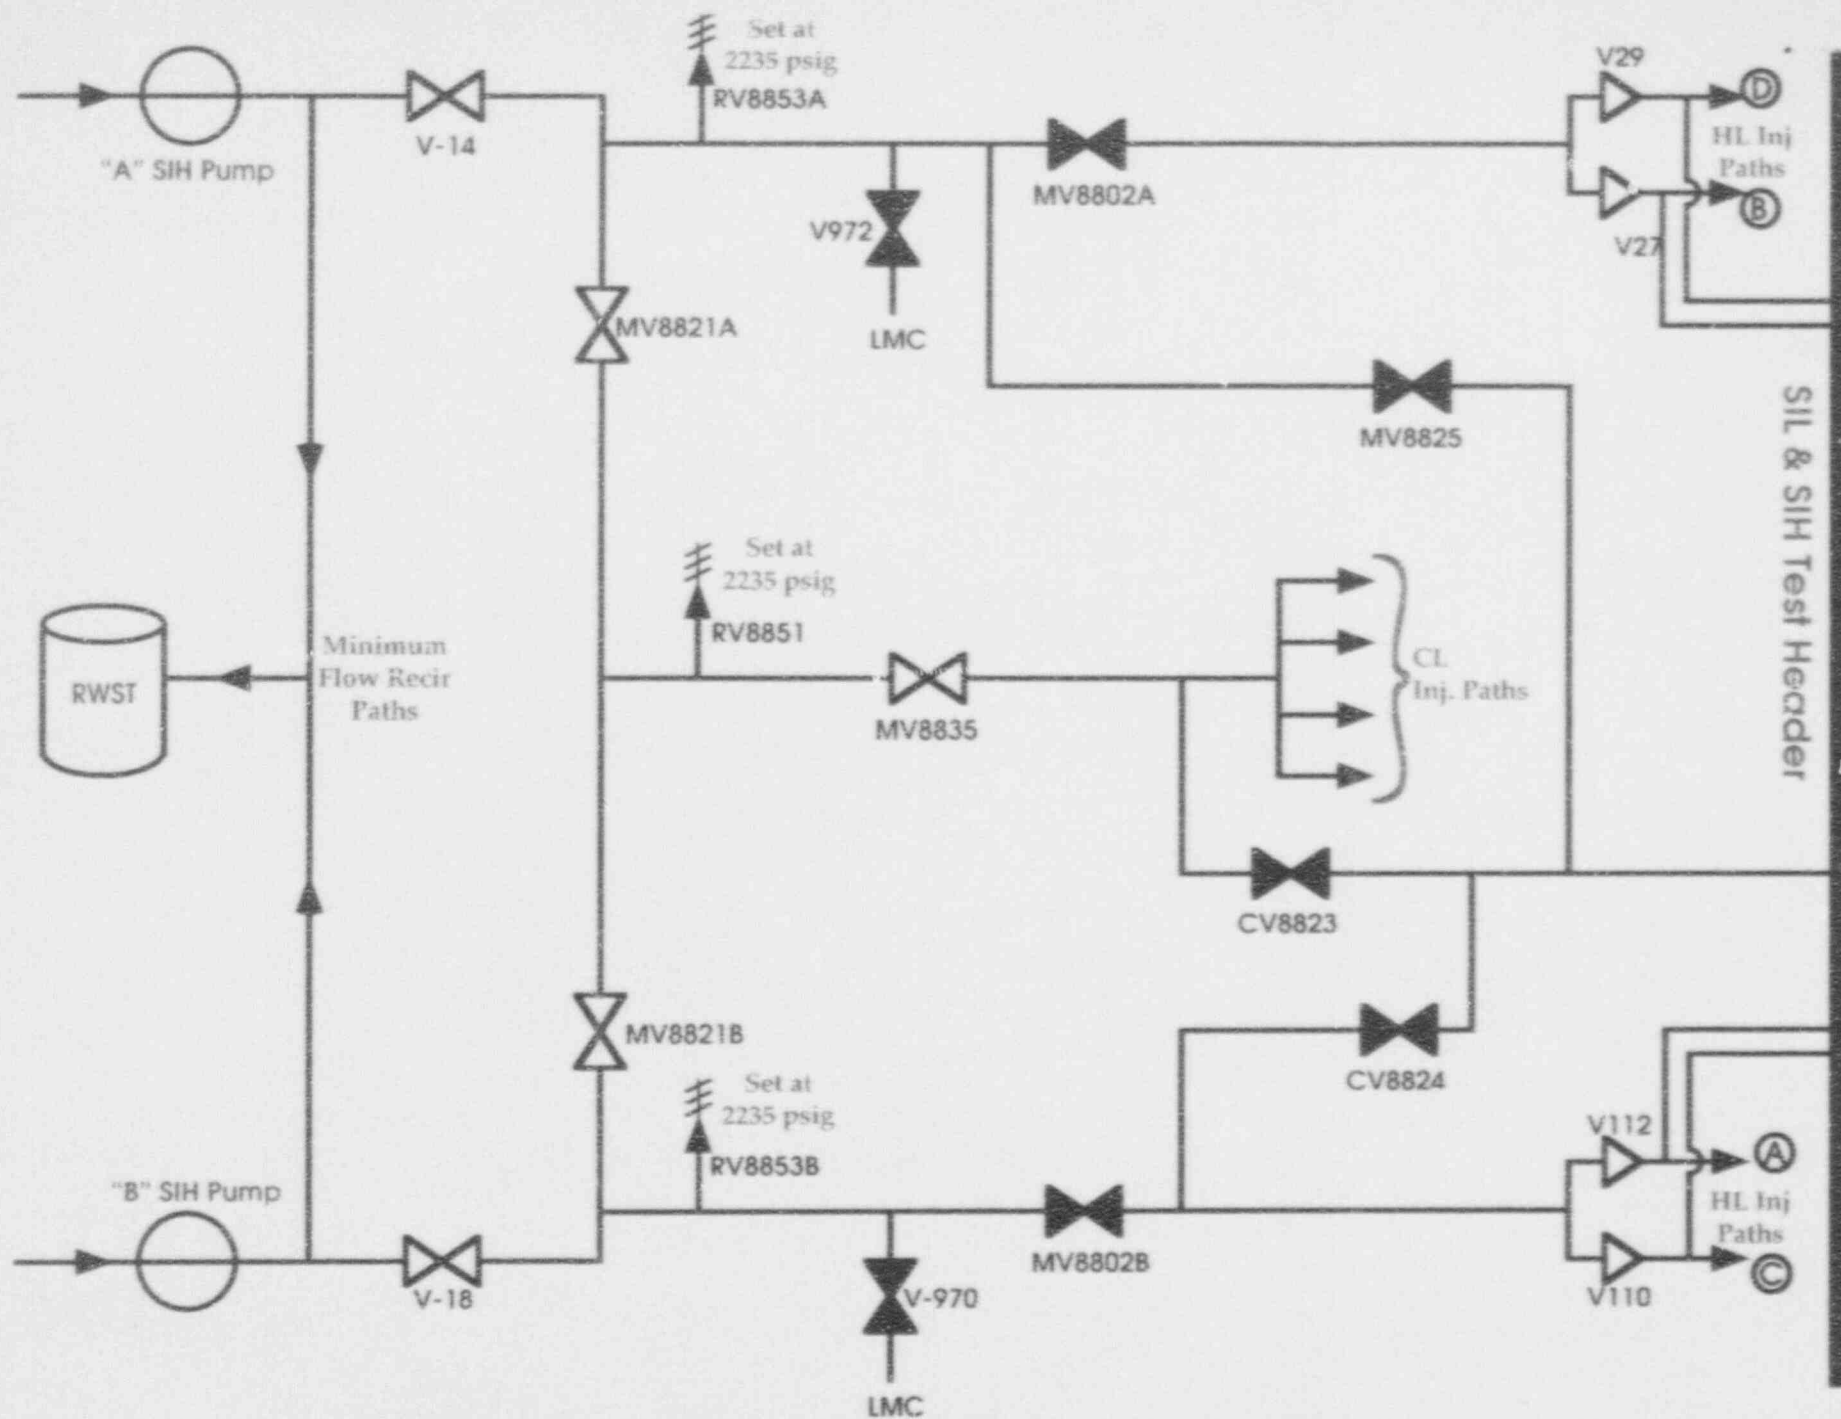
Normal SI Injection Lineup

On November 3, 1992, at 1415 with the plant in Mode 3 at 0% power (2250 psia and 557 degrees Fahrenheit), the control room staff determined that performing the SIH and Low Pressure Safety Injection (SIL) system check valve testing in accordance with the surveillance procedure would render both trains of the SIH system inoperable. The "B" train would become inoperable if it was aligned to both hot and cold leg injection paths due to possible pump run out. The "A" train was inoperable because the pump was isolated. The discovery was made while performing the test, but before the condition of the "B" train was changed. The test was stopped and the SIH system was aligned for normal standby operation.

The surveillance procedure was performed on February 1, 1992, with the cross connect valve for the "B" SIH pump open and the "B" SIH hot leg isolation valve open to provide a flow path to back seat the test method "A" train SIH check valves. While performing the surveillance on November 3, 1992, the operator questioned the operability of the "B" SIH pump with the flow path open to both the hot and cold legs. The procedure had already isolated the "A" SIH pump. The procedure was stopped prior to aligning the "B" SIH pump to both headers.

The procedure was revised to the original alignment used prior to the implementation of the bypass jumper. This flow path used the cold leg check valve leakage test connection which remained aligned to the operable pump.

In addition, the surveillance procedure was changed to use the cold leg connection to the test header.
