REGION V

March 31, 1976

The U.S. Nuclear Regulatory Commission and the State of Nevada Department of Human Resources recently cooperated in a joint investigation into allegations that employees at a radioactive waste burial ground near Beatty, Nevada, had been removing equipment and materials from the site.

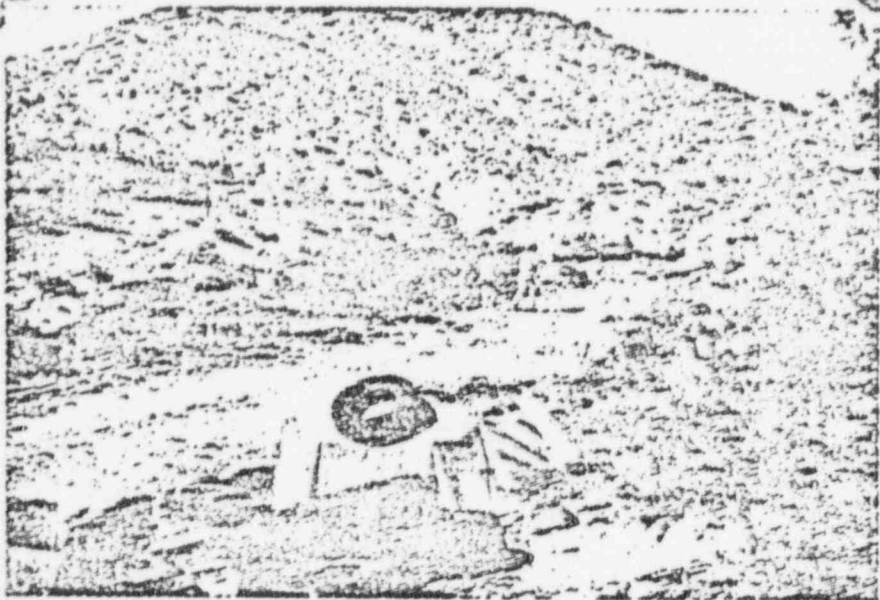
#4

Beatty vicinity residence, illustrating the piles of salvable refuse prevalent throughout town. Structure in left foreground was made from plywood removed from the NECO site. The structure was not contaminated.
