U.S. NUCLEAR REGULATORY COMMISSION

Report No. 030-32702/92002

Licensee: Old Vic, Inc.

Inspection on November 4-5, 1992 (Report No. 030-32702/92002 (DRSS))

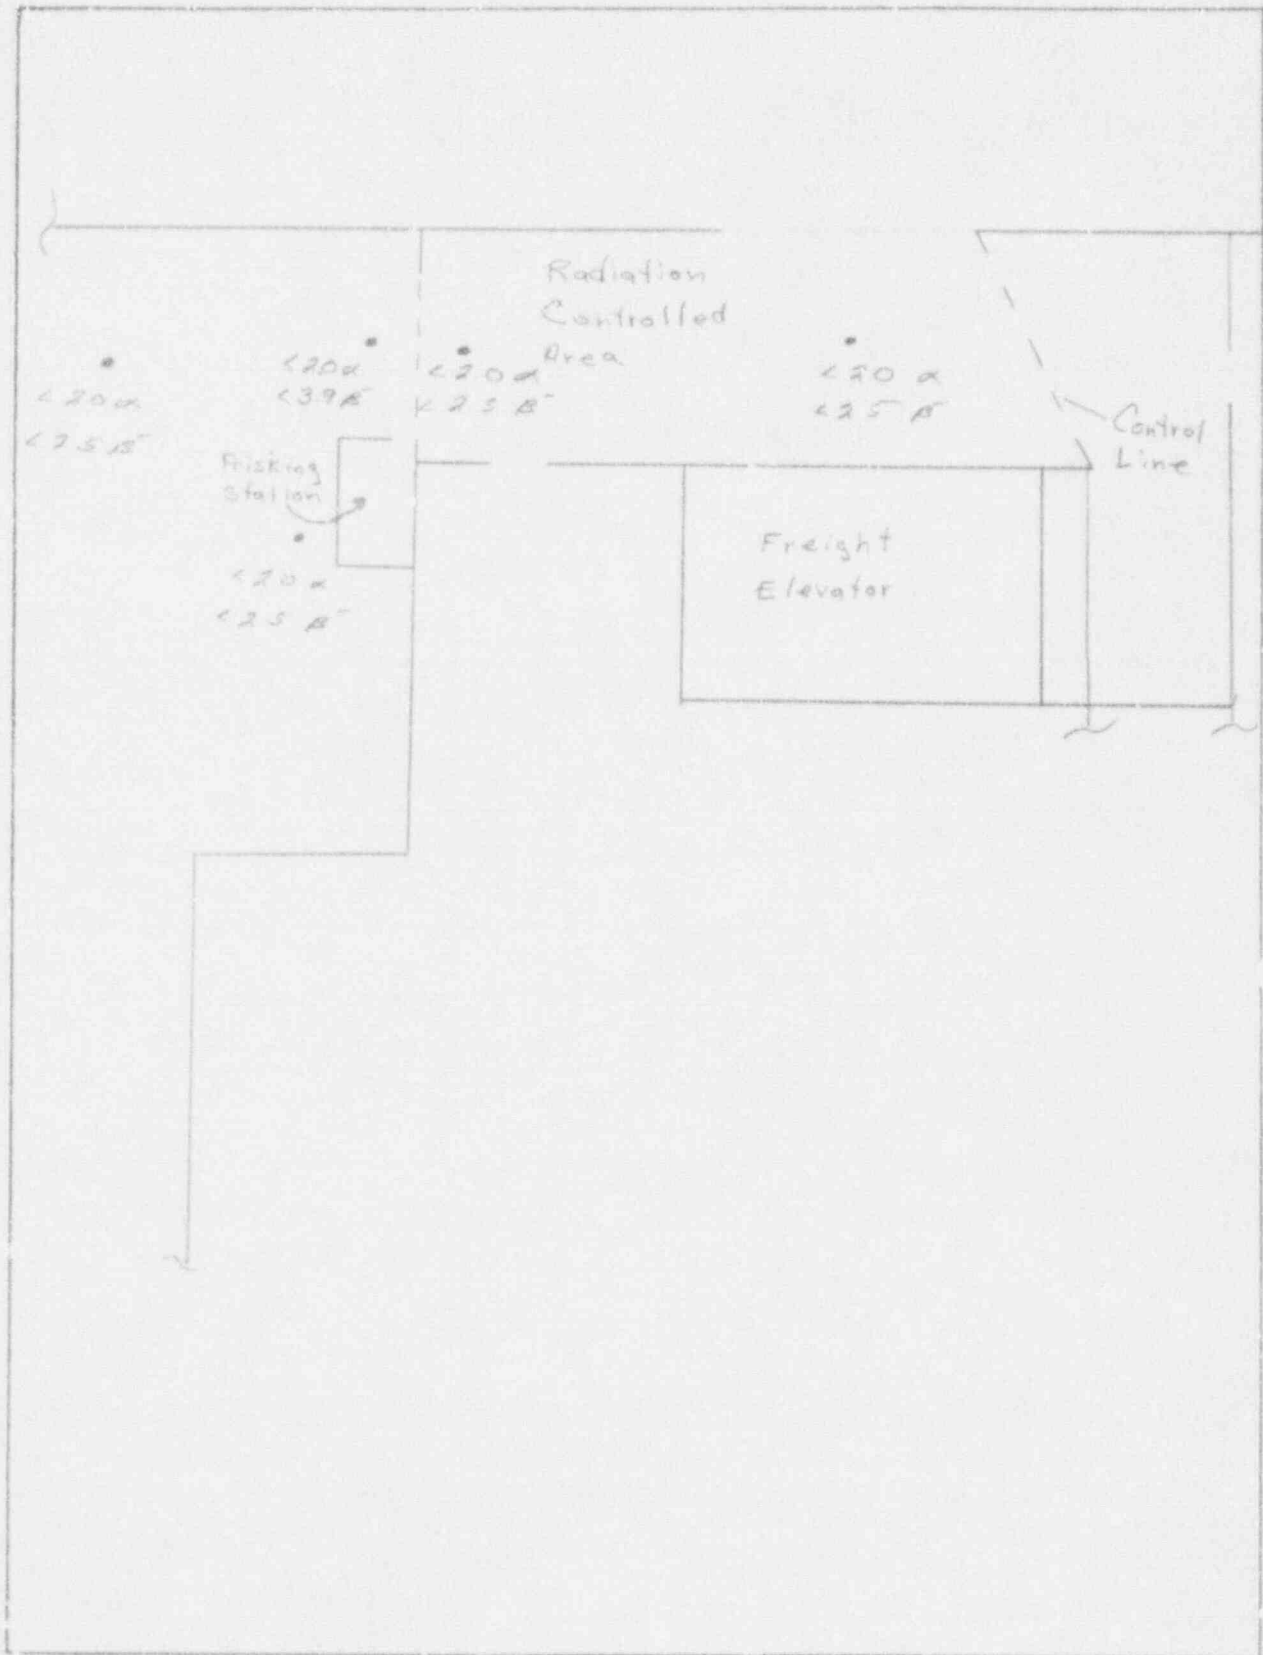
ATTACHMENT A

Five wipes, approximately 100 square centimeters each, were taken to determine removable activity in the vicinity of the restricted area access point, as indicated in the attached diagram (Attachment A). The wipes were analyzed for gross alpha and beta activity. The detected levels of removable activity were <2 disintegrations per minute (dpm) alpha and <3.9 dpm beta for each of the five wipes.
