UNITED STATES
NUCLEAR REGULATORY COMMISSION
WASHINGTON, D. C. 20555

SAFETY EVALUATION BY THE OFFICE OF NUCLEAR REACTOR REGULATION
RELATING TO THE UPPER REACTOR BUILDING AND NON-SAFETY ARCHITECTURAL
COMPONENTS SUBJECTED TO TORNADO-WIND LOADING
ITEMS 1 AND 11 OF SEP TOPIC III-2
GPU NUCLEAR CORPORATION
OYSTER CREEK NUCLEAR GENERATING STATION
DOCKET NO. 50-219

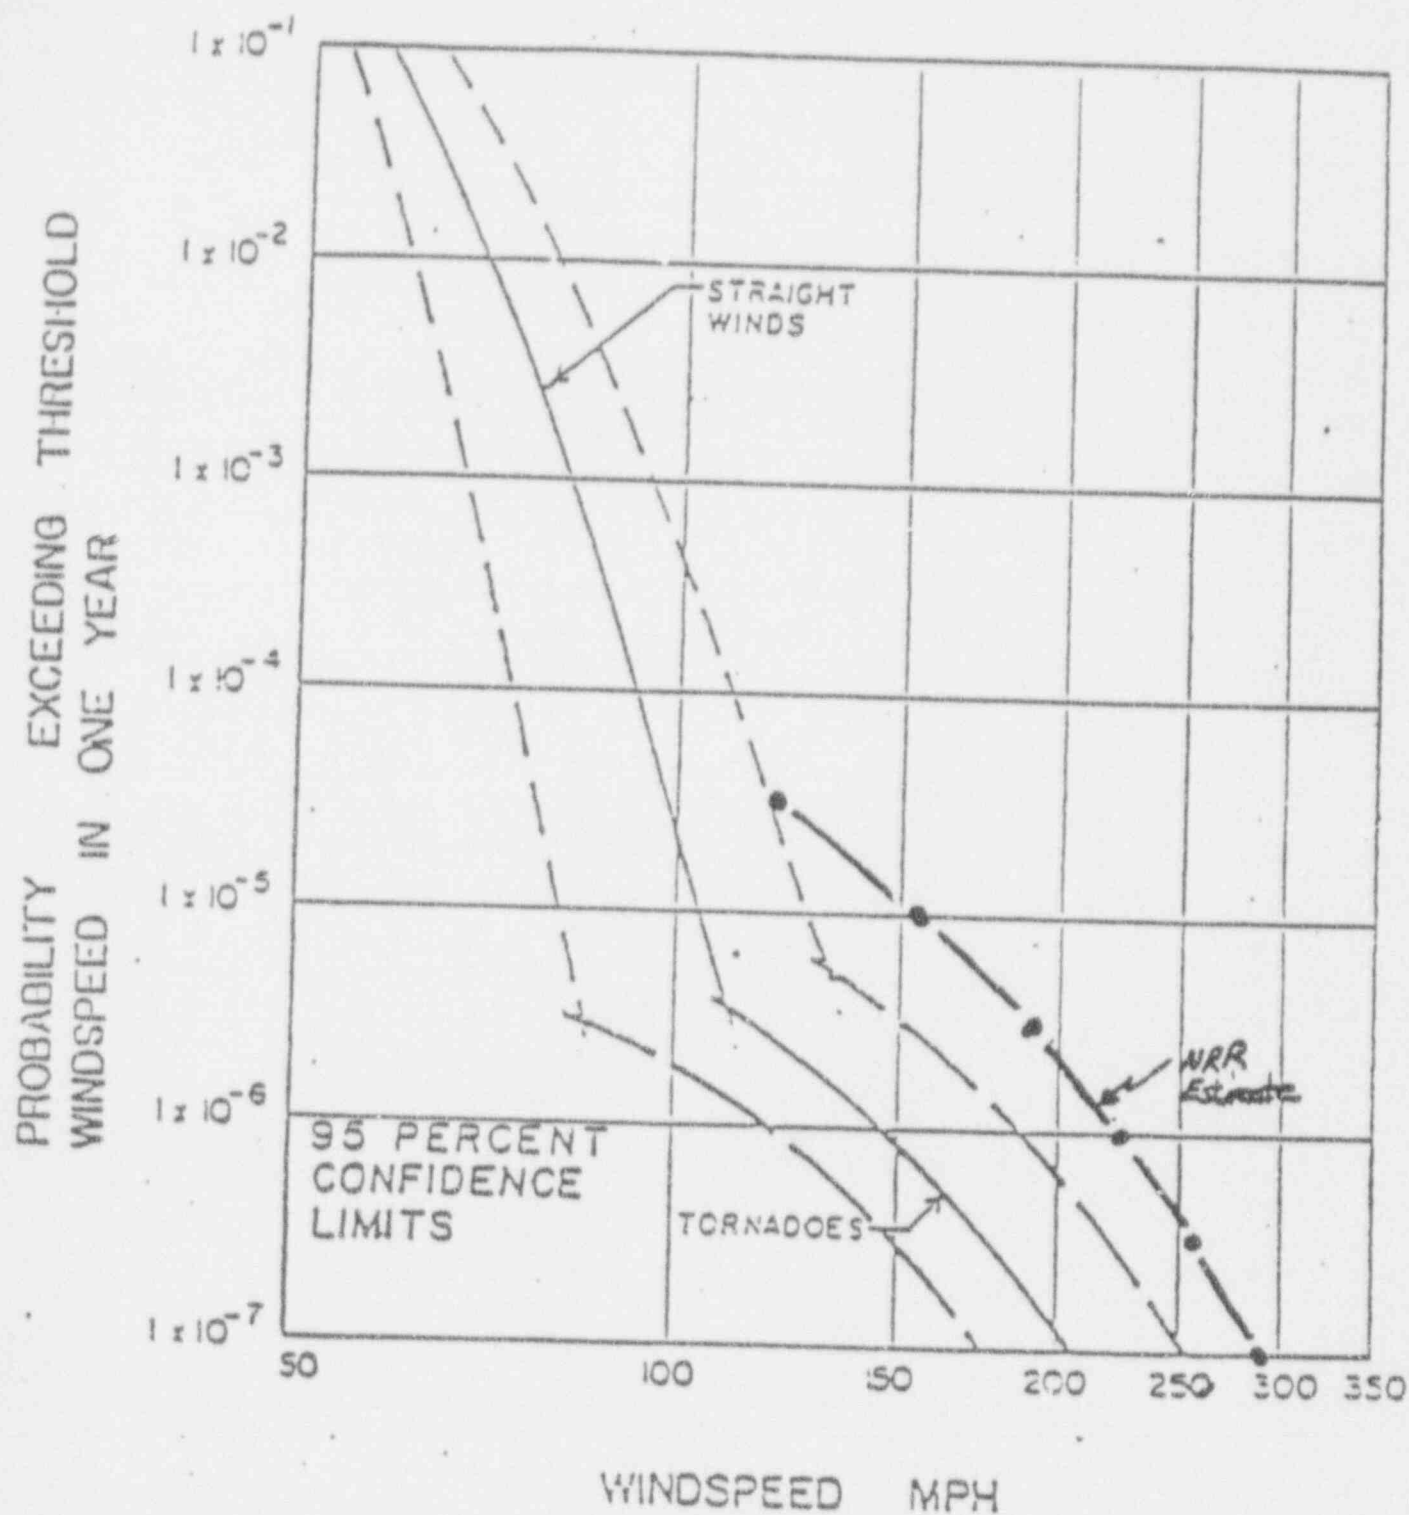
FIGURE 1

In the Integrated Plant Safety Assessment (IPSA-Ref. 1), the staff indicated that the roof framing of the upper portion of the Reactor building is likely to be structurally unstable at tornado-wind velocities in excess of 164 km/h (102 mi/h). By NRC staff estimate (Fig. 1), this wind velocity corresponds to the annual probability of exceedance (PE) of 5×10^{-3} . For the SEP plants, the staff has accepted the tornado-wind velocities corresponding to the PE lower than 10^{-5} . In the cover letter to the IPSA (Ref. 1), the staff requested the licensee to re-evaluate the structure and to assess if any modification to the structure would be needed to increase its capability.

TORNADO AND STRAIGHT WIND HAZARD
PROBABILITY MODEL FOR OYSTER CREEK
POWER REACTOR SITE, NEW JERSEY
