Portland General Electric Company
Trojan Nuclear Plant
71760 Columbia River Hwy
Rainier, Oregon 97048
(503) 556-3713

December 9, 1992
RDM-559-92

FACILITY NAME (1) Trojan Nuclear Plant										DOCKET NUMBER (2) 0 5 0 0 0 3 4 4				PAGE (3) 1 OF 10					
TITLE (4) Failure to Properly Stress Relieve a Steam Generator Tube Sleeve Causes Primary to Secondary Leakage to Exceed Limits																			
EVENT DATE (5)			LER NUMBER (6)				REPORT DATE (7)			OTHER FACILITIES INVOLVED (8)									
MONTH	DAY	YEAR	YEAR	SEQUENTIAL NUMBER			REVISION NUMBER	MONTH	DAY	YEAR	FACILITY NAMES			DOCKET NUMBER(S)					
											N/A			0 5 0 0 0					
11	09	92	92	-	0	3	3	-	0	3	11	09	92	0 5 0 0 0					
OPERATING MODE (9)		1		THIS REPORT IS SUBMITTED PURSUANT TO THE REQUIREMENTS OF 10 CFR 191.11															
POWER LEVEL (10) (10R)		0 9 5		20.402(b)				20.405(c)				50.73(a)(2)(iv)				73.71(b)

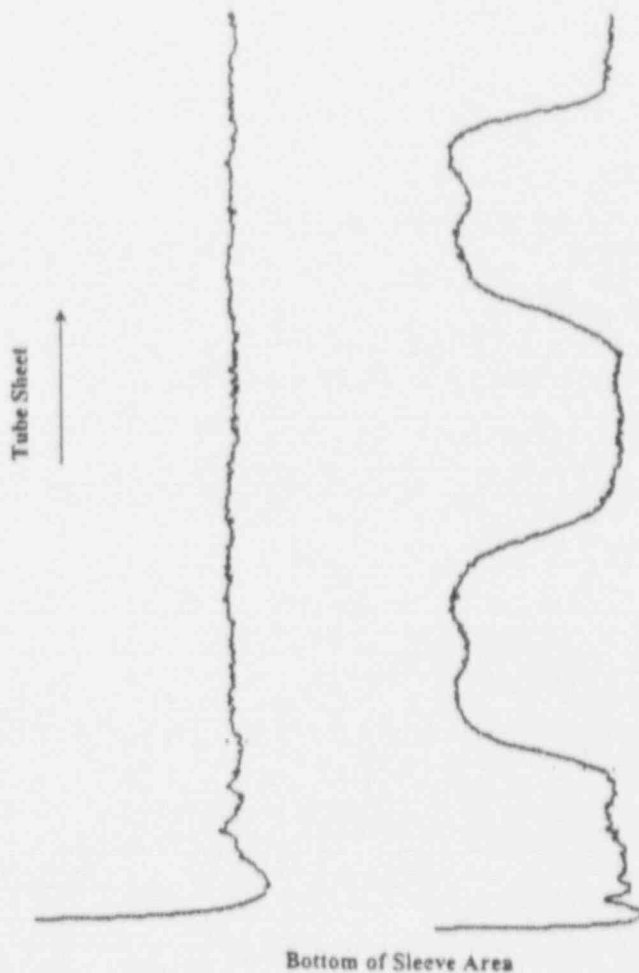
FIGURE 1

The cause of the primary to secondary leak was determined to be a defect in parent tube Row 25-Column 17 (R25C17) of S/G "B" adjacent to the lower weld expansion of the tube sleeve at the first tube support plate.

The cause of the tube failure was accelerated corrosion from unrelieved stresses left in the tube wall after the sleeve was kinetically welded to the tube. Laboratory tests have shown that accelerated corrosion at kinetic weld locations occur if the stress relieving process is not performed. The installation procedure requires the stresses to be thermally relieved by the use of a heater inserted into the sleeve. The heater was not properly inserted into the sleeve and remained in the tube area below the sleeve. The improper placement of the heater in tube R25C17 was verified using eddy current measurements which showed altered magnetic permeability in two regions of the parent tube several inches below the tube sleeve location. Figure 1 shows the eddy current trace of the parent tube below the sleeve for R25C17 and another tube. Figure 2 shows the eddy current trace within the sleeve area of R25C17 and another sleeve which was properly heat treated. The heat treatment was then performed, but the heating occurred in the tube region below the sleeve.

EDDY CURRENT TRACE OF PARENT TUBES BELOW SLEEVE

"B" S/G Row 17-Column 6

"B" S/G Row 25-Column 17

Tube R25C17 in the "B" S/G was stabilized and plugged. Adjacent inservice tubes were inspected to assure no damage occurred to these tubes; the tubes were found to be acceptable.

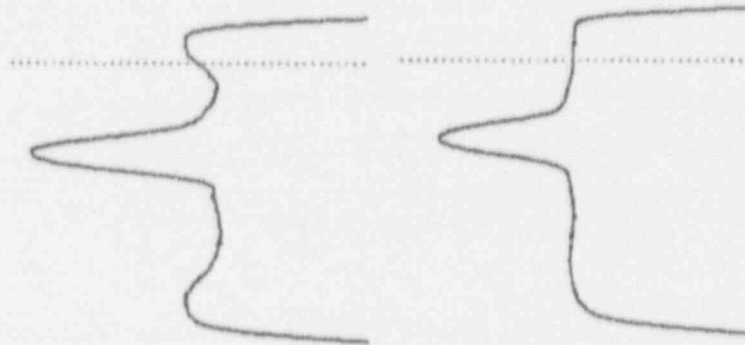
FIGURE 2

A program was developed to evaluate and confirm by a combination of eddy current examination, record review of past heater data, and record review of past hard stop pressure data that other tube support plate sleeves installed in the Trojan steam generators received heat stress relief at the weld locations. A bobbin coil eddy current probe was used to confirm that the stress relief process did occur within the tube support plate sleeves. To provide confirmation that the heater position within the sleeves was within required tolerances to provide adequate stress relief, three criteria were developed. They are: hard stop pressure, requirements for the Heat Affected Zone(HAZ), and heater performance. Satisfying one of these criteria in conjunction with confirming that the stress relief process occurred within the tube sleeves, not in the parent tube material below the sleeves, assures that the stress relief heater was properly positioned within the sleeve. This evaluation concluded that the remaining sleeves were properly stress relieved.

It was determined that the heater used on tube R25C17 was used on a total of eight tubes. These tubes were eddy current tested and found to have proper stress relief. However as a conservative measure, the remaining inservice sleeves were bobbin coil tested for indication that the stress relief occurred inside the sleeve. No other cases of failure to stress relieve were identified.

EDDY CURRENT TRACE WITHIN SLEEVE AREA

"B" S/G Row 17-Column 6

"B" S/G Row 25-Column 17
