LIMERICK GENERATING STATION

SUBJECT: Licensee Event Report
Limerick Generating Station - Unit 1

This LER concerns a Nuclear Steam Supply Shutoff System (NSSSS) Group III isolation of the Reactor Water Cleanup (RWCU) System due to high differential flow caused by a pressure transient while removing a RWCU filter demineralizer from service.

FACILITY NAME (1) Limerick Generating Station, Unit 1										DOCKET NUMBER (2) 0 5 0 0 0 3 5 2					PAGE (3) 1 OF 4	
TITLE (4) Reactor Water Cleanup Isolation Due to High Differential Flow Caused by a Pressure Transient While Removing a Filter Demineralizer From Service.																
EVENT DATE (5)			LER NUMBER (6)				REPORT DATE (7)			OTHER FACILITIES INVOLVED (8)						
MONTH	DAY	YEAR	YEAR	SEQUENTIAL NUMBER	REVISION NUMBER	MONTH	DAY	YEAR	FACILITY NAMES				DOCKET NUMBER(S)			
0	3	26	88	88	011	0	1	20					0 5 0 0 0			
THIS REPORT IS SUBMITTED PURSUANT TO THE REQUIREMENTS OF 10 CFR 8. (Check one or more of the following) (11)																
OPERATING MODE (9)		1		20 402(b)		20 406(c)		X		50.73(a)(2)(iv)		73.71(b)				
POWER LEVEL (10)		9.5		20 405(a)(1)(i)		50.36(a)(1)				50.73(a)(2)(v)		73.71(c)				
				20 405(a)(1)(ii)		50.36(a)(2)				50.73(

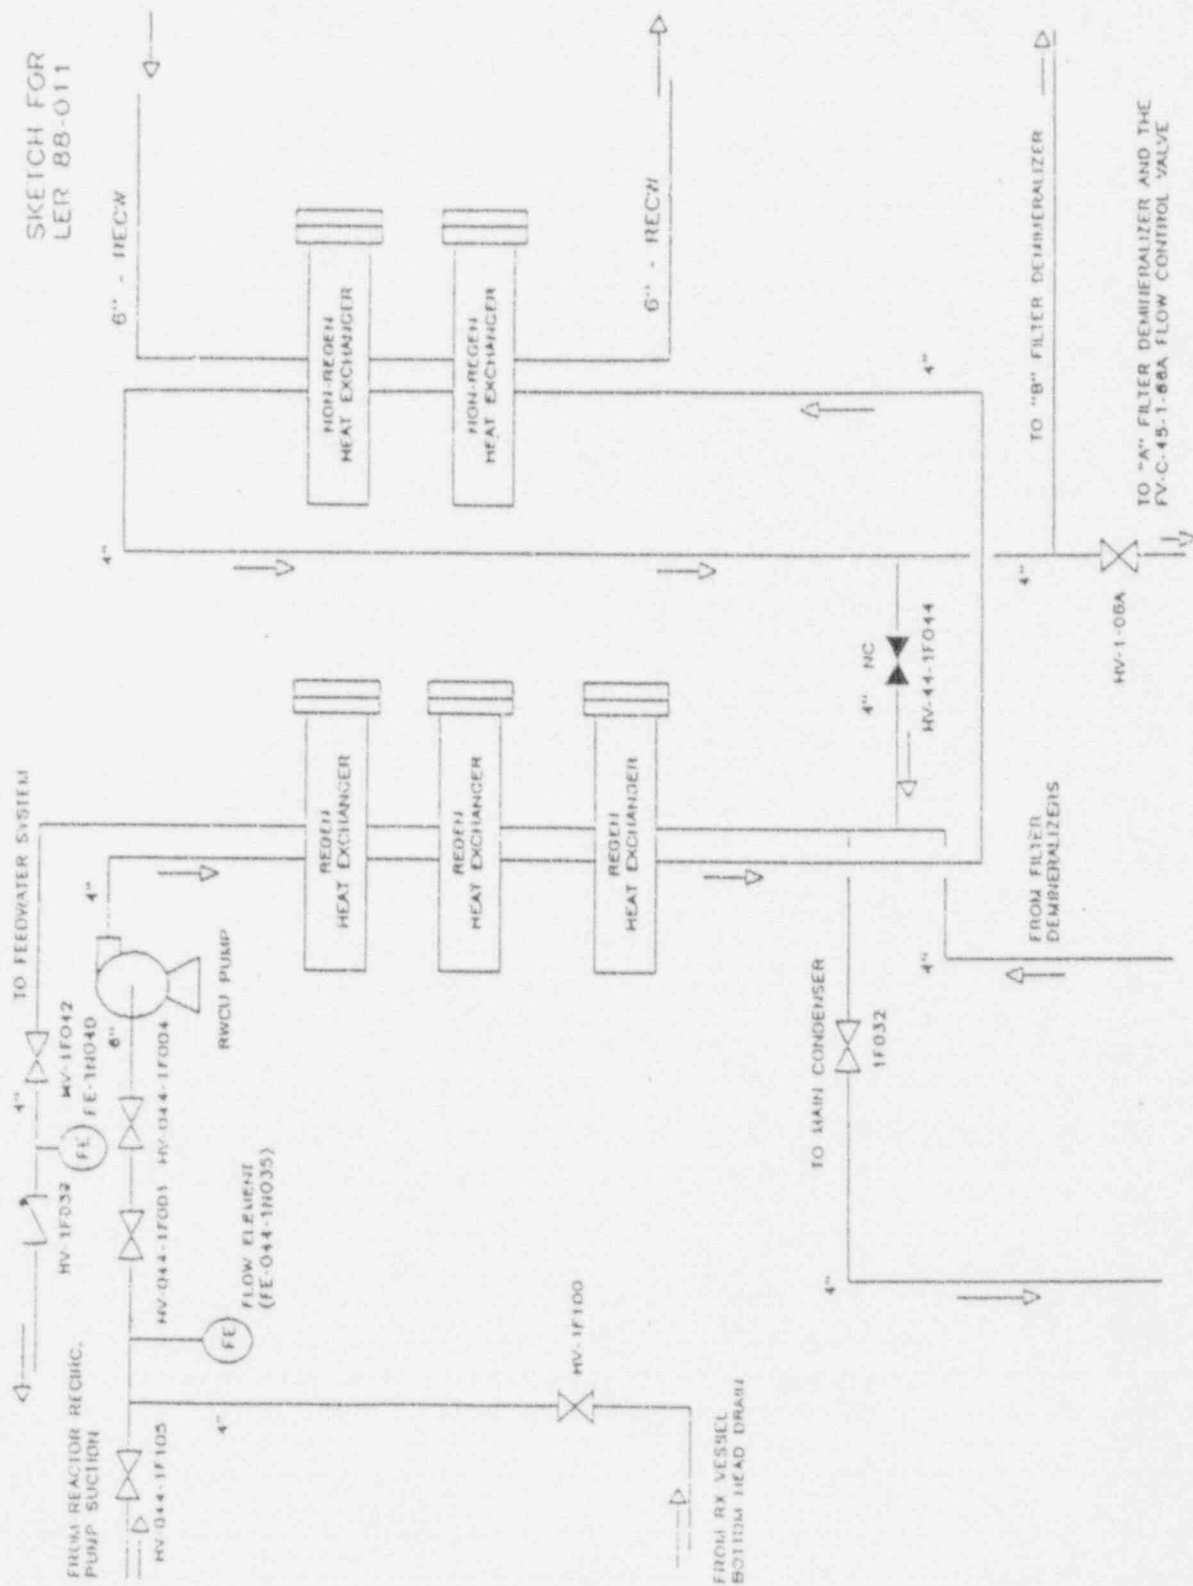
RWCU isolated on a pressure transient. The pressure transient was caused by an inability of the demineralizer bypass valve HV-44-1F044 to be adjusted to

properly control system flow. This valve is believed to be oversized for its application. As a result, Operations personnel experienced difficulty controlling RWCU flow while removing the 'A' filter demineralizer from service (see attached sketch). Operations personnel could not maintain the minimum required 60 gpm system flow because system flow is controlled by adjusting the filter demineralizer bypass valve (HV-44-1F044) in a very narrow range, less than 10% valve full open. This globe valve has a standard plug, or quick opening, type disc and the adjusting requirements are difficult to control. As a result, the 'A' RWCU pump tripped on low suction flow (pump protection). A pressure transient ensued causing a high differential flow condition of greater than 54.9 gpm. This condition lasted for greater than 45 seconds thereby initiating an NSSSS Group III, A and D Channel "high differential flow" isolation signal.

A modification to replace valve HV-44-1F044 was planned, as stated in Revision 0 of this LER. Instead, a modification has been implemented which lengthened the time delay of the RWCU pump low suction flow trip. The time delay was increased from 5 seconds to 180 seconds to allow operations personnel additional time to adjust valve positions during RWCU system flow alterations, including the repositioning of valve HV-44-1F044. Notes and caution statements in the RWCU system operating procedures have been revised, and have aided Operations personnel in minimizing differential flow isolations during RWCU system evolutions. Therefore, the planned modification to replace valve HV-44-1F044 has been cancelled since these alternative measures have prevented the recurrence of this event.
