POWER REACTOR EVENTS & ISSUES

NUREG/BR-0171
Vol. 1

The feature article in this issue of *Power Reactor Events & Issues* is based on AEOD Engineering Evaluation Report AEOD/E91-01, "A Review of Water Hammer Events After 1985," written by E. J. Brown. This study was initiated following several instances of water hammer involving the service water system at Arkansas Nuclear One. The task was to evaluate the need to reissue previous NRC guidance about water hammer or to suggest additional measures to prevent or mitigate their occurrence.

A REVIEW OF WATER HAMMER EVENTS AFTER 1985

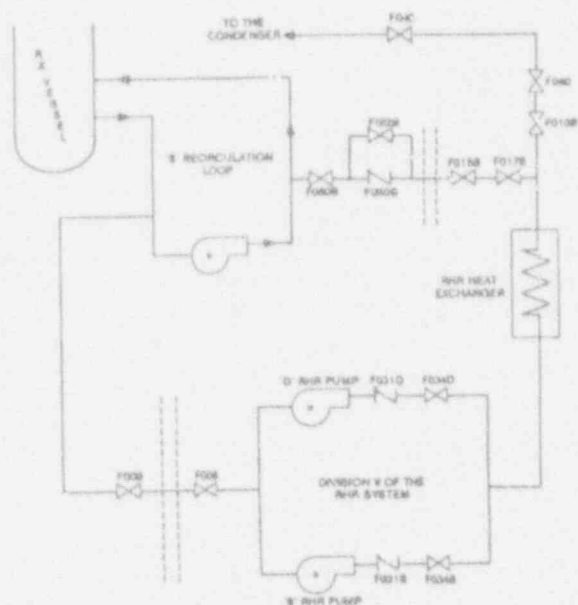
Figure 1

On October 12, 1986, the unit was in the shutdown cooling mode with the "D" residual heat removal (RHR) pump in service (Ref. 10). The "B" RHR pump was then started (see Figure 1). After

switchover to the "B" pump was completed, pump "D" was shut down. However, at about the same time, outboard isolation valve F008 in the letdown line from the "B" recirculation pump to the suction of the "B" RHR pump closed, causing the "B" RHR pump to trip. Operations personnel reset the logic

and reopened valve F008. Reopening valve F008 resulted in water hammer and valve F008 again closed. The water hammer was caused by partial draindown of the system through a pathway to the condenser. This pathway is used to control the reactor water level while the RHR system is in service. The operators failed to fill and vent the RHR system piping after the "B" RHR pump tripped.

Susquehanna Unit 2 RHR Shutdown Cooling

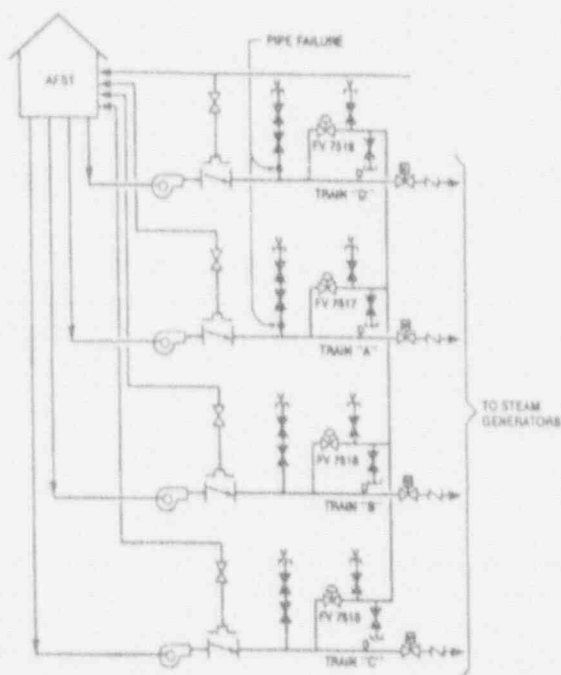
Figure 2

On November 5, 1987, while in hot shutdown and prior to initial criticality, a 1-inch diameter, double valve vent line in the pump discharge piping of the auxiliary feedwater (AFW) train "A" broke off (Ref. 13). A second failure occurred 3 days later in a similar manner in a double valve instrument

tap for the "D" train AFW pump discharge line (see Figure 2). The initial assessment cited the cause as water hammer resulting from improper venting of the AFW system. The AFW system however, continued to experience vibration when in operation. Subsequent testing revealed that over-throttling the flow control valves in trains "A" or "D" introduced pressure fluctuations at a dominant frequency of 24 hertz. This frequency matched the natural frequency of the piping system. Mechanical stops were installed to prohibit excessive throttling of the valves.

South Texas Unit 1 AFW System

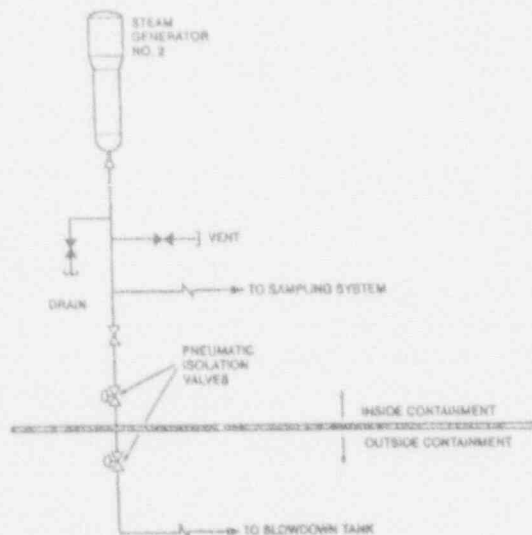
Figure 3

During a routine system walkdown on July 14, 1989, with the plant at full power, plant personnel found a damaged pipe support on a steam generator blowdown pipe (Ref. 18). It was later determined that in this condition, the structural

integrity of the blowdown system (including the outside containment isolation valve and shield building penetration) could not be assured during a seismic event.

The support was observed to be undamaged during a walkdown in June 1989. Between the two system walkdowns, personnel performed the operating test "Engineered Safety Feature Actuation Signal (ESFAS) Subgroup Relay Test." This test involved cycling the inside containment isolation valve to verify its operability in response to a containment isolation actuation signal or an emergency feedwater system actuation signal. The procedure did not require shutting the outboard containment isolation valve or minimizing the blowdown flow prior to opening the inboard isolation valve (see Figure 3). Thus, a water hammer transient most likely occurred when the inboard isolation valve was opened.

Waterford Unit 3
Steam Generator Blowdown System

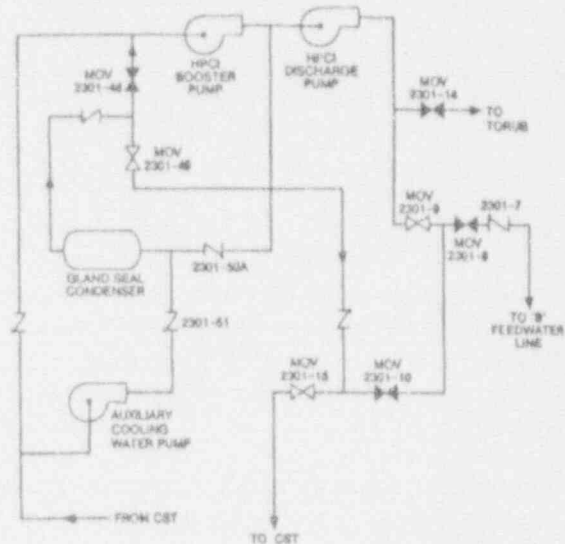
Figure 4

A series of three events involving water hammer in the high pressure coolant injection (HPCI) system occurred at Dresden Units 2 and 3 (Ref. 23). Two of these events were reviewed by an NRC Augmented Inspection Team in October and November 1989 (Ref. 24). Preliminary indications of a precursor to the initial Unit 2 damage in the HPCI system were provided by increasing HPCI cubicle temperatures in May 1989. The pipe temperature at the HPCI pump was 140°F, while the piping between MOVs 2-2301-8 and 2-2301-9 was 160°F (see Figure 4). Further pipe temperature measurements taken in July 1989 found the HPCI pump discharge piping at 175°F, while the pipe between MOVs 2-2301-8 and 2-2301-9 was 220°F. Closing MOV 2-2301-9 produced pipe temperatures of 106°F after 12 hours. Pipe temperatures returned to 220°F after MOV 2-2301-9 was reopened. This showed that check valve 2-2301-7 and MOV 2-2301-8 were both leaking feedwater back to the HPCI system piping.

Dresden Units 2 and 3 Basic HPCI System, Normal Valve Line-up

A pipe temperature survey conducted in October 1989 revealed that the HPCI pump discharge pipe temperature was 246°F, while the temperature of the piping between MOVs 2-2301-8 and 2-2301-9 was 275°F. An evaluation determined that steam voids could form in certain sections of the pipe under these conditions. Inspection of the Unit 2 HPCI discharge piping supports found deficiencies in 47 percent (or 16) of the supports. The Unit 2 HPCI system valve lineup was changed so that the injection valve function was moved from MOV 2-2301-8 to MOV 2-2301-9 (see Figure 5). Also, with MOV 2-2301-8 open, MOV 2-2301-10 becomes an isolation valve that is now subject to feedwater pressure.

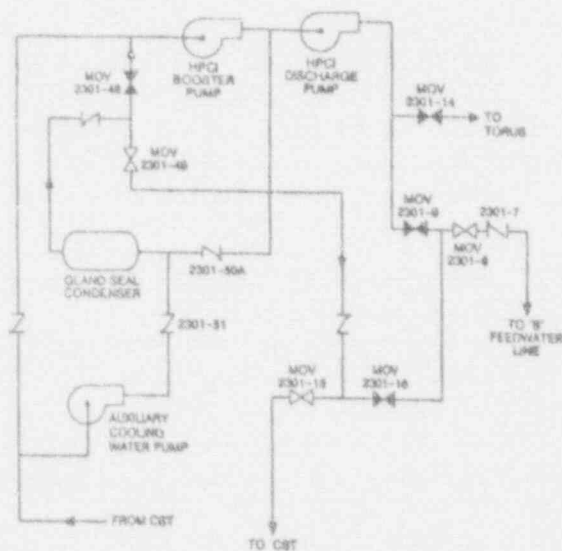
Figure 5

Dresden Unit 2 HPCI Alternate Valve Line-up
(Post-October 1989 Event)

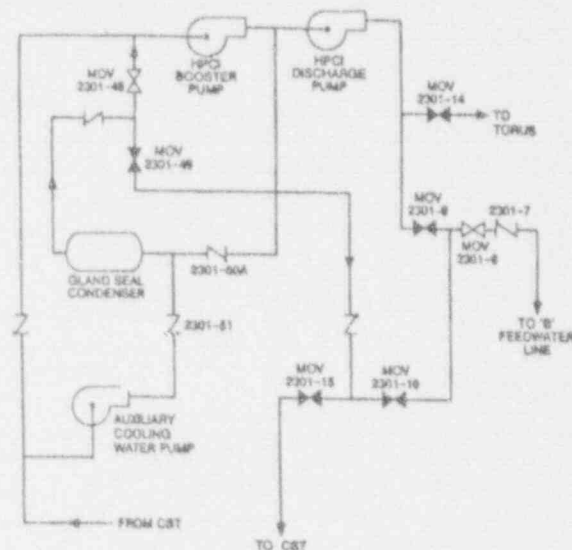
Figure 6

Dresden Units 2 and 3
HPCI Revised Alternate Valve Line-up
(Unit 2 Post-March 1990 Event and
Unit 3 Post-October 1989 Event)

2 HPCI pump discharge valves, the Unit 2 Shift Supervisor heard banging noises coming from the HPCI pump discharge piping (Ref. 23). The valve timing test was terminated and the HPCI system valve lineup was returned to the configuration shown in Figure 5. The pipe banging and motion was monitored until it eventually ceased about 1-1/2 hours later. Valve manipulation and temperature measurements along the HPCI pump discharge pipe led the licensee to conclude that feedwater leakage back through HPCI test return valve MOV 2-2301-10 was the root cause of this event.

Based on further investigation, the licensee postulated that MOV 2-2301-10 did not fully close after performing the HPCI system tests. However,

may or may not fully close when given a close signal. This valve does not have a seal-in feature to complete the stroke after closure initiation. In addition, the limit switches are set to provide a torque switch bypass function in the open direction until the valve is 25 percent open. This limit switch also controls the indicated "valve closed" light in the control room. Thus, an operator removing a closure signal shortly after the control room panel lights indicate that the valve has closed could leave the valve nearly 25 percent open. A procedure was introduced to continue the closure signal 30 seconds after the panel lights indicate MOV 2-2301-10 has closed. The Unit 2 HPCI system valve lineup was again revised, and left to match the HPCI system valve lineup for Unit 3 (see Figure 6).

Inspection of Unit 3 HPCI discharge pipe supports found deficiencies in 52 percent (or 21) of the supports. The Unit 3 HPCI system valve lineup was changed so that MOVs 3-2301-15 and -49 were normally closed and MOV 3-2301-48 was normally open (see Figure 6).
