Docket No. 50-336
File Nos. RI-90-A-180, RI-90-A-198

Subject: Allegations Concerning (1) Wide Range Nuclear Instrumentation Operability, (2) Operator Attentiveness, and (3) Alignment of Reactor Coolant Flow Transmitters.

CONCERNS FROM A NORTHEAST EMPLOYEE

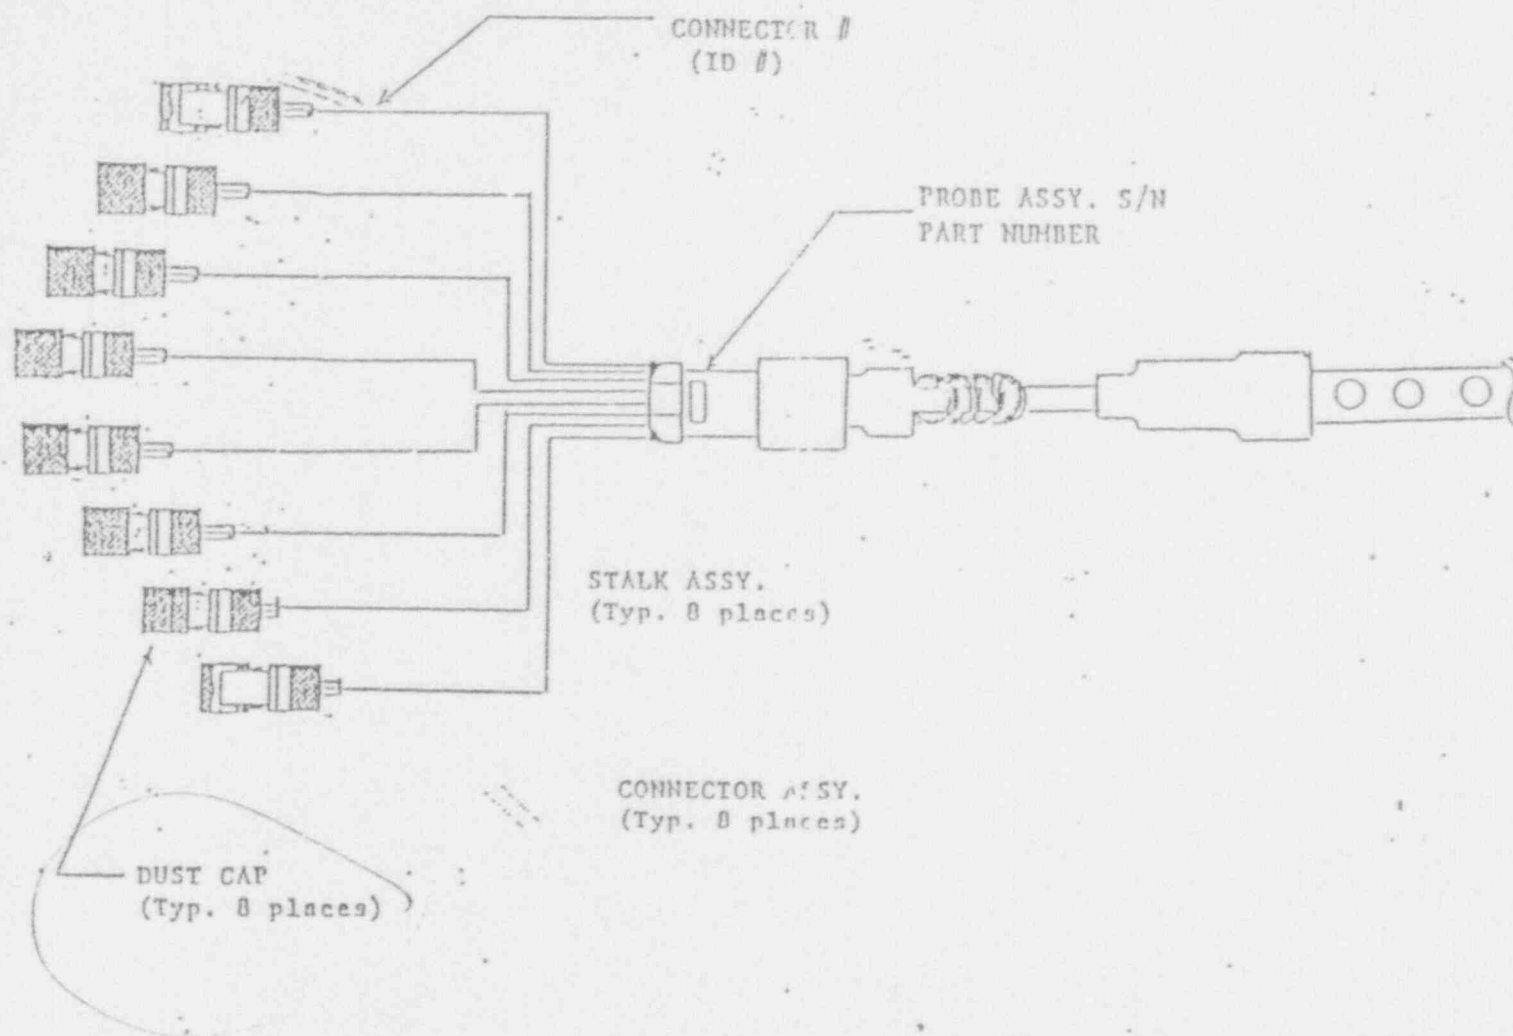
FIGURE B 5
NJTC PROBE ASSEMBLY MT-2

e. According to the allegor dust covers are installed on the HJTC connectors when disconnected as depicted on procedure figure B.5 of IC2421C. Inspector review of procedure IC 2421C section 5.5.6 on reconnection of connections did not identify a specific procedural step to remove dust covers on the connectors.
