UNITED STATES
NUCLEAR REGULATORY COMMISSION
WASHINGTON, D. C. 20555
July 14, 1982

FACILITY: Three Mile Island, Unit No. 1 (TMI-1)
LICENSEE: GPU Nuclear Corporation (GPUN)
SUBJECT: SUMMARY OF MEETING WITH GPUN ON JUNE 28 and 29, 1982
CONCERNING GPUN'S STEAM GENERATOR RECOVERY PROGRAM

**TMI-1 OTSG Status
and
Repair Process Description**

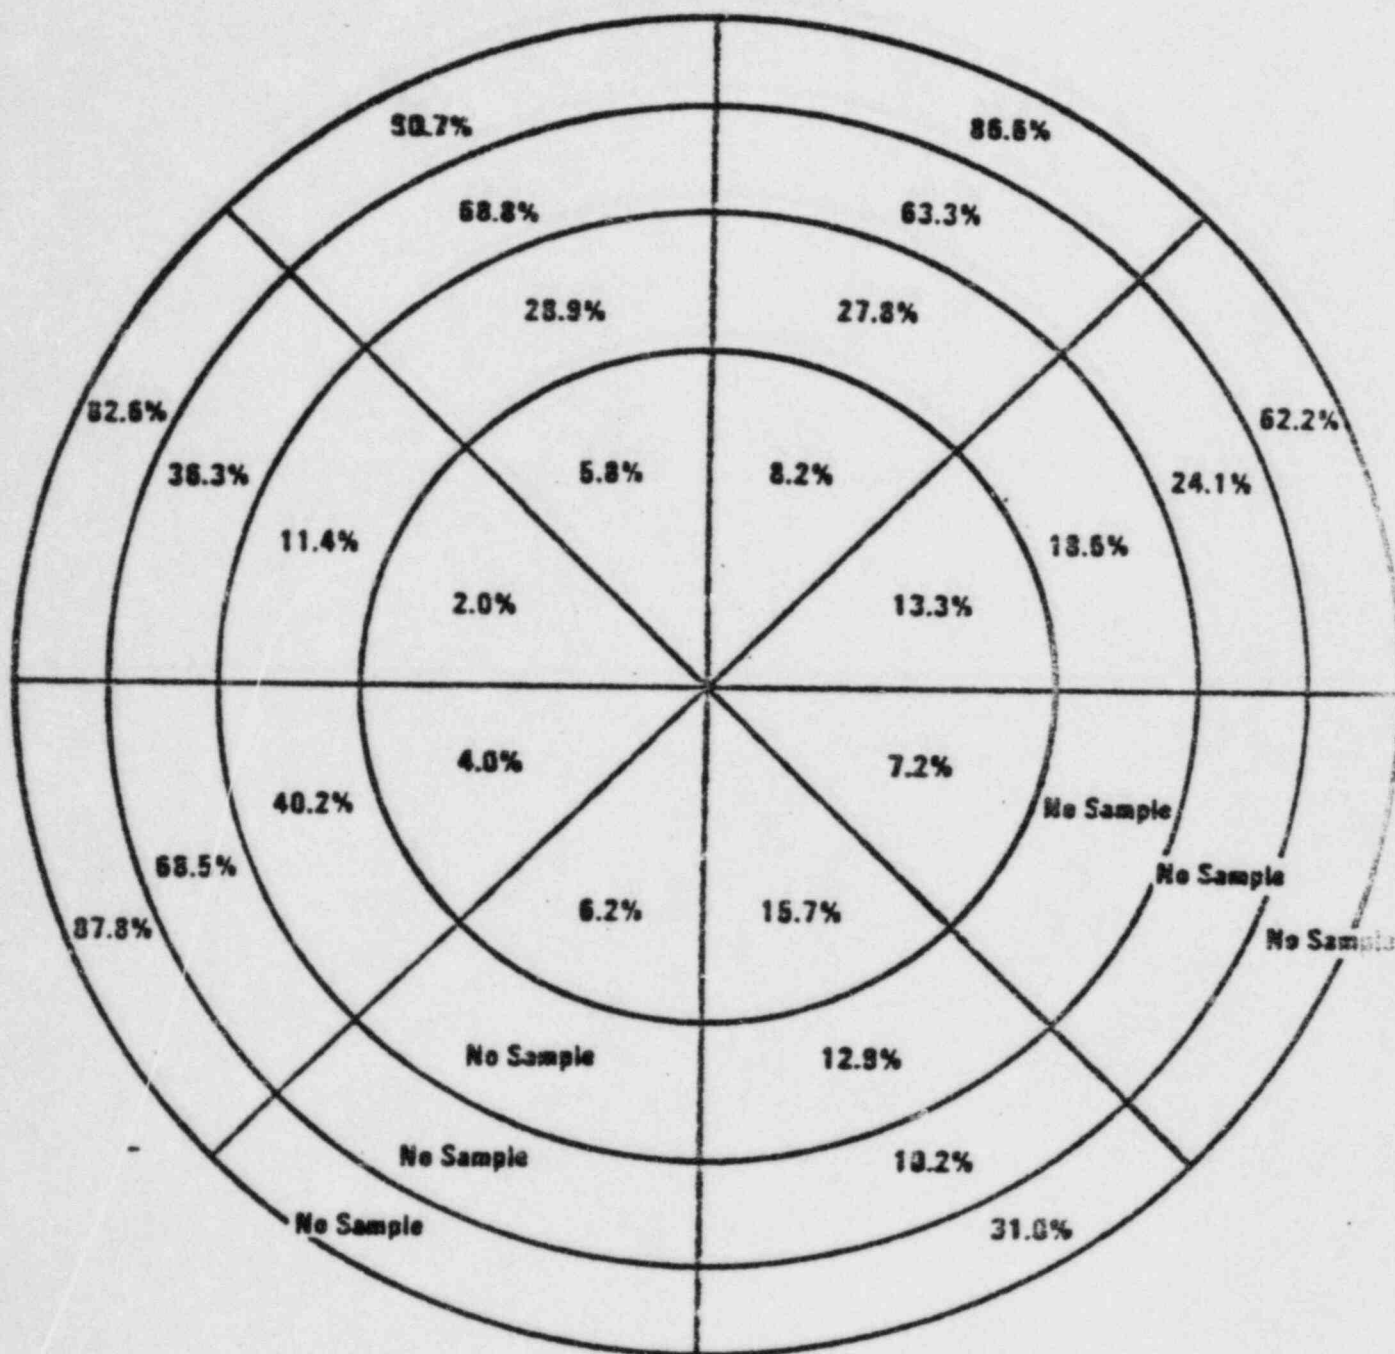
Three Mile Island Nuclear Generating Station Unit 1 Steam Generator A

4 X 1 Eddy Current Results
Percent of Tubes with Defects

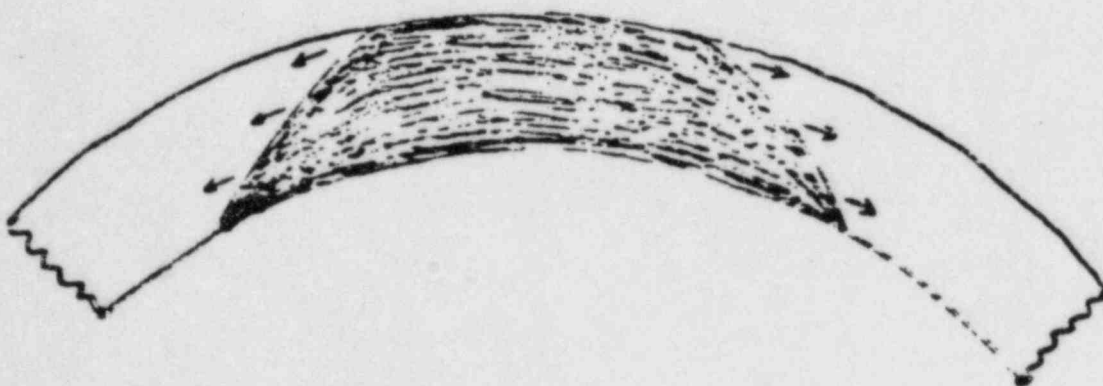
FIGURE VI - 1

SKETCH OF TYPICAL CRACK SHAPES

a) Advancing crack not yet through wall.

b) 100% through-wall crack continuing to grow.

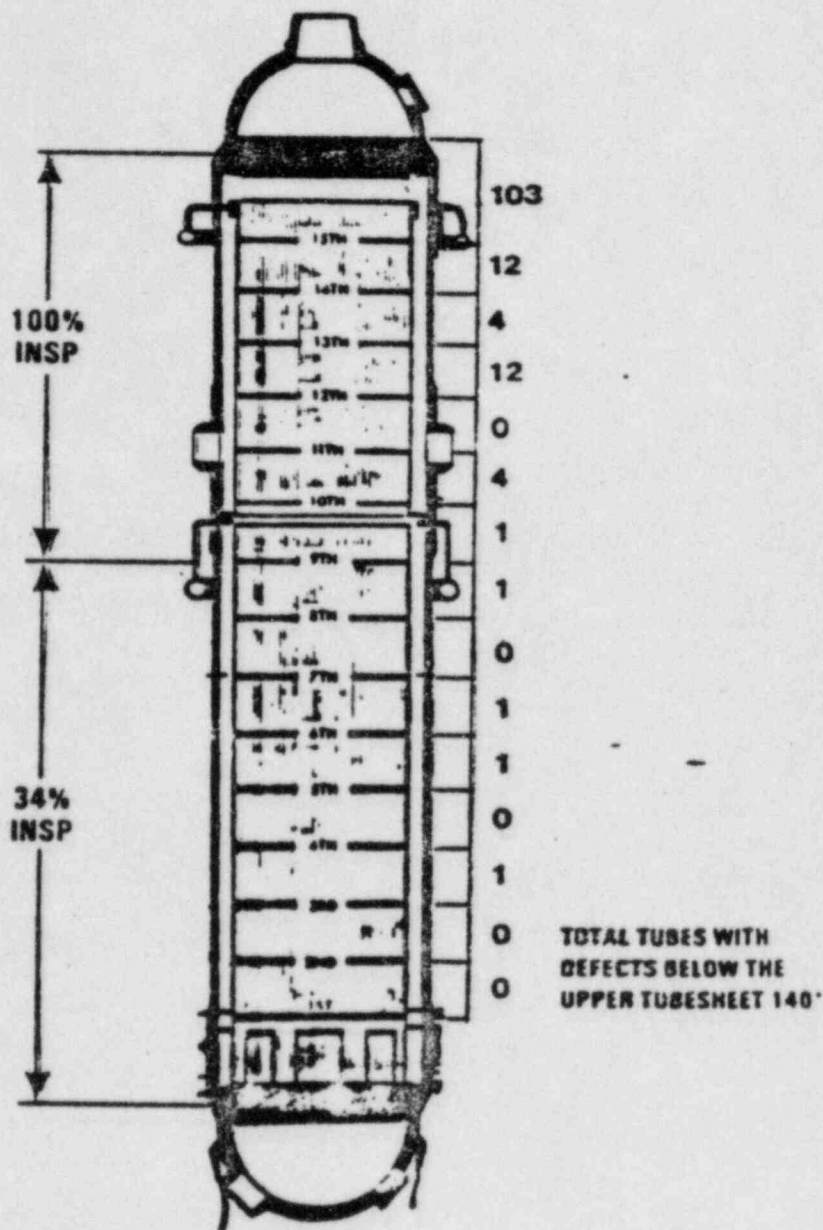
OTSG-A Tubes With Eddy-Current Defect Indications Located Below Upper Tubesheet

*Most tubes contain more than one (1) defect indication. Lowest defect in tube exhibited, only.

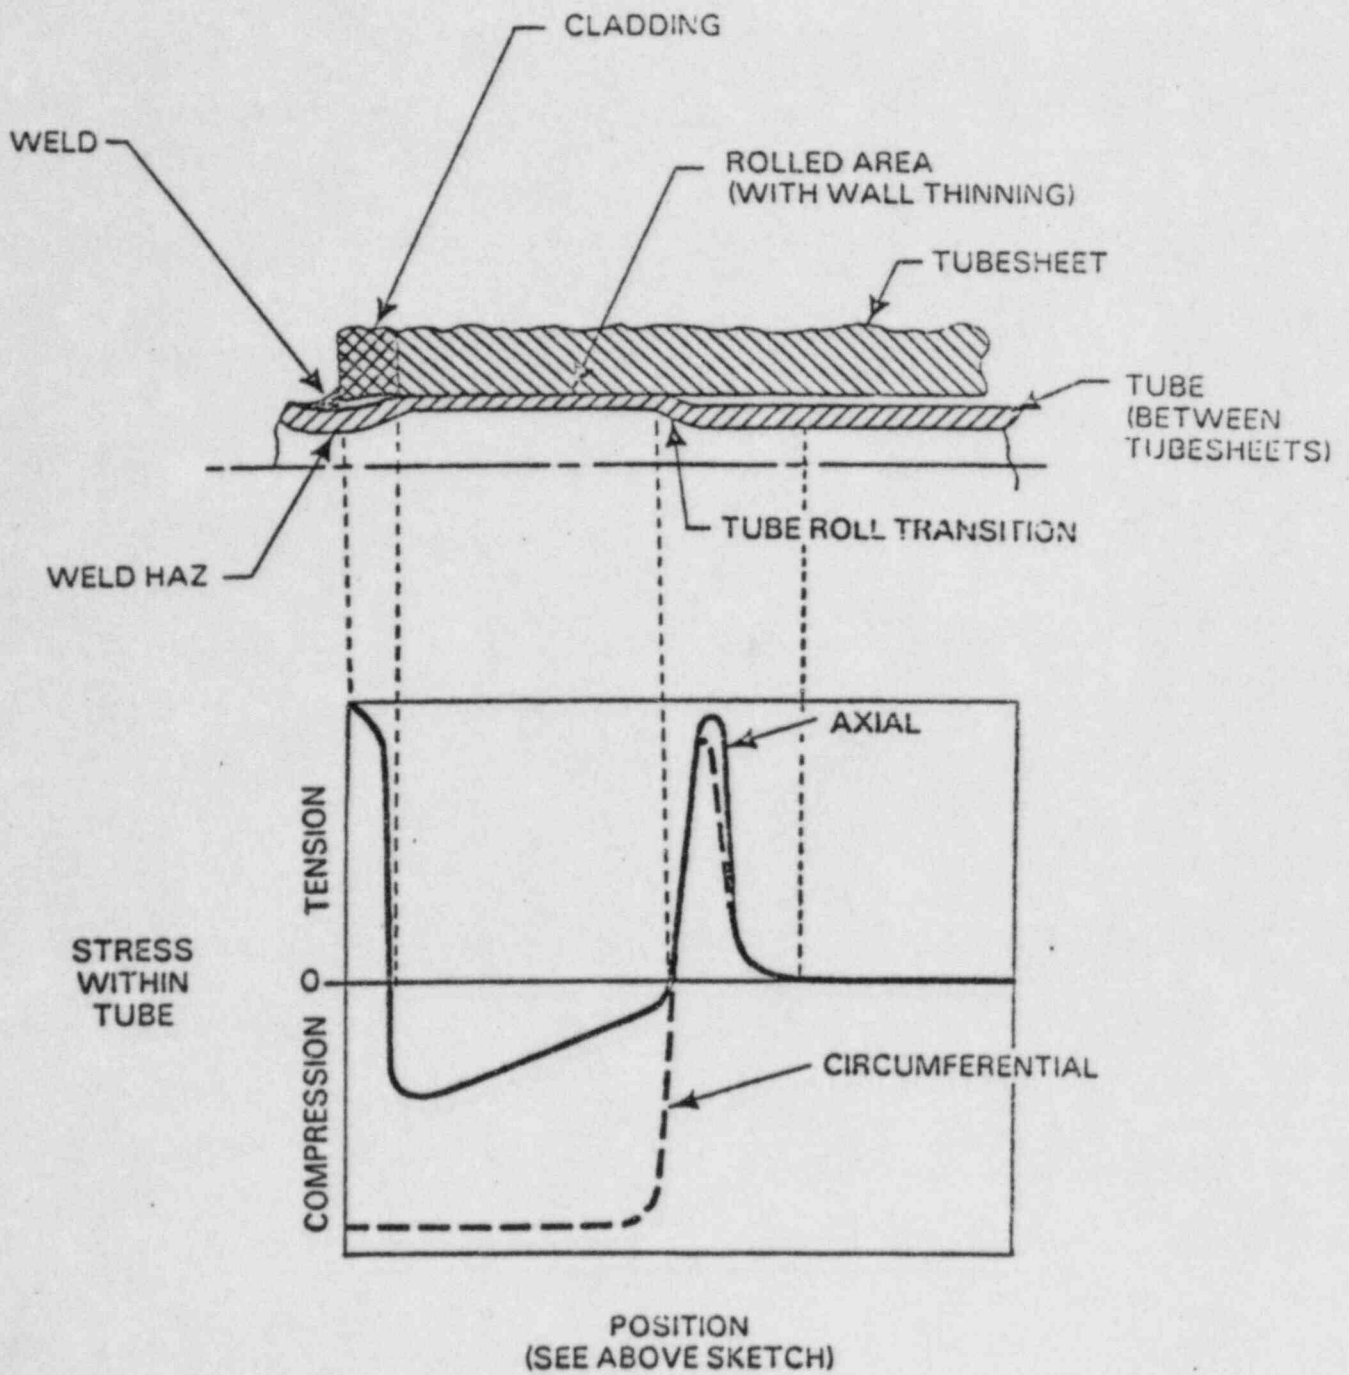
FIGURE VIII-1

TUBE/TUBESHEET ROLLED/WELDED JOINT
ESTIMATED DISTRIBUTION OF TUBE RESIDUAL STRESSES

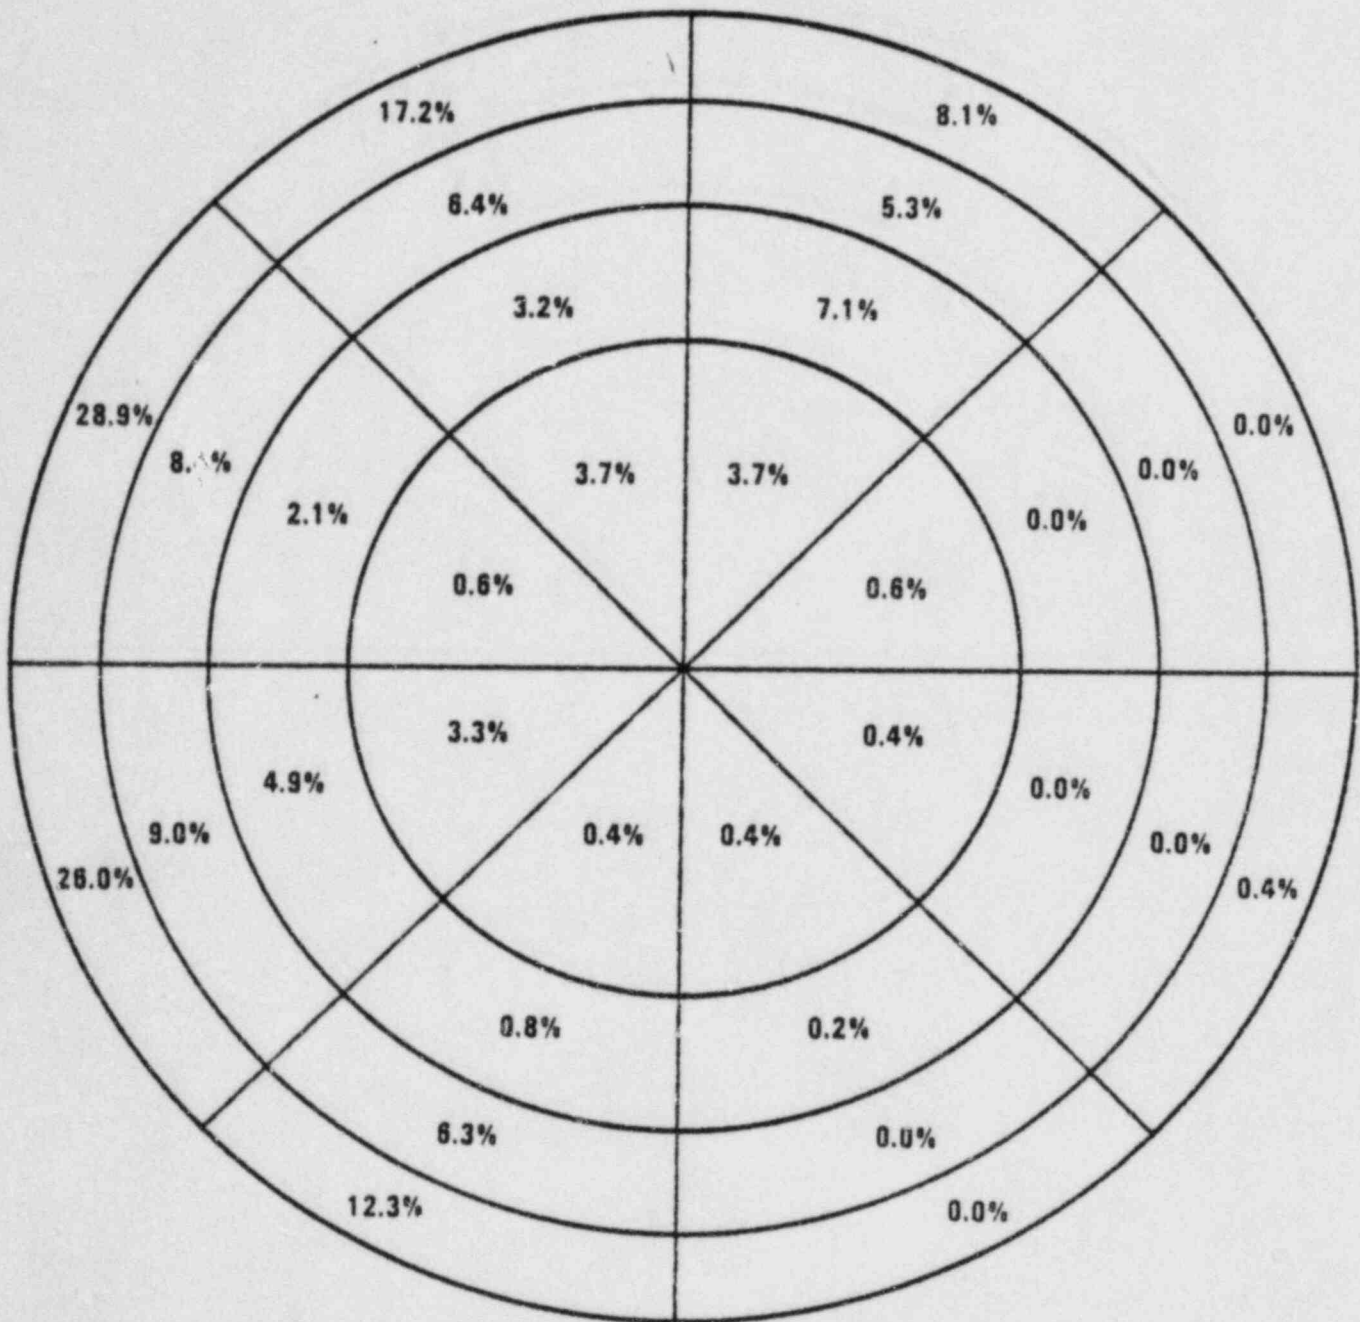
**Three Mile Island Nuclear
Generating Station
Unit 1 Steam Generator B**

**Standard Differential
Eddy Current Results
Percent of Tubes with Defects**

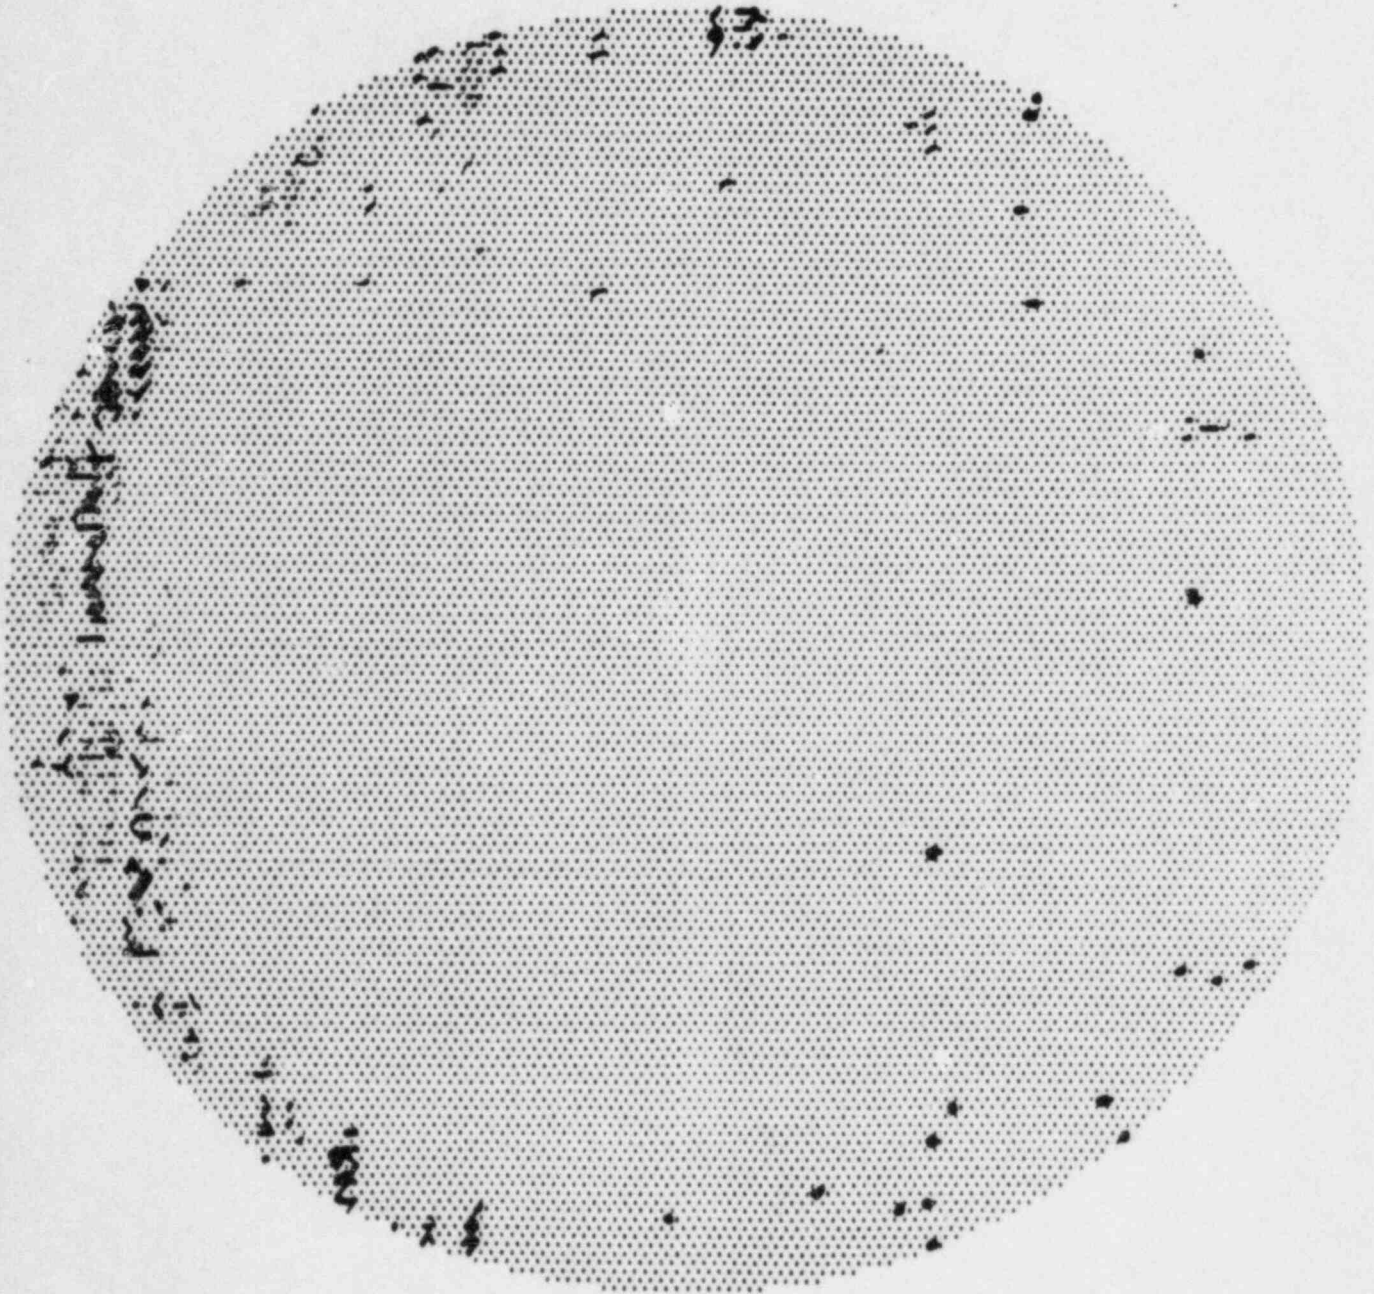
**TMI-1 Steam Generator A
Defective Tube Locations of Four Tube Heats**

- **Tube failures are associated with specific locations in the generator not heat relationships**
- **The defect patterns in the two generators appear to be different and this will need to be explained by a parameter other than heat number**
- **Heats of material exist which have high defect frequencies in bad areas and the same heats will have low defect frequencies in good areas**

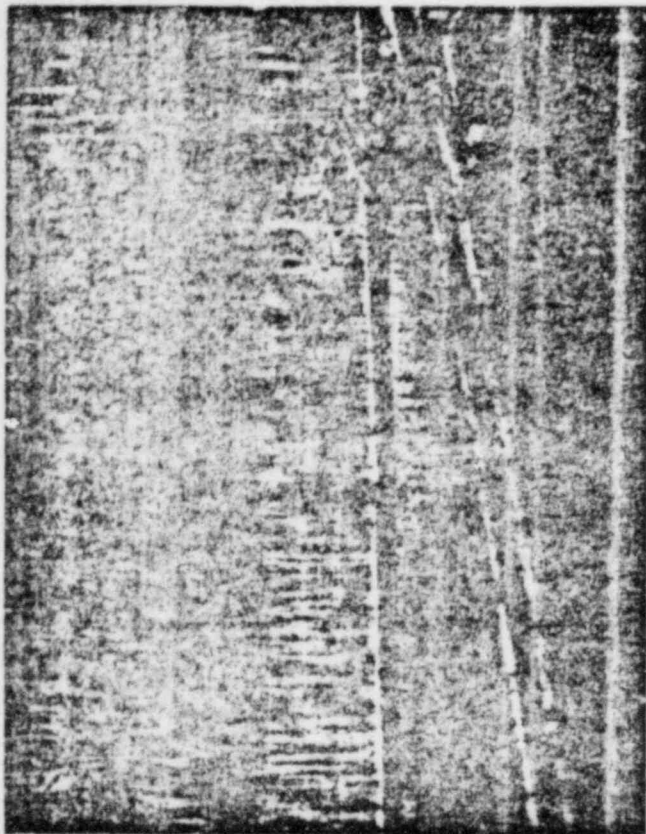
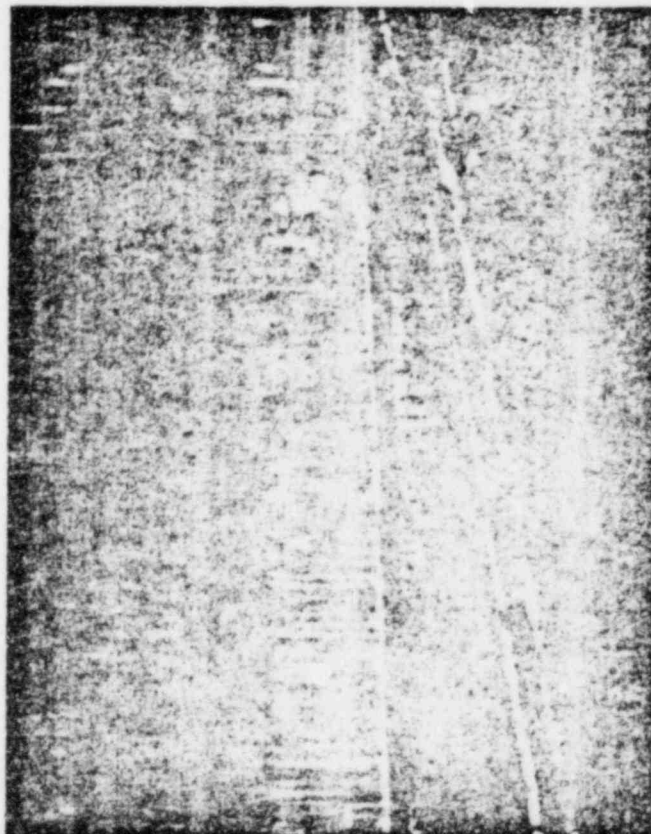
STEREO PAIR

- TMI-1 TUBE #A133-74 (PIECE 2)
UPPER CRACK - 18.1" FROM TOP OF TUBE
- TUBE EXPLOSIVELY EXPANDED - 25 GRAINS/FT
- MAGNIFICATION - 63 X
- ONLY ABOUT 1/3 OF CRACK SHOWS IN PICTURES
