FILE NO. G9.25.1.1
CODE OF FEDERAL REGULATIONS
REPORTABLE DEFICIENCY - 10CFR50.55(e)
RIVER BEND STATION - UNIT 1

CAUSE-AND-CORRECTIVE-ACTION ANALYSIS
CONCERNING SUB-SURFACE DEFECTS FOUND
IN
RIVER BEND CORNER JUNCTION TEE WELDS

This report describes the metallurgical investigation undertaken to determine the cause of cracking in River Bend Units 1 and 2 containment shell to mat embedment plate tee weld (corner junction). This investigation was also undertaken to determine if a proper metallurgical structure exists for the weld and its heat-affected zone if it were decided to simply remove the cracks and use the remaining weld. It was determined that the crack was actually a centerline linear shrinkage-voids, interconnected by fine cracks, which occurred during solidification of the undesirable weld nugget or bead shape deposited at the root. If the defect is removed, the remaining weld material is metallurgically acceptable to the ASME Section III, Class MC Code requirements.

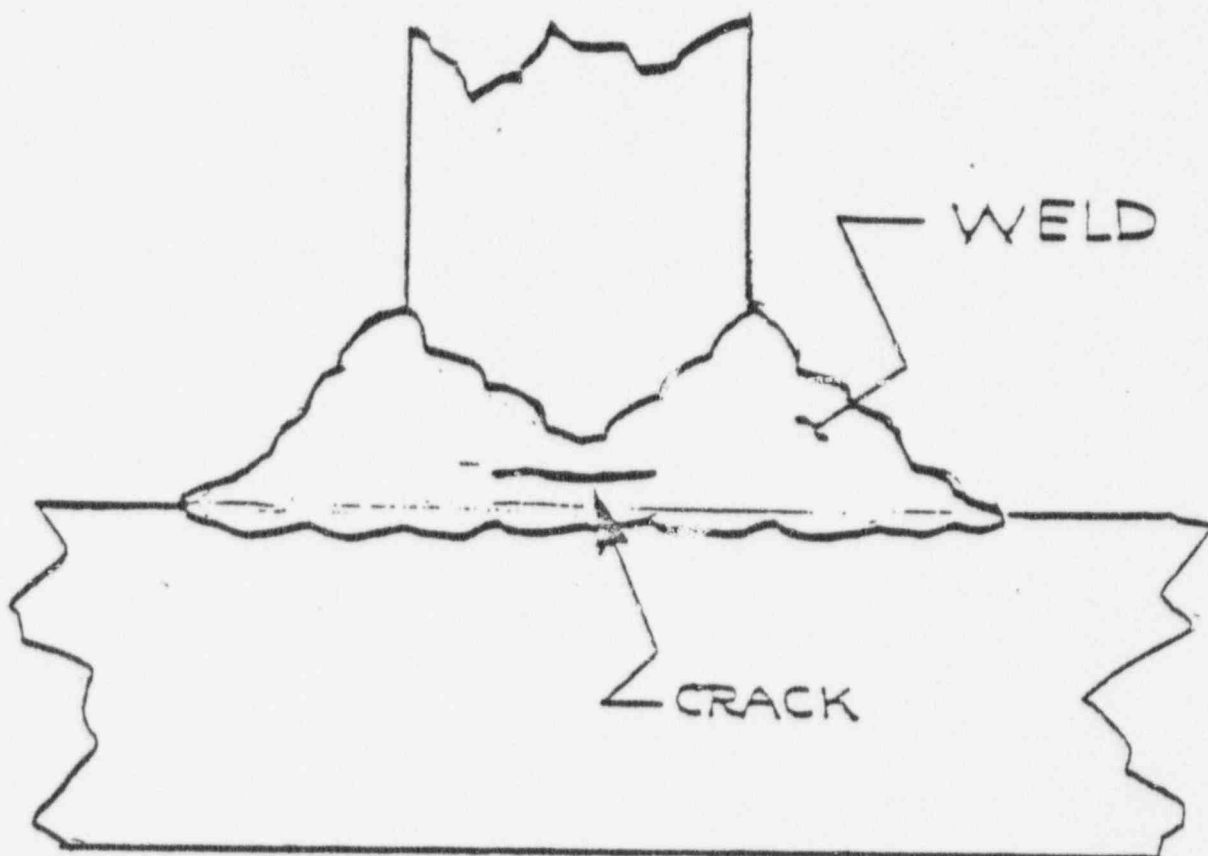
Figure 1

The unacceptable linear discontinuity which is the subject of the above earlier reports, as well as this particular report, is a crack produced in the root area, taking the form illustrated in the sketch contained in Figure 1.

SKETCH OF CROSS-SECTION OF CORNER
JUNCTION TEE WELD ILLUSTRATING
THE CHARACTERISTIC CRACK WHICH IS
THE SUBJECT OF THE CAUSE-AND-
CORRECTIVE-ACTION ANALYSIS DISCUSSED
IN THIS REPORT,

The sub-surface cracks, which are covered by NCR No. 77 (Reference (1)) and illustrated in Figure 1, are probably the result of a solidification phenomenon, related to the convergence of two solidification fronts.

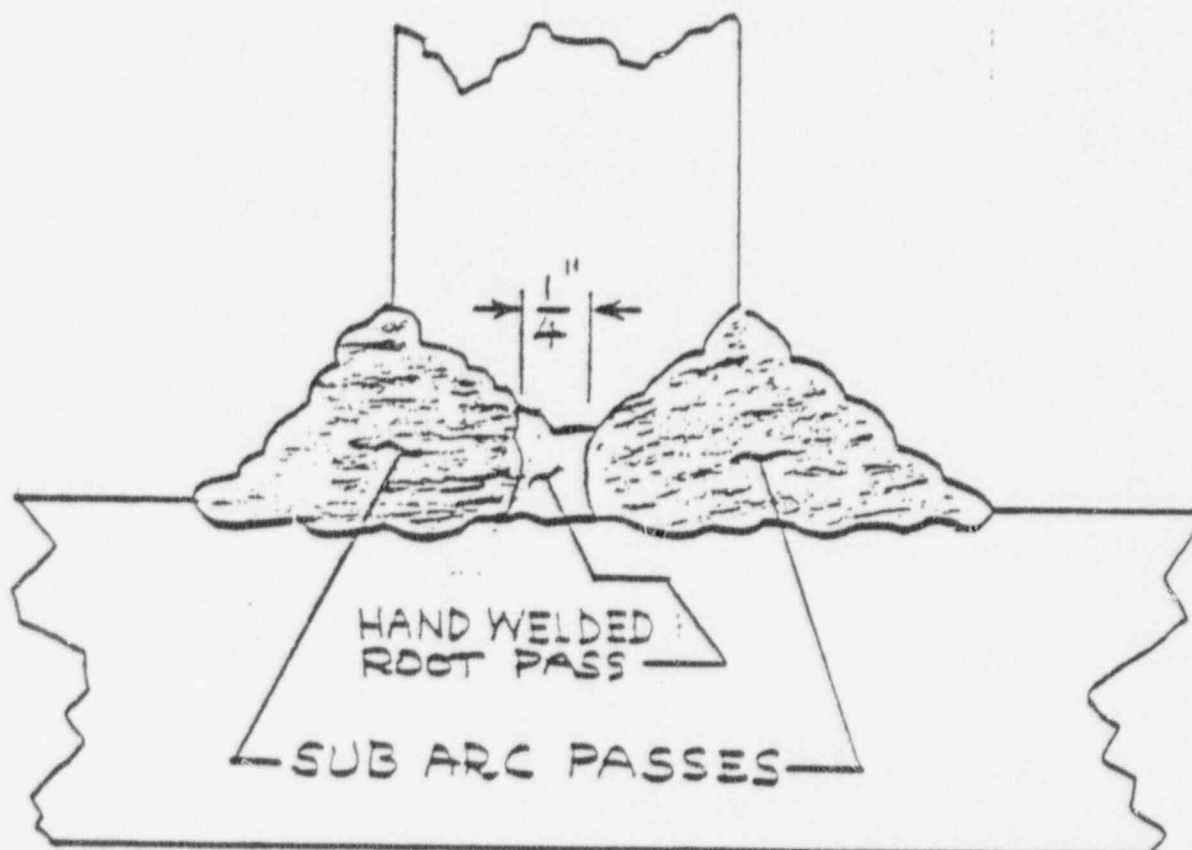
Figure 2

SKETCH OF MACRO-SECTION FROM
MOCK-UP NO. 1

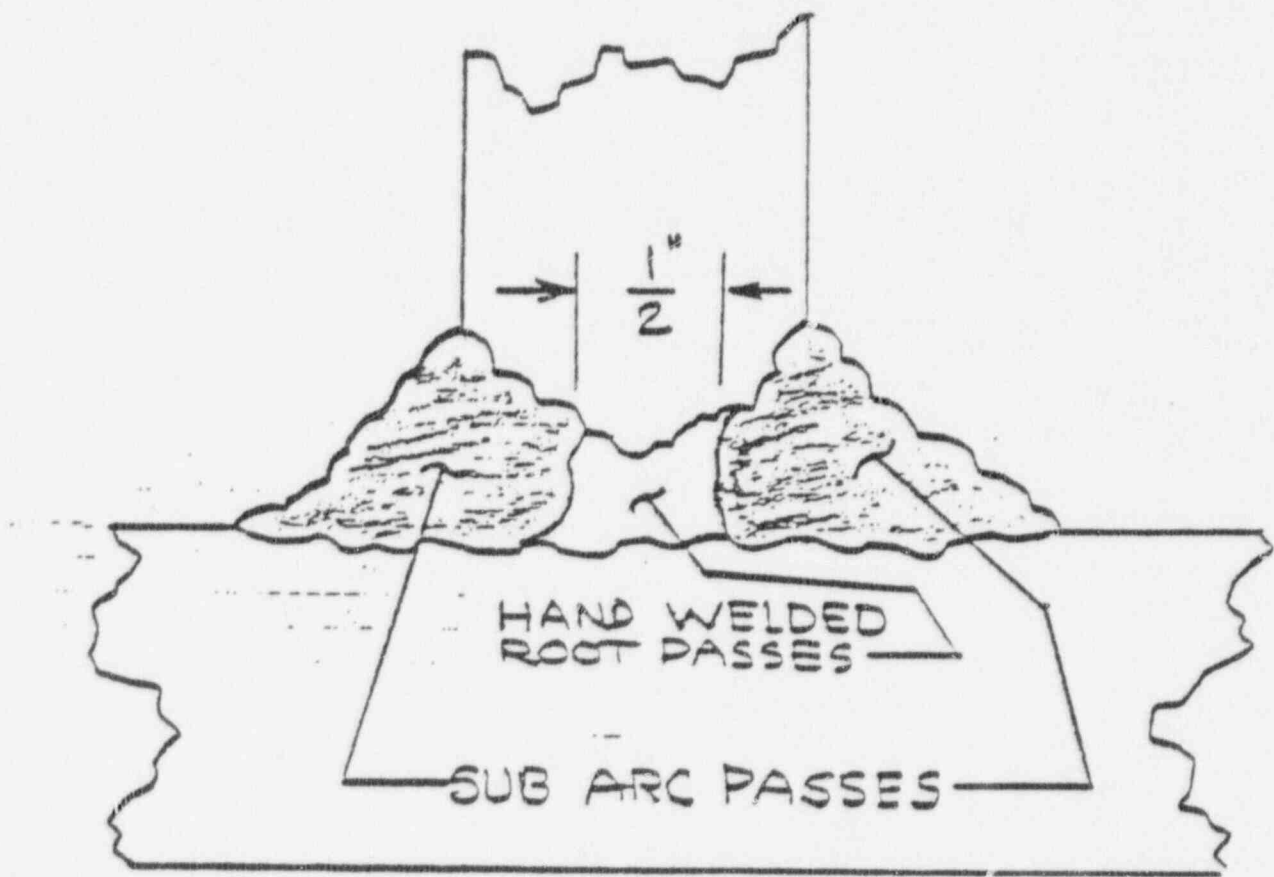
Figure 3

SKETCH OF MACRO-SECTION FROM
MOCK-UP NO. 2

Ultrasonic inspection indicated the presence of nine cracks in the weld root area, ranging in length from 1 to 11-1/4 inches.

For the above reasons, the approach reflected in Mock-Up No. 2 is probably the only practical method that can be used to prevent, or minimize, the initiation of sub-surface cracks when corner junction tee joints are welded using Procedure 302N and the DART 2108 dual-head submerged arc automatic welding machine. This would involve changing Welding Procedure 302N to require that at least four hand passes be made prior to initiation of sub arc welding, plus reducing the current used on the initial dual-head sub arc pass by at least 100 amps.

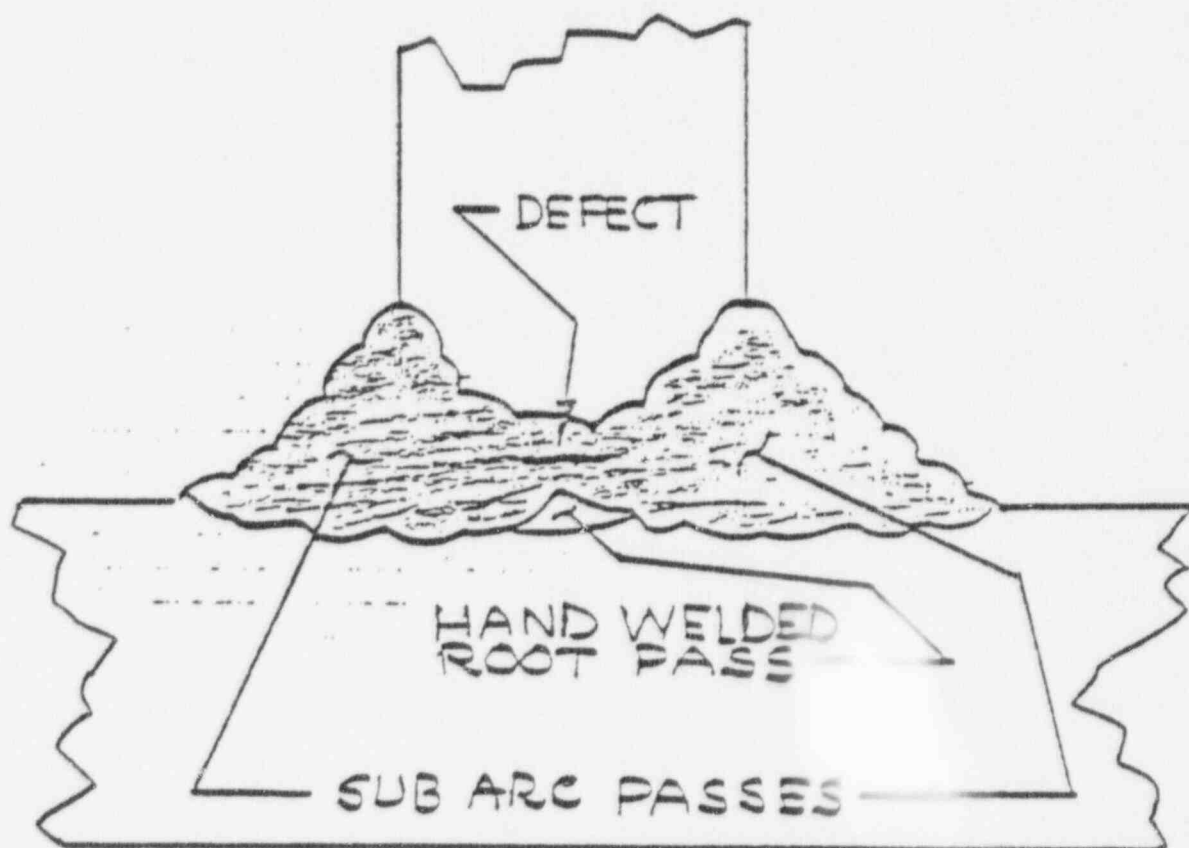
Figure 4

SKETCH OF MACRO-SECTION FROM
MOCK-UP NO. 3

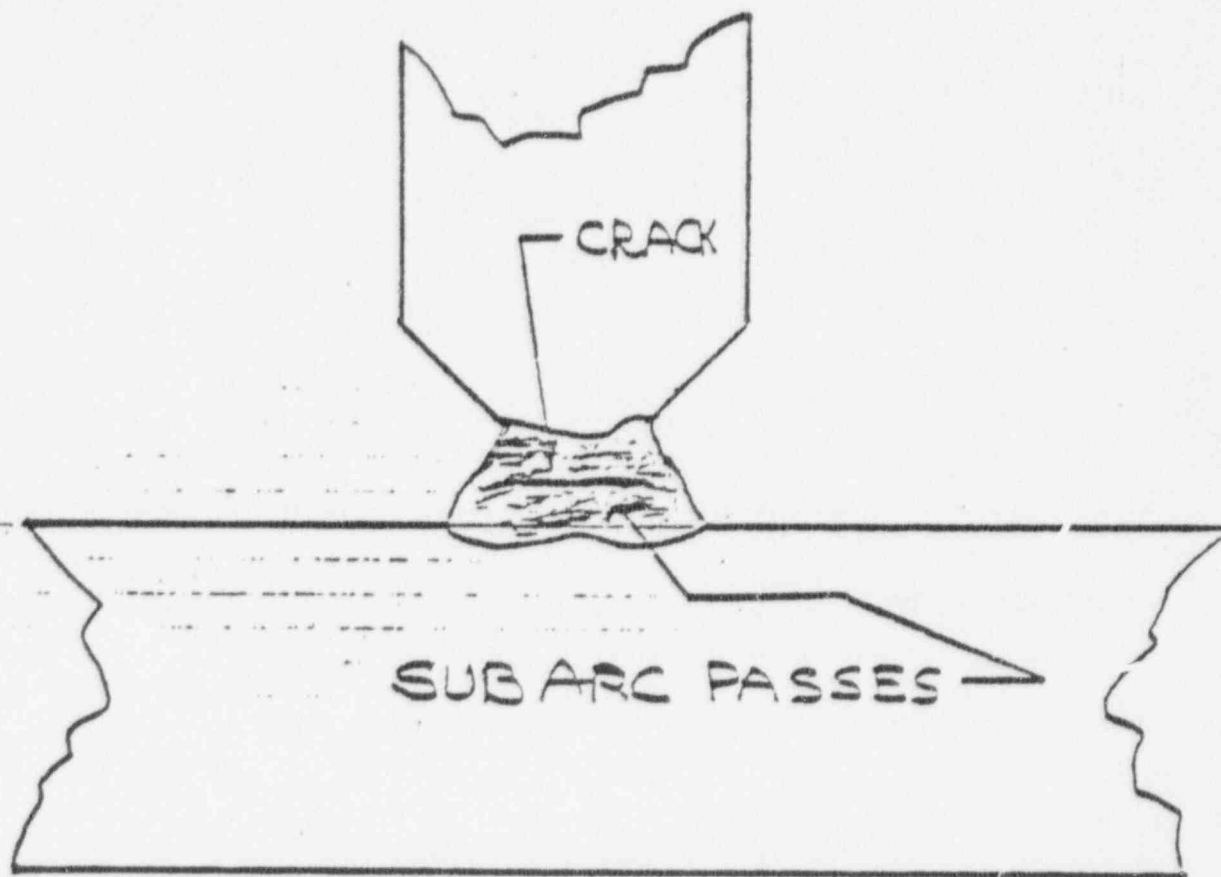
Figure 5

The sub arc welding on Mock-Up No. 4 was stopped after completion of the first dual-head pass. When the sub arc weld was initiated, one head started erratically and then settled down after about four inches of welding. Therefore, this area was arc gouged in preparation for hand weld touch-up prior to starting the second dual-head pass. The arc gouging revealed the presence of a crack in the root area, approximately 1/4 inch below the surface, and at least 4 inches in length. The sub arc weld was magnetic particle inspected in the arc gouged area, and for a distance of about 6 inches down stream from the arc gouge. This revealed that the crack did not penetrate through to the surface of the sub arc weld. After magnetic particle inspecting this area of the weld, a decision was made to discontinue sub arc welding and explore the joint by macro-sectioning.

Three macro-sections were made; in the arc gouged area, 6-3/4 inches down stream from the arc gouged area, and 13-1/8 inches down stream from the arc gouged area. At 6-3/4 inches down stream from the arc gouged area there was no evidence of the crack. At 13-1/8 inches down stream, the crack reappeared.

SKETCH OF MACRO-SECTION FROM
MOCK-UP NO. 4

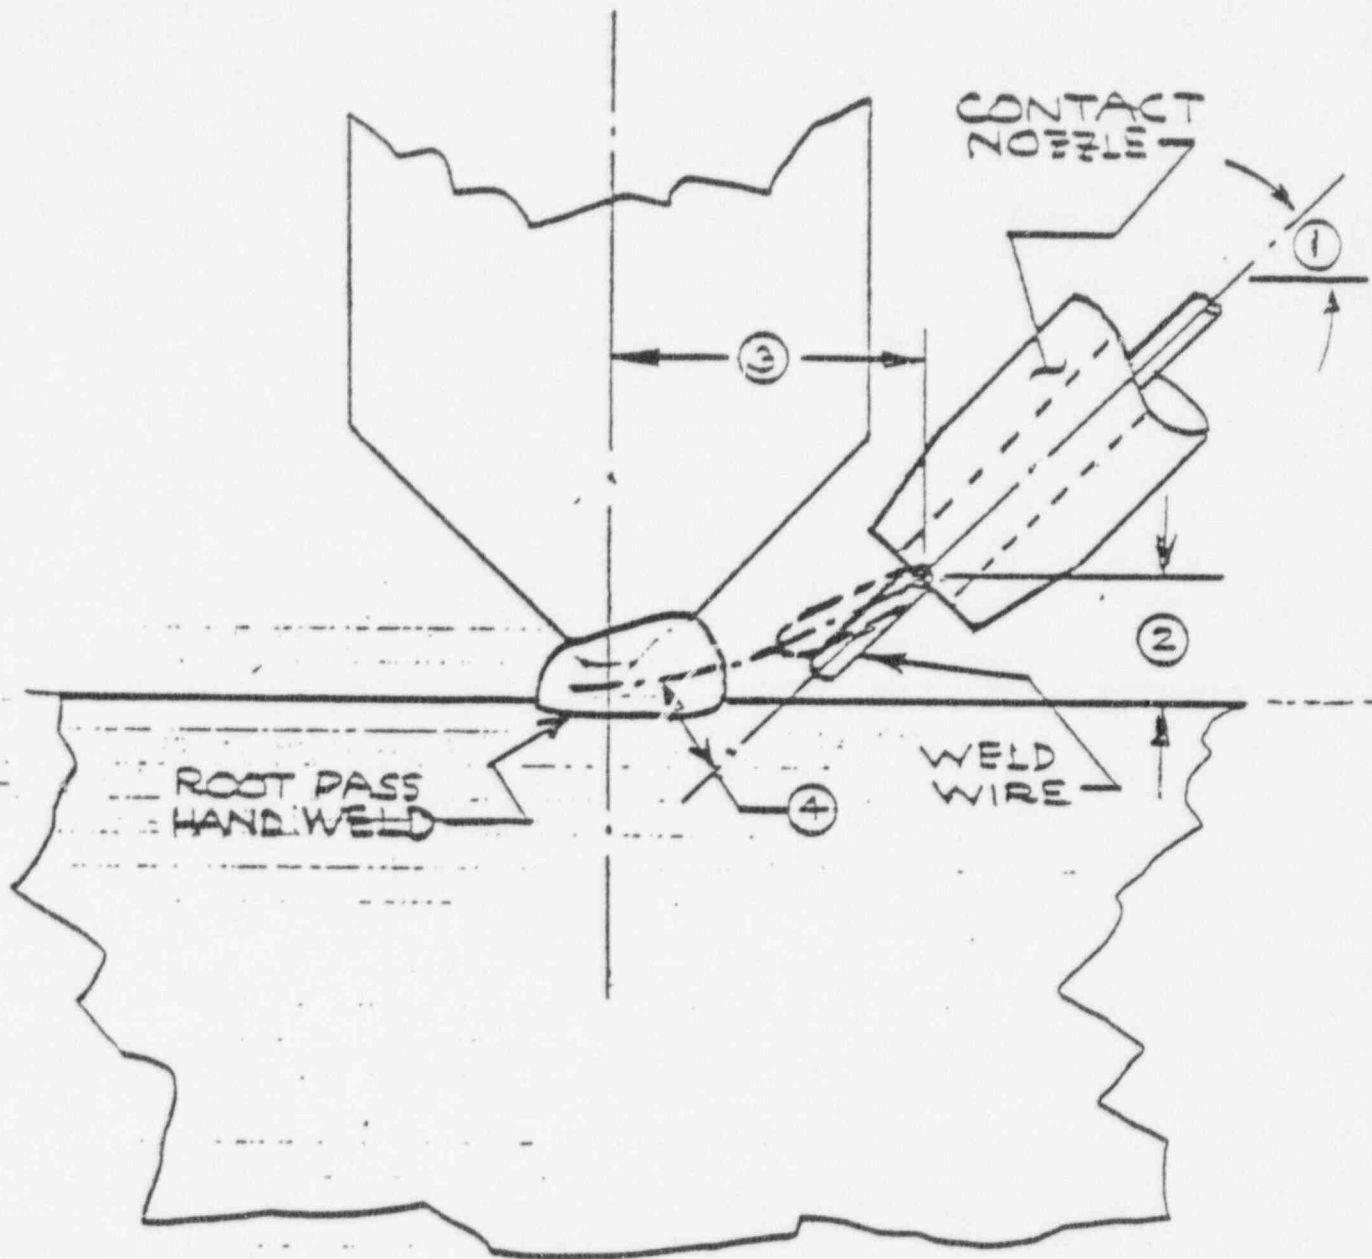
Figure 6

In order to attempt to control electrode position, and thus prevent the initiation of the sub-surface cracks, it would be necessary to define values for dimensions ① through ④, shown in Figure 6, and inspect to verify adherence to these values prior to initiation of the initial sub arc pass. This would be very difficult to accomplish. Angle ④, in particular, would be virtually impossible to control, since it is influenced by both the wear on the bore of the contact nozzle and the amount of welding wire left on the spool.

CRITICAL ELECTRODE POSITION
DIMENSIONS

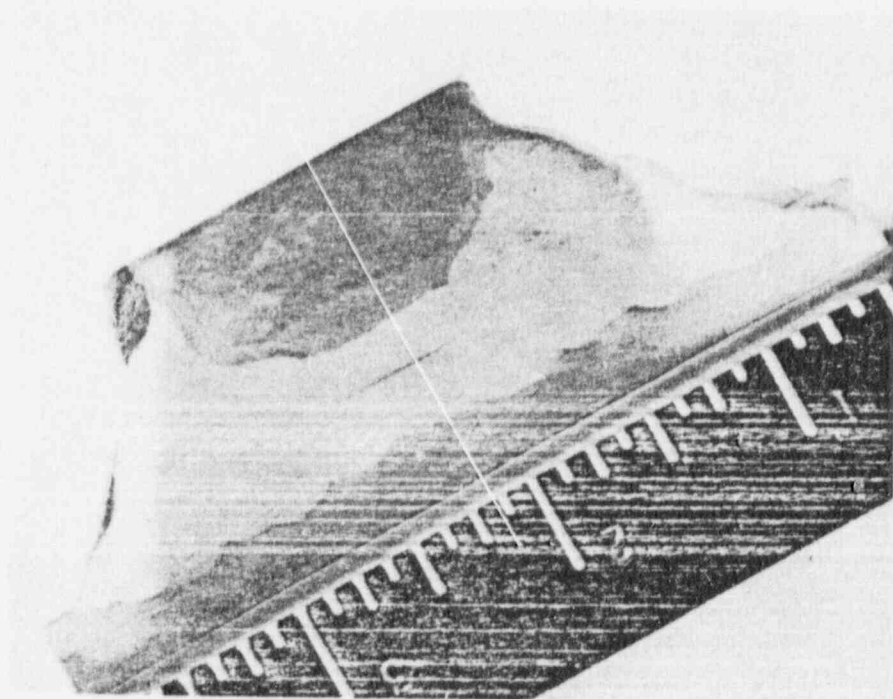
Figure 3 shows a polished and etched cross-section specimen containing the defect in the root area. This specimen shows all weld beads. The SAW pass in the root area was deposited from both sides of the shell plate and forms a single large bead, approximately 1 inch deep by 1/2 inch wide with a centerline defect. This bead remelts and consumes part or all of SMAW bead. Figures 4A and 4B show the microstructure near the defect. The microstructure consists of boundary ferrite (light area), acicular ferrite, and carbides (dark etched) (References 1 and 2). Figure 5 shows the weld metal metallurgical structure away from the root, which is the same as the weld metal structure near the defect. Figure 6 shows the heat-affected zone in the shell plate. The structure consists of prior austenite grain boundaries surrounding bainite colonies. Figures 7A and 7B show the base metal structures which are ferrite (light areas) and pearlite (dark areas).

Figure 3 shows that the crack-like defect is located approximately at the center of the first SAW passes. Figure 4A shows that the defect consists of a series shrinkage-voids connected by the fine cracks. The appearance of the defect can be understood by considering the progress of solidification of the first SAW passes.

FIGURE 3 CROSS SECTION SHOWING DEFECT IN THE ROOT AREA

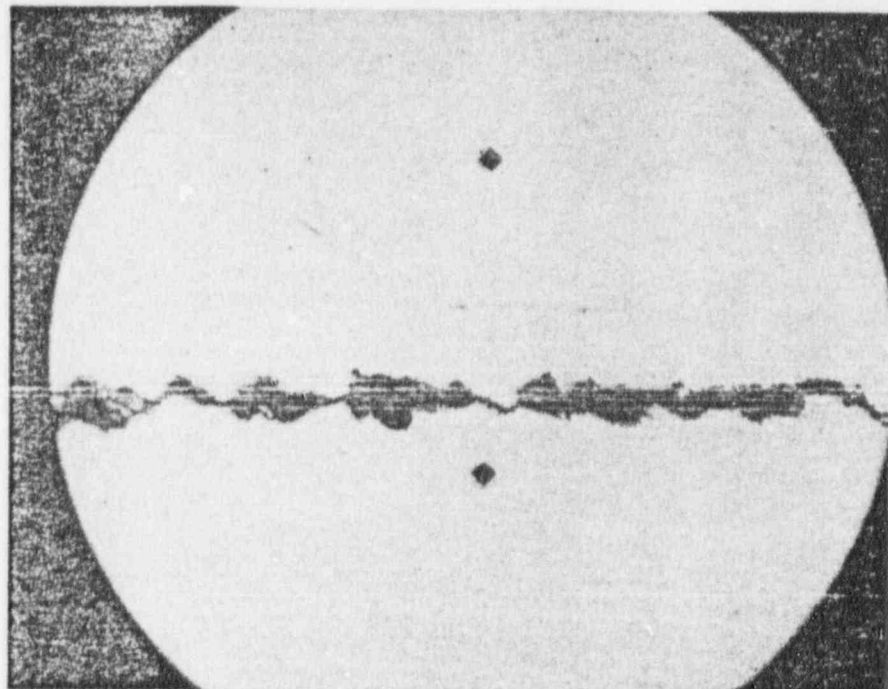
FIGURE 4A

Solidification of molten weld metal due to the quenching effect of the base metal starts along the sides of the weld metal and progresses inward by growing columnar grains. The last liquid metal to solidify lies in a plane through the centerline of the weld. If the weld depth is greater than the width of the face, the weld bead surface usually solidifies prior to center solidification. This prevents flow of liquid weld metal to the center to compensate for liquid to solid shrinkage and causes centerline shrinkage-voids. Further, the shrinkage stresses rupture or crack any solid weld metal connecting these shrinkage-voids, as shown in Figure 4A.

CENTER PORTION OF THE DEFECT ALONG WITH
TWO DIAMOND PYRAMID HARDNESS INDENTATIONS

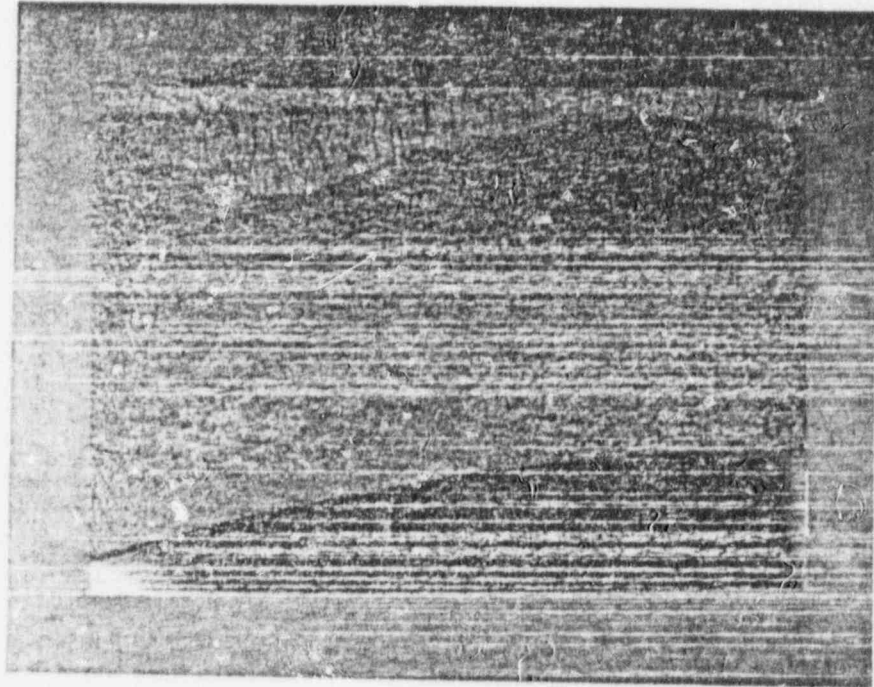
The specimen crack-like defect was opened to expose its surface. Figure 8 shows the defective surface. Figures 9 and 10 show this surface as viewed by a scanning electron microscope. In Figure 9, the surface topography is shown as globular and not fibrous, which confirms a welding-related shrinkage solidification defect.

FIGURE 8 PHOTOGRAPH OF DEFECT SURFACE

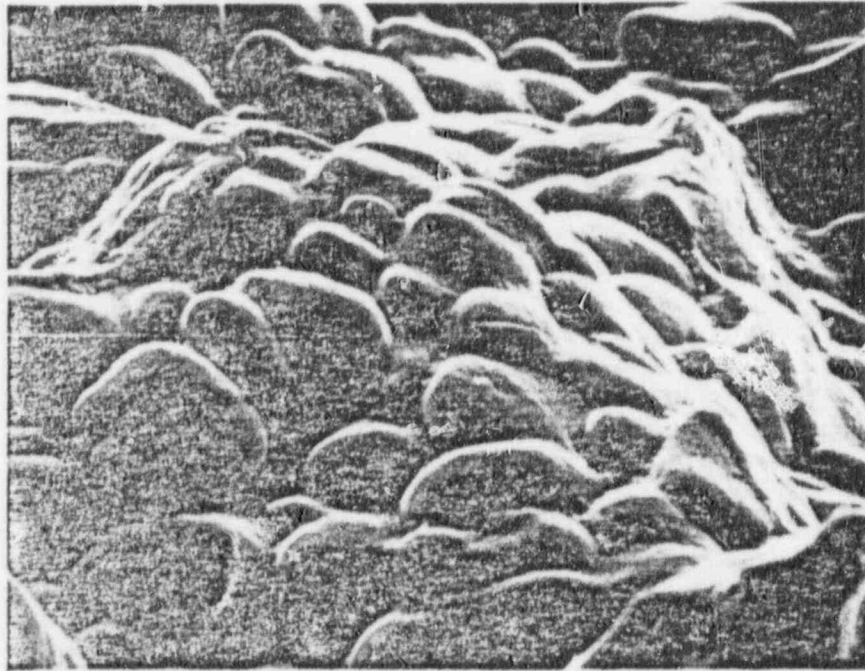
The scanning electron microscopy examination of the defect surface showed the globular topography interdendritic structure, which indicates that the defect was shrinkage-related, and occurred during solidification of the weld nugget or bead.

FIGURE 9 INTERDENDRITIC STRUCTURE OF THE DEFECT SURFACE
UNDER SCANNING ELECTRON MICROSCOPE

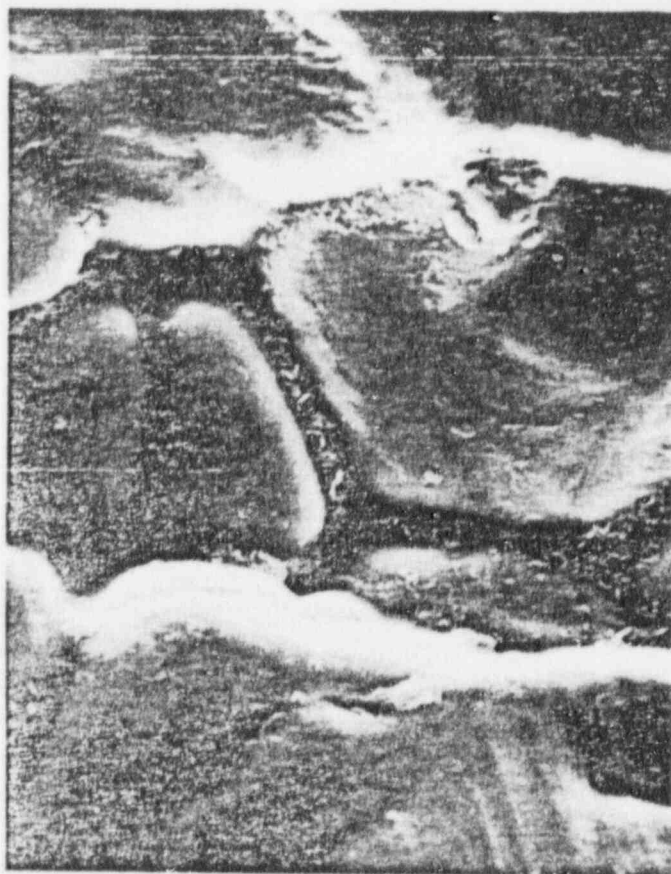
FIGURE 10

DEFECT SURFACE SHOWN IN FIGURE 9 AT HIGHER
MAGNIFICATION, SHOWING DENDRITIC GRAINS
