LONG ISLAND LIGHTING COMPANY

(Shoreham Nuclear Power Station,
Unit 1)

PARTIAL INITIAL DECISION

ON EMERGENCY DIESEL GENERATORS

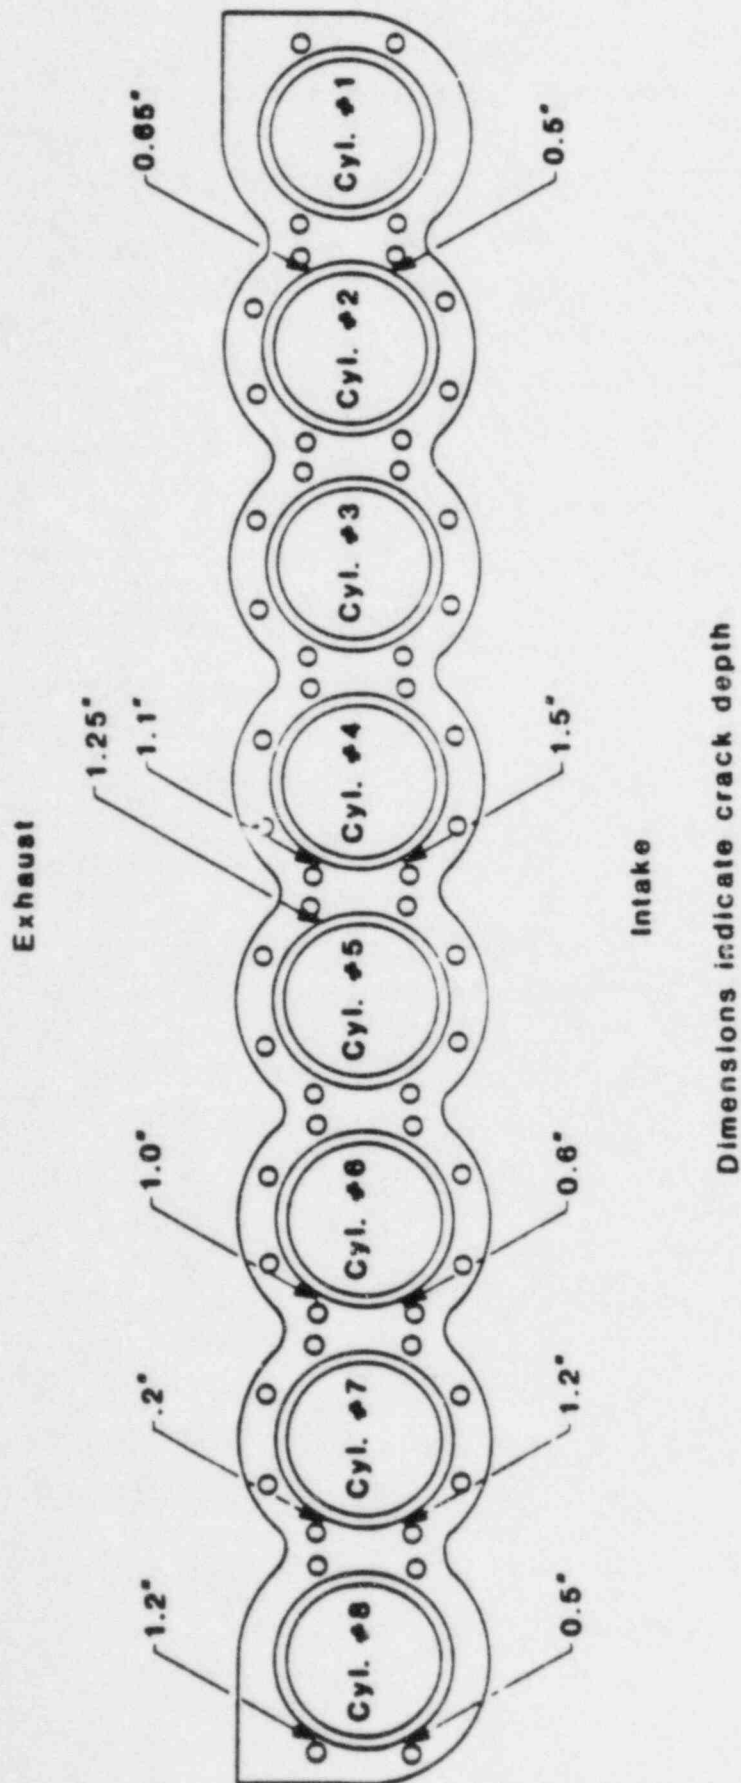
Figure 2.

B-5. The location and depth of the ligament cracks were measured using a series of liquid penetrant, eddy current and visual inspections of the block tops, stud holes and cylinder liner landings. Id. at 13. EDG 101 had 13 ligament cracks, EDG 102 had 18 ligament cracks and EDG 103 had 21 ligament cracks at the time of these inspections. LILCO Exs.

B-16, B-17 and B-18. These cracks varied in depth, with the ones in EDG 103 being the most severe. Id. No ligament crack in EDGs 101 and 102 extended below a depth of 1.5 inches nor on to the liner landing. As of March 11, 1984, the original EDG 103 block had no measured ligament cracks deeper than 1.5 inches. The deepest stud-to-stud crack in the original EDG 103, between cylinders No. 4 and 5, was measured by eddy current to have a depth of 1.4 to 1.6 inches. LILCO Exs. B-16, B-17, B-18; McCarthy et al., ff. Tr. 24,372, at 14, 15; Tr. 28,823-24 (Johnson); Tr. 28,825-27 (Rau). The original EDG 103 also had seven surface "indications" (cracks which were not deep enough to be measurable), five of which occurred in stud-to-stud locations and two of which were located between a stud hole and the outer perimeter of the block top. Id.

SNPS DG101 crack map.

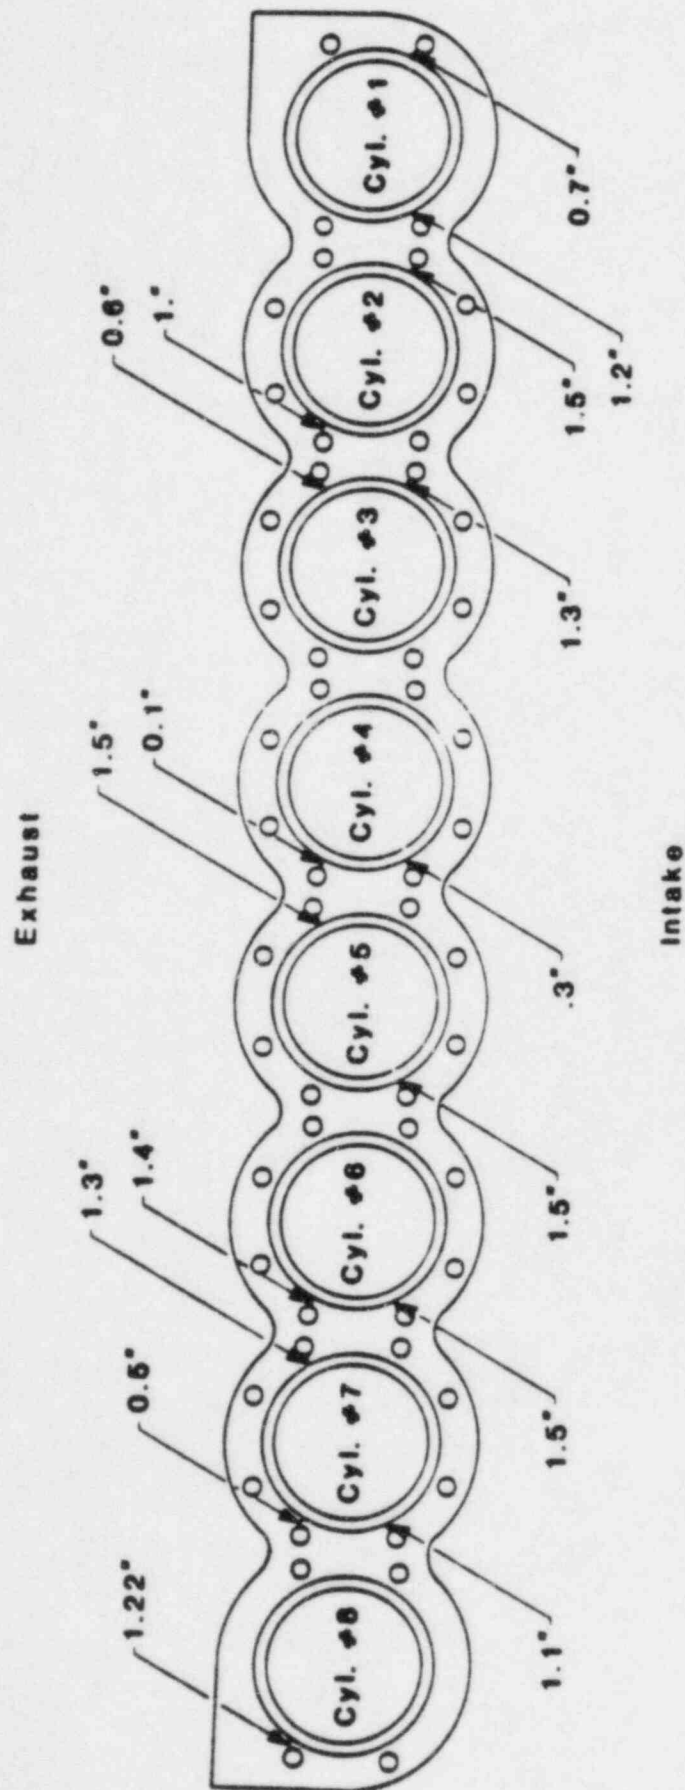
Figure 3.

SNPS DG102 crack map.

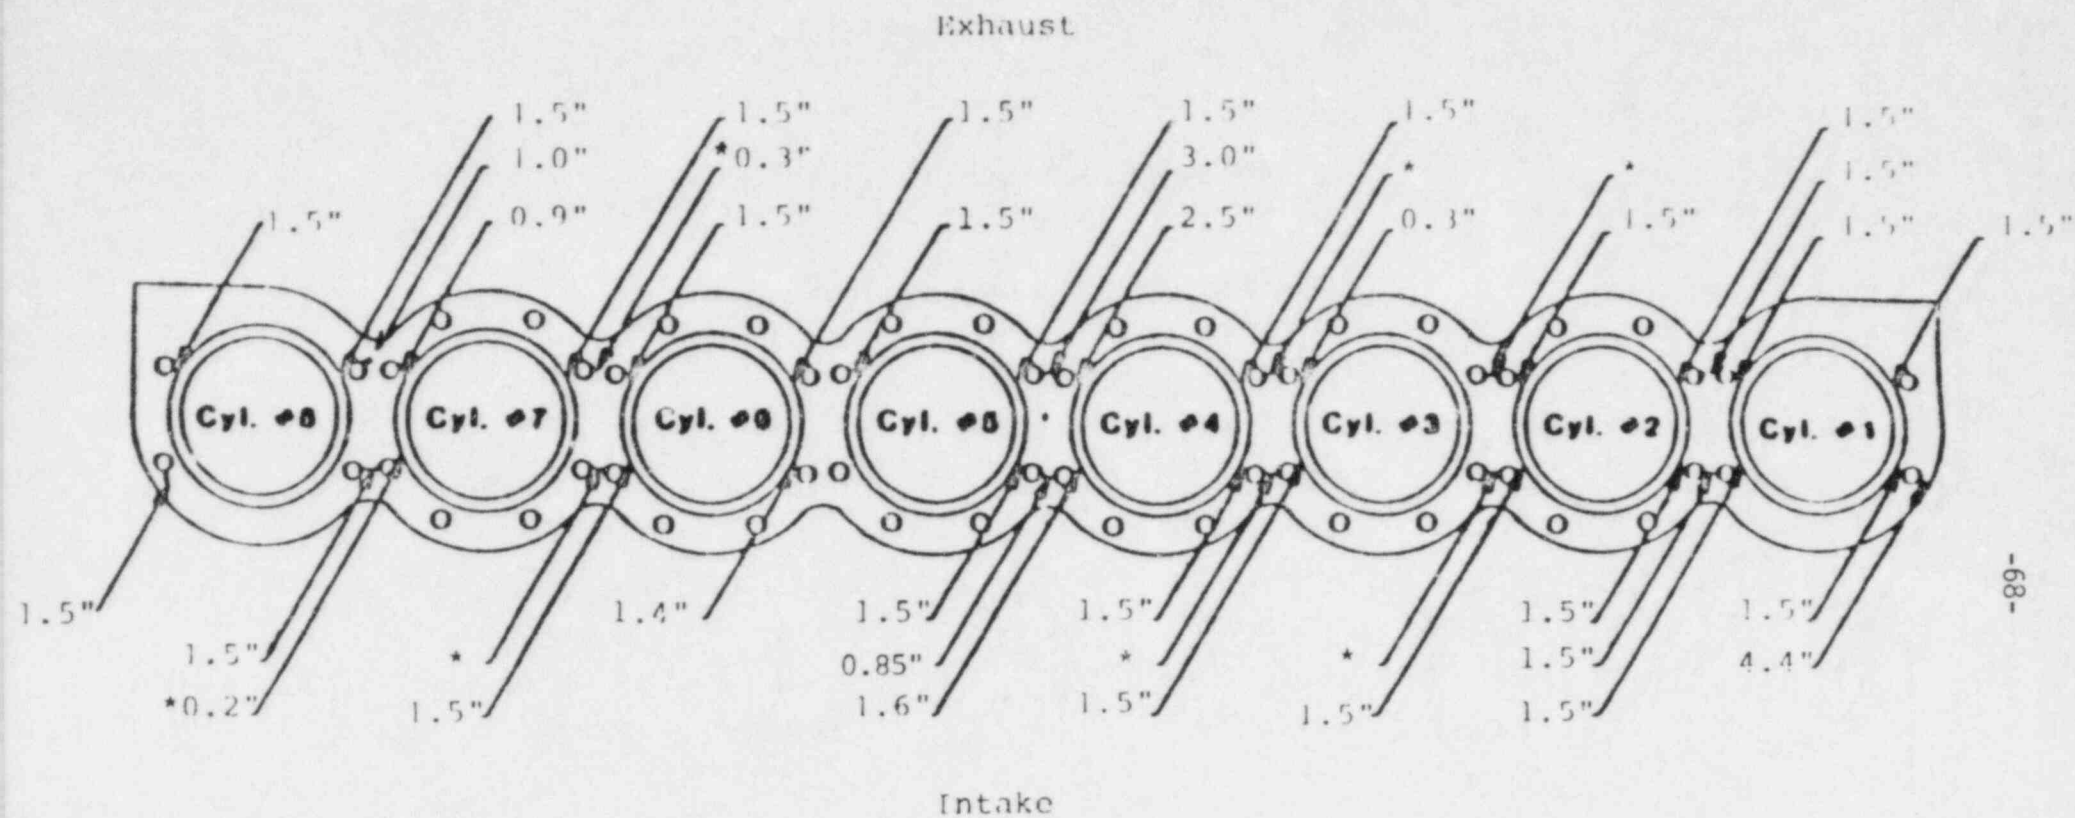
Figure 4.

B-8. After shutdown of the EDG 103 engine on April 14, 1984, inspection of the block revealed that the deepest stud-to-stud crack, located between cylinders No. 4 and 5, had extended from a depth of 1.4 to 1.6 inches to a maximum depth of three inches.^{3/} McCarthy et al., ff. Tr. 24,372, at 18; Tr. 28,823-24 (Johnson); Tr. 28,905-06 (Rau); LILCO Exs. B-18, B-25. Between March 11 and April 14, 1984, additional ligament and stud-to-stud cracks had initiated and propagated at other block top locations; however, none of the ligament cracks extended on to the liner landing. McCarthy et al., ff. Tr. 24,372, at 18-19; Tr. 25,538 (Johnson); LILCO Exs. B-16, B-18, B-25.

SNPS DG103 crack map as of 9/22/84.

B-9. Based on the lack of confidence that the EDG 103 block could be repaired satisfactorily, LILCO decided to replace it. Tr. 24,665-66 (Youngling). A new block was installed in the EDG 103 in June 1984. Johnson et al., ff. Tr. 28,799, at 5.

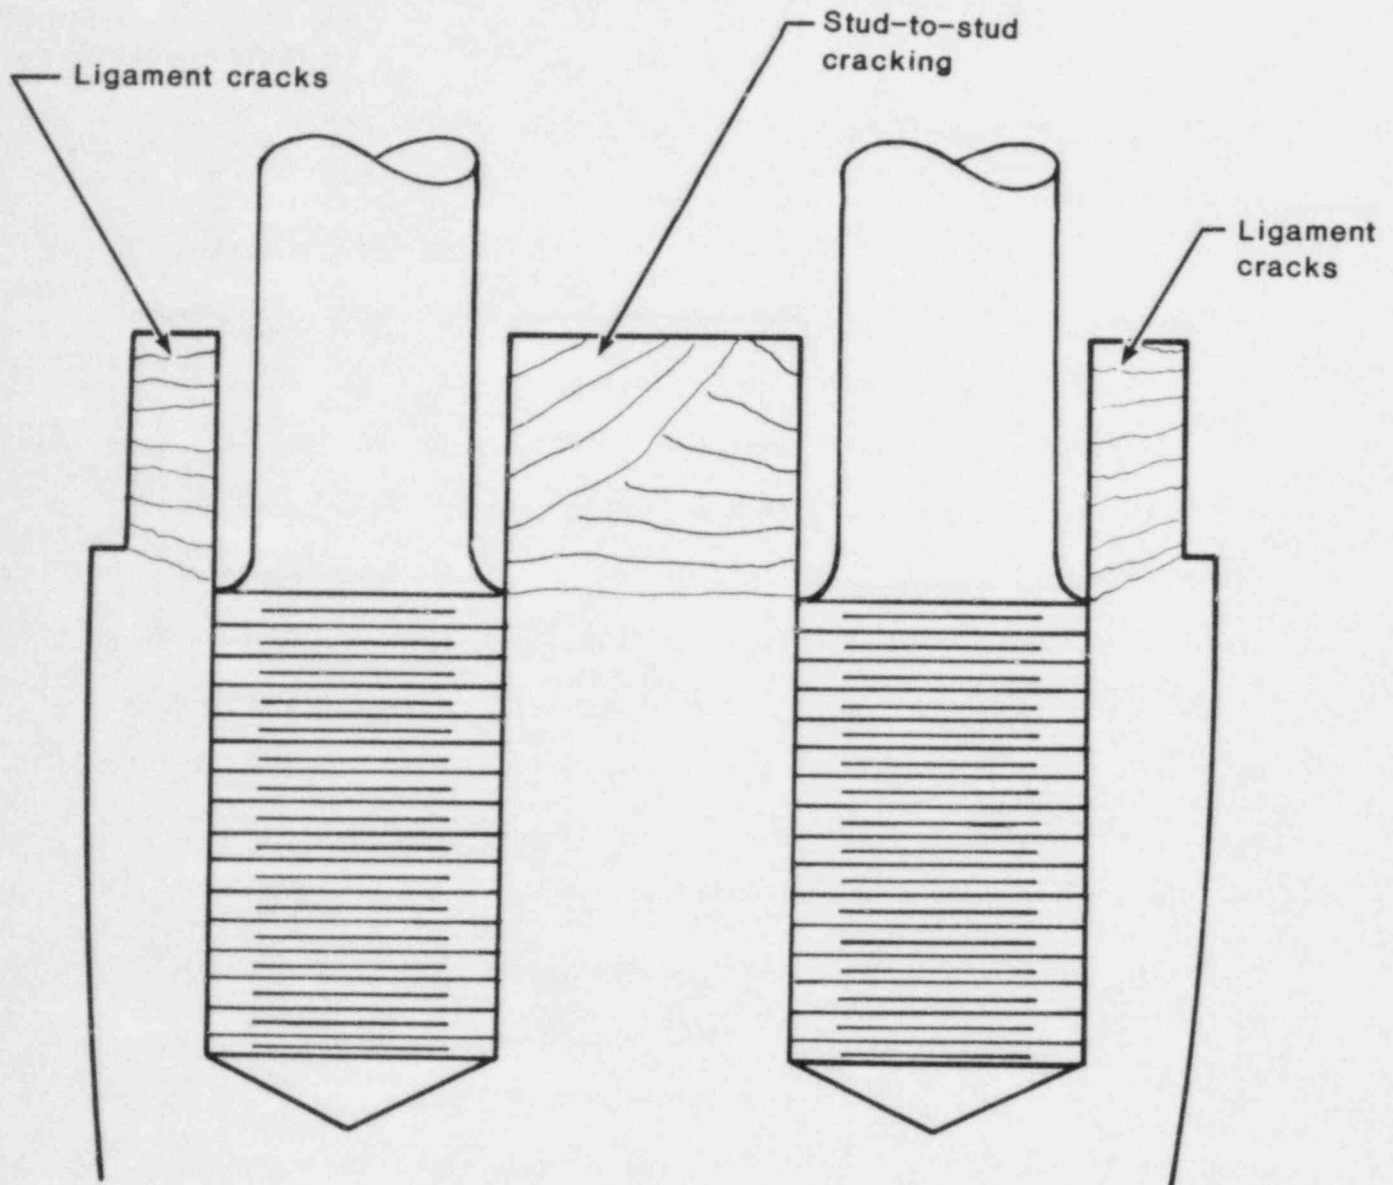
Stud-to-stud cracking in SNPS DG103.

NOTE: Cracks are vertical, i.e., approximately parallel to the plane of the page, and not all extend as far as portrayed.
