RECOMMENDATIONS RELATED TO BROWNS FERRY FIRE

NUCLEAR REGULATORY COMMISSION

FEBRUARY 1976

NUREG-0050

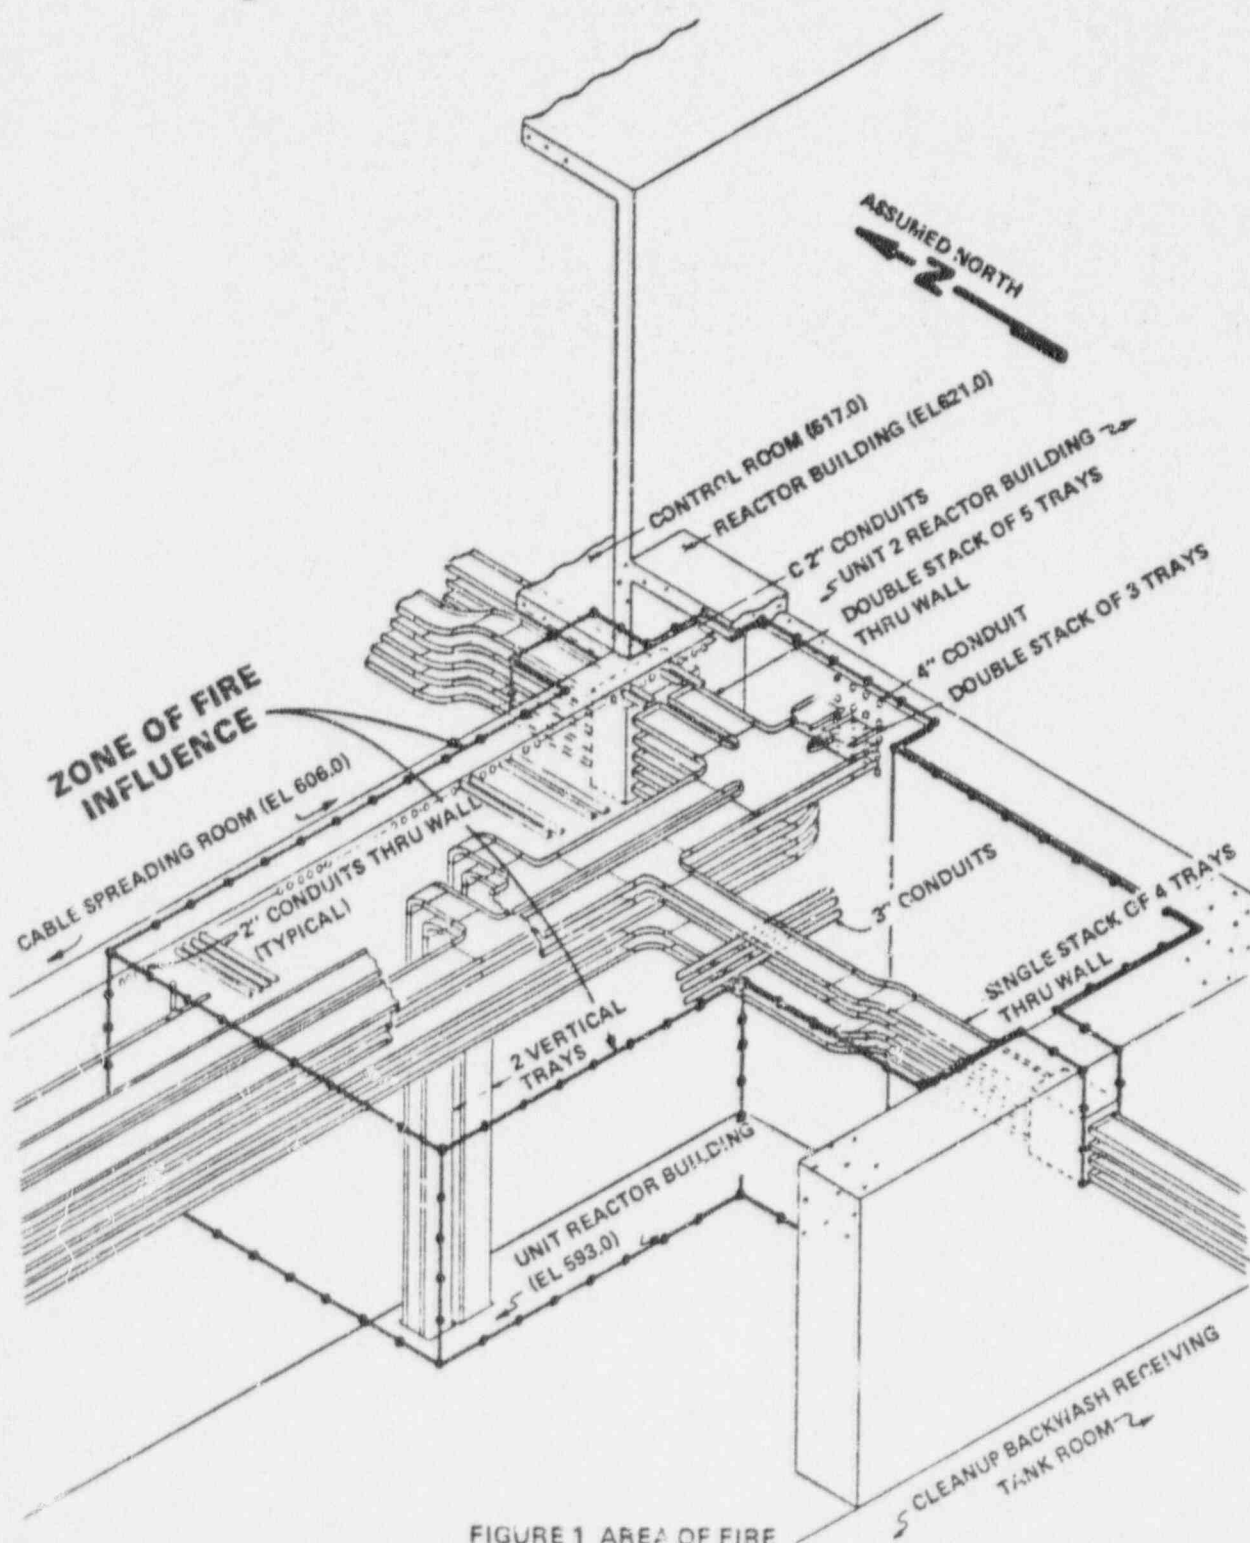
FIGURE 1 AREA OF FIRE

The fire originated in a cable tray penetration between the cable spreading room and the reactor building. Figure 1 shows the extent of the fire damage. Cables and raceways were damaged for a distance of about five feet inside the spreading room. The major damage occurred on the reactor building side of the penetration. Visible damage was observed in the cables in a double stack of three trays south as far as a fire stop about 28 feet from the penetration and west along the double stack of five trays for a distance of about 38 feet. Cables in four vertical trays were also damaged downwards for a distance of about 10 feet.

TVA has identified and tabulated 117 conduits, 8 conduit boxes, 26 cable trays and a total of 1611 cables routed in these trays and conduits that are damaged or assumed damaged (11).

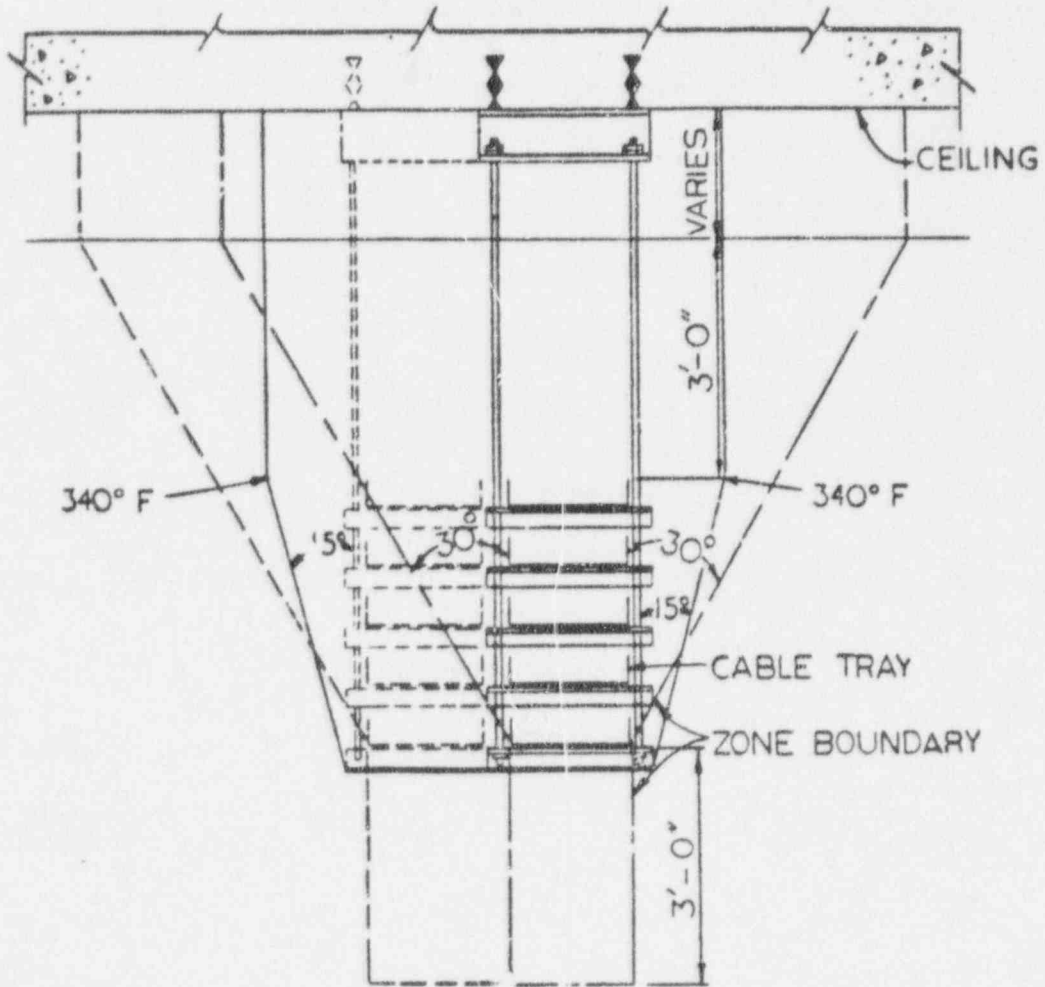
FIGURE 2 REGION OF INFLUENCE OF FIRE IN CABLE TRAY

The Review Group has concluded that the existing NRC separation and isolation criteria require improvement. The Browns Ferry fire has shown a number of areas in which improvement is needed

These include the assumptions underlying isolation criteria, the ways in which the requirements are stated, inclusion of conduit, and the role of fire barriers and fire retardant coatings.
