Docket No. 50-346  
License No. NPF-3  
Serial No. 1-525  
May 15, 1985

On April 4, 1985, your office issued a Confirmatory Action Letter (CAL) (Log No. 1-1144) to Toledo Edison regarding the failed Control Rod Drive Mechanism (CRDM) Lead Screw Nut Leaf Spring on Davis-Besse Nuclear Power Station Unit No. 1. Toledo Edison provided its formal response on April 11, 1985, (Serial No. 1-512) which you found acceptable and in conformance with the CAL. Your letter of April 12, 1985 (Log No. 1-1151) documented this finding. In accordance with our commitment to provide a summary of the status of our activities which were planned or in progress at that time, we are pleased to provide the enclosed information.

EVALUATION OF  
CONTROL ROD DRIVE  
LEAF SPRING FAILURES  
AT DAVIS-BESSE

EXAMINATION OF CRDM  
LEAF SPRING AND FOREIGN DEBRIS  
SAMPLES REMOVED FROM DAVIS-BESSE 1

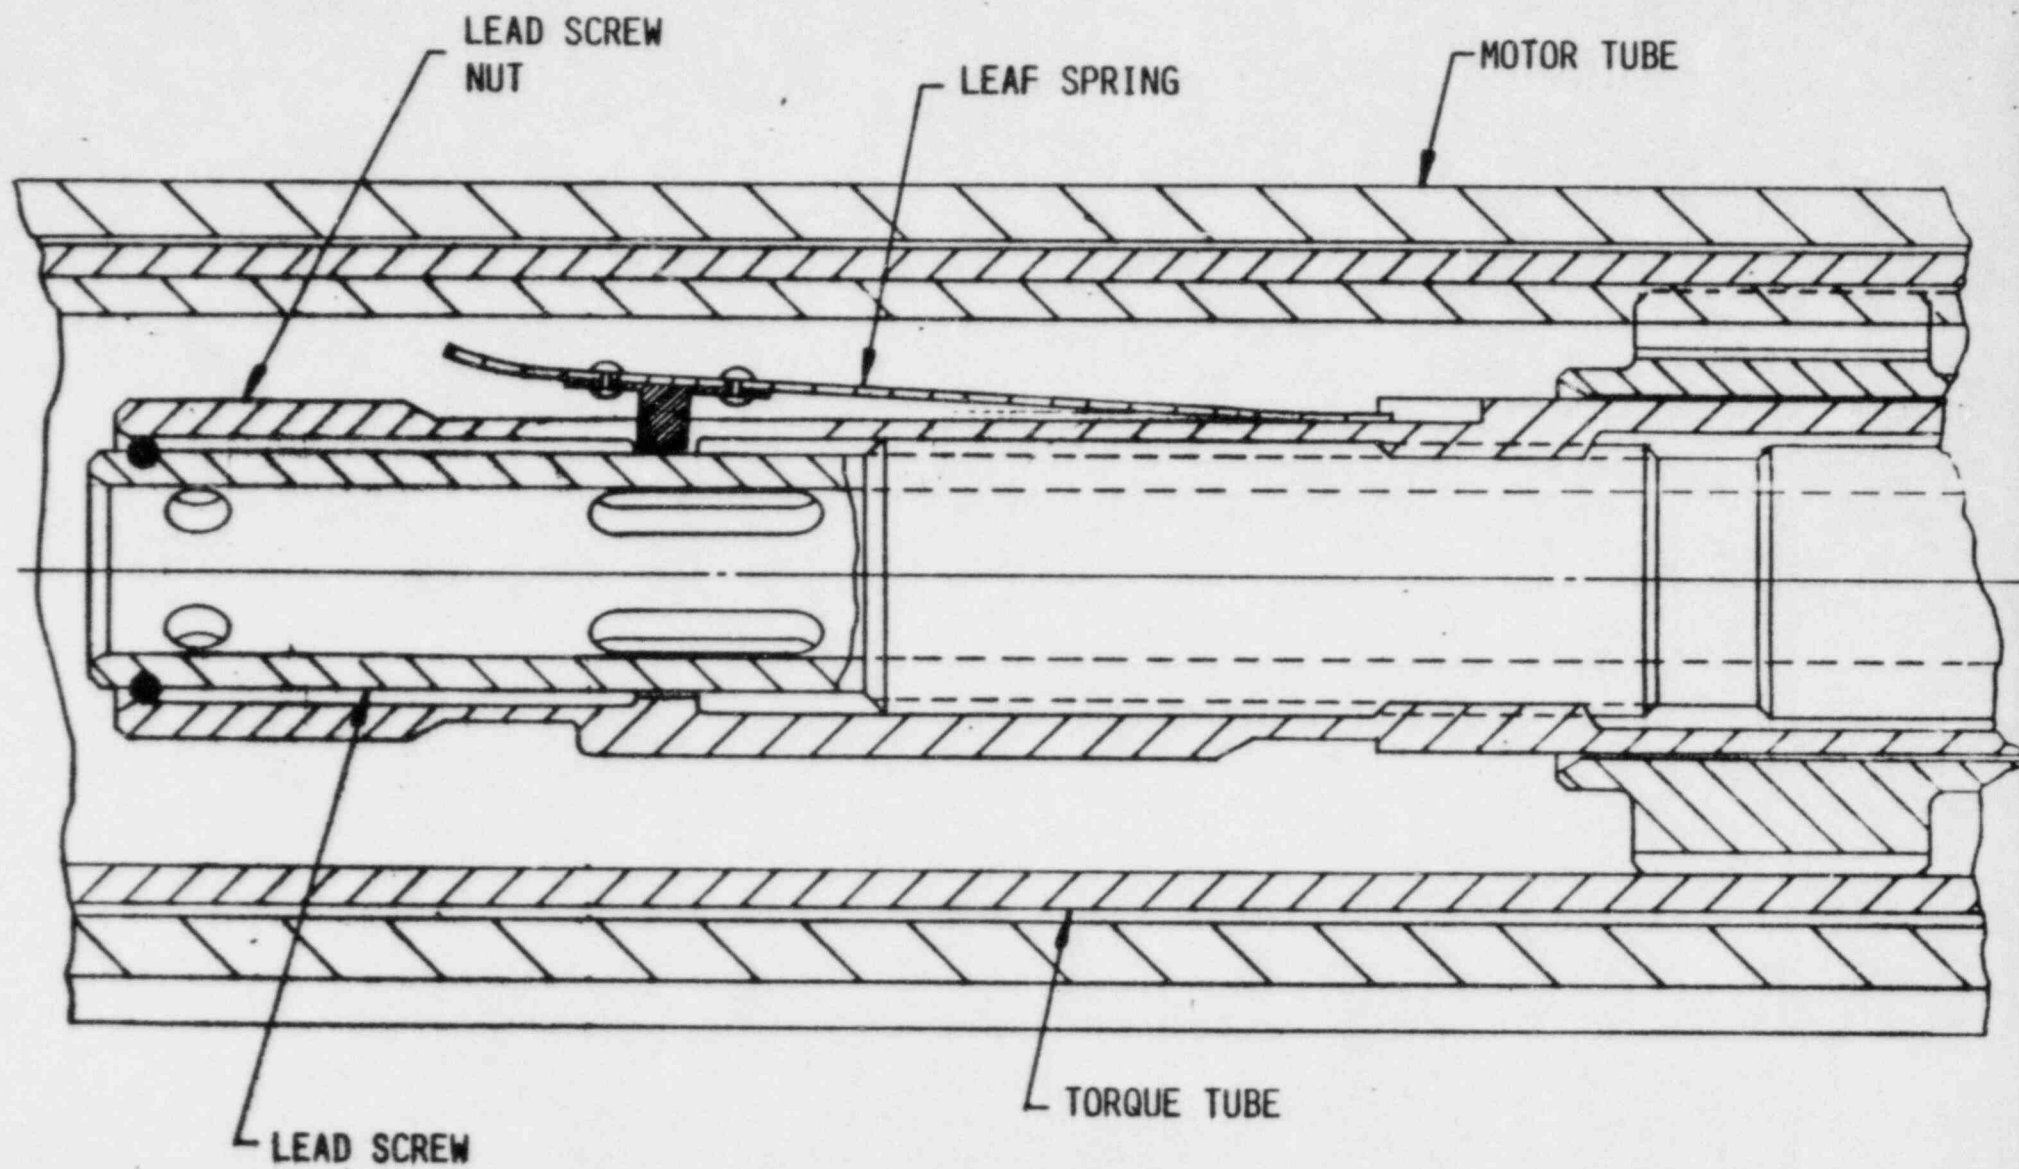
FIGURE 3  
CROSS SECTION OF LEAD SCREW AND LEAD SCREW NUT  
WITH LEAF SPRING IN UNLATCHED POSITION

It is believed that these springs failed because they had been left in an unlatched state at some time in the past. While in the unlatched state, these springs could interfere with a surface of the torque tube cap as the rods are fully withdrawn. There is more than sufficient force available from the drive stator to cause this spring to fail. Since all the CRDMs on the DB-1 head have been inspected to verify all the springs are intact, and fully latched, it is very reasonable to expect that there will be no further failure of these parts. All those springs which were found to be unlatched were removed from service to ensure that no potentially damaged parts would be placed back into service.

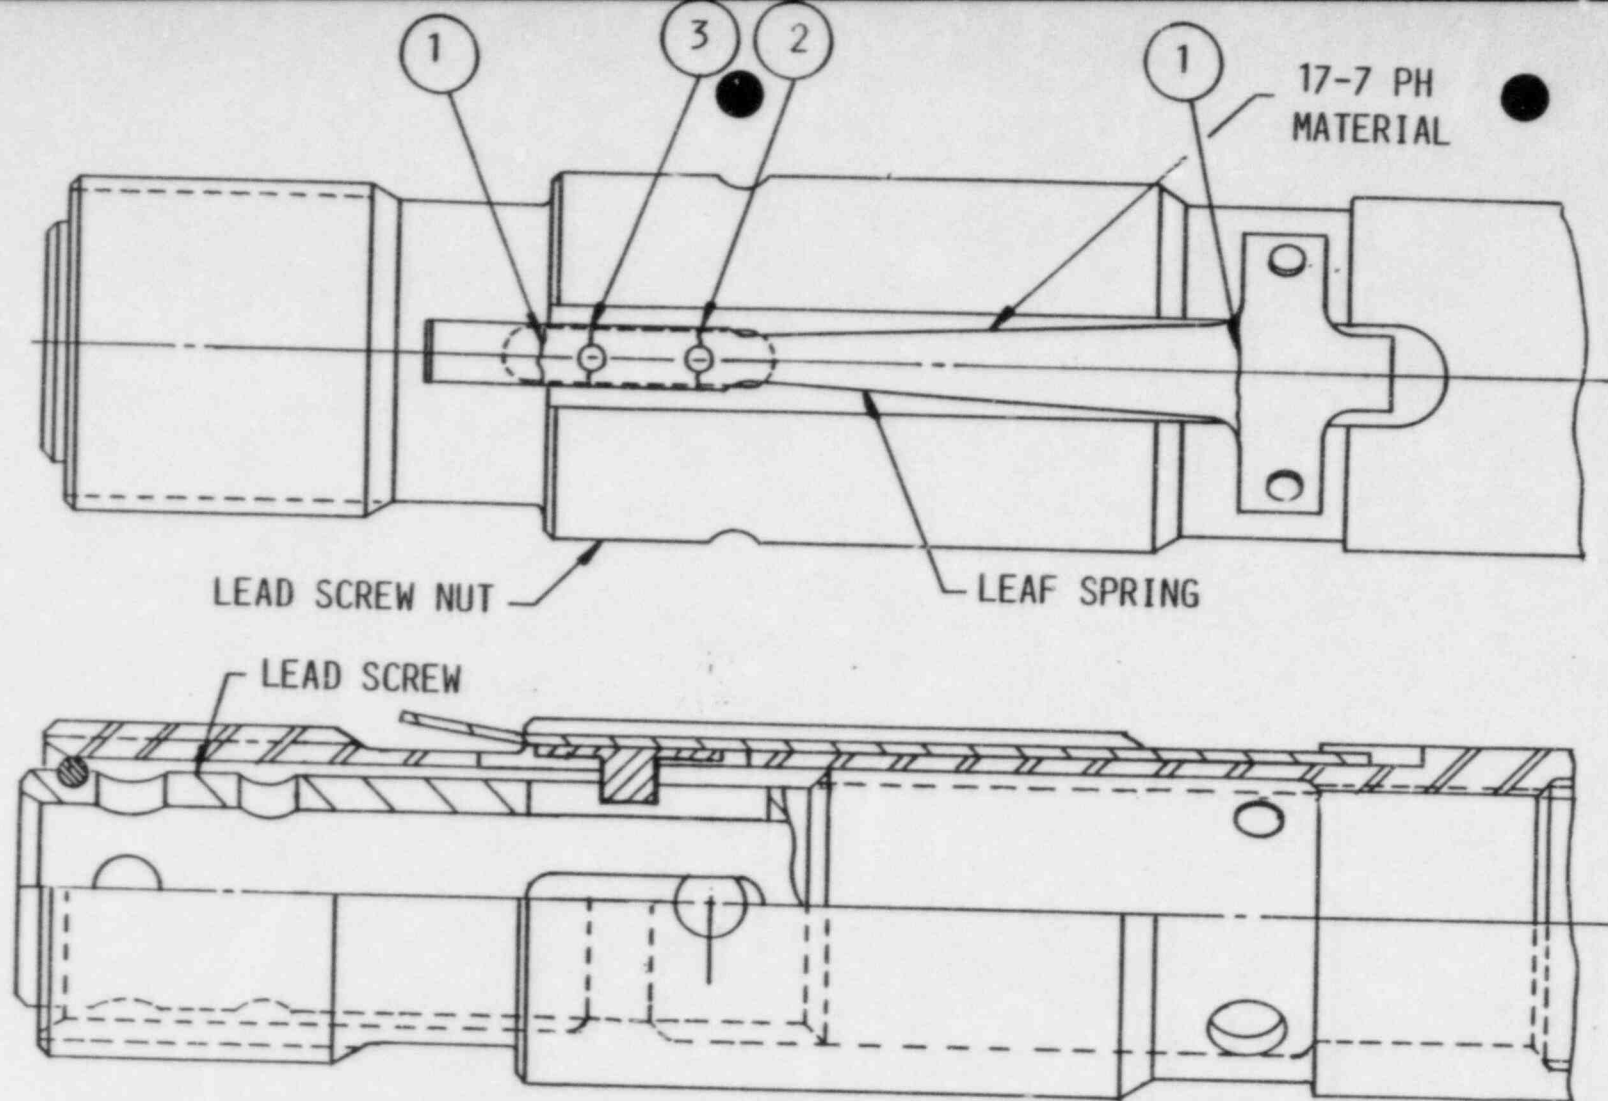
FIGURE 4  
HISTORY OF LEAF SPRING CRACKS

The spring that retains the leadscrew nut locking pin was found to be broken in two places and the main part was found and inspected. The failure of this spring, and a similar spring that failed in 1981, had fracture surfaces that exhibited predominantly intergranular fracture patterns. Although this could lead to the conclusion that a stress corrosion cracking mechanism was operating, there was significant evidence to indicate a mechanical failure mechanism.

- 1 TED 1985 CRACKS
- 2 TED 1981 CRACK
- 3 ARC 1984 CRACK

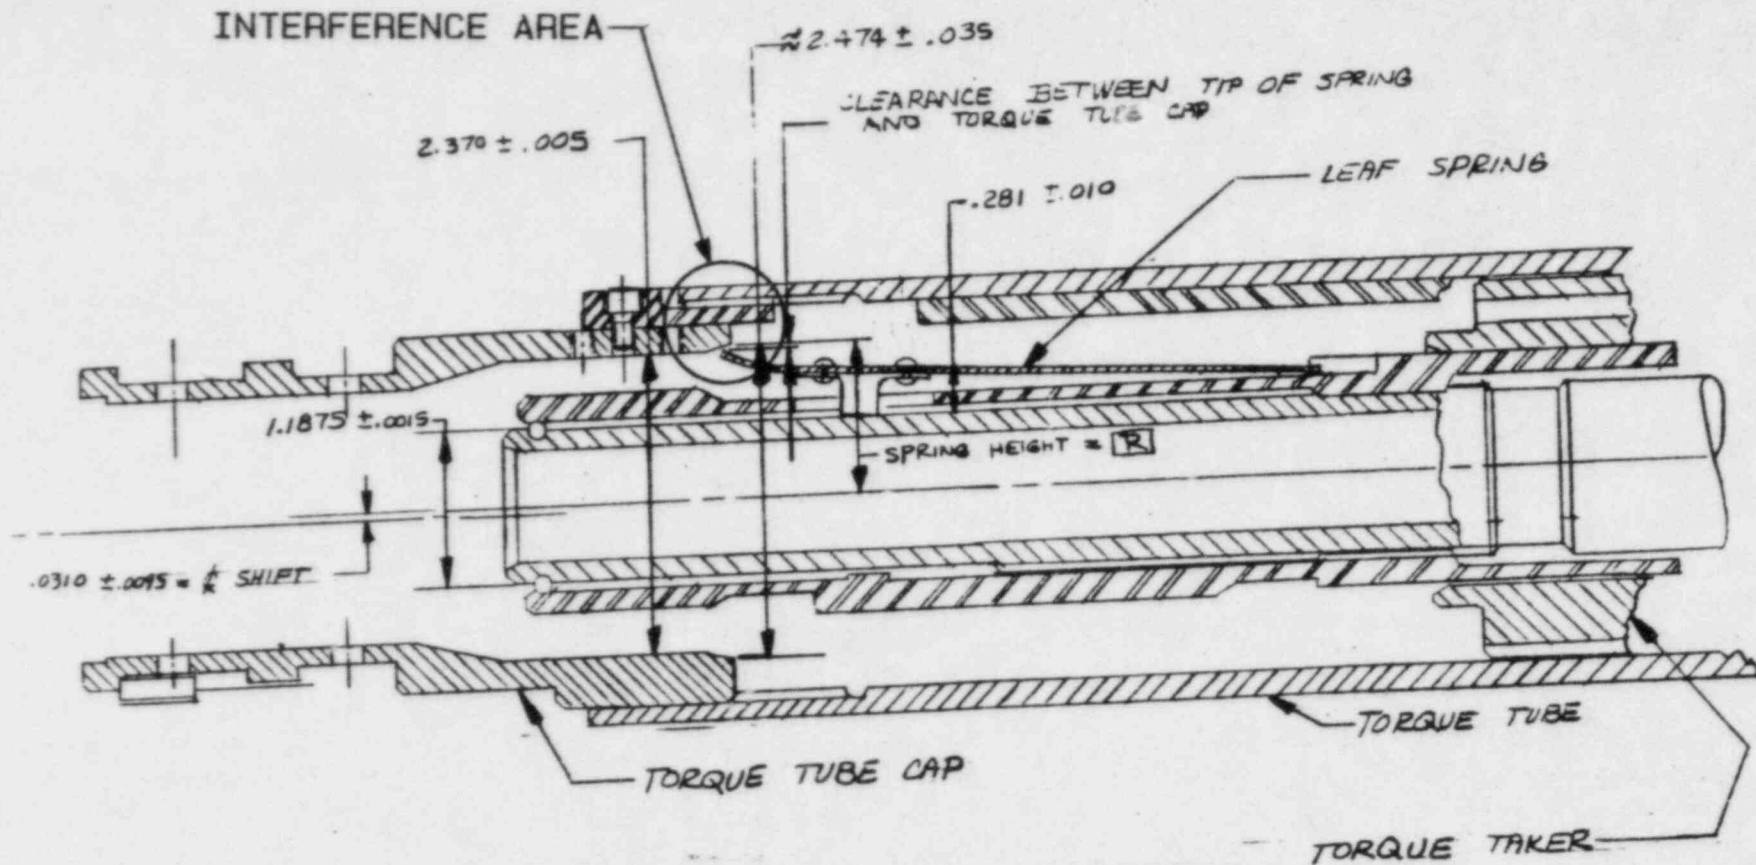
FIGURE 5  
INTERFERENCE BETWEEN  
EXTENDED SPRING &  
BASE OF TORQUE TUBE CAP

The investigation revealed that the most likely way in which the failure occurred was with the tip of an unlocked spring interfering with the torque tube cap when the leadscrew was raised to the full out position.

- o Extended Leafspring Hitting the Torque Tube Cap on Leadscrew Parking - A worstcase tolerance stackup has shown that an extended spring could hit or interfere with either the necked-down region or the bottom surface of the torque tube cap on withdrawal. If sufficient force were applied, the spring could be broken. Although several of the leadscrew nuts were found with the locking pins not disengaged from the leadscrew, the probability of their failure in this way is not likely due to the use of a spring scale and great care in limiting the lifting loads to 20 pounds over the hanging assembly weight. Again, if the spring were loaded in this fashion, the spring would have broken and the loose segment would have dropped off immediately. The spring tip would not have shown in the inspection which was performed in Nov. 1984.

The most probable cause of the spring material failure is as a result of the leadscrew locking pin on that drive having been left in the unlatched position. With the locking pins unlatched from their locking slots, the tip of the spring can easily interfere with the reduced diameter portion of the torque tube cap located near the top of the drive (See Figure 5). Inspection of the torque tube cap in the drive recently removed for this investigation shows an indication of something having struck it in a manner which would be expected from this failure mechanism.

Since a total of five pins were found not to be in their correct locations it is recommended that the procedures for maintenance of the CRDM be reviewed, and modified if needed, to assure that they include instructions to verify that the locking pins are properly positioned.
