Report to Congress on Abnormal Occurrences

October - December 1984

**U.S. Nuclear Regulatory
Commission**

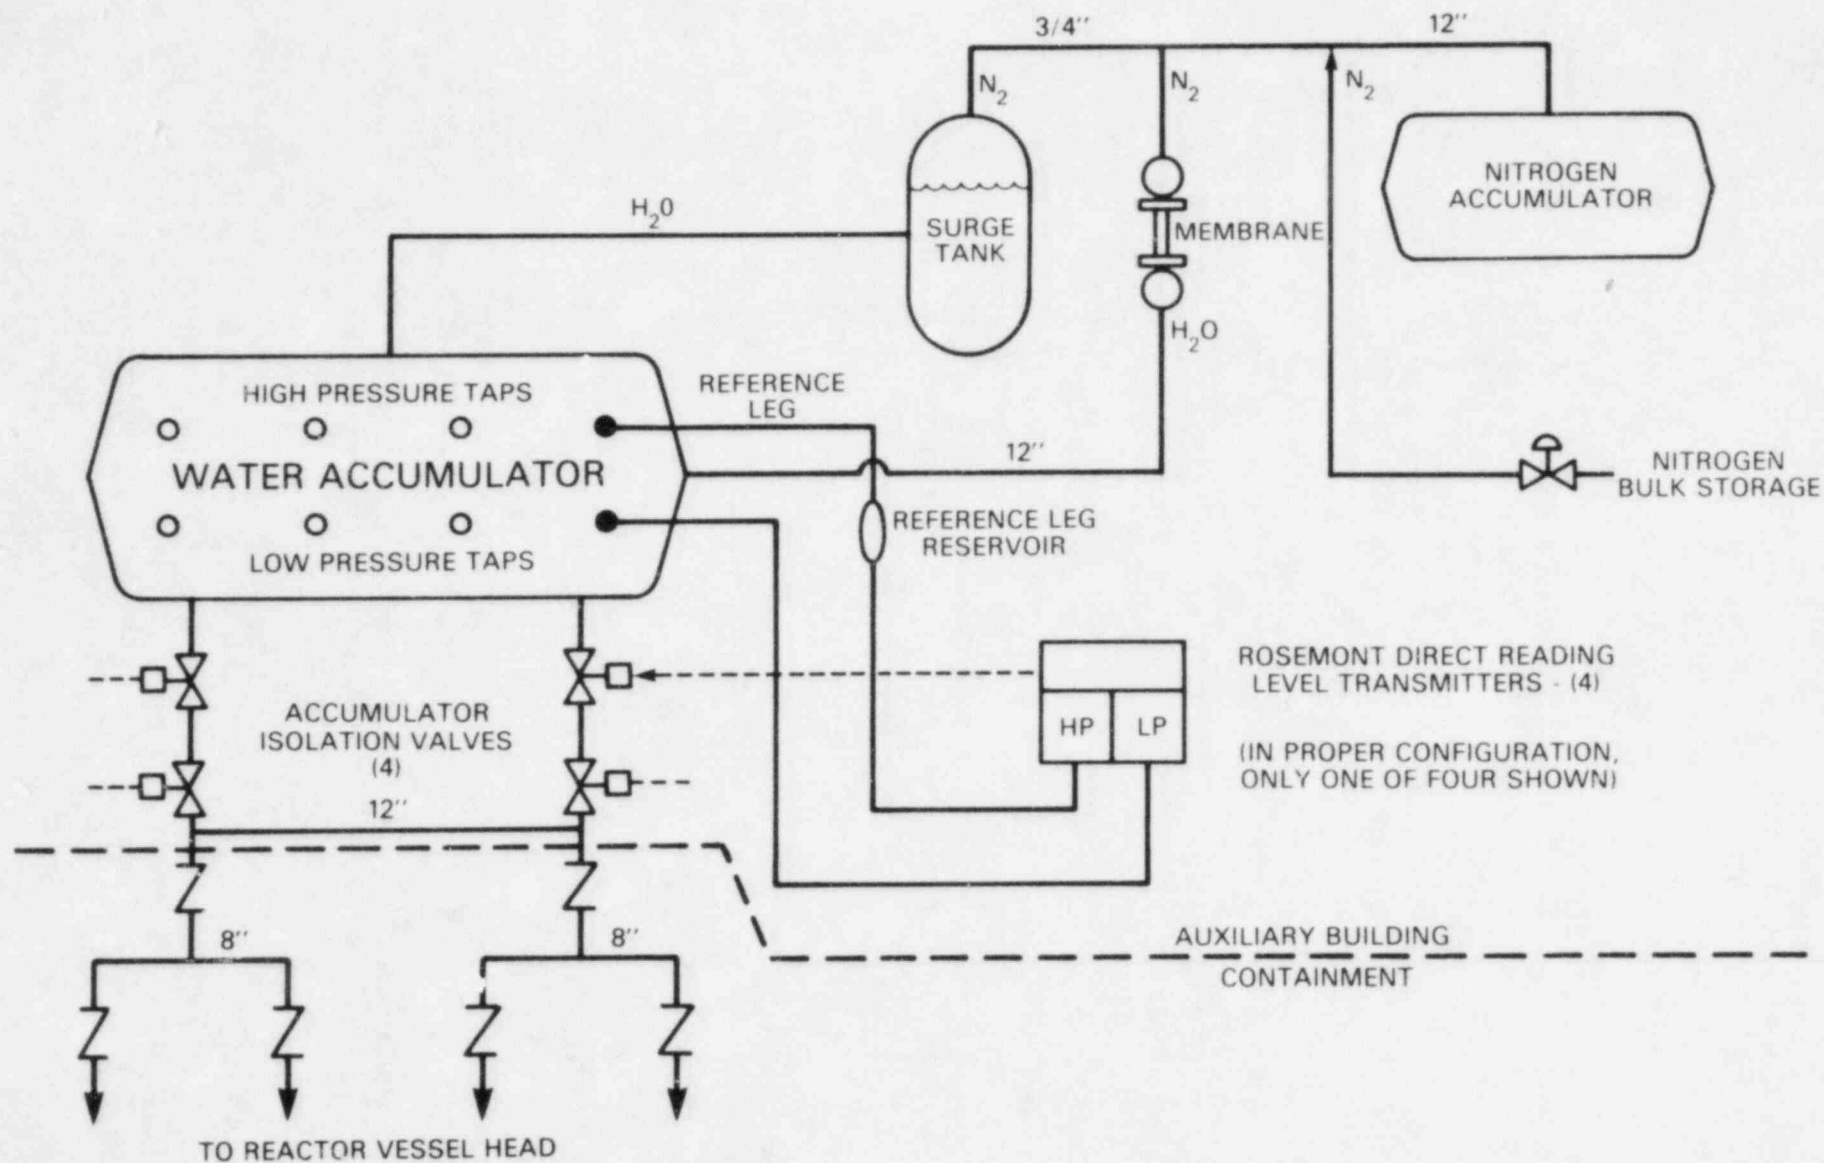
Figure 1 Simplified Piping and Instrumentation Diagram (McGuire Upper Head Injection System)

Date and Place - On November 1, 1984, the upper head injection (UHI) system accumulator isolation valves were discovered to have been incapable of required automatic closure for Duke Power Company's McGuire Nuclear Station, Unit 1, a pressurized water reactor plant, located in Mecklenburg County, North Carolina.

Nature and Probable Consequences - At McGuire Unit 1, the UHI system is an engineered safety feature, designed to provide cooling (borated water) of the core during the blowdown portion of the postulated loss of coolant accident (LOCA) transient for a large rupture in the cold leg of the reactor coolant system (RCS). The system (see Figure 1) consists primarily of two pressure

vessels (accumulators), one filled with borated water and the other with pressurized nitrogen gas. Pressure is maintained to the borated water in the first accumulator by the nitrogen gas in the other accumulator. During normal operations, the contents of the two accumulators are separated by a membrane in the 12" diameter line connecting the accumulators, and pressure is maintained at equilibrium through a surge tank.

On October 31, 1984, while Unit 1 was operating at 100% power, the licensee found that nitrogen in excess of technical specifications was entrained in the water accumulator. A plant shutdown was initiated. On November 1, 1984, while the licensee was draining the tank, it was discovered that the four isolation valves failed to close on accumulator water low level. Investigation showed that the valves had been incapable of required automatic closure since April 25, 1984. From this date until the condition was discovered on November 1, 1984, the plant had been operated for about five months. During this period, had a large LOCA occurred, a considerable amount of nitrogen could have been injected into the reactor vessel upper head.

Although the effects of injecting the non-condensable gas has not been analyzed in detail, it could interfere with cooling the reactor core during such an accident. This condition is beyond the design bases for the plant and is not specifically analyzed in the safety analysis report.

Cause or Causes - Investigations revealed that the water accumulator differential pressure transmitters, which sense accumulator water level and provide the initiating signal for isolation valve closure, had been improperly installed on Unit 1. The impulse lines were not connected to the appropriate transmitter ports. This resulted in a loss of function of the transmitters and, consequently, in the inability for automatic closure of the accumulator isolation valves. Further investigation revealed that the transmitters had been incorrectly installed during a plant modification in April 1984, which replaced the Barton differential pressure instruments by Rosemont instruments. The cause of this incorrect installation is attributed to inadequate instructions which did not provide sufficient direction for proper connection of the transmitters. The installation errors were similar to those previously addressed in NRC Inspection and Enforcement Information Notice No. 84-45, which was issued on June 11, 1984 (Ref. 8).

In addition, the functional testing of the system following completion of this modification was limited to a dry calibration of the differential pressure transmitters. This dry calibration was not an adequate method of functional testing because it was unable to detect improper installation of the differential pressure transmitters and did not demonstrate that the transmitters would function properly with respect to water level in the accumulator.

Licensee - A new installation procedure has been issued which now requires verification of proper tubing connections for differential pressure transmitters, and the licensee has committed to strengthening the post modification testing program. Additionally, the licensee reviewed other safety-related differential pressure applications for similar problems. No other problems were identified. Prior to startup of Unit 1, the UHI differential pressure transmitters were properly connected and the system functionally tested using an adequate method. Unit 2 was inspected and found to have the UHI differential pressure transmitters properly connected.
