**Babcock & Wilcox**

RDD:85:5104-02:03

EXAMINATION OF CRDM LEAFSPRING AND FOREIGN DEBRIS  
SAMPLES REMOVED FROM DAVIS BESSE-1

MAY 13, 1985

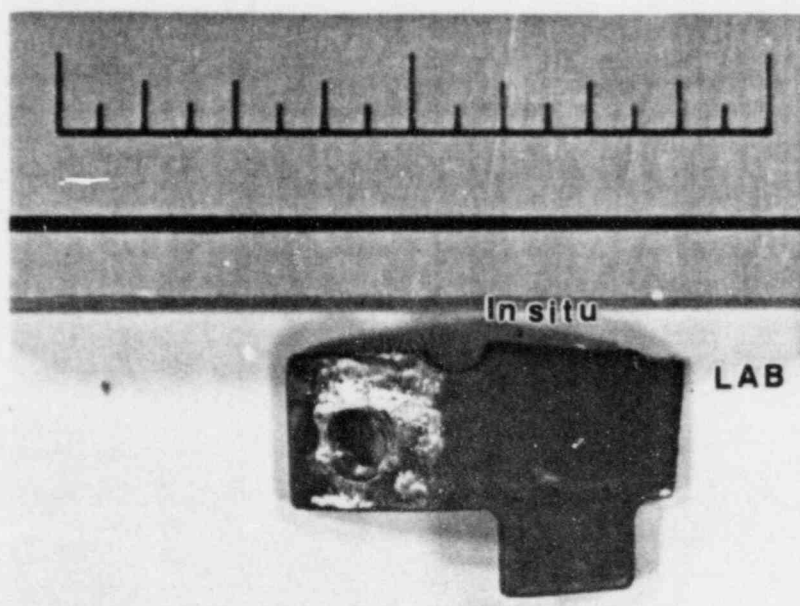
2. A leadscrew nut with a portion of a broken leafspring attached to it was removed from core location E-3. The portion of the leafspring originally attached to the nut is shown in Figure 2. A large part of the remainder of the leafspring was recovered from another location in the CRDM, and is shown here in Figure 3. These two portions of this broken leafspring are labeled DB-5 for this examination.

Figure 2 - Portion of Leafspring Attached to DB-5 After Ear Was Removed During Laboratory Fracture

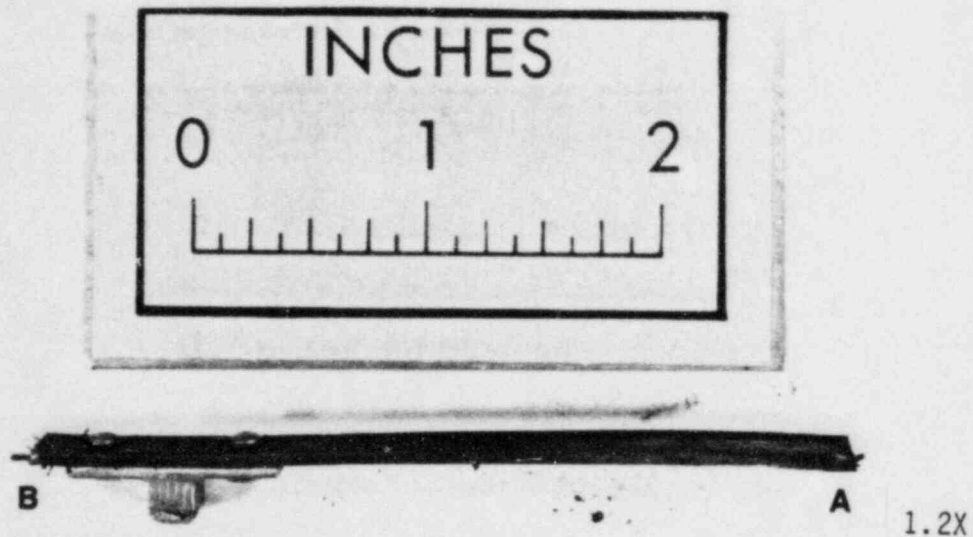
The top and the bottom (side closest to the leadscrew nut) of the as-received DB-5 detached broken spring specimen are shown in Figures 10 and 11, respectively. This specimen appeared to be at least partially magnetic. The larger fracture surface (on the right) was previously labeled A (Figure 3).

The fracture surface on the opposite end was labeled B. As indicated, the fractures occurred at the fillet end (A) and beyond the second rivet hole (B). Fracture surface A is shown in Figure 12. The lighter area near the top of the photograph is an impact zone which can be seen with difficulty in Figure 11. The top surface of the fracture is actually the bottom of the spring. A more detailed photograph of the center of fracture surface A is shown in Figure 13. The impact zone is at the upper left side of the photograph. The entire fracture surface and impact zone is covered with surface deposits. The impact zone on the bottom at a location near the center of the fracture infers that the impact occurred after the formation of fracture surface A.

Figure 3 - Remainder of DB-5 Leafspring. The end (A) on the right side of the photo is the mating surface with the leafspring portion shown in Figure 2. The opposite end fracture (B) mates with a small piece not recovered.

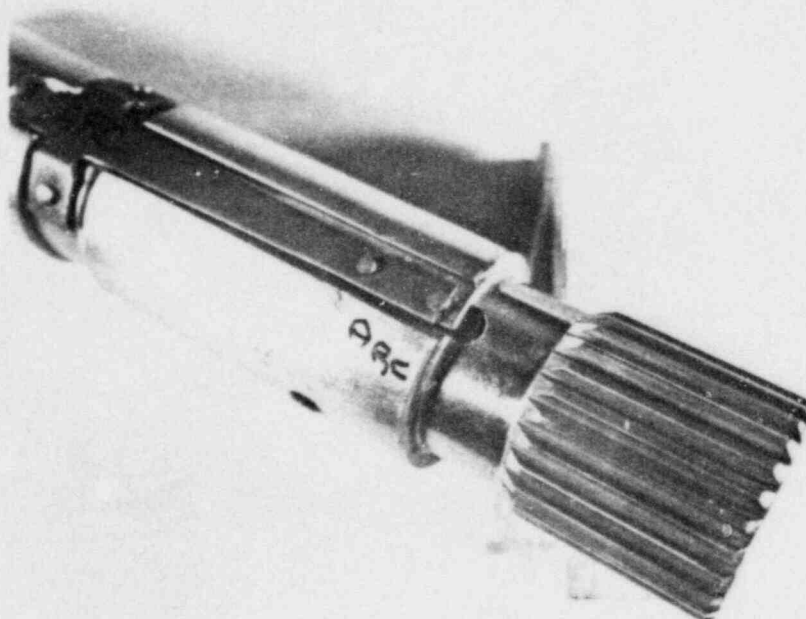
3. A leadscrew nut with a portion of a broken leafspring attached to it was removed from the CRDM test facility at ARC. These parts are shown in Figure 4. This broken spring is labeled DB-6.

Figure 4 - Leadscrew Nut and Portion of Leafspring DB-6 Attached. Leafspring fracture is adjacent to second rivet near center of photo.

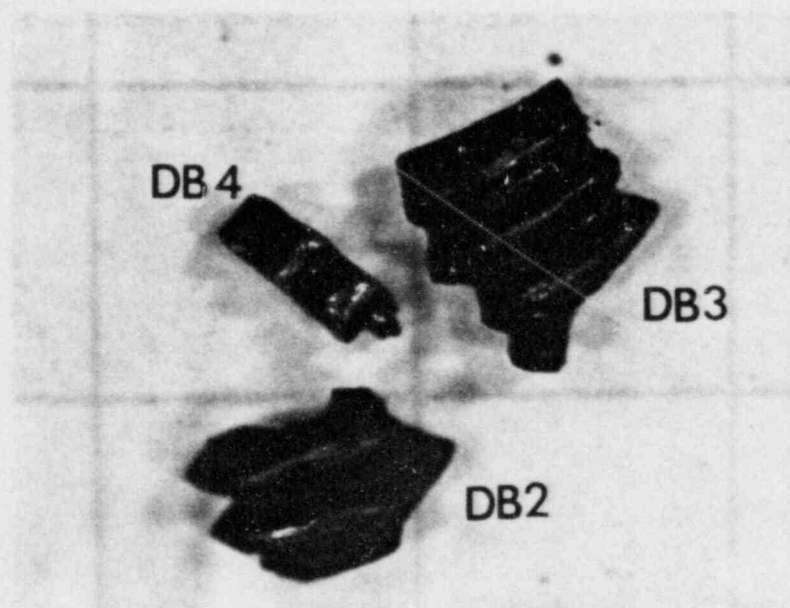
7. Three leadscrew nuts with unbroken springs removed from core locations E-5, O-5 and H-6 are labeled DB-11, DB-12 and DB-13, respectively.
8. Three pieces of debris (foreign material) were removed from the CRDM which contained the broken spring DB-5. These are shown in Figure 6, and are labeled DB-2, DB-3 and DB-4.

Figure 6 - Debris Particles DB-2, DB-3 and DB-4  
Background grid is 1/4" square

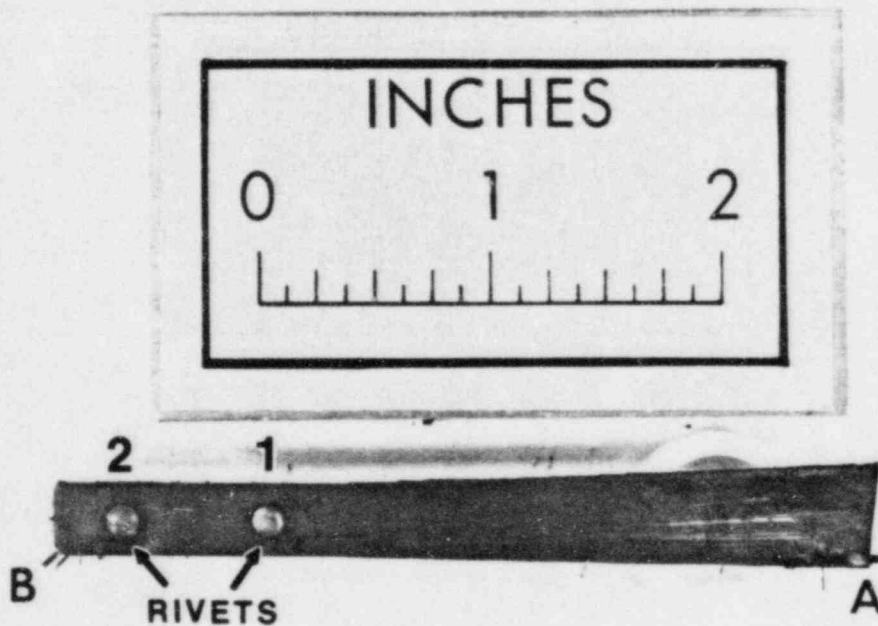
Figure 10 - Photomicrograph of the Top Surface of Spring DB-5. 1.2X

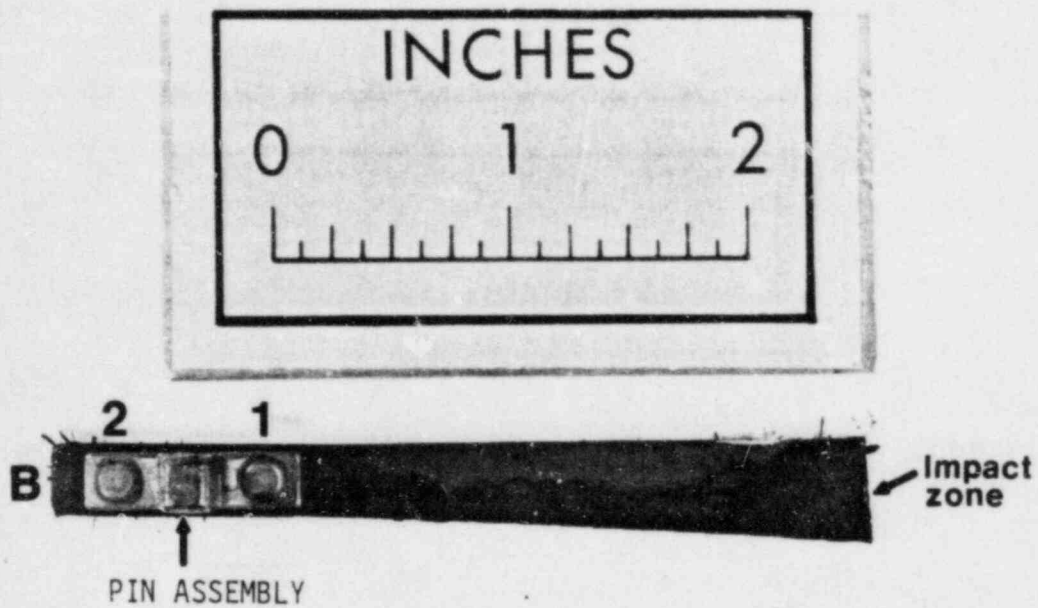
Figure 11 - Photomicrograph of the Bottom Surface of Spring DB-5. 1.2X

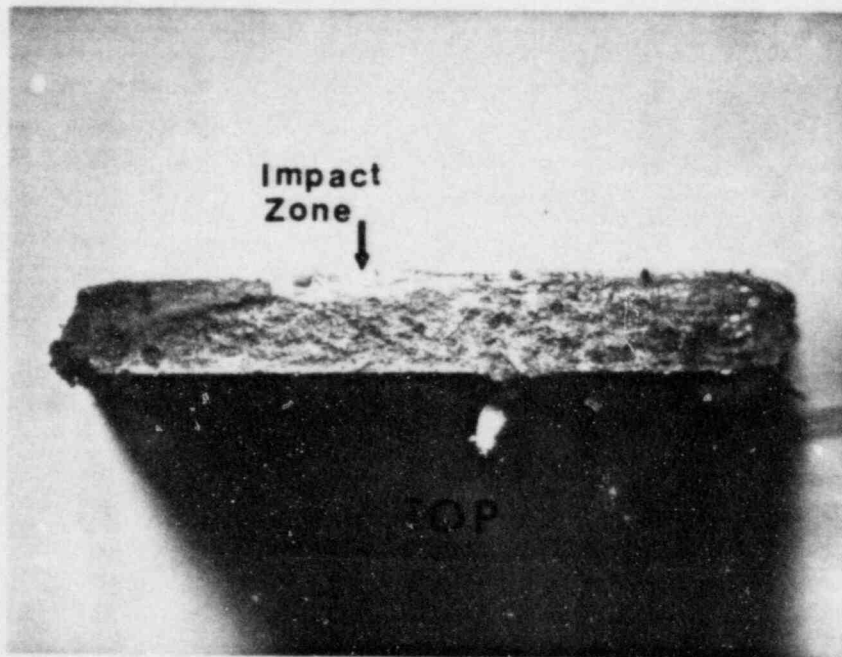
Figure 12 - Fractograph of the Large Fracture, End "A", of Spring DB-5. 8X.

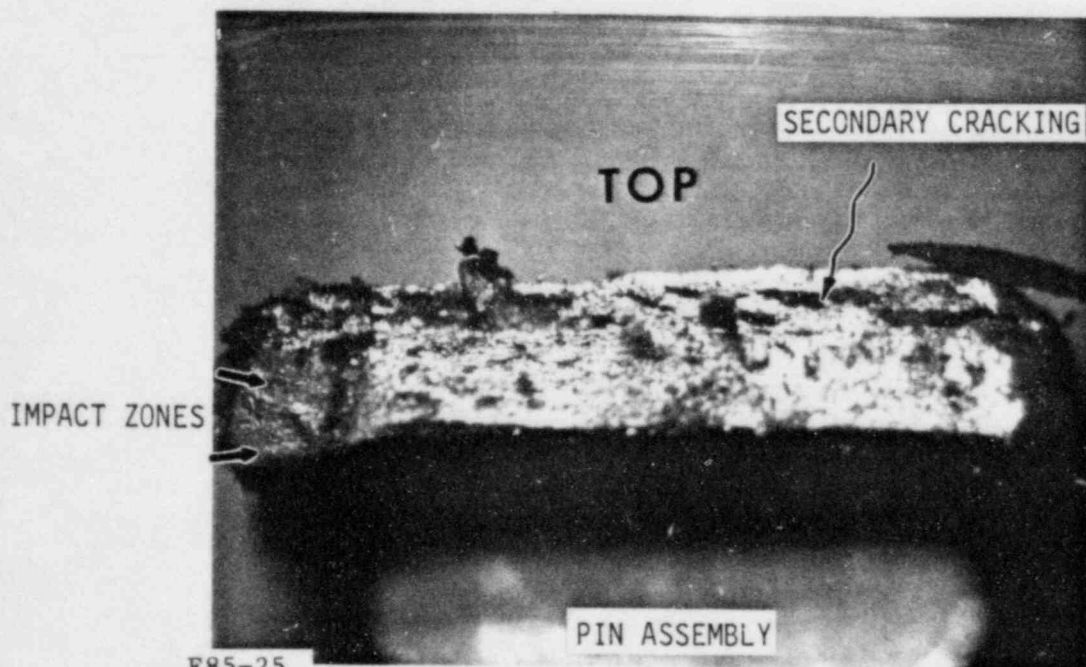
Fracture surface B is shown in the as-received condition in Figure 14. As indicated by the location of the pin, the bottom edge of the fracture surface corresponds to the bottom edge of the spring. This fracture surface has several impact zones one of which can be easily seen at the lower left side of Figure 14. Others which cannot be easily seen are located at the lower edge of the fracture surface on the left side (adjacent to the impact zone mentioned above) and an area on the right edge of the photograph. These areas will be seen more easily in subsequent photographs. A zone of secondary cracking was also seen on the right side near the top of the fracture surface.

Figure 14 - Fractograph of the Small Fracture Surface of Spring DB-5, End "B", in the As-Received Condition Showing Impact Zones. 8X.

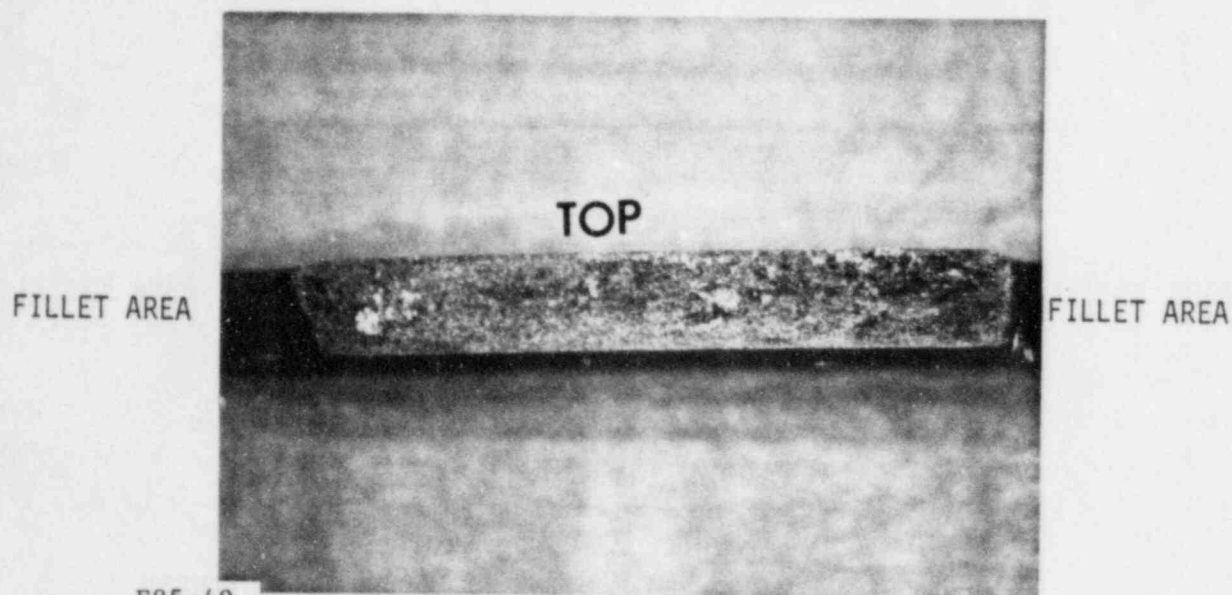
The portion of the DB-5 spring which was attached to the leadscrew nut when received at the LRC was inadvertently not photographed in the as-received condition. This portion of the spring was removed from the leadscrew nut by drilling out both rivet holes. One of the ears containing a rivet hole was used as a notched laboratory fracture specimen. This portion of DB-5 is shown following removal from the nut and fracture of the ear in Figures 15 and 16. Figures 15 and 16 show the top side and bottom sides, respectively. A photograph of the in situ fracture surface is shown in Figure 17. The fillet areas are shown at each end of the photograph.

Figure 17 - Fractograph of the Fracture from the Large End of DB-5. Mating Surface to Fracture "A" in Figure 12.

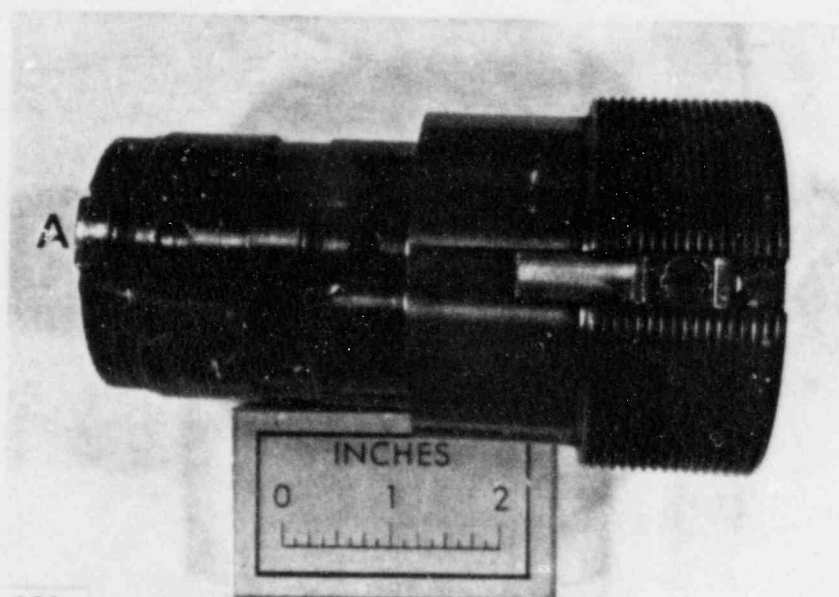
examination. This part is seen in a side view in Figure 18. A deformed or chipped area was noted at the smaller diameter (non-threaded) end as seen in Figure 19. More detailed views of the deformed area are shown in Figure 20. The deformation apparently occurred at different times. The dark area was smooth and discolored indicating that it had not formed recently. The lighter surface abrasions were recently formed and correspond closely to the width of the spring tip. Apparently the spring tip contacted the torque tube cap when the spring was in the retracted position near the ID surface of the cap. Because of the contact force and the spring taper, the contact surface extended toward the center of the cross section. Apparently the fillet end fracture of DB-5 probably broke from this contact at the outer edge of the contact area.

Figure 18 - Photomacrograph of the Side View of CRDM Part # 706329-1145, Torque Tube Cap from Core Location E-3. 0.5X.

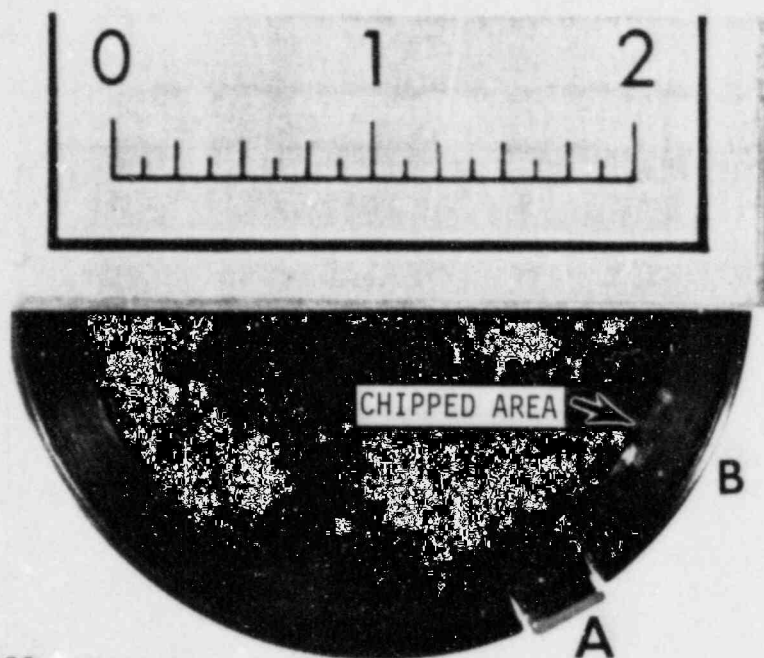
The visual inspection results indicate that the initial fracture of DB-5 was probably caused by contact with the end of the torque tube cap when the spring was in the retracted position. This is known to be a possible occurrence based on a tolerance study performed at NPD. Based on the probable stress distribution in the spring when this interaction occurred, it is likely that the fillet end fracture occurred first. The fracture at the base of the ski jump apparently occurred by mechanical interaction with the CRDM.

Figure 19 - Photomacrograph Showing a Chipped Area on the Small End of the Torque Tube Cap in Figure 18. 1.3X.

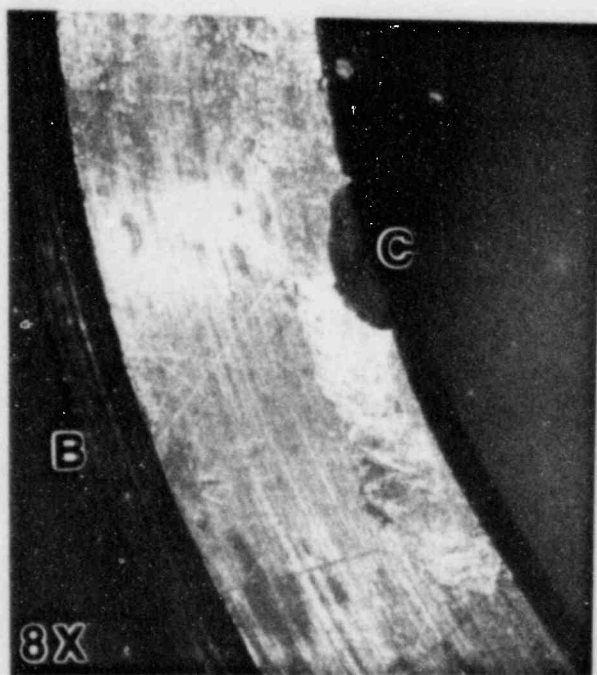
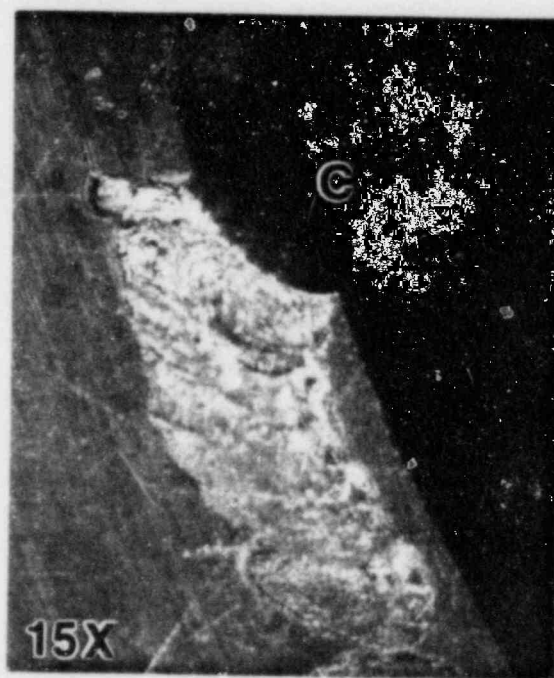
Figure 20 - Higher Magnification Views of the Chipped Area in Figure 19.

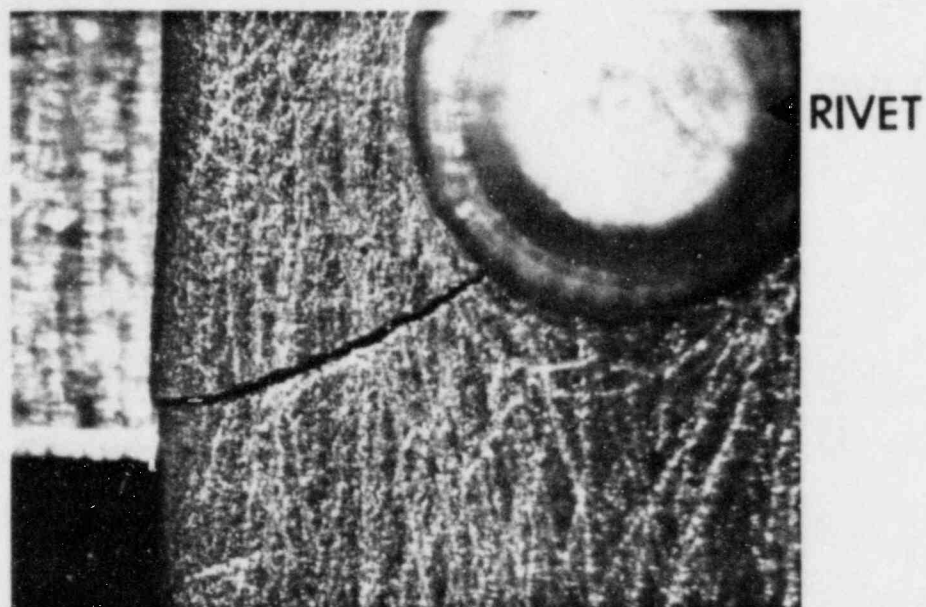
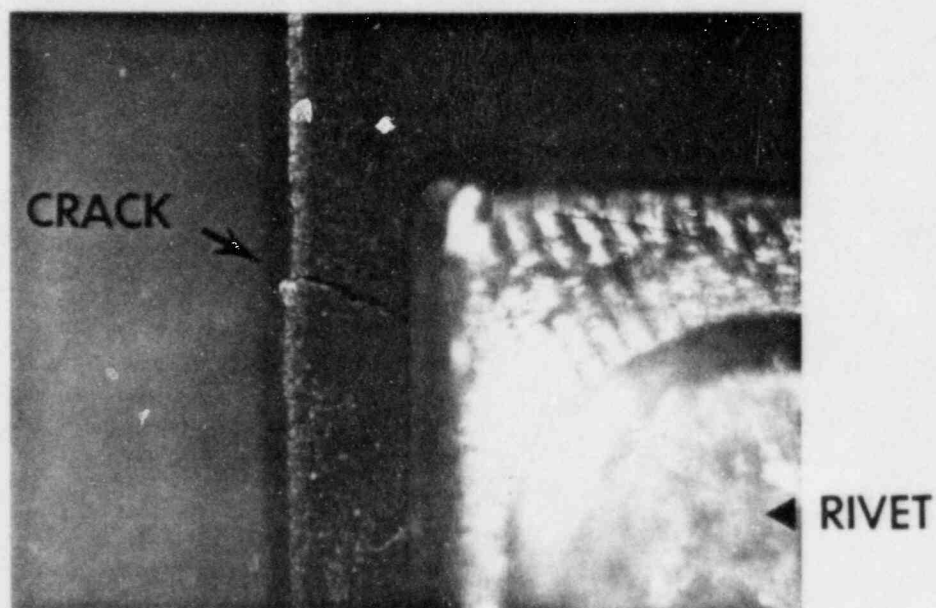
Spring DB-10 was determined to be fractured on one side of the second rivet hole (one of two that holds the pin in place) closest to the end of the spring. This fractured area is seen looking from the top and the bottom of the spring in Figures 21 and 22, respectively. The fracture surfaces are slightly separated and the lower ligament near the outer edge of the spring is protruding slightly. These observations indicate that the rivet was exerting stress on the spring which was subsequently relieved by the crack. The crack occurs at an inclined angle near one side of the rivet hole. The crack seen in spring DB-8 also occurs at an inclined angle near the back of the first rivet. The location and orientation of the cracks is undoubtedly related to the stress distribution around the rivet hole.

Figure 21 - Photomicrograph of the Crack at the Second Rivet  
F85-90 Hole Viewed From the Top of DB-10. 16X.

Figure 22 - Photomicrograph of the Bottom of Spring DB-10,  
F85-105 Showing the Crack at the Second Rivet Hole. 14X.

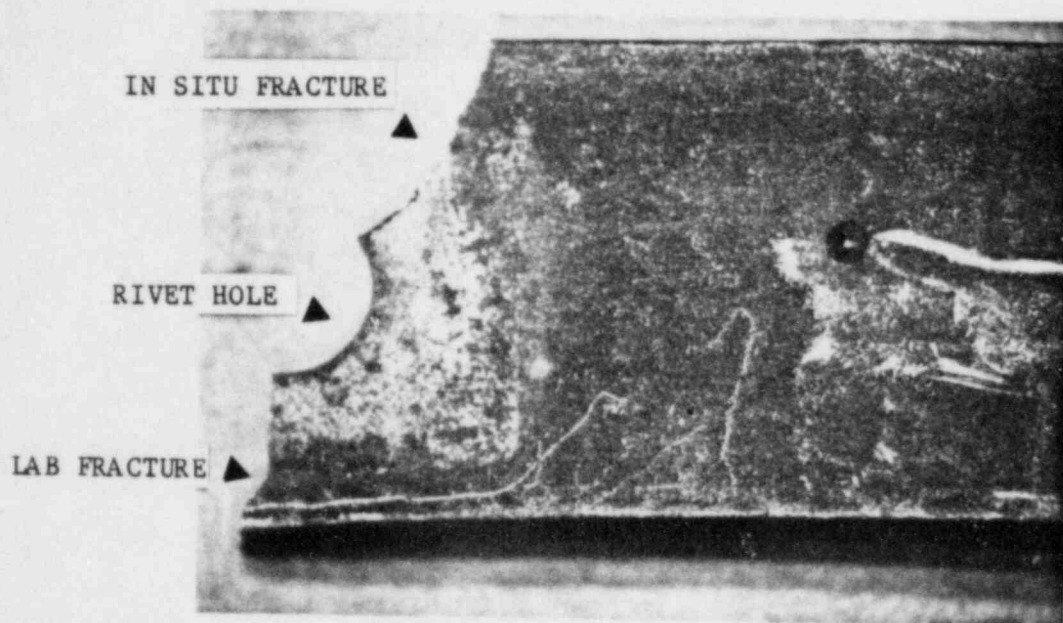
The crack noted previously, was opened by impacting the spring on the side containing the crack. This was performed by holding the bottom end of the spring in a vice and impacting on the side near the top. A bottom view of the fracture profile is seen in Figure 24. A macrophotograph of the in situ fracture surface is shown in Figure 25. This fracture probably initiated on the bottom surface and propagated upward and may have been caused by a bending stress applied preferentially to one side of the rivet.

Figure 24 - Photomacrograph of the Bottom View of the Fracture in Spring DB-10 After Removal and Fracturing the Remaining Ligament. 8X.

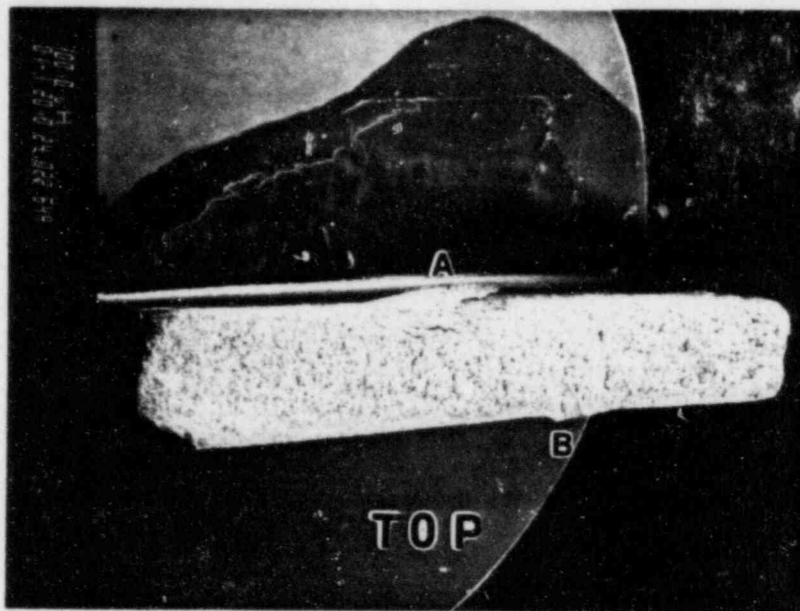
After cleaning, fracture surfaces A and B from DB-5 were examined in detail using the SEM. The fracture surfaces were almost entirely intergranular. Several impact zones were seen while performing the examination. Figure 32 gives an SEM photograph of the DB-5 location A fracture surface. The impact zones are labeled as A and B. A detail of area A is given in Figure 33. The cracks that can be seen normal to the fracture surface were apparently caused

by the impact which deformed the fracture surfaces above the lower crack (darker gray area). The fact that localized deformation of this type would cause cracking normal to the primary fracture surface is an indication of the brittleness of the material. Area B, which is a much smaller and more localized area is shown in Figure 34. Areas A and B impact zones may have been formed at the time that the small end of the spring.

Figure 32 - SEM Fractograph of In Situ Fracture "A" in Spring DB-5.

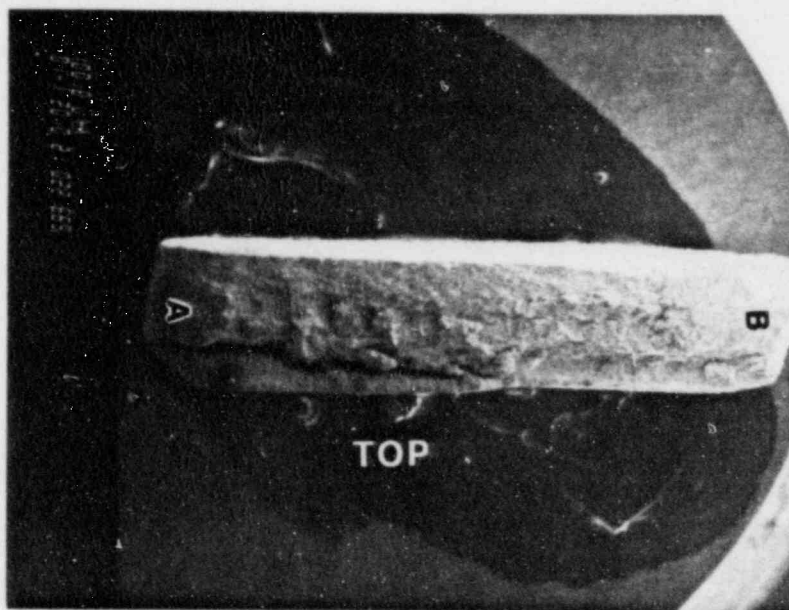
An SEM photograph of the DB-5 location B fracture (small end fracture) is shown in Figure 35. This fracture is at the base of the tapered area (ski jump) at the end of the spring. The largest impact zone (Area A) is illustrated in Figure 36. The large normal crack network observed in Figures 35 and 36 was apparently caused by impact to the end of the spring and along the lower edge in this same area. A second impact zone was also seen at location B. These impacts probably occurred after the fillet end of DB-5 (location A) had fractured. The resulting loose piece could then have been damaged in the CRDM.

Figure 35 - SEM Fractograph of the Small End In Situ Fracture (B) on Spring Sample DB-5. Large cracks and Two Impact Areas, "A" and "E", are Shown.

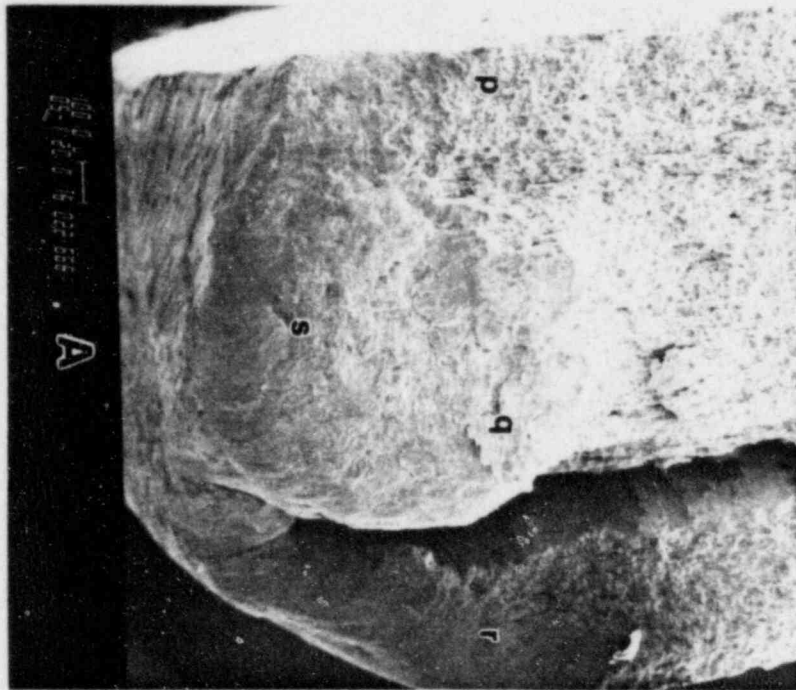
Figure 36 - SEM Fractograph of the Largest Impact Area, Area "A" and Secondary Cracking shown in Figure 35.

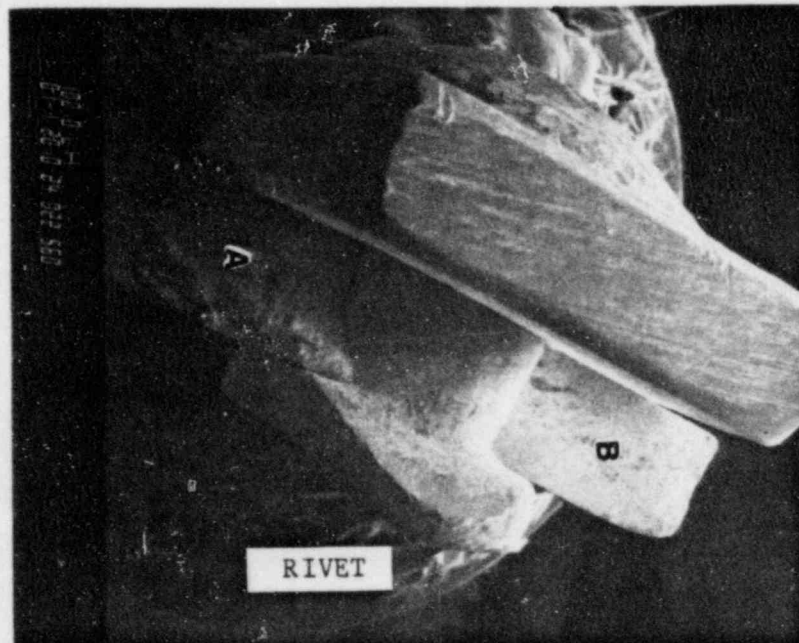
An SEM photograph of the DB-6 fracture surfaces A and B is given in Figure 37. The rivet, pin assembly and spring fracture surface on both sides of the rivet are shown. The A half of the fracture is slightly inclined from perpendicular to the longitudinal axis of the spring. The B half is close to perpendicular (normal to the spring axis). One of the fractures in spring DB-8 and the in situ fracture in spring DB-10 were inclined at a greater angle (from perpendicular) than fracture A. The presence of a crack at an angle associated with the rivet hole (as discussed above) implies that the rivet is exerting a considerable stress on the rivet hole. This stress is being exerted in all directions around the circumference of the hole. Another indication of this stress was mentioned previously in Section 2.1 for spring DB-10. The magnitude of the axial stress vector across the rivet hole apparently causes the maximum stress intensity contour to deviate from an angle normal to the axis of the spring. A larger amount of rivet hole stress would cause a larger angle of deviation. Also, the fractures which are not normal to rivet holes are apparently those which occurred first, i.e., before the stress was relieved in the rivet hole area by the initial fracture.

Therefore, by this argument, fracture A occurred prior to fracture B. Fracture A clearly initiated at the bottom and was caused by a bending stress. This is also indicated by the upward deformation noted on the bottom of the rivet top. Details of fractures A and B are shown in Figure 38. Both fractures were predominately intergranular.

Figure 37 - SEM Fractograph of the In Situ Fractures in Spring Sample DB-6 Showing Rivet, Pin Assembly, and Fracture Surface

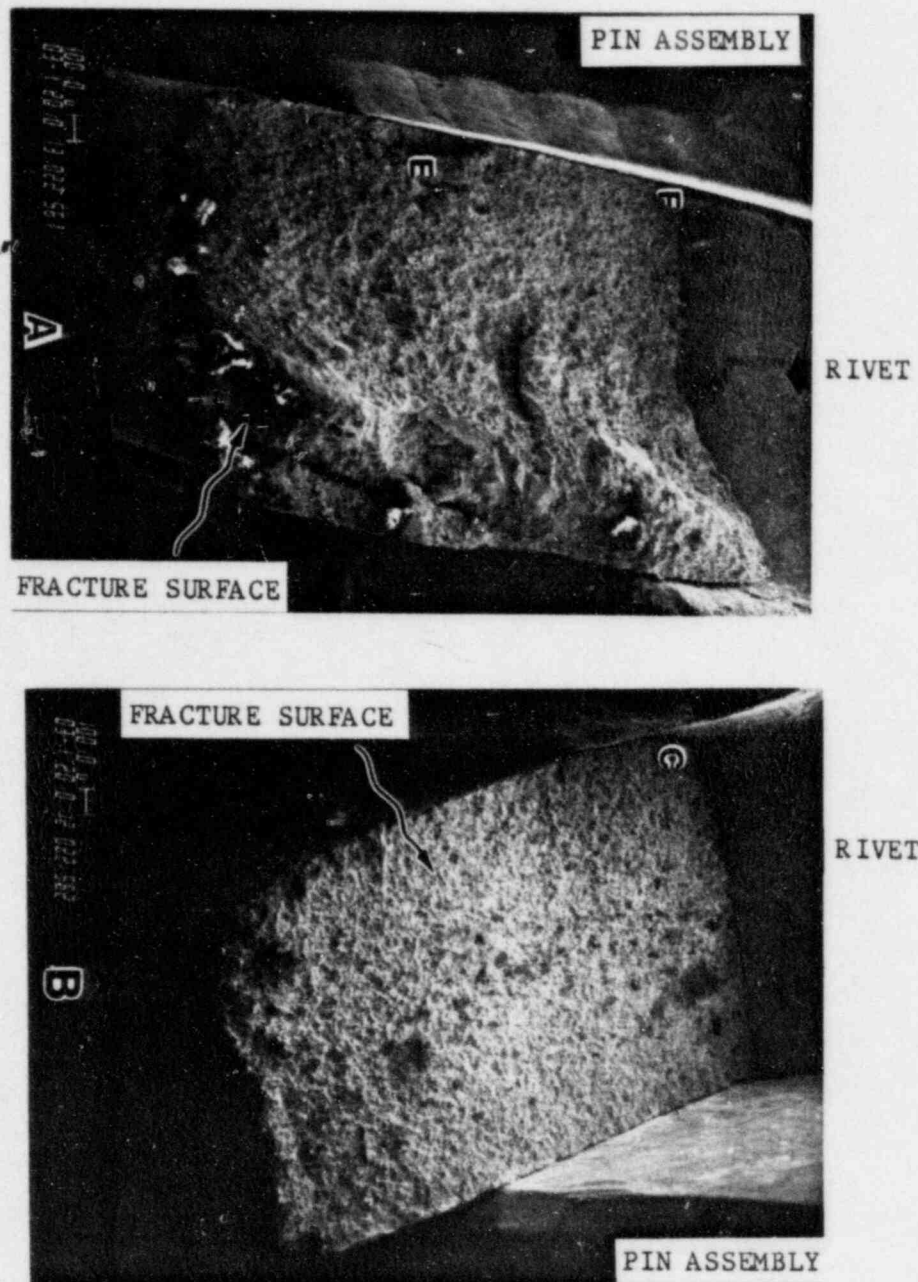
Figure 38 - Higher Magnification Views of In Situ Fractures in Figure 37

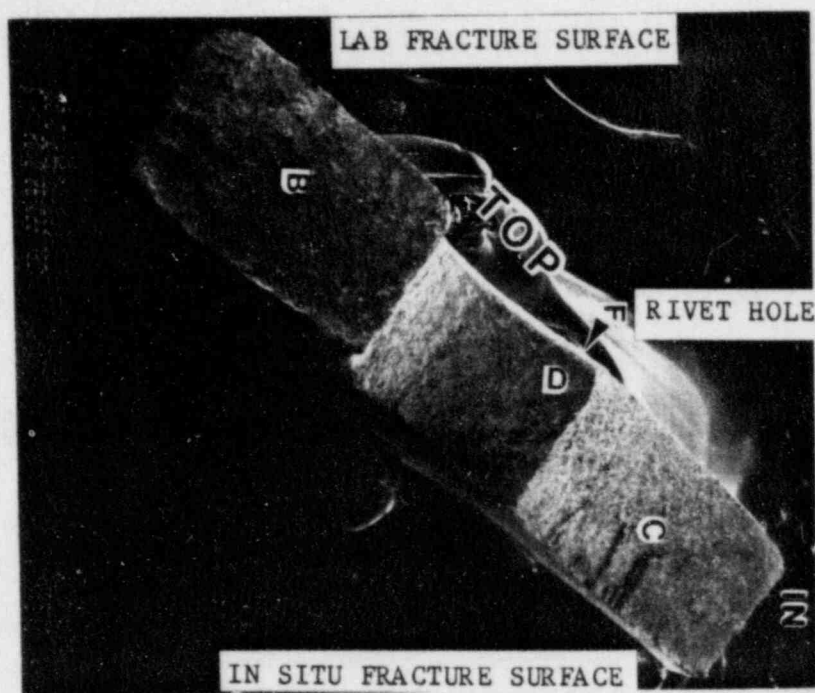
The fracture surface generated by opening the DB-10 crack noted previously was examined using the SEM. An SEM photograph of the in situ and lab fracture surfaces with the rivet hole between is shown in Figure 39. The side labeled C is the in situ service fracture. A more detailed photograph of the in situ fracture is given in Figure 40. The bottom surface of the spring is downward in this figure. The fracture surface is primarily intergranular with crack propagation from bottom to top. An energy dispersive X-ray (EDX) spectrum of the fracture surface shown in Figure 40 is given in Figure 41. This spectrum indicates that the major elements present with atomic numbers  $\geq$  Na are Cr, Fe and Ni. Lesser amounts of Al and Si were also detected with trace amounts of Ca and Ti. Si and Ca are present in small amounts in the primary water. All other elements noted are present in the spring composition.

Figure 39 - SEM Fractograph of the Fracture Surface on Spring DB-10 showing the Rivet Hole and Lab and In Situ Fractures.

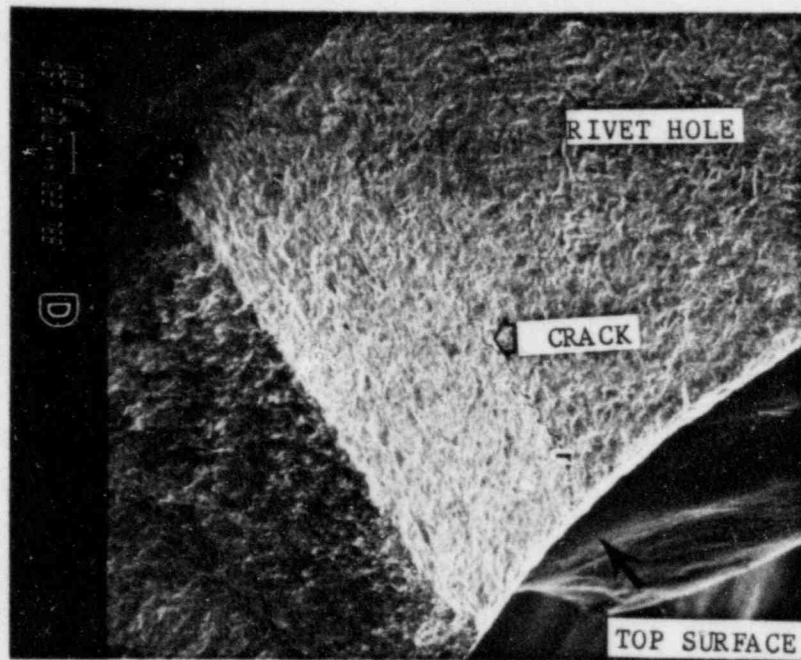
An SEM photograph of area D (Figure 39) is given in Figure 42. A small cracked area (labeled r) was seen that intercepted the rivet hole. The top of the spring is in the lower right of the photograph. It was determined from more detailed examination that the small crack under cuts a portion of the rivet hole/fracture surface interface and also intercepts the main fracture surface and the top surface of the spring. This crack apparently initiated on the top surface of the spring after the main fracture had occurred and is probably unrelated to the main fracture. A more detailed photograph of area r is shown in Figure 43. An EDX spectrum of the rivet hole surface seen in Figure 43 is shown in Figure 44. The elements detected included Al, Si, Cr, Fe and Ni. Elements (such as S or Cl) from compounds which could contribute to a corrosive environment in the crevice area were not detected.

Figure 42 - SEM Fractograph of Area "D" in Figure 39  
Showing a Crack in the Rivet Hole Area.

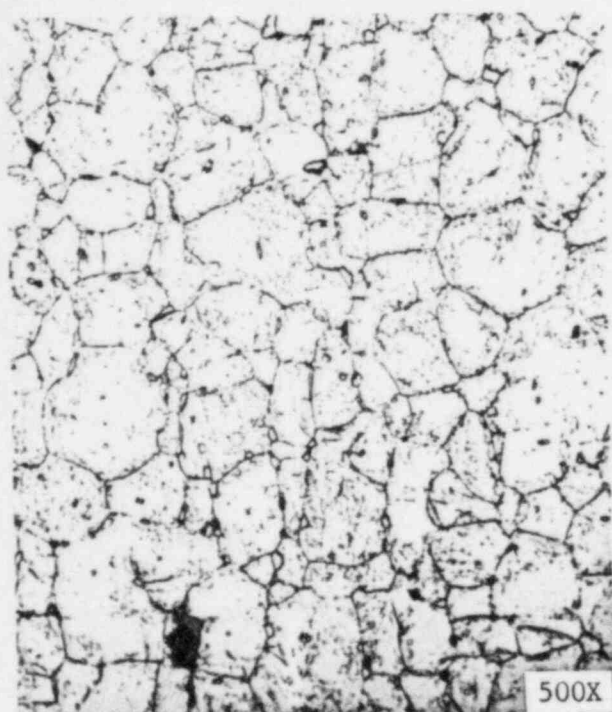
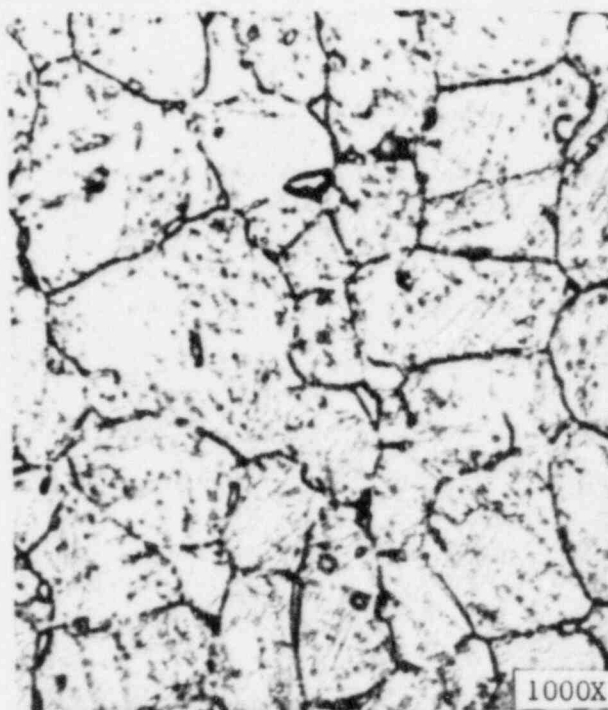
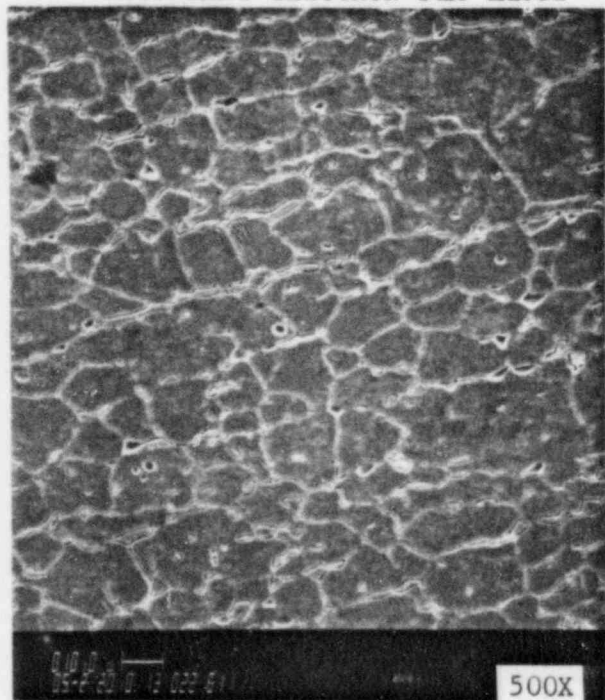
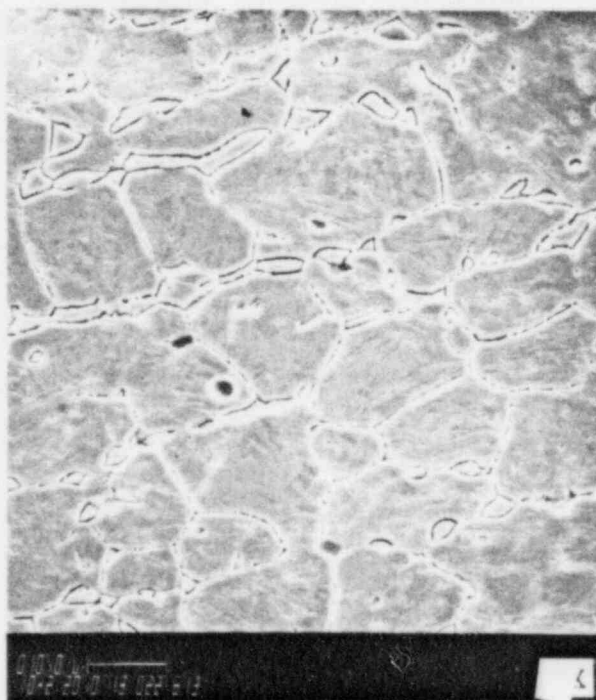
Figure 45 shows the typical microstructure observed for springs DB-1, 5, 6, 8 and 10 from heat 300130 and DB-14 from heat 230232. This microstructure is characteristic of the TH-1050 heat treatment for 17-7 pH stainless steel.(2) The upper photomicrographs are optical micrographs of DB-5 after etching. The lower photomicrographs are SEM secondary electron images (SE) of the metallographically prepared surface of spring DB-5 after etching. The optical micrographs show stringers and globules of ferrite in a martensite matrix. The grain boundaries are partial carbide networks, probably Cr<sub>23</sub>C<sub>6</sub>, which are typical of this heat treatment. The chromium carbides form during the austenite conditioning treatment, first at the ferrite - austenite interface and then, if the carbon is on the high side, at austenite grain boundaries.(3) The ditches in the SEM micrograph also show this and result from the etchant selectively attacking the Cr depleted zones adjacent to the grain boundaries.

Figure 45 - Optical (Upper Row) and SEM (Lower Row)  
Photomicrographs of Spring DB-5 (Heat 300130)  
Showing Stringers and Globules of Ferrite  
and Carbide Networks in a Martensite Matrix.  
Electrolytic 10% Ammonium Persulfate Etch.

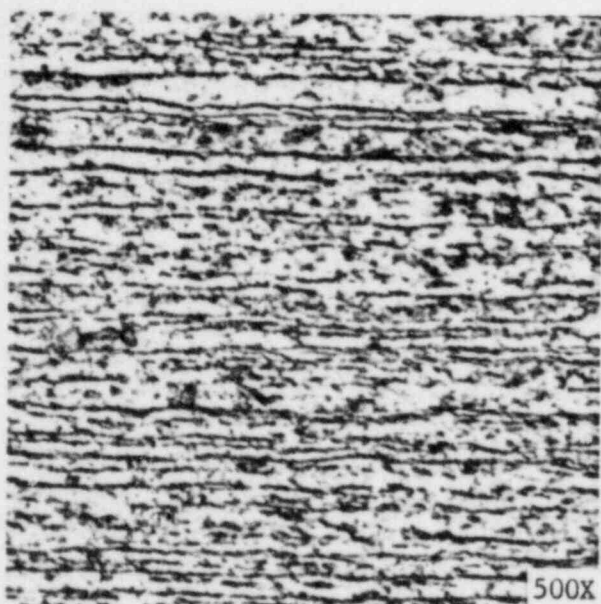
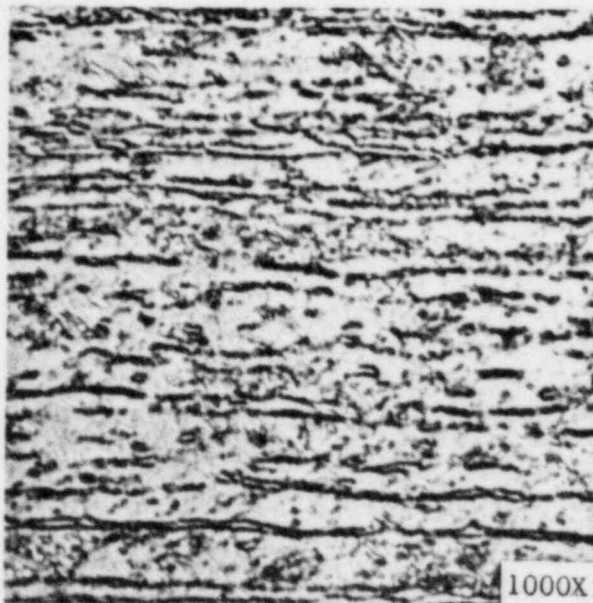
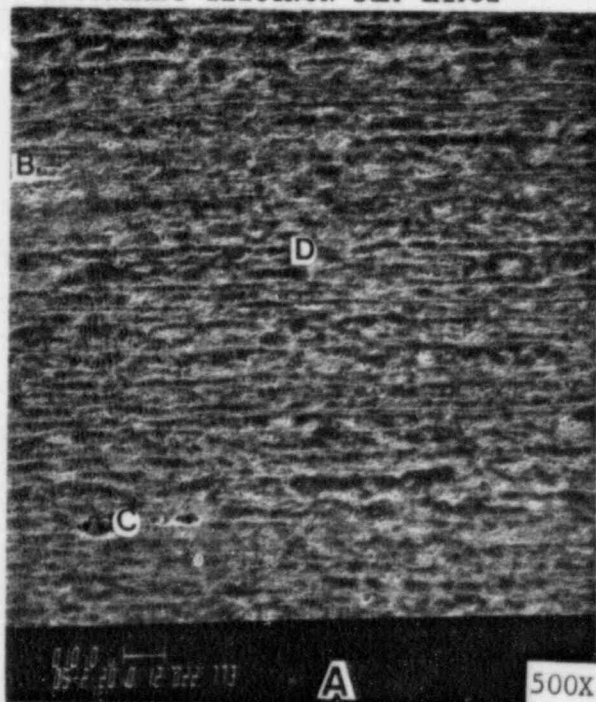
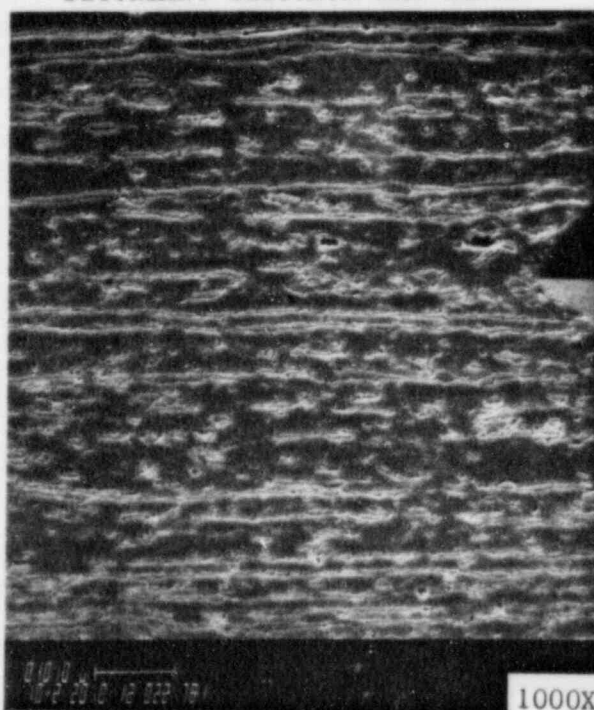
The heat 610073 microstructure (spring DB-9) showed a distorted microstructure which would be characteristic of cold worked condition A sheet stock being used as the starting material rather than annealed sheet (condition A). If cold worked sheet stock was used as the starting material, the martensite transformation would take place during cold work (prior to heat treatment). Subsequent heat treatment at 1400°F and 1050°F for 90 min. would cause recrystallization and overaging. The heat treatment received by the 610073

Figure 46 - Optical (Upper Row) and SEM (Lower Row) Photomicrographs of Spring DB-9 (Heat 610073) Showing Distorted Structure With Stringers and Globules of Ferrite and Carbide Networks in a Martensite Matrix. Electrolytic 10% Ammonium Persulfate Etch.

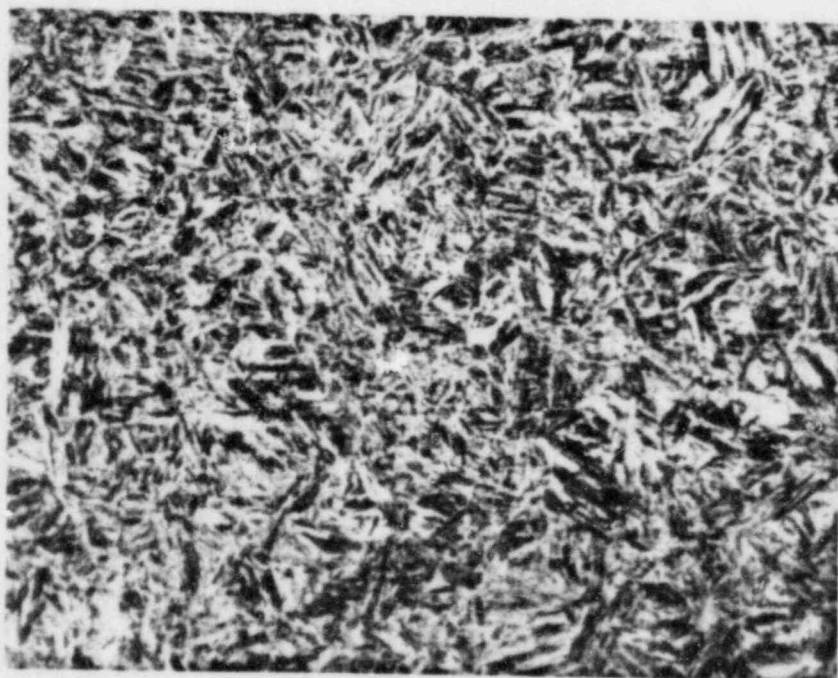
The microstructure of the debris samples DB-2, 3 and 4 (Figure 49) was a normal tempered martensitic structure. The EDS system on the SEM was used to qualitatively determine the major chemical constituents of the material. Results showed the alloy was primarily iron with a small amount of silicon. (The EDS system does not detect elements in concentrations under 1 weight percent or elements with an atomic number less than that of sodium). These results indicate that the debris material is probably plain carbon steel. This is consistent with the facts i.e.; the samples were magnetic, a large amount of iron oxide corrosion product was found on the samples during the visual examination, and Allen-Head set screws are fabricated from a plain carbon steel.

Figure 49 - Optical Photomicrograph of the Martenistic Structure  
in Debris Sample DB-3. Nital Etch. 1000X.
