SUBJECT: ASSESSMENT OF THE PUBLIC HEALTH IMPACT OF THE FAILED
MILL TAILINGS DAM -- UNITED NUCLEAR - HOMESTAKE
PARTNERS MILL, GRANTS, NEW MEXICO

ASSESSMENT OF PUBLIC HEALTH IMPACT
OF THE FAILED
MILL TAILINGS DAM--UNITED NUCLEAR HOMESPAKE
PARTNERS MILL, GRANTS, NEW MEXICO

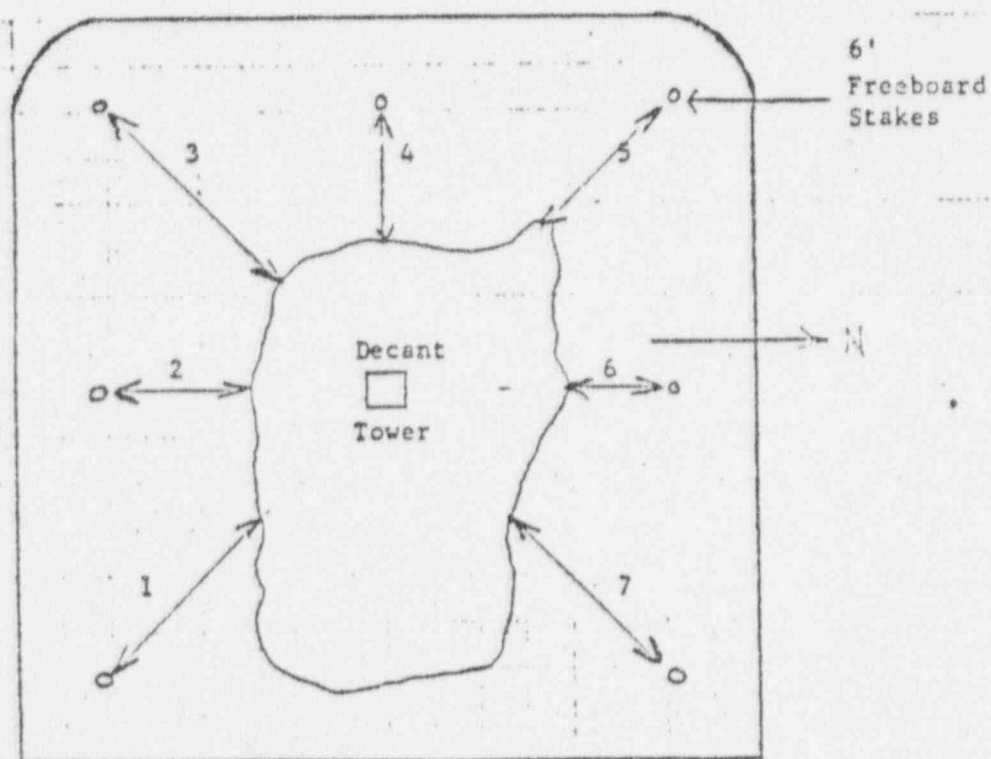
WEST POND BEACH AREAS

It was noted that licensees were required to reply within 30 days. It was also noted that the State is obtaining reports at weekly intervals from the licensee regarding the water levels in the west pond area including information on the extent of the beach area. An example of the weekly report is attached as Appendix C.
