NUCLEAR REGULATORY COMMISSION
ABNORMAL OCCURRENCE
MILL TAILINGS IMPOUNDMENT DAM FAILURE

EVALUATION OF URANIUM MILL TAILINGS RETENTION
SYSTEMS FOLLOWING THE EMBANKMENT
FAILURE AT CHURCH ROCK

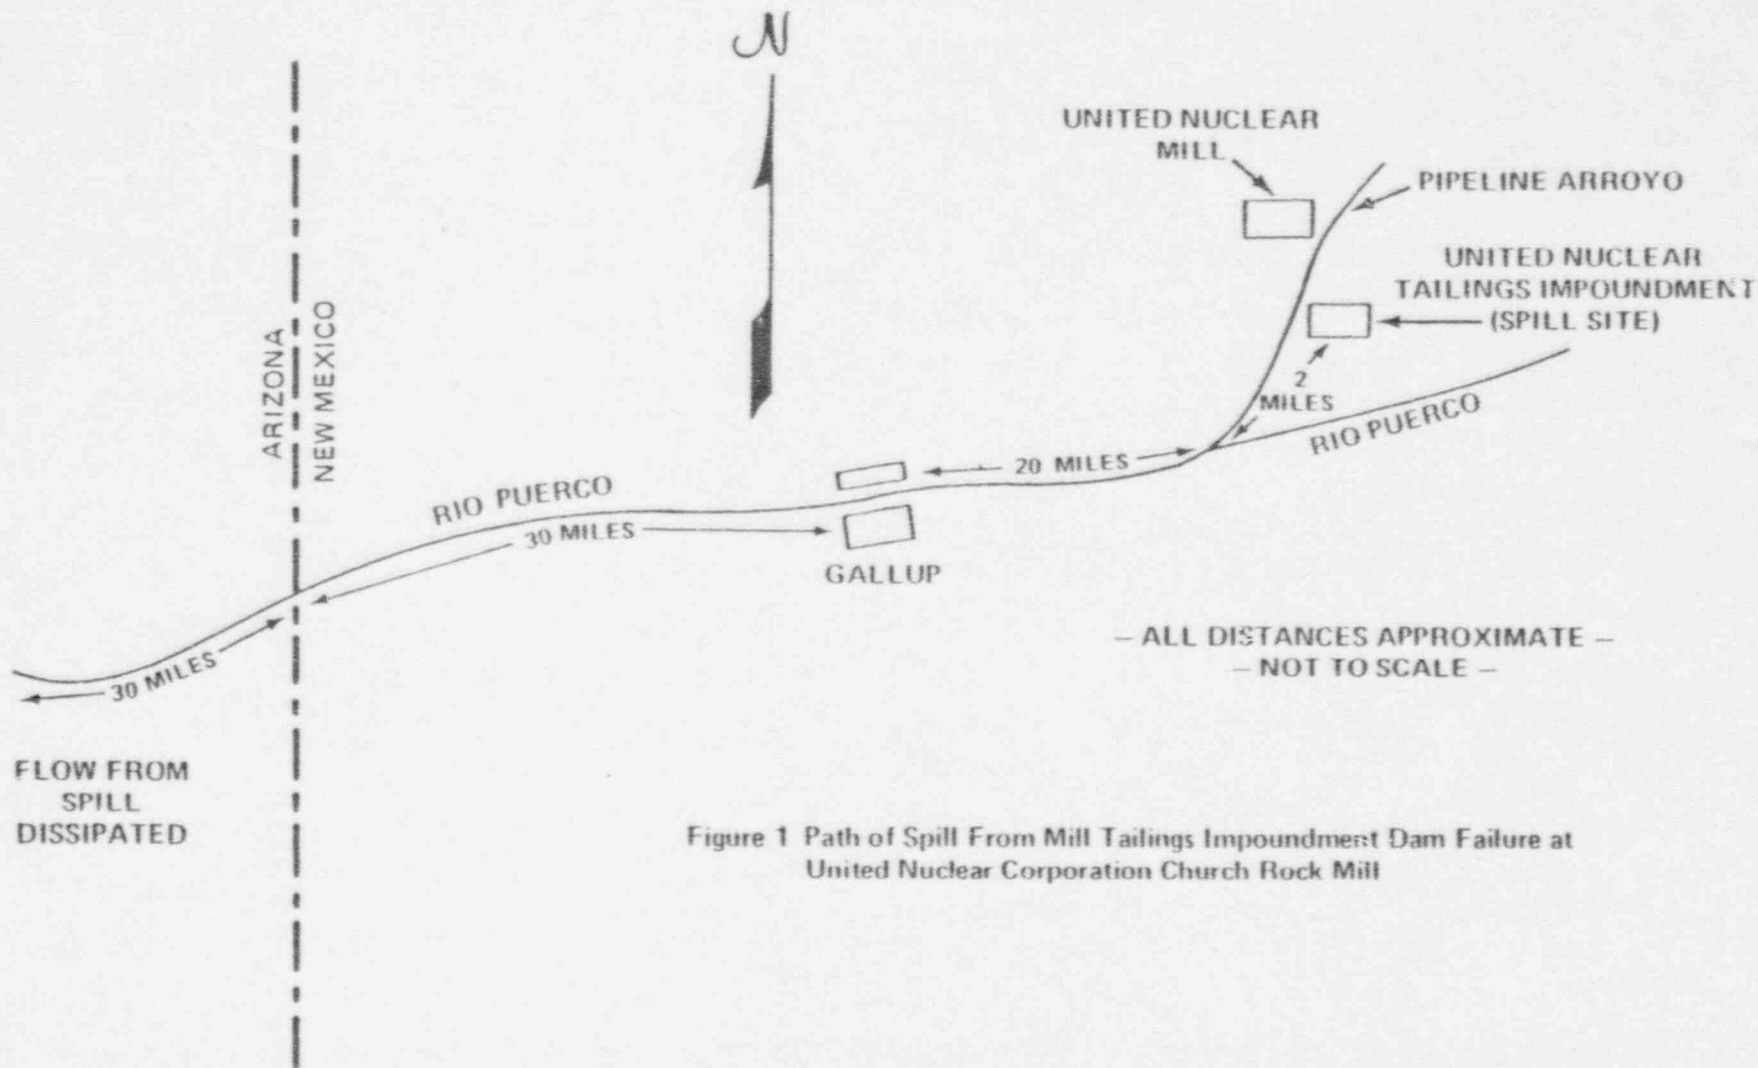
The break in the dam allowed approximately 100 million gallons of tailings solution and 1100 tons of tailings solids (sand) to flow out of the impoundment before it could be closed. Most of the solids were deposited in an area very near the impoundment in a backup containment area on United Nuclear Corporation property and in an adjacent stream, the "Pipeline Arroyo." The tailings solutions travelled in the Pipeline Arroyo to the Rio Puerco which flows through Gallup, New Mexico, a town about 20 miles southwest of the mill site, and into Arizona. The spilled solutions eventually dissipated at a point estimated to be about 30 miles into Arizona. (See Figure 1.)

Figure 1 Path of Spill From Mill Tailings Impoundment Dam Failure at United Nuclear Corporation Church Rock Mill
