UNITED NUCLEAR CORPORATION
CHURCH ROCK TAILINGS IMPOUNDMENT DAM

Evaluation of Probable Cause of
July 16, 1979 Failure

Evaluation of the Integrity of the
Remaining Starter Dam and
Present Divider Dike

JACOBS ENGINEERING GROUP INC.

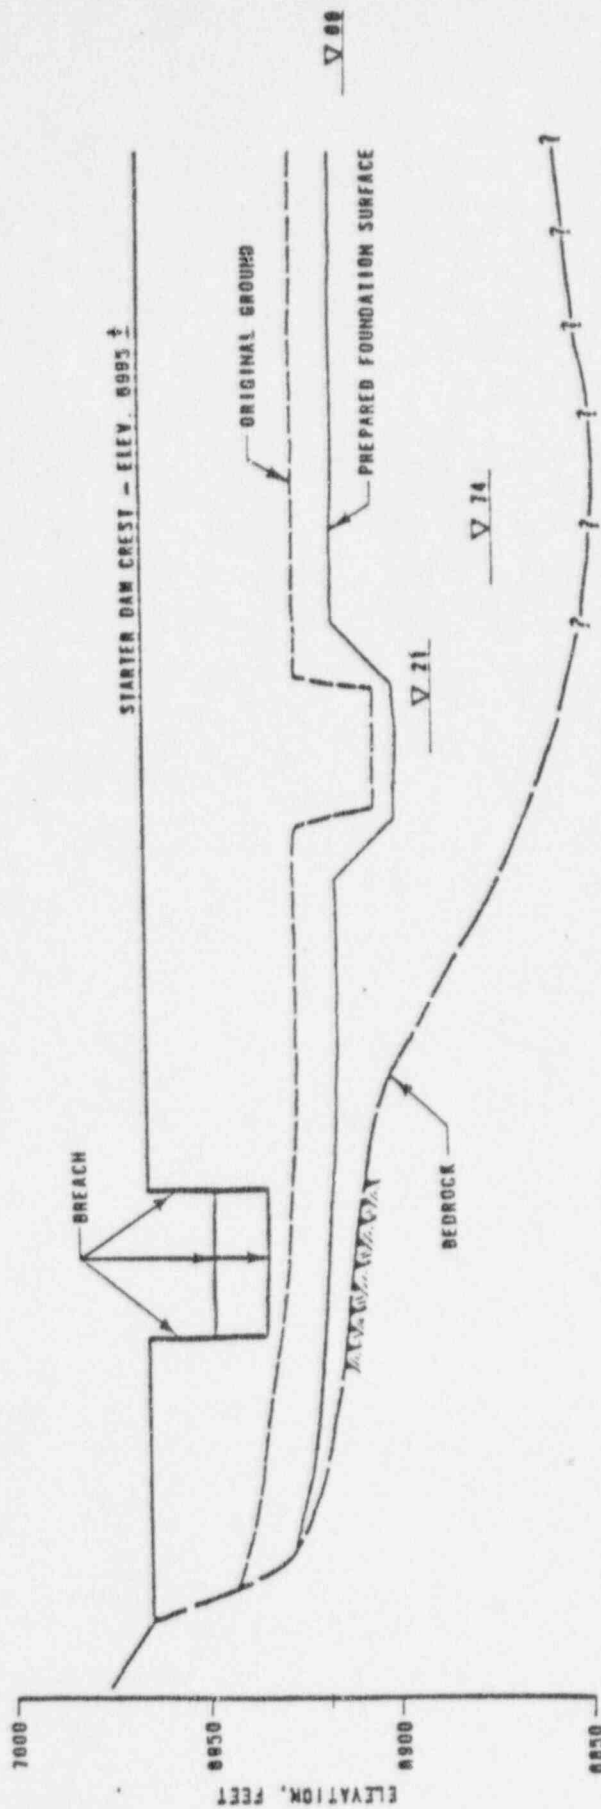
PROFILE ALONG STARTER DAM CENTERLINE
(LOOKING DOWNSTREAM)
SCALE: 1" = 50'

The non-uniform and steeply inclined bedrock profile and backfilled arroyo (See Figure 1) and the configuration of the bedrock contours (see Figure 2) jutting from the near vertical rock face above the general level of the alluvial valley floor influenced the non-uniform consolidation and stress distribution in the embankment.
