December 30, 1992  
MP-92-1369

Reference: Facility Operating License No. DPR-65  
Docket No. 50-336  
Licensee Event Report 90-015-02

FACILITY NAME (1) Millstone Nuclear Power Station Unit 2										DOCKET NUMBER (2) 0 5 0 0 0 3 3 6 1				PAGE (3) 1 OF 0 3	
TITLE (4) Inadvertent ESAS Actuations															
EVENT DATE (5)			LER NUMBER (6)				REPORT DATE (7)			OTHER FACILITIES INVOLVED (8)					
MONTH	DAY	YEAR	YEAR	SEQUENTIAL NUMBER	REVISION NUMBER	MONTH	DAY	YEAR	FACILITY NAMES						
0 9	1 9	9 0	9 0	0 1 5	0 2	1 2	3 0	9 2	0 5 0 0 0 0 0 0 0 0 0 0						
OPERATING MODE (9) 5		THIS REPORT IS BEING SUBMITTED PURSUANT TO THE REQUIREMENTS OF 10-CFR §: (Check one or more of the following) (11)													
POWER LEVEL (10) 0 0 0		20.402(b)				20.402(c)				<input checked="" type="checkbox"/> 50.73(a)(2)(iv)				73.71(b)

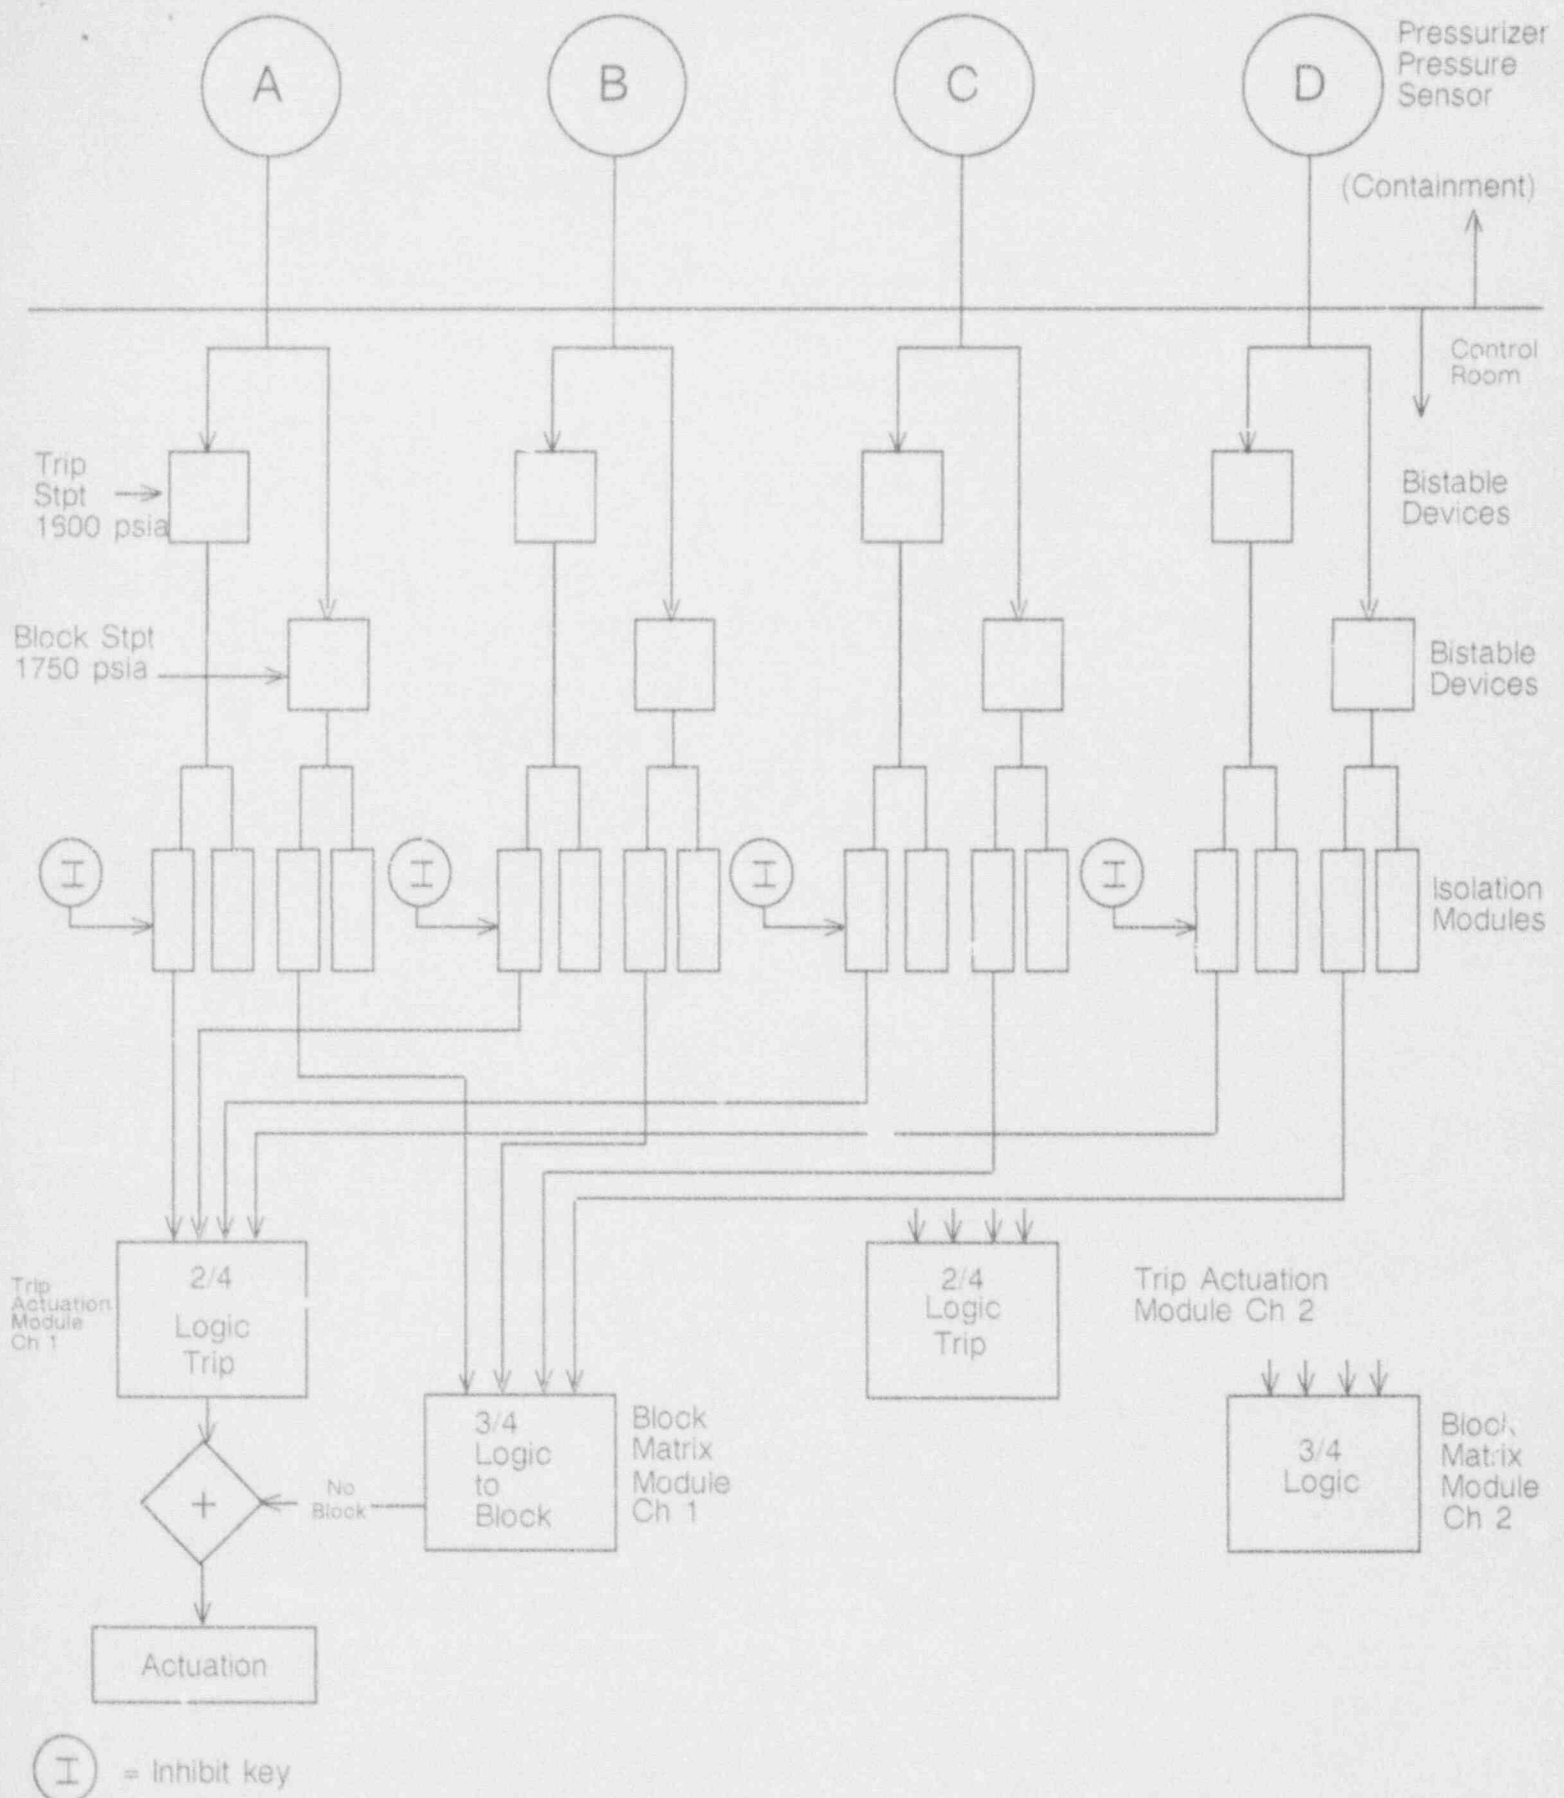
# Attachment 1 to LER 90-015-02

An ESAS actuation can be initiated when any 2 of 4 Pressurize Pressure signals reach a specified low pressure setpoint. This actuation can be blocked if any 3 of the 4 pressure signals reach a separate "Block" pressure setpoint, and a manual blocking pushbutton is pushed. This is a process routinely followed for placing the unit in a cold shutdown condition. Refer to Attachment 1 for a sample logic diagram that illustrates the relationships between bistables, isolation modules, trip actuation modules, and block matrix modules.

The block matrix module was in the block condition as a result of the plant being previously shut down. An I&C technician began calibrating Channel "A" Pressurizer Pressure instrument loop with the inhibit key in the "inhibit" position. When starting to perform the pressure transmitter calibration portion of the procedure, he discovered other workers in the area of the transmitter and felt it prudent to work on Channel "D" as authorized by the Work Order. He began exercising the transmitter on Channel "D" above the block reset value and then realized that the inhibit key was still in Channel "A." He called the control room and requested another I&C technician to remove the key from Channel "A" and put it in Channel "D." When the inhibit key was switched from the "inhibit" to the "operate" position on Channel "A," a voltage transient was created from the deenergization of a relay in the trip isolation module. Because of the close proximity between the block isolation module and the trip isolation module, the block isolation module circuitry received transmitted Electromagnetic Interference (EMI) and momentarily produced a change in state. This created a 2 out of 4 logic input to the block matrix module resulting in removal of its block voltage from the actuation modules. This initiated an actuation because the 2 out of 4 logic was satisfied and the blocking signal was removed.

The root cause for the event which occurred on September 20, 1990, was EMI resulting from the collapsing magnetic field of the relay in the trip isolation module. This relay deenergizes when the inhibit keyswitch is placed in the "inhibit" position. Failure to follow the proper procedure step sequence also contributed to the conditions that caused the actuation.

For the event occurring on September 20, 1990, the technician has also been counseled to follow procedural sequences and the ESAS calibration procedure has been revised to limit the calibration of one channel of one parameter at any given time.

The ESAS Bistables, Isolation Modules, Block Logic Modules, Undervoltage Modules and Sequencers have been replaced. The upgraded isolation modules have been verified not to be susceptible to the type of interference that previously occurred.
