MEMORANDUM FOR: John J. Linehan
Uranium Recovery Licensing Branch

FROM: Terry Vandell
Uranium Recovery Licensing Branch

SUBJECT: REVIEW AND CONCLUSIONS REGARDING "SPECIAL REPORT ON
MONITOR WELL ANALYTICAL RESULTS," MARCH 25, 1981, FROM
OGLE PETROLEUM

BISON BASIN MINE
WELLFIELD LAYOUT
(R&D AREA)

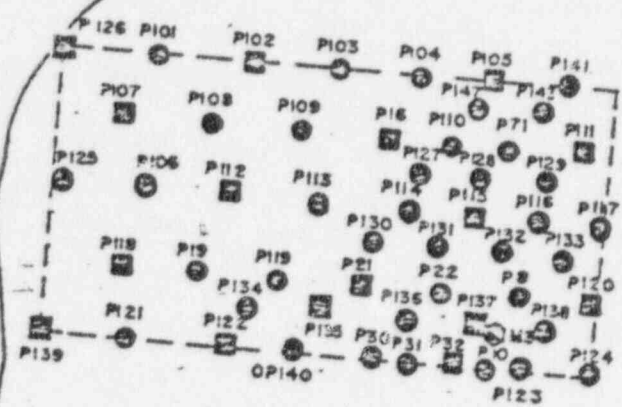
FIGURE 1

- (1) Two "minor" lateral excursions occurred at Ogle Petroleum's R&D well field in wells M-2 and M-4 (see attached Figure 1) where (a) well M-2 exceeded UCL's for Cl and $\text{CO}_3 + \text{H}_2\text{CO}_3$ by a maximum of = 15 ppm and = 118 ppm, respectively, and (b) well M-4 exceeded UCL's for Cl, $\text{CO}_3 + \text{H}_2\text{CO}_3$, and specific conductance by a maximum of = 63 ppm, = 118 ppm, and = 71 mhos/cm, respectively.
- (2) During the past month or two, well M-2 has been experiencing above-normal values for chloride and carbonate plus bicarbonate which were believed by Ogle to be caused by the normal outside sweep of the lixiviant during mining operations. An expanded outside sweep by the lixiviant was expected due to the increased injection capacity resulting from new injection wells being placed into operation in the southeast corner of the R&D well field.

The sudden increase over a two-week period in carbonate plus bicarbonate, chloride, and specific conductivity at well M-4 is believed by Ogle to have resulted from a typical horizontal excursion which was most likely caused by localized over-injection on the south side of the field well.
- (3) Control measures were implemented
 - (a) plant bleed increased,
 - (b) injection stopped and reduced and recovery increased, and
 - (c) fresh water injection into an ore zone control well 50 feet from M-2, to reverse the gradient towards the well field.
- (4) All parameters are below their UCL's for well M-4; and although Cl is still high, only $\text{CO}_3 + \text{H}_2\text{CO}_3$ exceeds its UCL at well M-2.

*new well
drilled
injected
from H₂C
well (1)
to reverse
excursion*

I believe that OPI has implemented very effective clean-up and control techniques and that they are and should continue on with their monitoring and reporting to us, as they have done, if another excursion occurs.

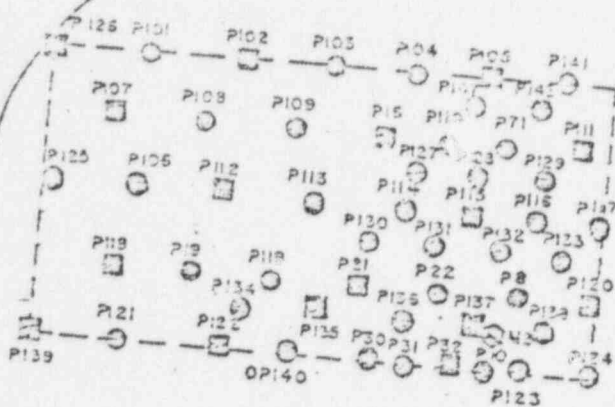
FIGURE 1

- (1.) Two "minor" lateral excursions occurred at Ogle Petroleum's R & D wellfield in wells M2 and M4 (see attached Figure 1) where (a) well M2 exceeded UCL's for Cl and $\text{CO}_3 + \text{H}_2\text{CO}_3$ by a maximum of $\approx 15 \text{ ppm}$ and $\approx 115 \text{ ppm}$ respectively, and (b) well M4 exceeded UCL's for Cl, $\text{CO}_3 + \text{H}_2\text{CO}_3$, and Specific Conductance by a maximum of $\approx 163 \text{ ppm}$, $\approx 118 \text{ ppm}$, and $\approx 71 \text{ mhos/cm}$, respectively.

During the past month or two, well M 2 has been experiencing above-normal values for chloride and carbonate plus bicarbonate which were believed to be caused by the normal outside sweep of the lixiviant during mining operations. An expanded outside sweep of the lixiviant was expected due to the increased injection capacity resulting from new injection wells being placed into operation in the southeast corner of the R & D wellfield.

The sudden increase over a two-week period in carbonate plus bicarbonate, chloride, and specific conductivity at well M 4 is believed to have resulted from a typical horizontal excursion which was most likely caused by localized over-injection on the south side of the wellfield.

*new well
drilled
injected
fresh H₂O
to reverse
excursion*

- (3) After control measures had been implemented
 - (a) plant UCL increased.
 - (b) injection stopped and allowed and recovery increased and
 - (c) fresh water injection into an onshore control well 50 ft from M2, to reverse the gradient towards the well field,
- (4) All parameters are below their UCLs for well M4, and although Cl is still high, only $\text{CO}_2 + \text{H}_2\text{CO}_3$ exceeds its UCL at well M2.

- (1) I believe that OPI has implemented very effective clean-up and control techniques and that they are and should continue on with their monitoring and reporting to us, as they have done, if another excursion occurs.
