1992 THERMAL SHIELD
INSPECTION AND REPAIR

OMAHA PUBLIC POWER DISTRICT
FORT CALHOUN STATION

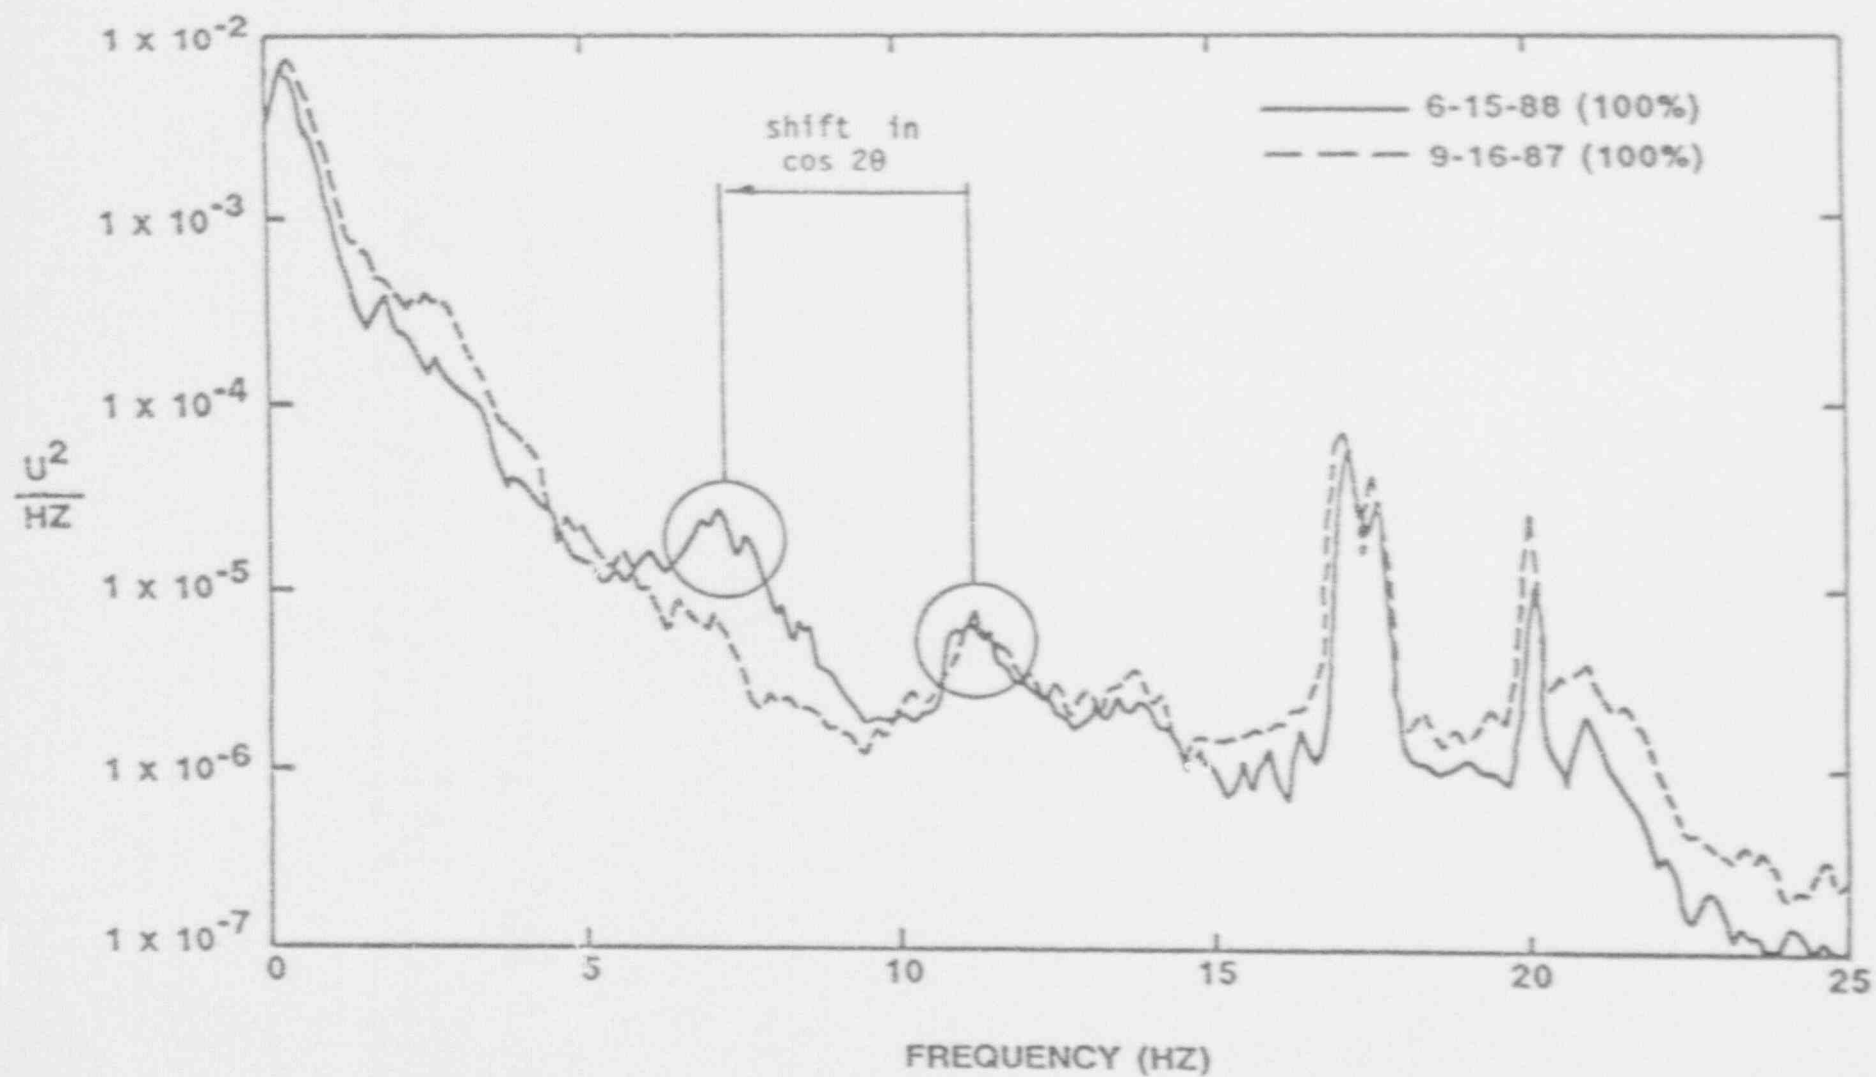
FIGURE 4

Experience gained from the St. Lucie Unit 1 thermal shield program demonstrated that degradation in the thermal shield support system is detectable as frequency peak shifts in the spectra of the excore detector noise signals. Analytical models are used to establish the coupled and uncoupled frequency response of the thermal shield support system. In the case where the thermal shield uncouples from the core support barrel, there is a corresponding decrease in the frequency of the COS 20 and COS 30 modes of vibration (Table 1). The COS 20 mode, which is in-phase for cross-core detector pair data, and the COS 30 mode, which is out-of-phase for cross-core detector pair data, provide two identifiers of the condition of the thermal shield support system which can be tracked via a neutron noise monitoring program. The COS 20 mode, with its much larger frequency decrease for loose positioning pins, is considered to be the main identifier of the condition of the TS support system. The actual corresponding frequency peaks in the IVM data can vary from the analytical predictions due to various neutronic factors associated with each fuel cycle. Figures 4 through 6 show the trends observed in the IVM data for the degraded condition identified in 1988.

The baseline response was taken from IVM data obtained on September 16, 1987. At this point, frequency peaks were found at 11 Hertz for the COS 20 in-phase mode. Also, frequency peaks were found as expected at 16 Hertz for the COS 30 out-of-phase mode. The figures also show that after June 1988, a clear peak was also seen in the 8 to 9 Hertz range for the COS 20 mode (Figures 4 and 5). Also, the 16 Hertz peak decreased for the COS 30 mode with a corresponding increase in the 14 Hertz range (Figure 6). Subsequent IVM data up to December 1991 showed similar trends. The IVM data indicated loosening of the thermal shield positioning pins. LPM data from 1988 through December 1991 did not show signs of impacting of the positioning pins against the CSB. Therefore, although the IVM data showed signs of loosening, the LPM data indicated that a complete loss of preload had not occurred.

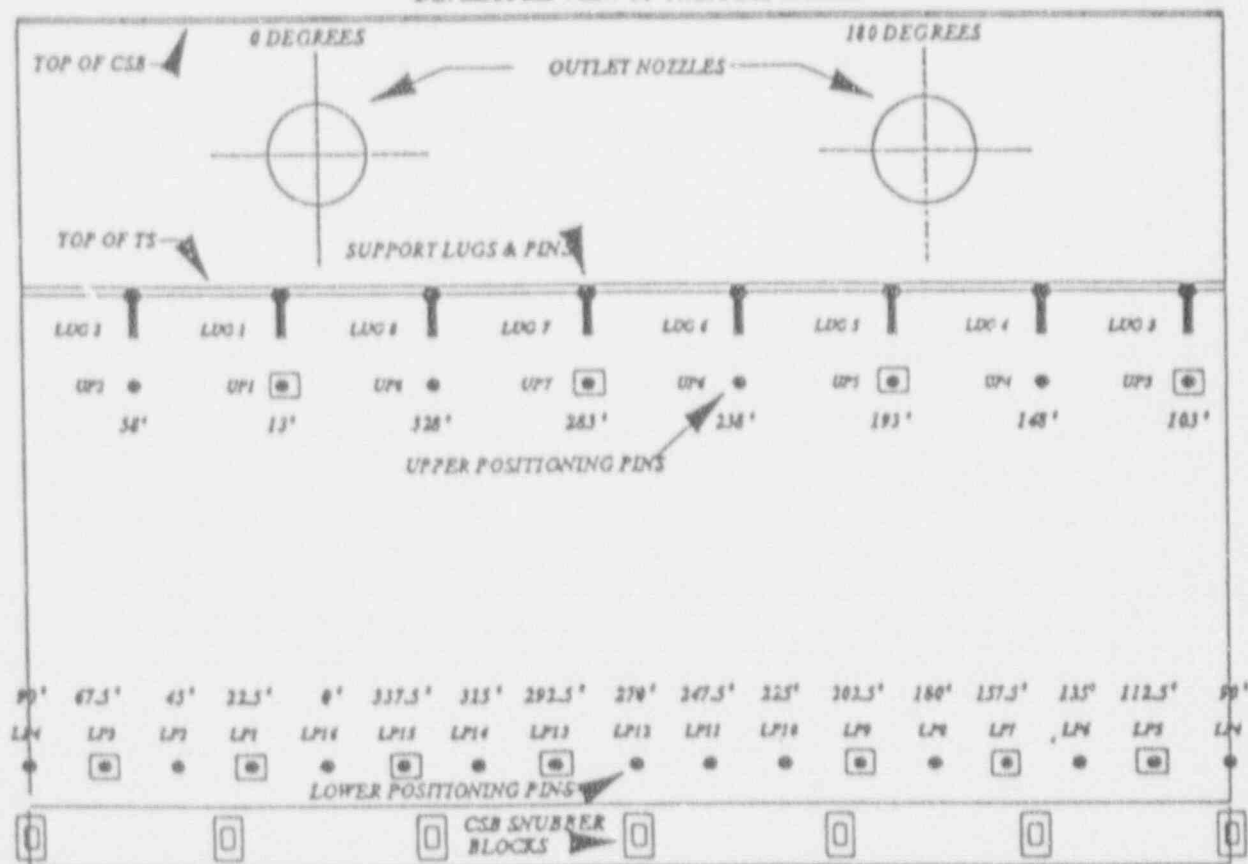
FIGURE 7

As part of the repair, seven (7) lower positioning pins were removed and replaced (Figure 7). After the removal, a visual inspection was performed on the pin contact face and the stellite pad on the CSB. In all seven of the lower positioning pins wear was discovered as evidenced by shiny surfaces on the pin face and CSB stellite pads. A direct measurement of the amount of wear was not possible. With close video camera examinations of the CSB stellite surface, the amount of wear was noticeable and judged to be on the order of several mils.

As part of the repair, four (4) upper positioning pins were removed and replaced (Figure 7). After removal, a visual inspection was performed on the pin contact face and the bearing surface of the CSB. There is no stellite on the CSB at the top positioning pin location. In all four cases, wear was not noticeable. The condition of the CSB was such that a lightly burnished surface was noticeable. No noticeable wear was noted on the removed top positioning pins.

During the removal of the lower positioning pins, six positioning pins were found not to be in contact with the CSB and one was found to be slightly loaded (Table 2). During the removal of the top positioning pins, it was found that the odd pins had marginal preload (approximately 5,000 pounds). The marginal loads found in the odd upper positioning pins indicates a condition better than was expected. Sufficient preload had decreased from initial installation values (approximately 10,000 pounds) to warrant reloading. The positive preload reinstatement at the odd positioning pins ensures long term integrity for the support system. The reinstating of high preload on the odd positioning pins also had the effect of closing potential gaps and increasing the existing preload at the even positioning pin locations.

In order to remove locknuts, a larger than anticipated EDM cut depth was required because of the larger than expected locknut welds. In some cases, locknuts/positioning pins had to be removed together. This made usage of the old positioning pins impossible and all 11 positioning pins were replaced (Table 3).

The repair consisted of replacing and advancing bottom positioning pins LP1, LP3, LP5, LP7, LP9, LP13 and LP15 to 9.45 mils of preload, and of replacing and advancing top positioning pins UP1, UP3, UP5, and UP7 to 18.3 mils of preload. After accounting for positioning pin compression, this results in nine mils of pin advancement in the bottom locations and 18 mils at the top. The nine mils advancement of the lower positioning pins correlates to approximately 25,000 to 28,000 pounds of preload in the lower pins (Table 4). The wear found at the lower positioning pin locations implies that the initial preload should be as high as possible in order to achieve added margin against wear. It was decided to install preloads higher than the desired minimum to include margin for wear and measurement uncertainties.

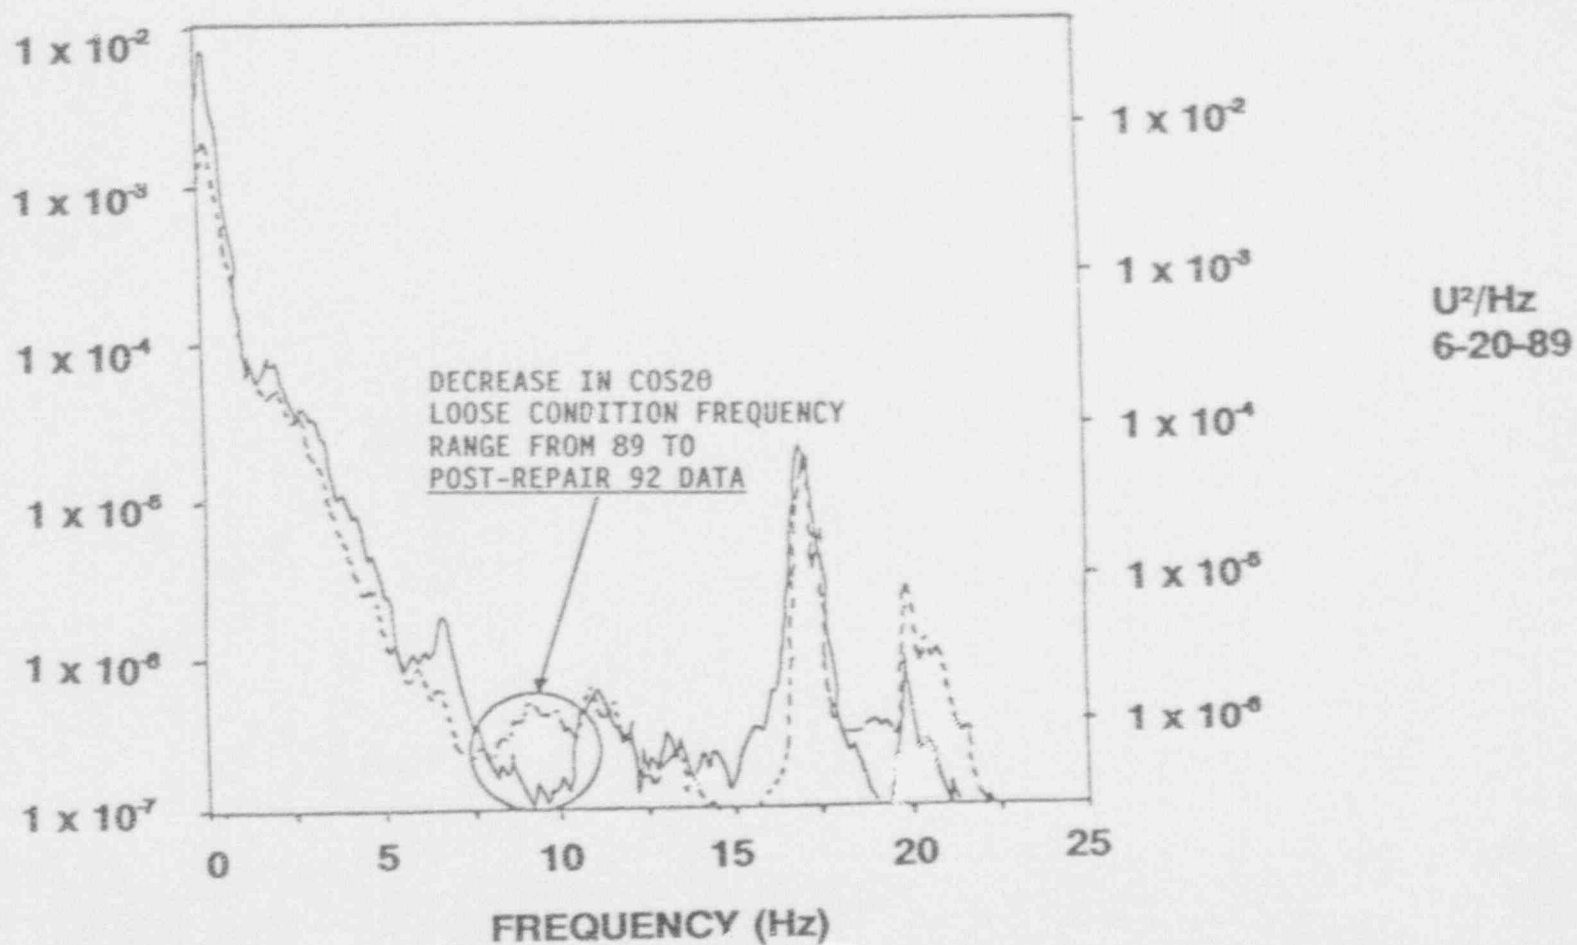
FIGURE 8

Post repair IVM results support the objectives of the field repair. The thermal shield repair is reflected in positive spectral changes in the COS 20 and COS 30 shell modes of vibration (Figures 8 - 11). It is concluded that these positive spectral changes support the fact that significant thermal shield to core support barrel tightening was achieved.
