DOCKET NO. 50-301
REPORT OF STEAM GENERATOR TUBE INSPECTION
POINT BEACH NUCLEAR PLANT, UNIT NO. 2

EXAMINATION OF POINT BEACH UNIT #2

STEAM GENERATOR TUBE SAMPLE

POINT BEACH UNIT 2 (WIS)
ANALYSIS OF APRIL, 1981
EDDY CURRENT INSPECTION RESULTS

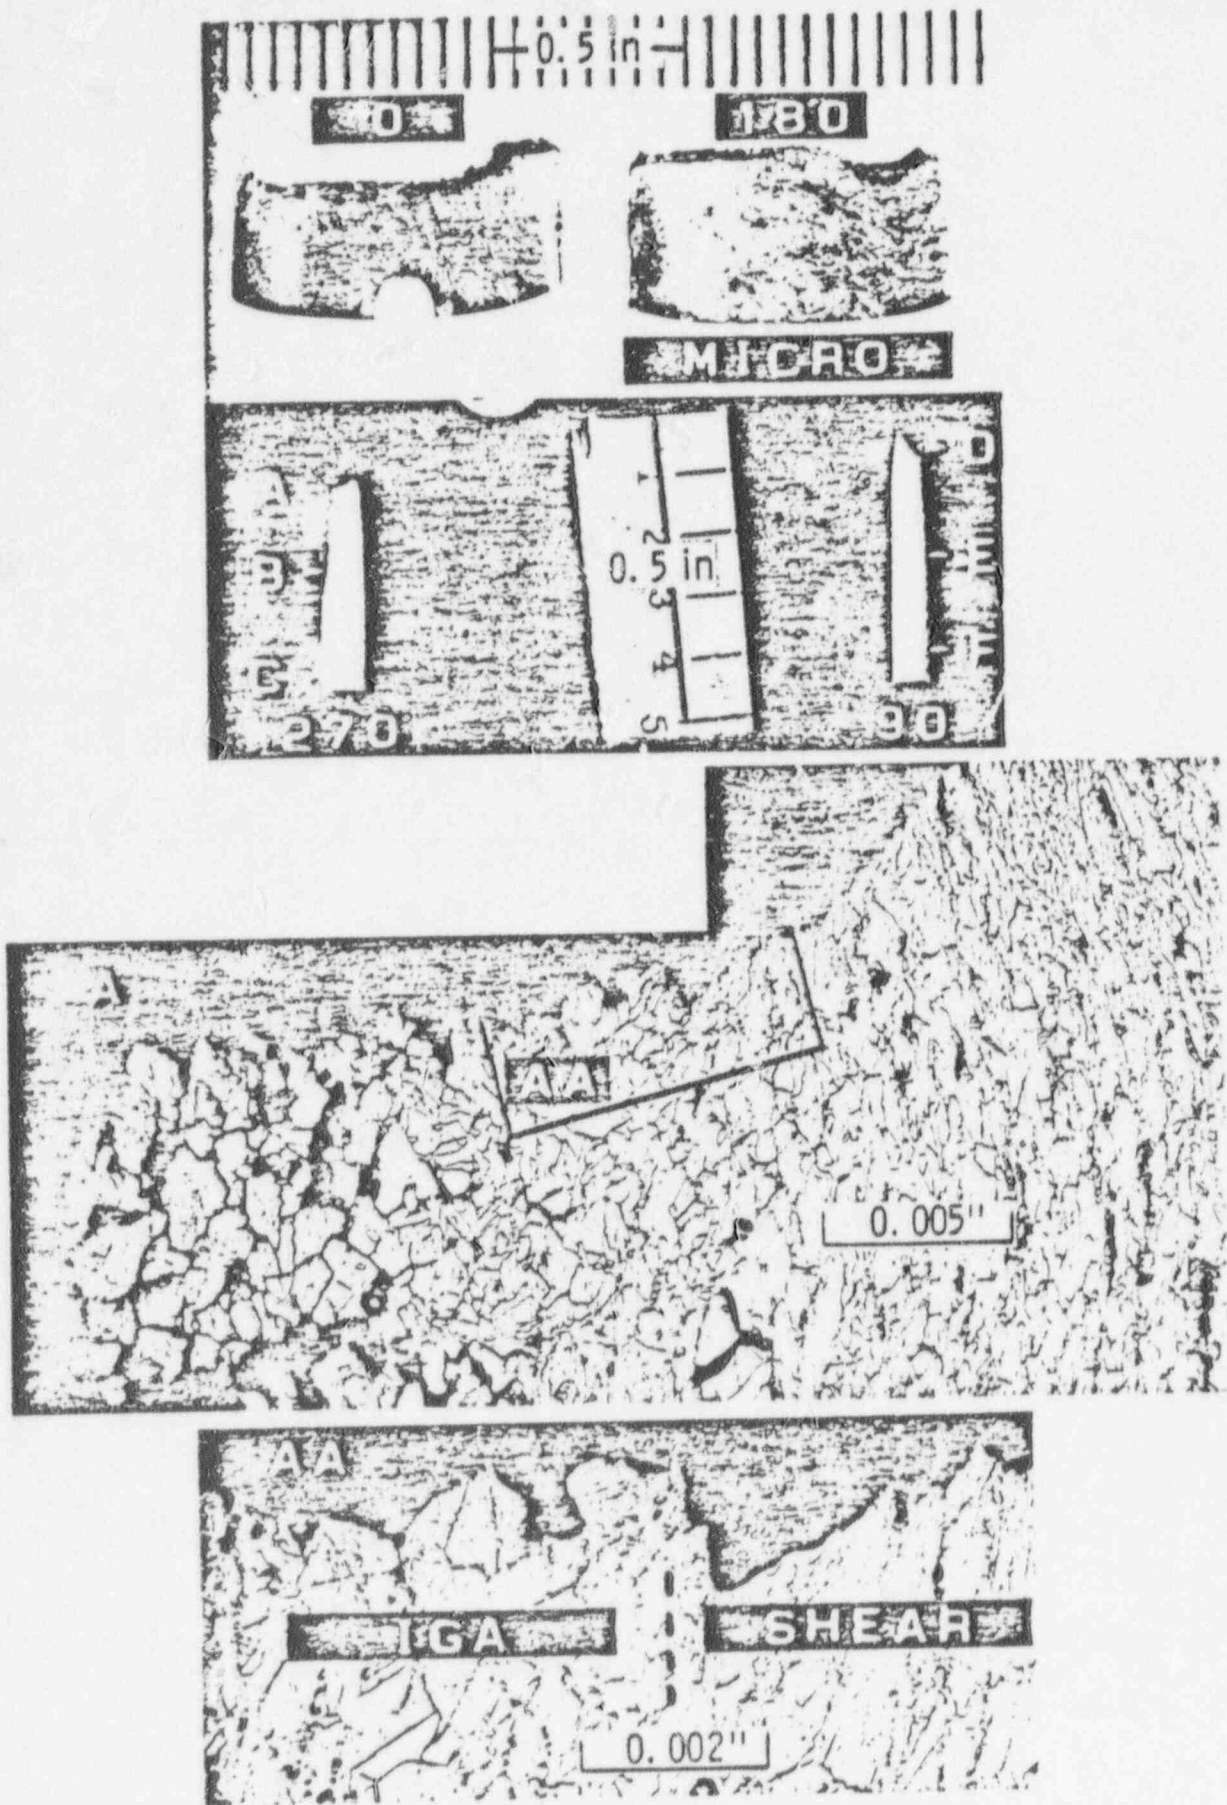
A (15-73), Continuation of Axial Metallography, on 270° Side, Section 1, Figure 3

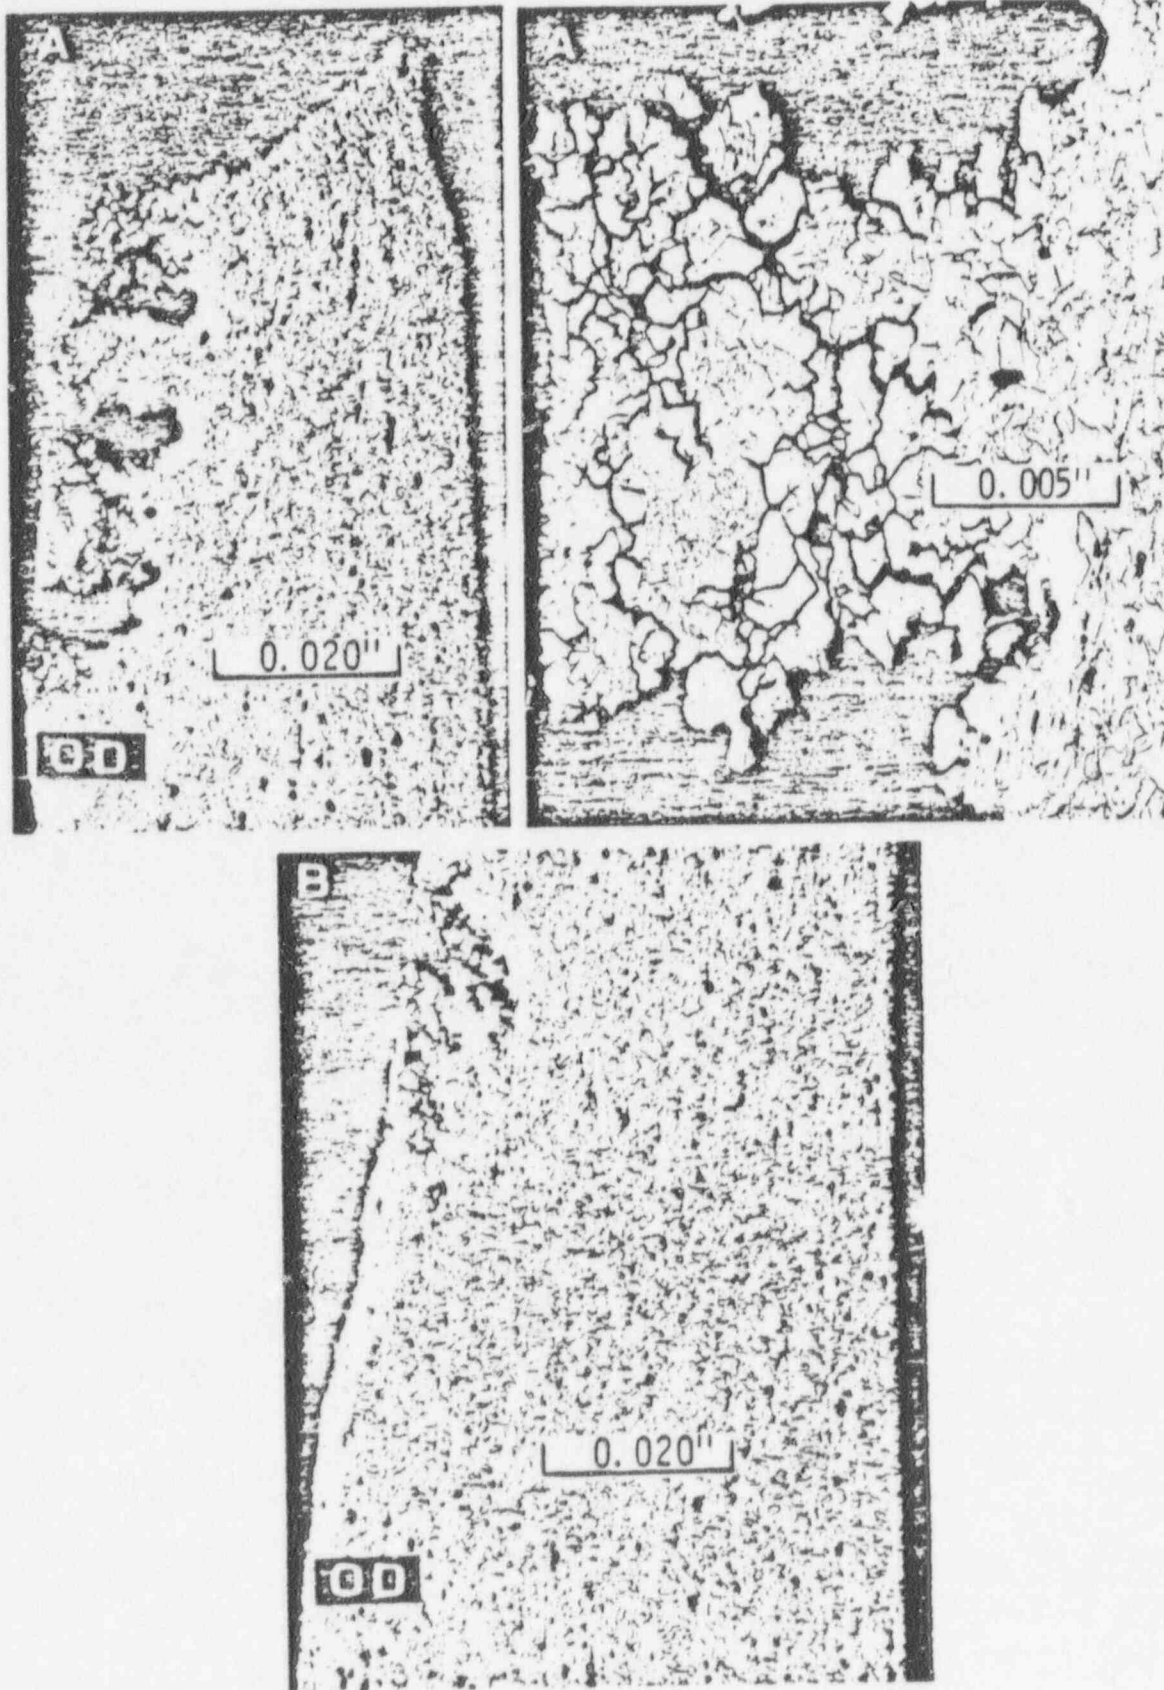
Figure 4

observations, particularly at 210° , to be estimates, since the original OD edges may have been distorted due to the elongation. Essentially, no IGA was observed on the fracture edge at 90° (Figure 5). The axial extent of IGA below the fracture, as shown by Figures 4, 5, 7, and 8, was about 0.10-0.15 in. (for any IGA of ± 0.001 in.).

A (15-73), Continuation of Axial Metallography, Section 1, Figure 3

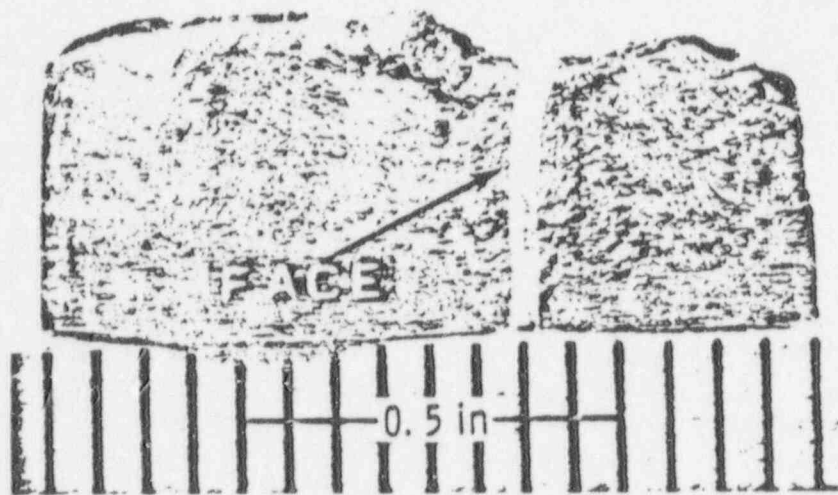
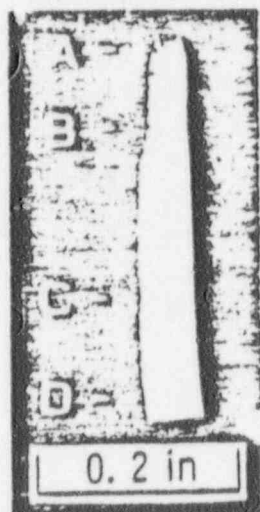
Figure 6

A (15-73), Section 1, Axial Cross Section
Through Fracture, approx. 210° Orientation.
Depth of IGAs Measures 0.010-0.012 in.
(Measurement is complicated by necking
down of tube at fracture)

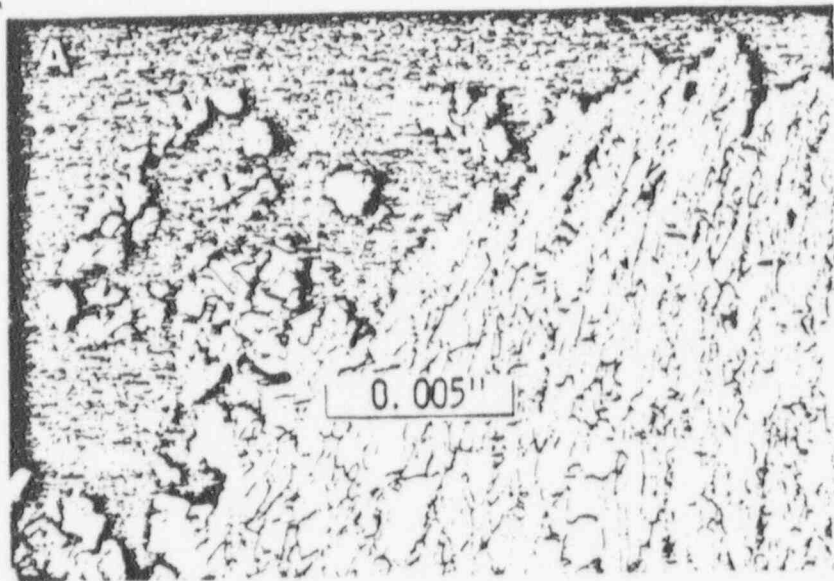
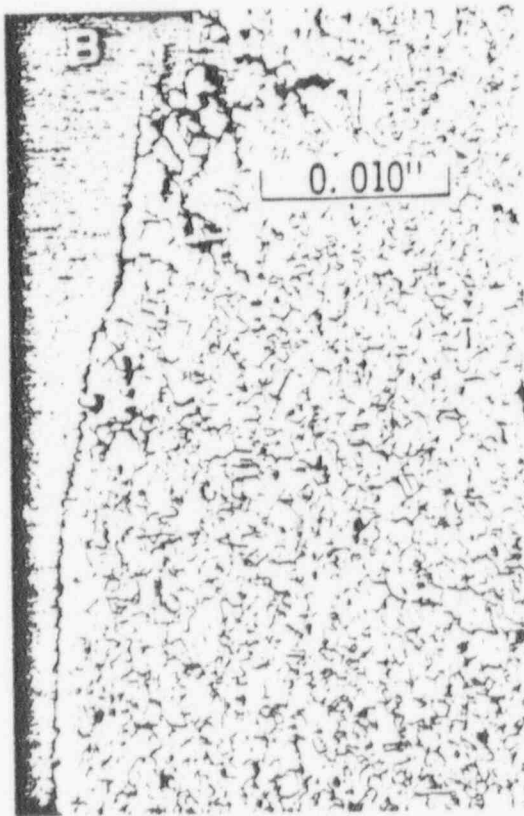
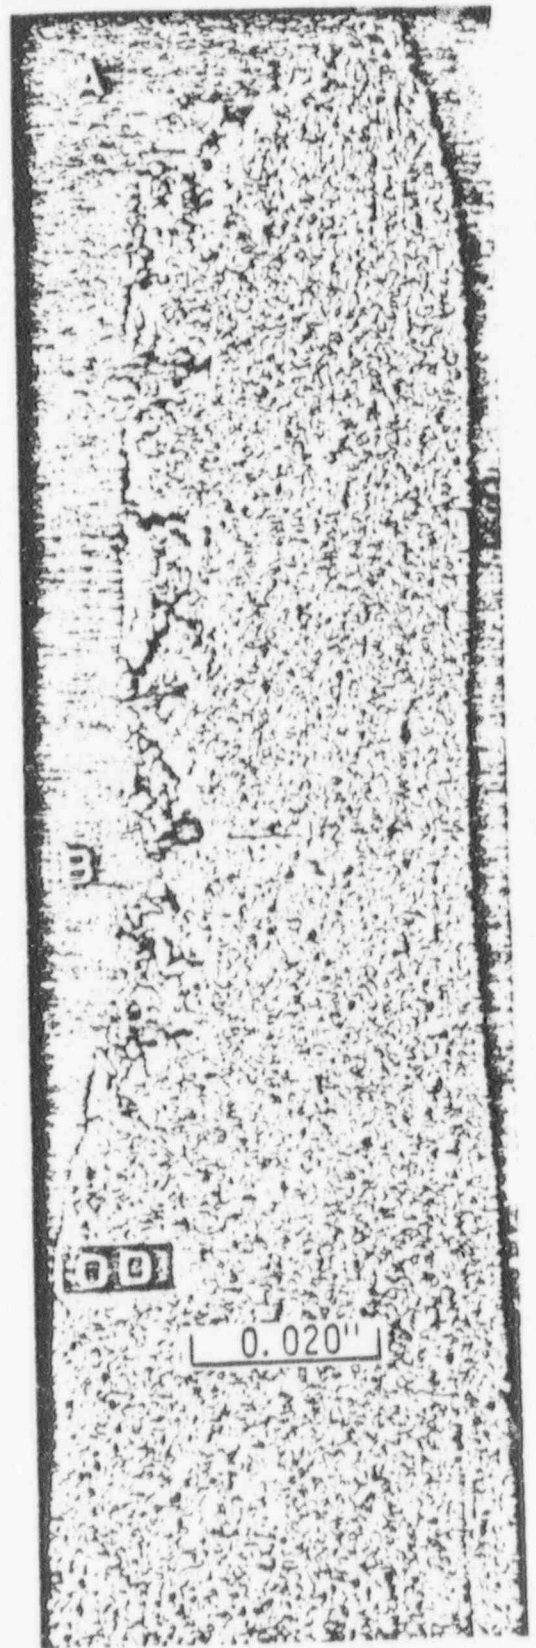
A (15-73), Continuation of Axial
Metallography of Figure 7

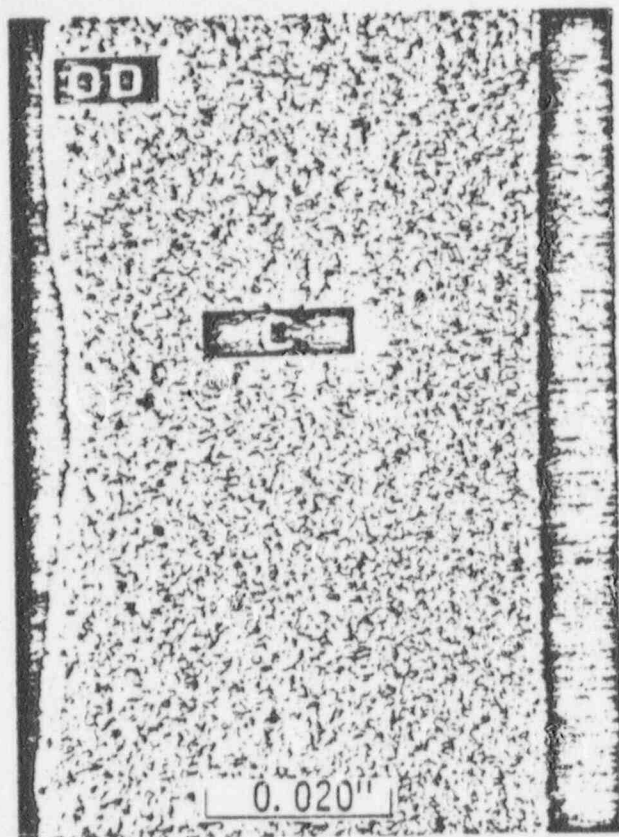
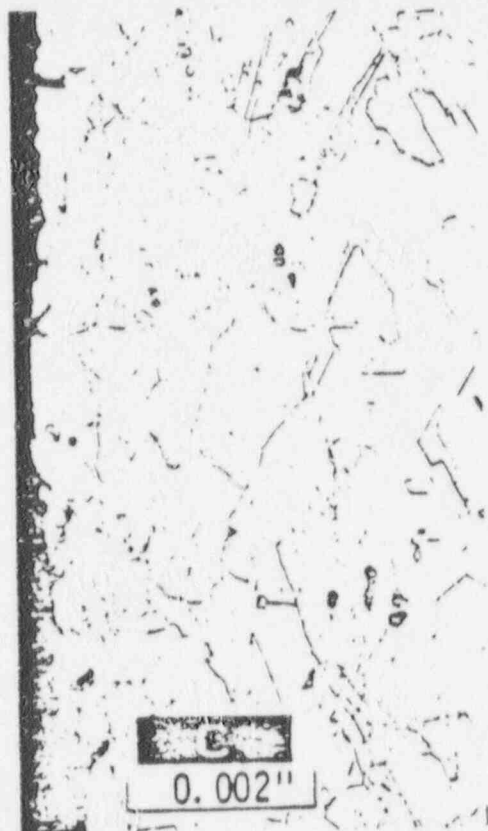
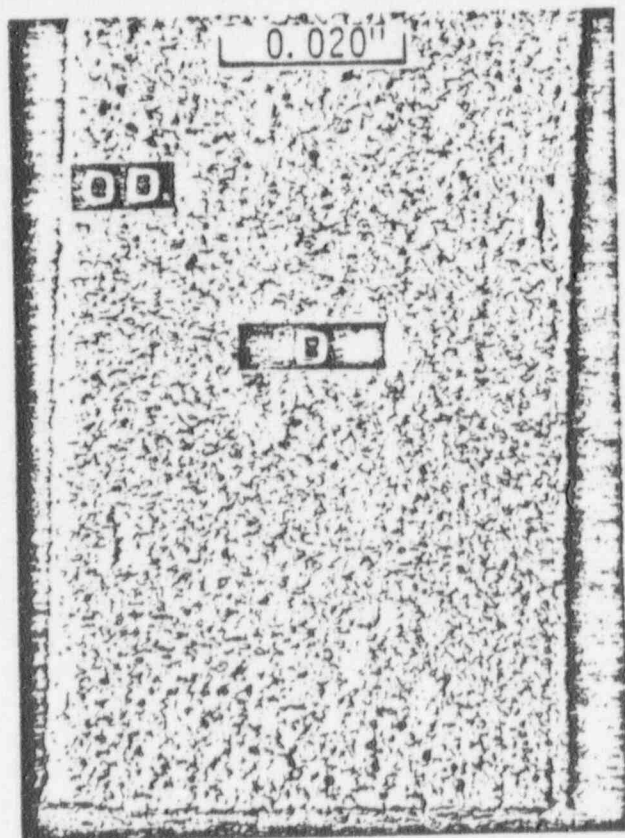
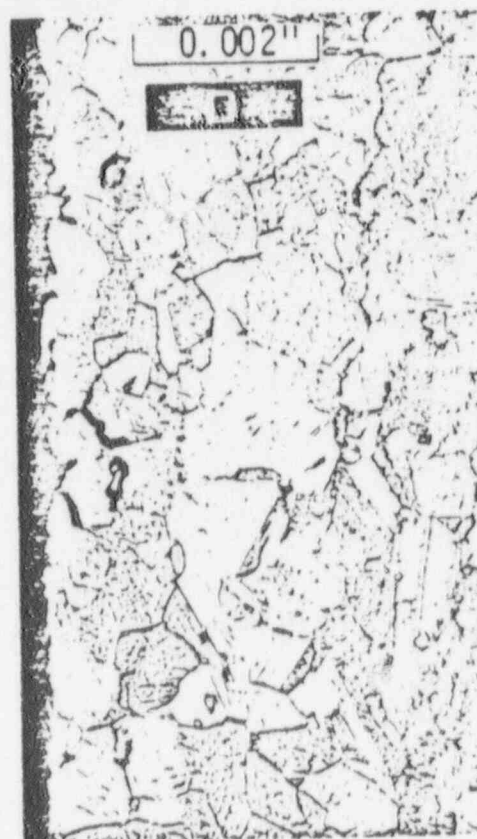
Figure 8

A (15-73), Lower End of Section 2,
at Fracture, 0°, 90°, etc.

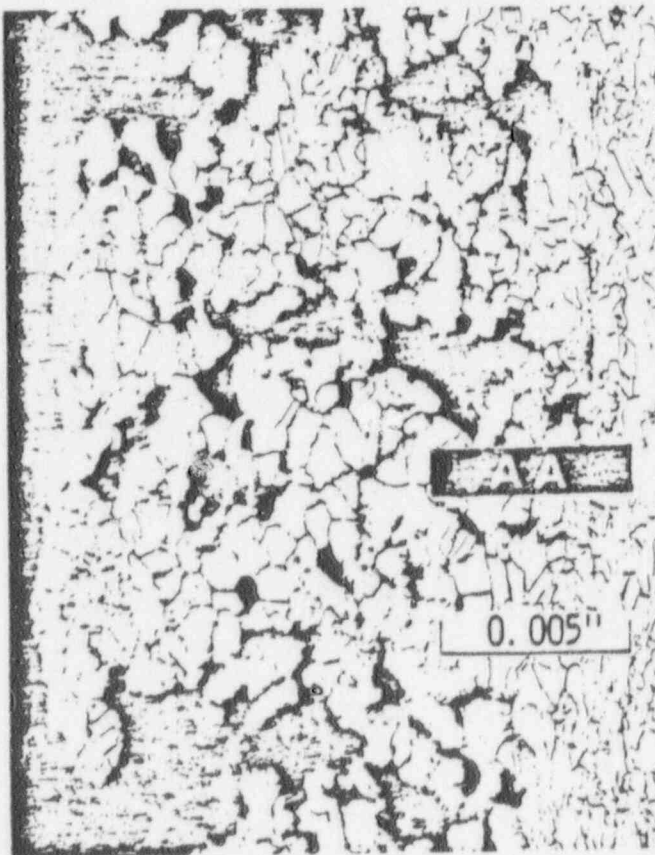
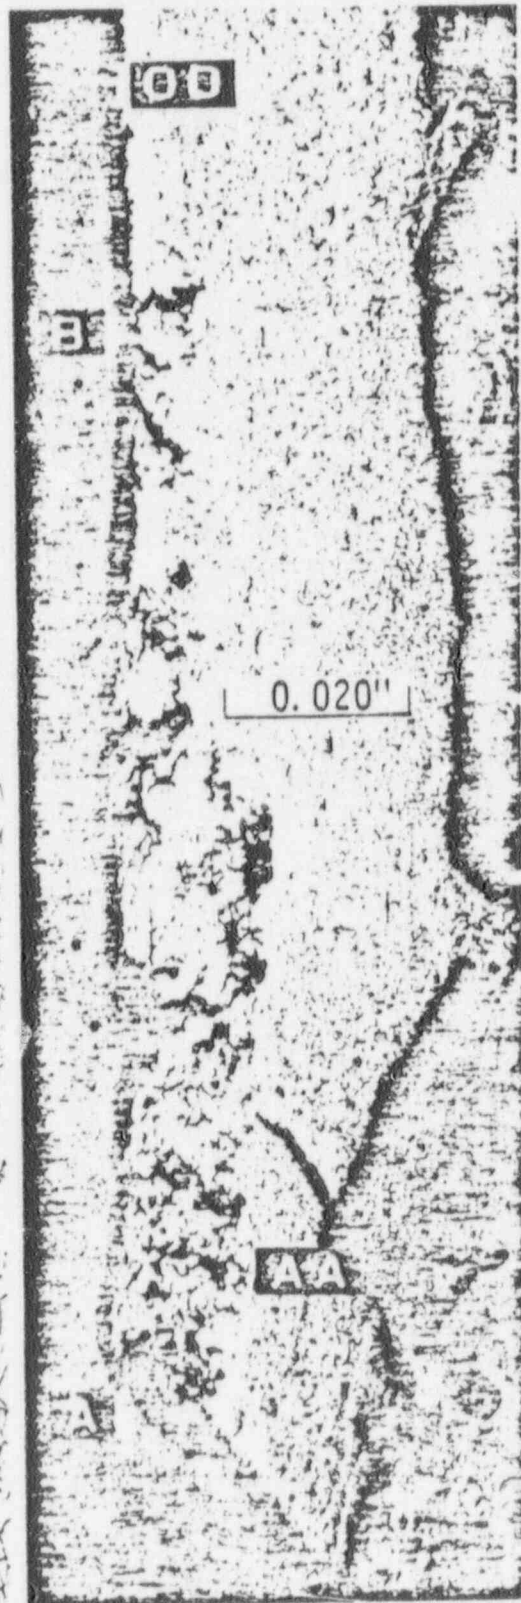
Figure 11

A (15-73), Continuation of Axial
Metallography of Figures 10 & 11

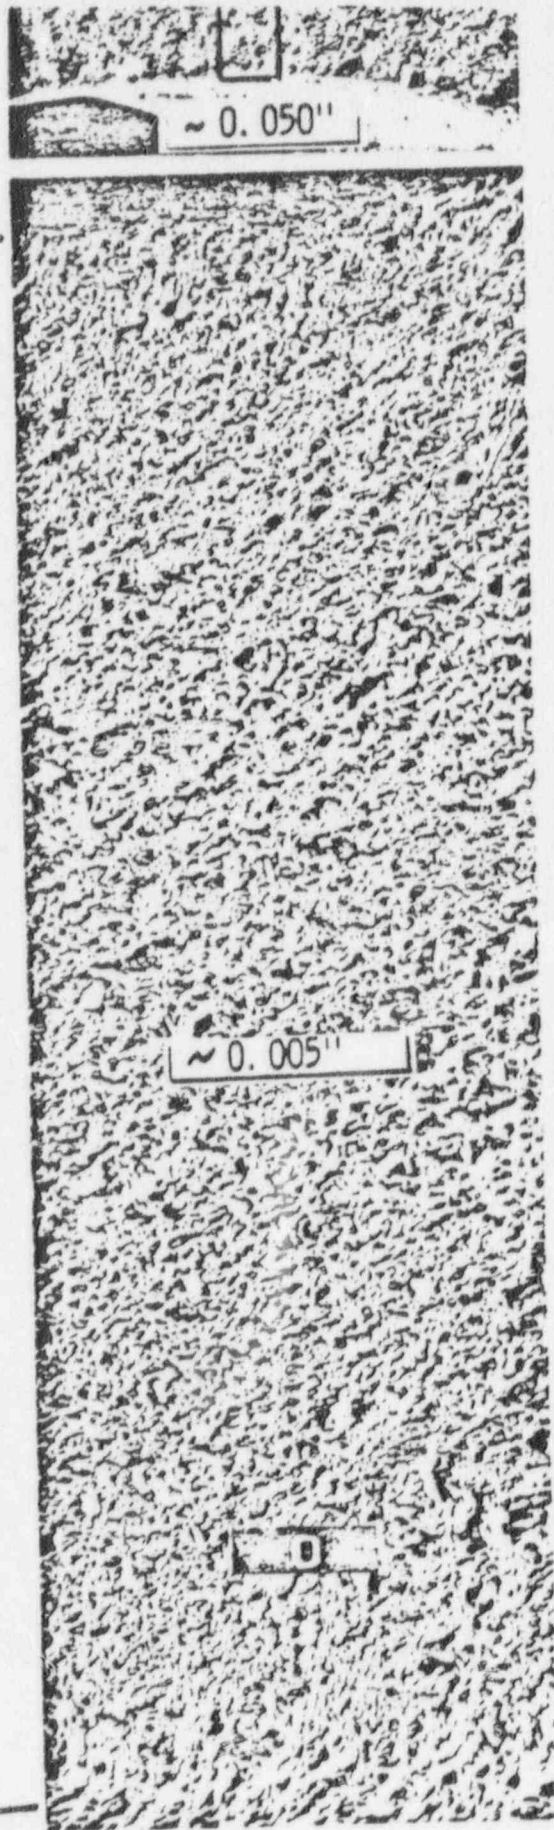
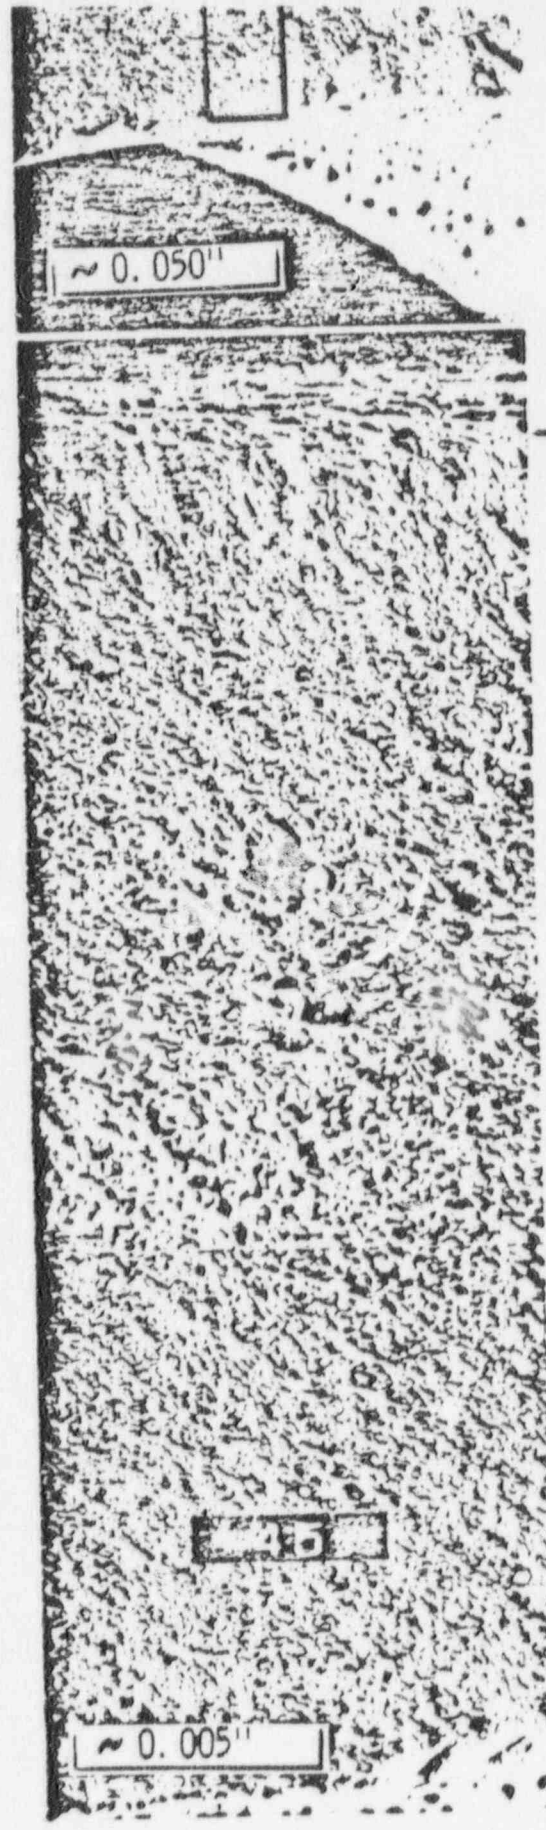
Figure 13

A (15-73), SEM Fractographs at 90° and 135° . Shear predominates at 90° ; approx. 1/3 of fracture at 135° is apparent IGA. (OD edges are at top)

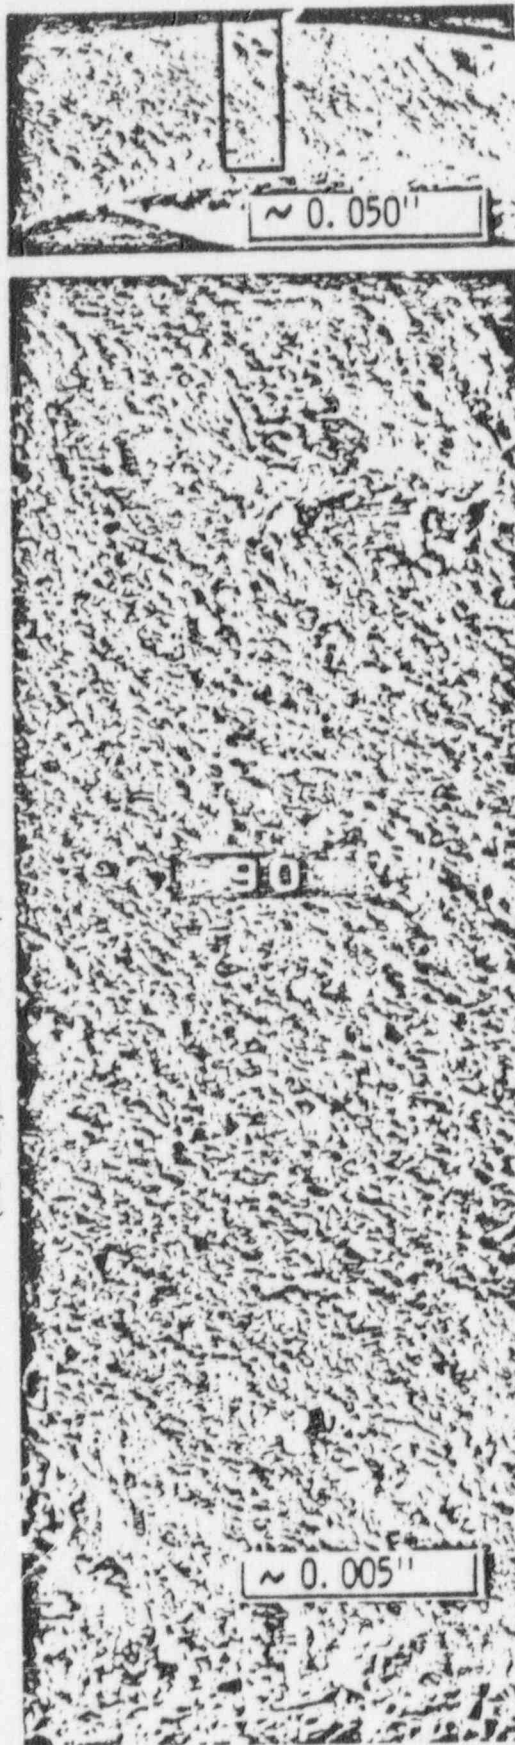
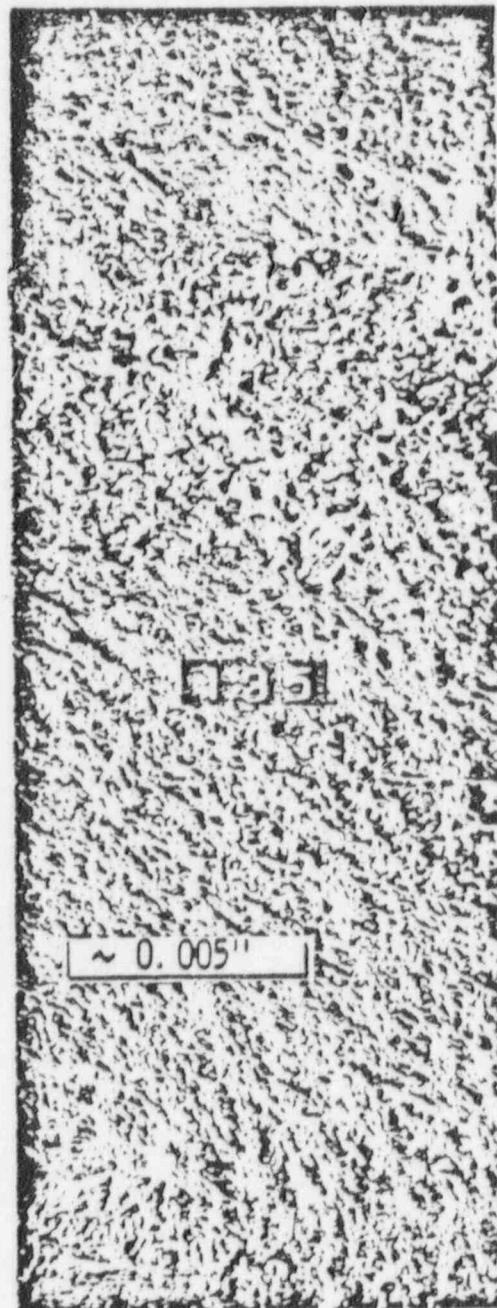
Figure 14

A (15-73), SEM Fractographs at 180° and 225° . At 180° , the IGA zone is approx. $3/4$ of the fracture, and at 225° , IGA is about $2/3$ of the fracture

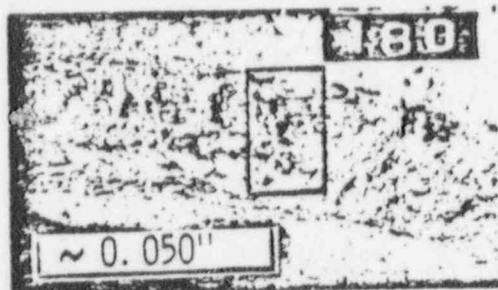
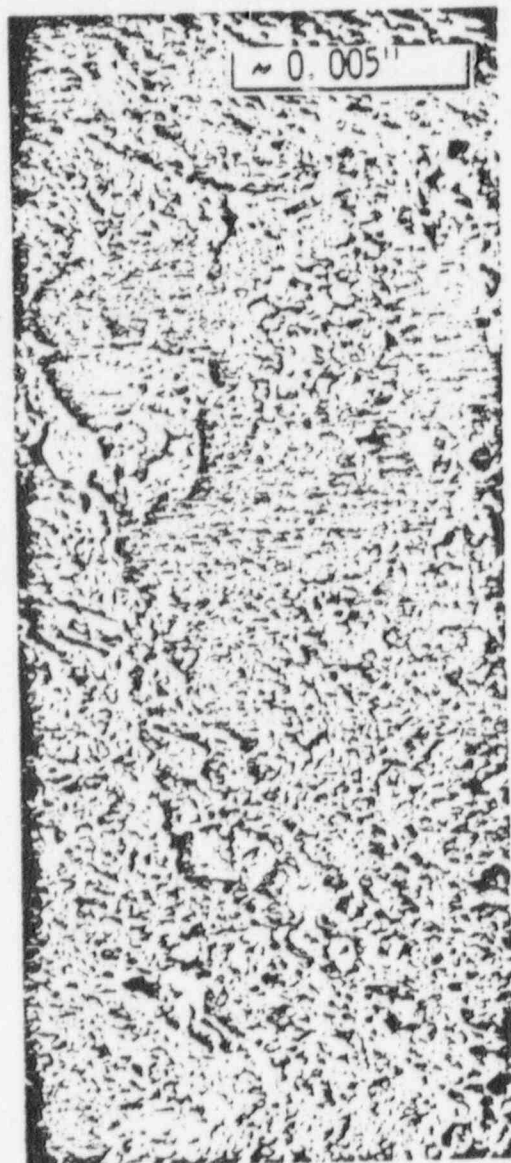
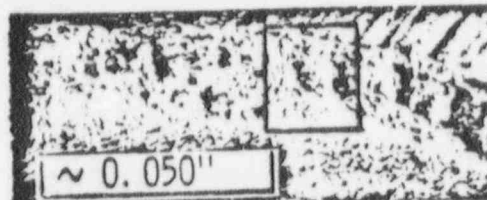
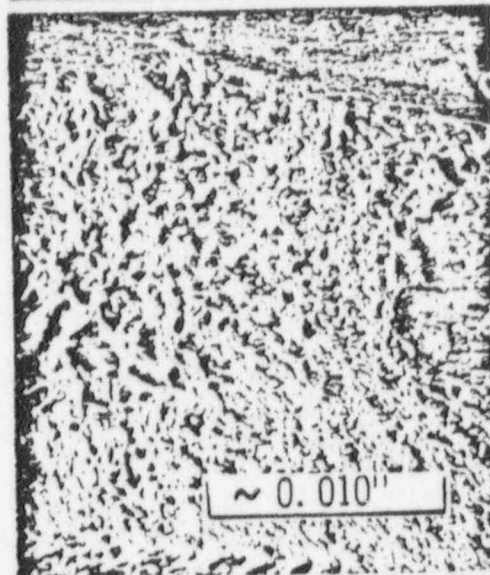
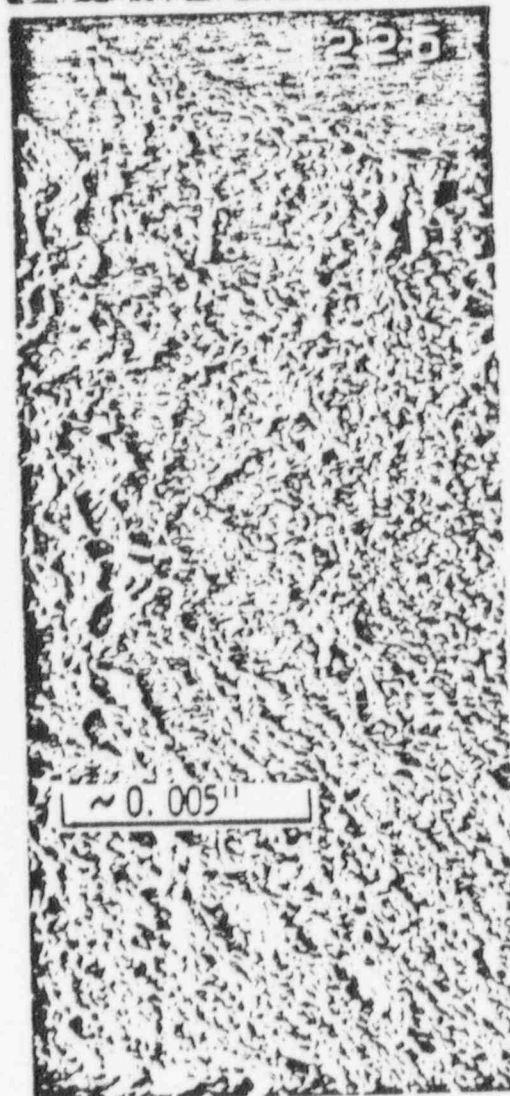
Figure 15

A (15-73), SEM Fractographs at 235° and 250°. The zones of 16A appear to be approx. 1/2 of fracture in both areas.

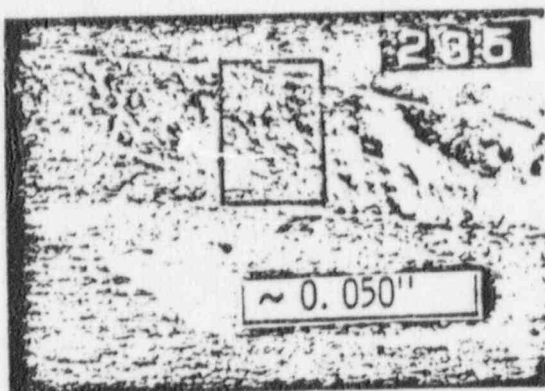
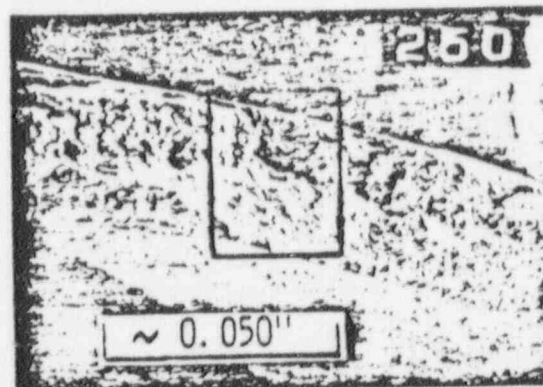
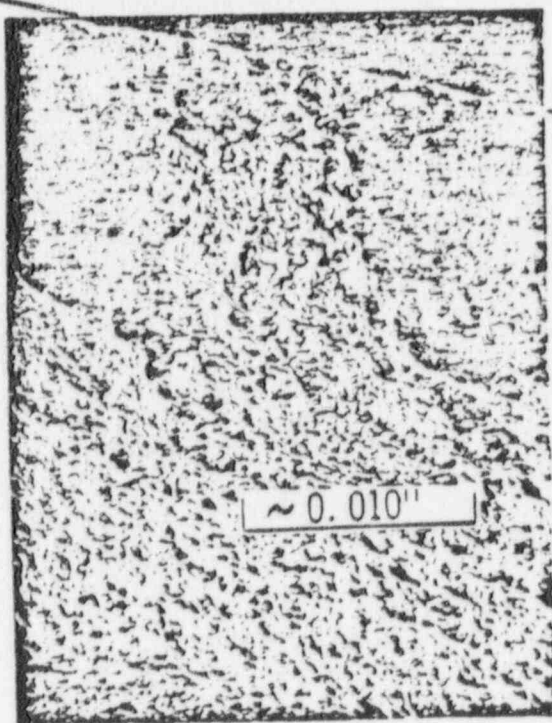
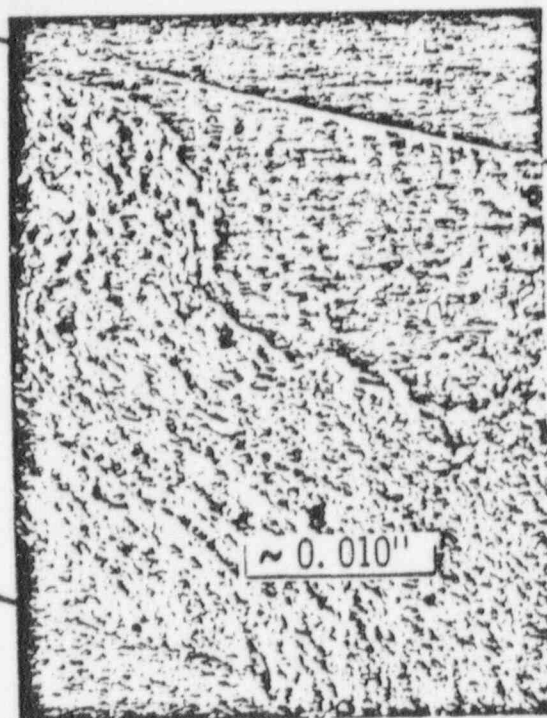
Figure 16

Λ (15-73), SEM Fractographs at 270° .
16A appears to be $\geq 1/4$ of the fracture
face.

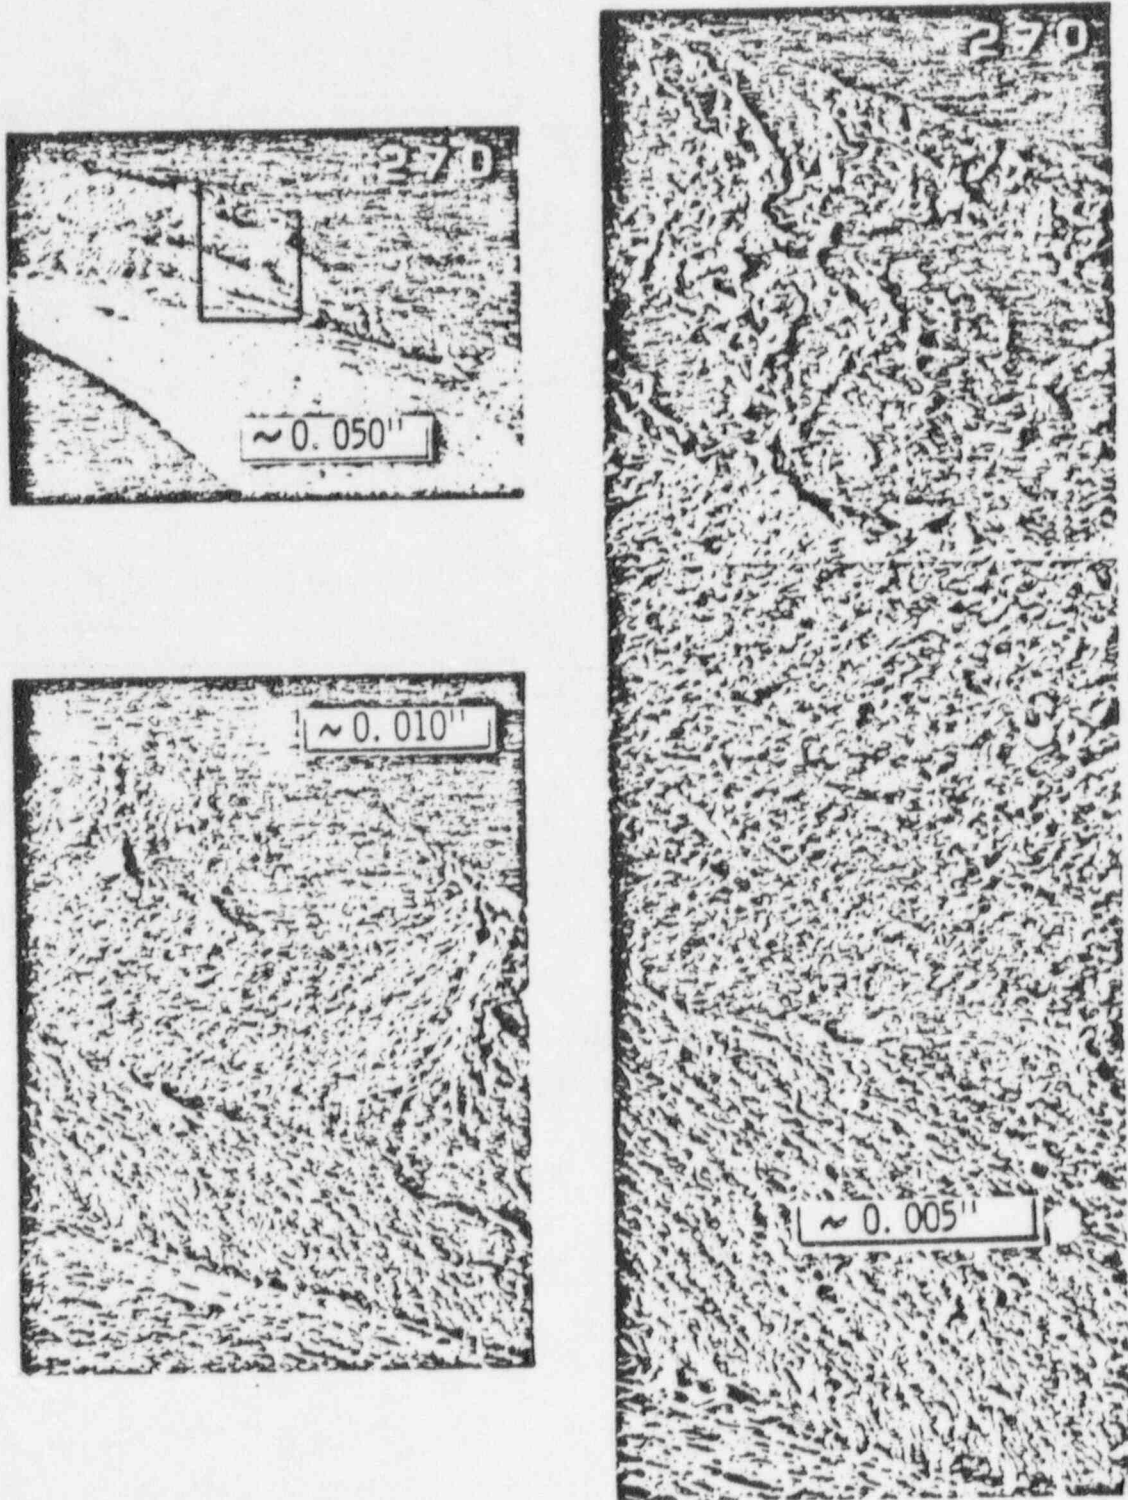
Figure 17

A (15-73), SEM Fractographs at 315°
Fracture appears to be predominantly
shear only

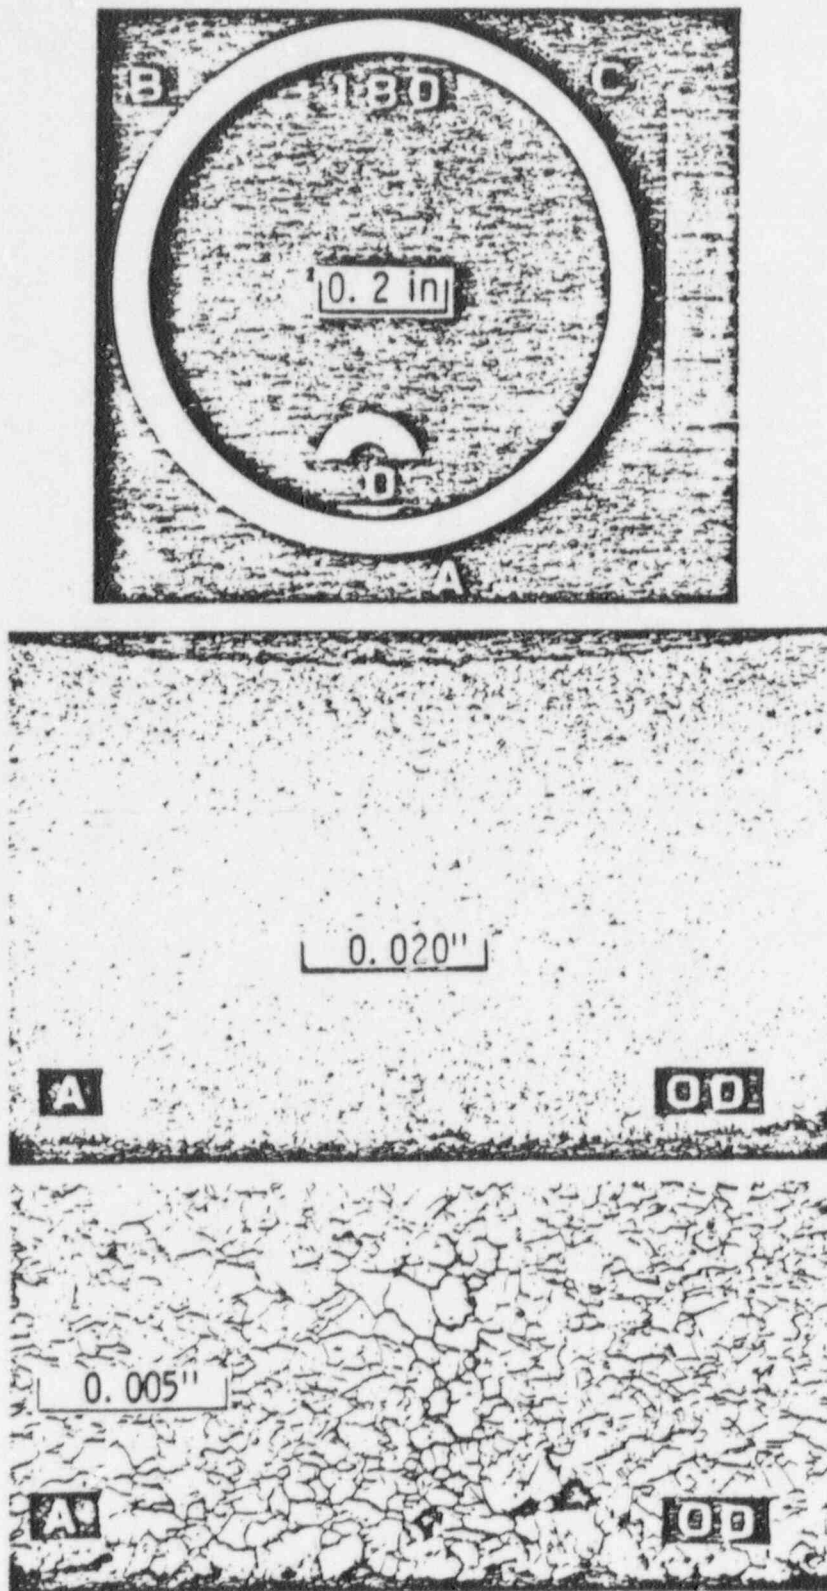
Figure 23

A (15-73), 11 in. above bottom. Areas B
and C of Figure 23.

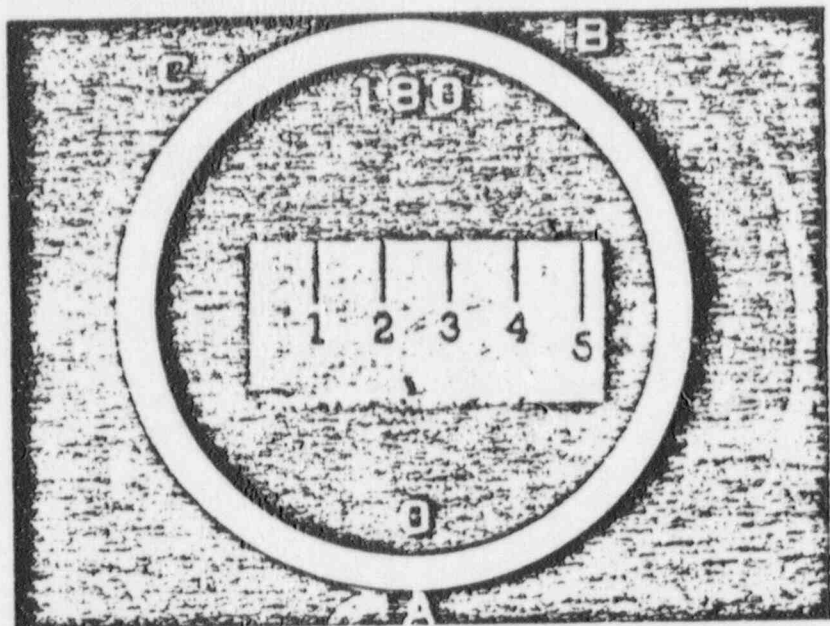
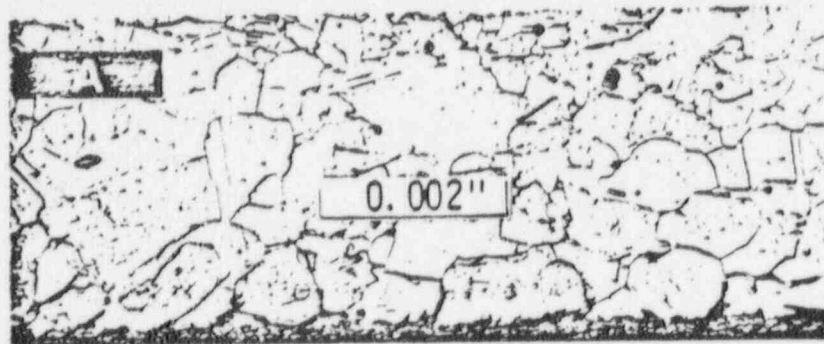
Figure 25

A (15-73), 1-1/2 in. below Fracture Areas B
& C of Figure 25. The OD conditions at B
represents intergranular penetrations of
about 1 grain in depth (approx. 0.006 in.
or 0.6 mil)

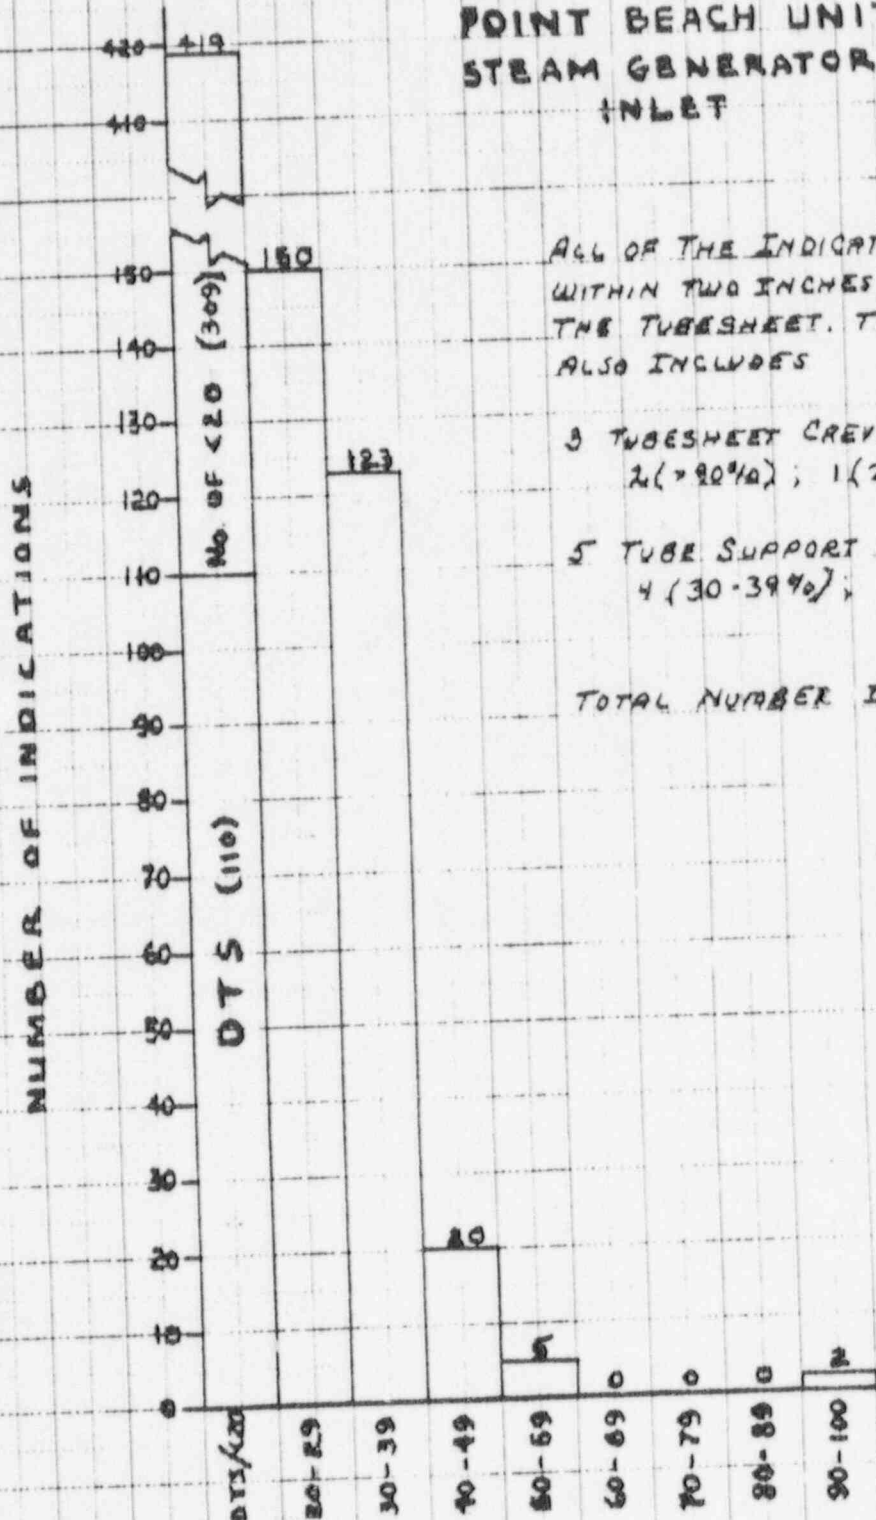
FIGURE 1

DISTRIBUTION OF ALL EDDY CURRENT INDICATIONS REPORTED AT THE APRIL 1981 INSPECTION

ALL OF THE INDICATIONS ARE REPORTED
WITHIN TWO INCHES FROM THE TOP OF
THE TUBESHEET. THIS DISTRIBUTION
ALSO INCLUDES

3 TUBESHEET CREVICE INDICATIONS
2 (> 90%) ; 1 (21%)

5 TUBE SUPPORT INDICATIONS
4 (30-39%) ; 1 (21%)

TOTAL NUMBER INDICATIONS = 719

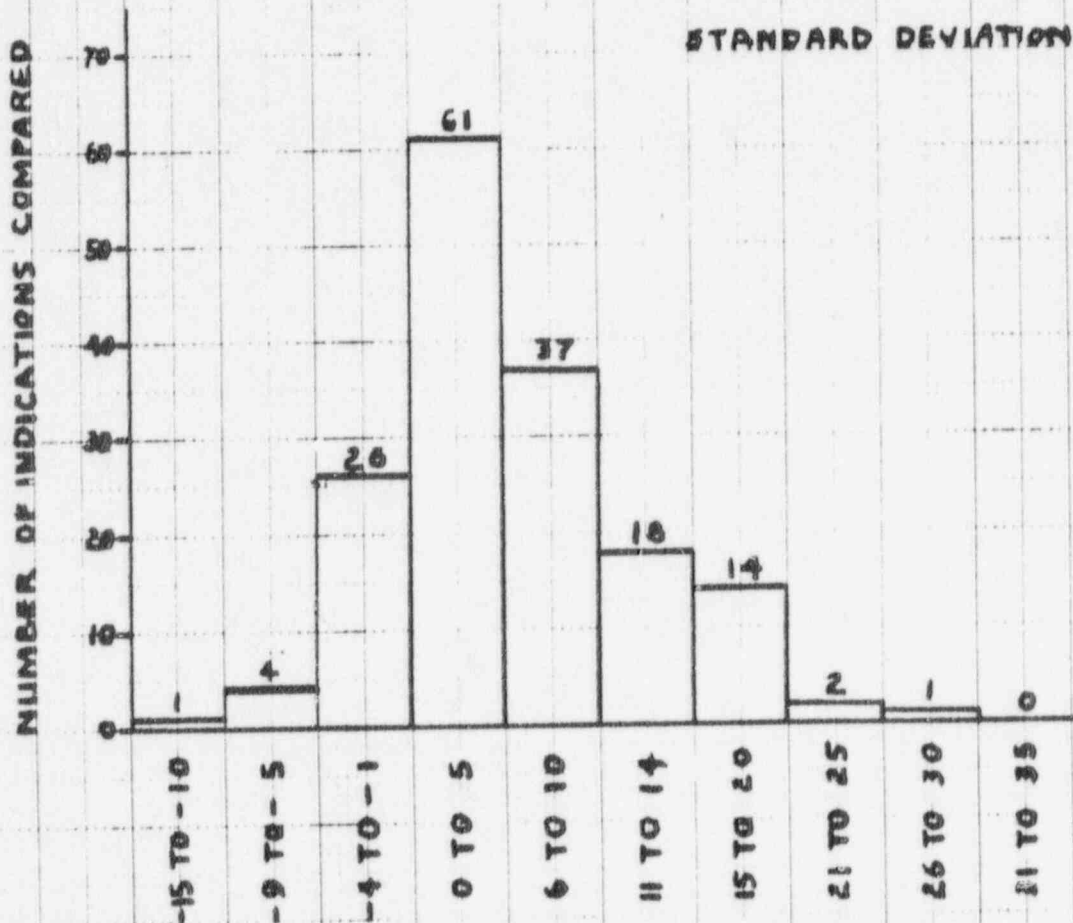
FIGURE 3

DISTRIBUTION OF THE CHANGE IN SIZE OF INDICATIONS REPORTED AS 220% AT THE TOP OF THE TUBESHEET IN BOTH MARCH 1980 AND APRIL 1981

NUMBER OF INDICATIONS
COMPARED = 164
MEAN CHANGE IN SIZE = 5.5%
STANDARD DEVIATION = 6.5%
