DOCKET NO. 50-301
REPORT OF STEAM GENERATOR TUBE INSPECTION
POINT BEACH NUCLEAR PLANT, UNIT NO. 2

EXAMINATION OF POINT BEACH UNIT #2

STEAM GENERATOR TUBE SAMPLE

POINT BEACH UNIT 2 (WIS)
ANALYSIS OF APRIL, 1981
EDDY CURRENT INSPECTION RESULTS

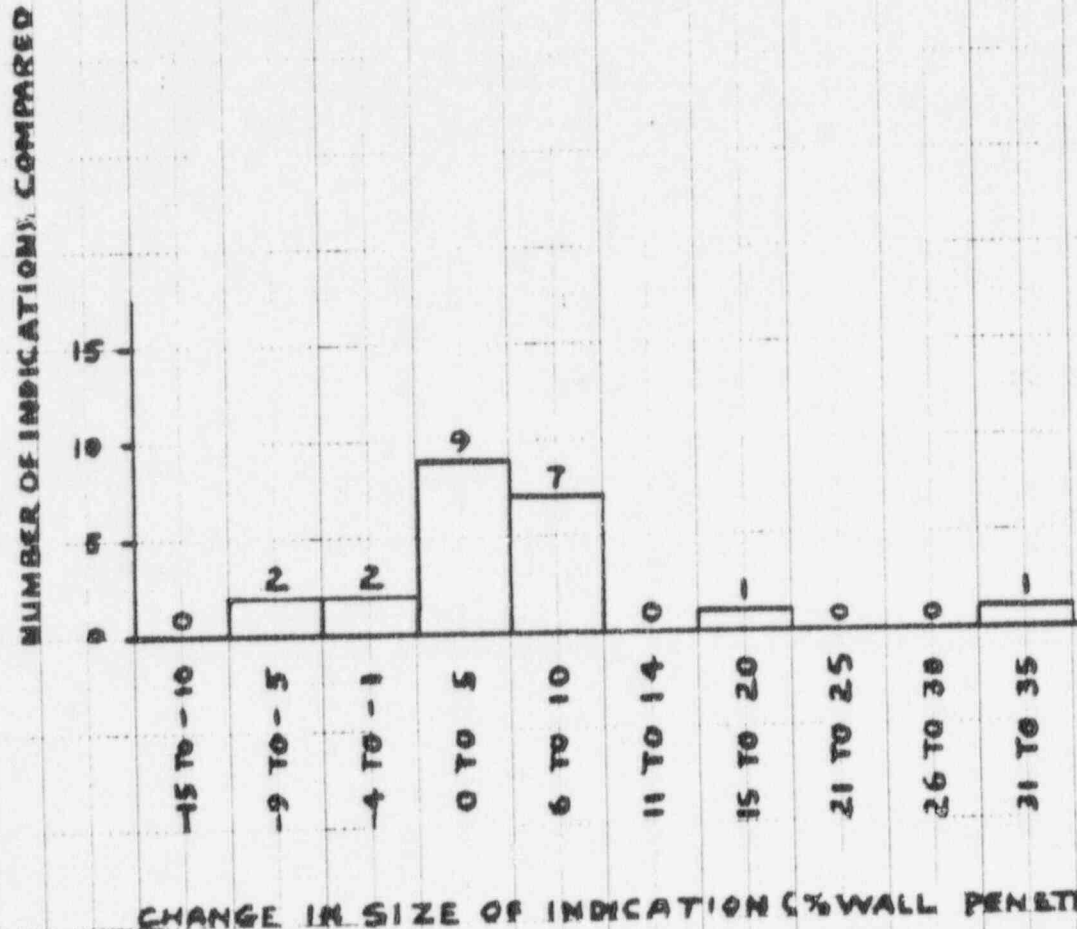
FIGURE 4

DISTRIBUTION OF THE CHANGE IN SIZE
OF INDICATIONS REPORTED AS $\geq 20\%$
AT THE TOP OF THE TUBESHEET IN
BOTH MARCH 1980 AND APRIL 1981

NUMBER OF INDICATIONS
COMPARED = 22
MEAN CHANGE IN SIZE = 4.91
STANDARD DEVIATION = 7.92
