MIDLAND UNITS 1 & 2
JOB NO. 7220

REVIEW OF U.S. TESTING
FIELD AND LABORATORY CONSTRUCTION
TEST DATA ON SOILS USED AS FILL

BECHTEL ASSOCIATES PROFESSIONAL CORPORATION
July 1979

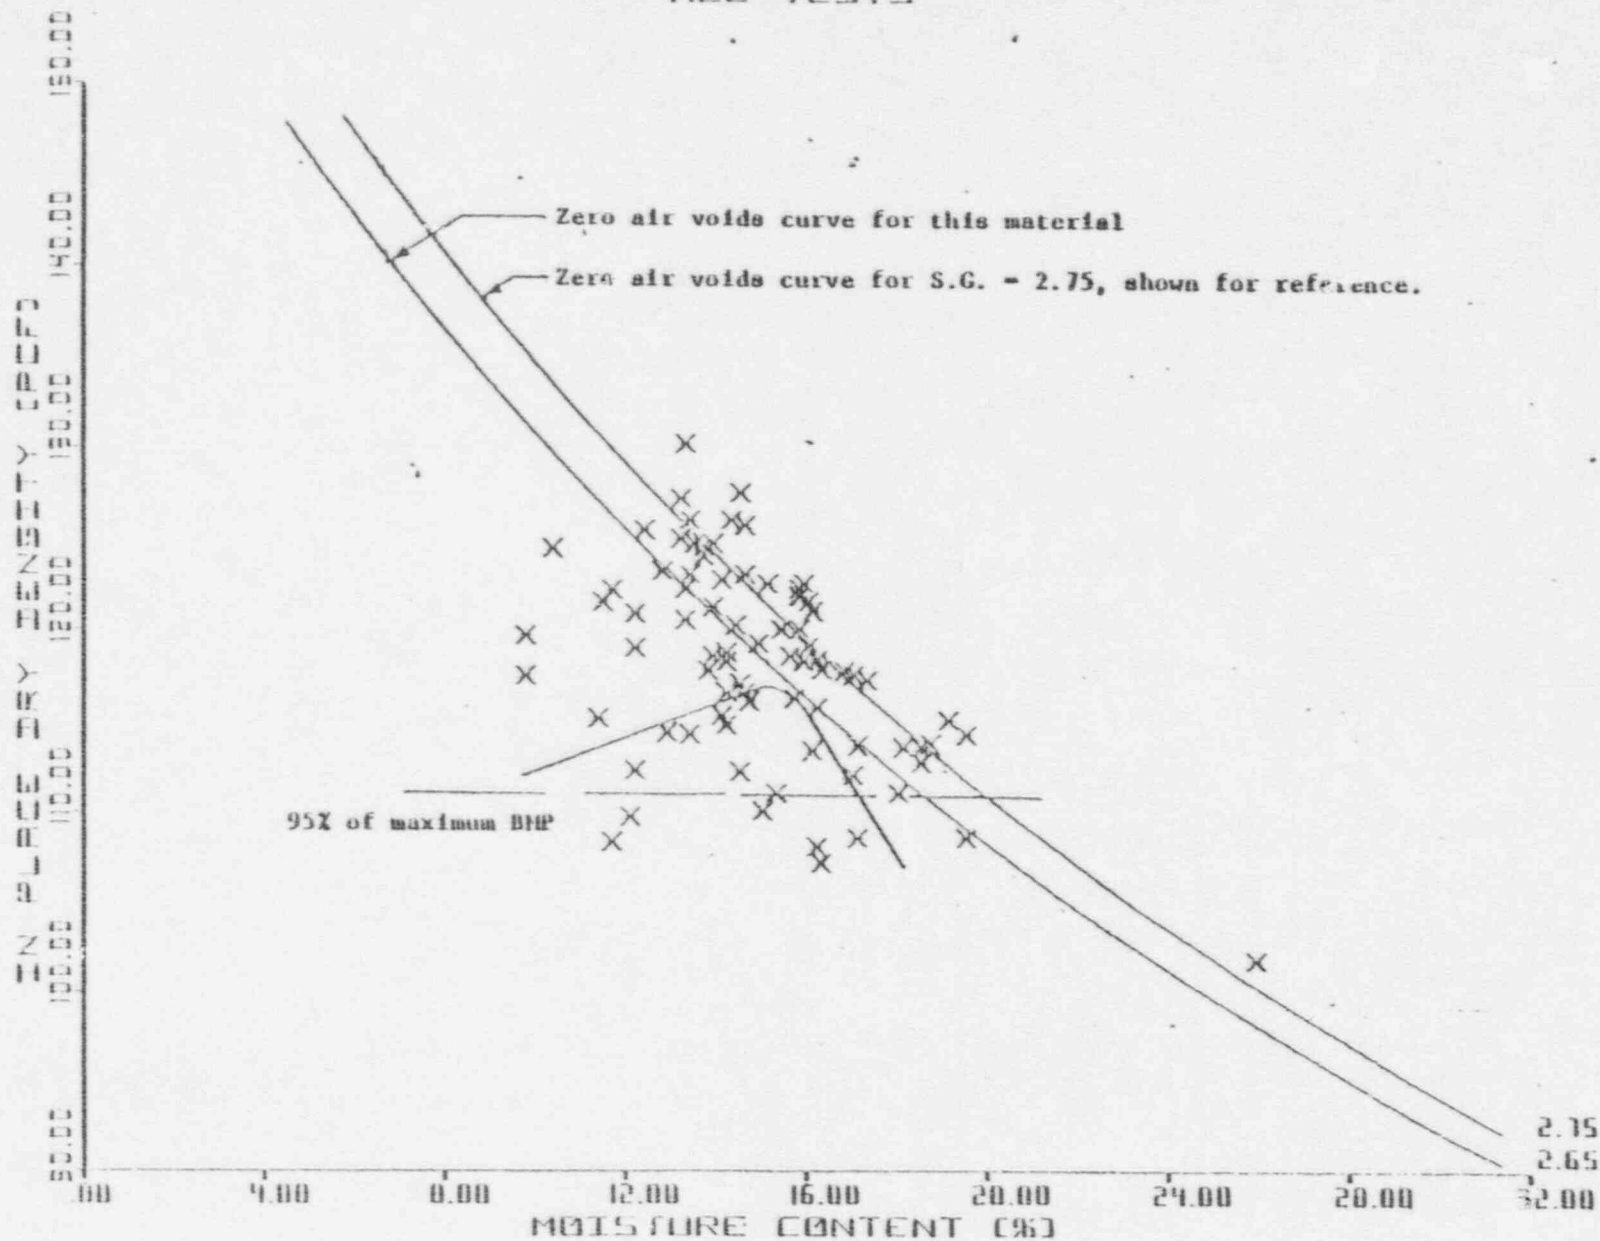
FIGURE 1

Soils cannot be more than 100 percent saturated; therefore, all field density test data points, when plotted as dry density versus moisture content, must be below the zero air voids curve as defined by the specific gravity of the material. Specifications do not require examination of the zero air voids curve, but it is considered common practice relative to compaction plots. There are numerous cases in the U. S. Testing Company data where points plot above the zero air voids curve. Figure 1 attached shows a typical laboratory compaction test curve with field test results plotted on it. Many of the field test results are to determine percent compaction plot above the zero air voids curve. Provided the specific gravity is correct this is not possible so that all such points must represent erroneous data.

MOISTURE-DENSITY FOR BMP 278

SPECIFIC GRAVITY = 2.65
ALL TESTS

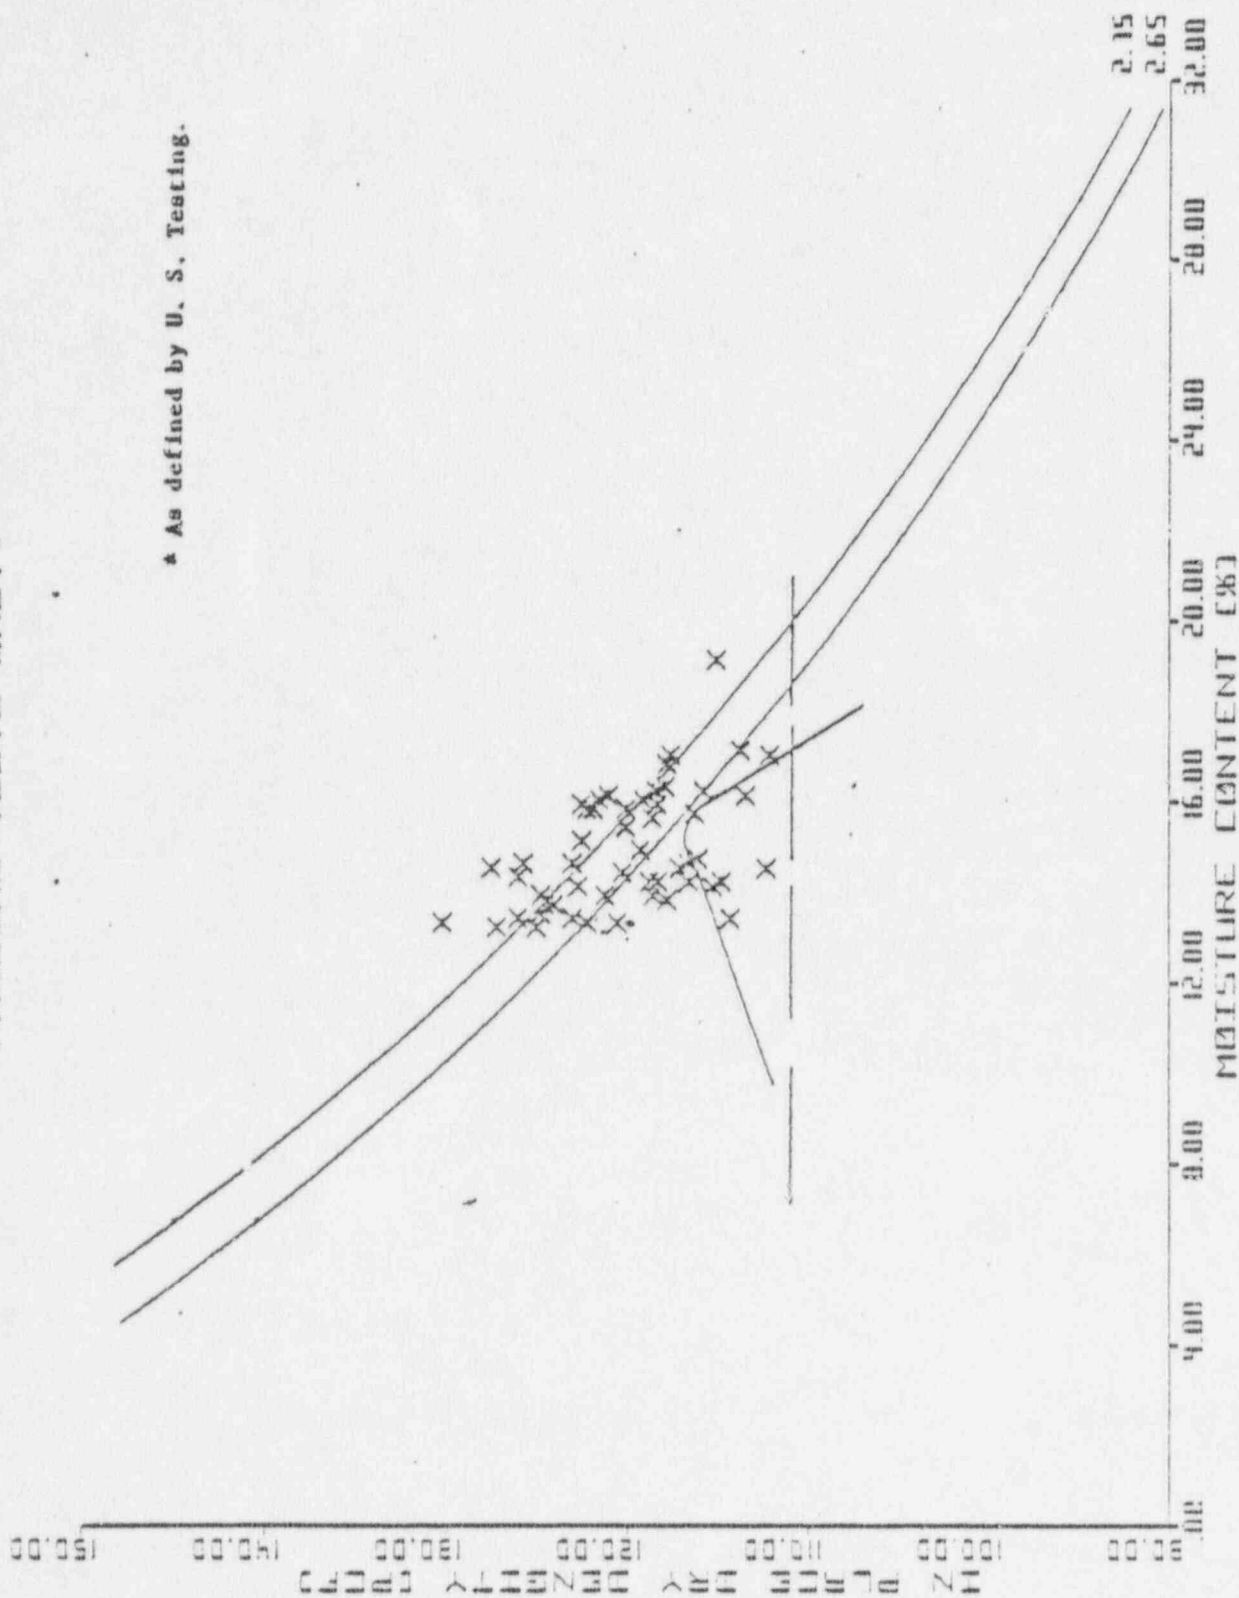
FIGURE 2

MOISTURE-DENSITY FOR BMD 27L SPECIFIC GRAVITY = 2.65 PASSING TESTS ONLY*

* As defined by U. S. Testing.

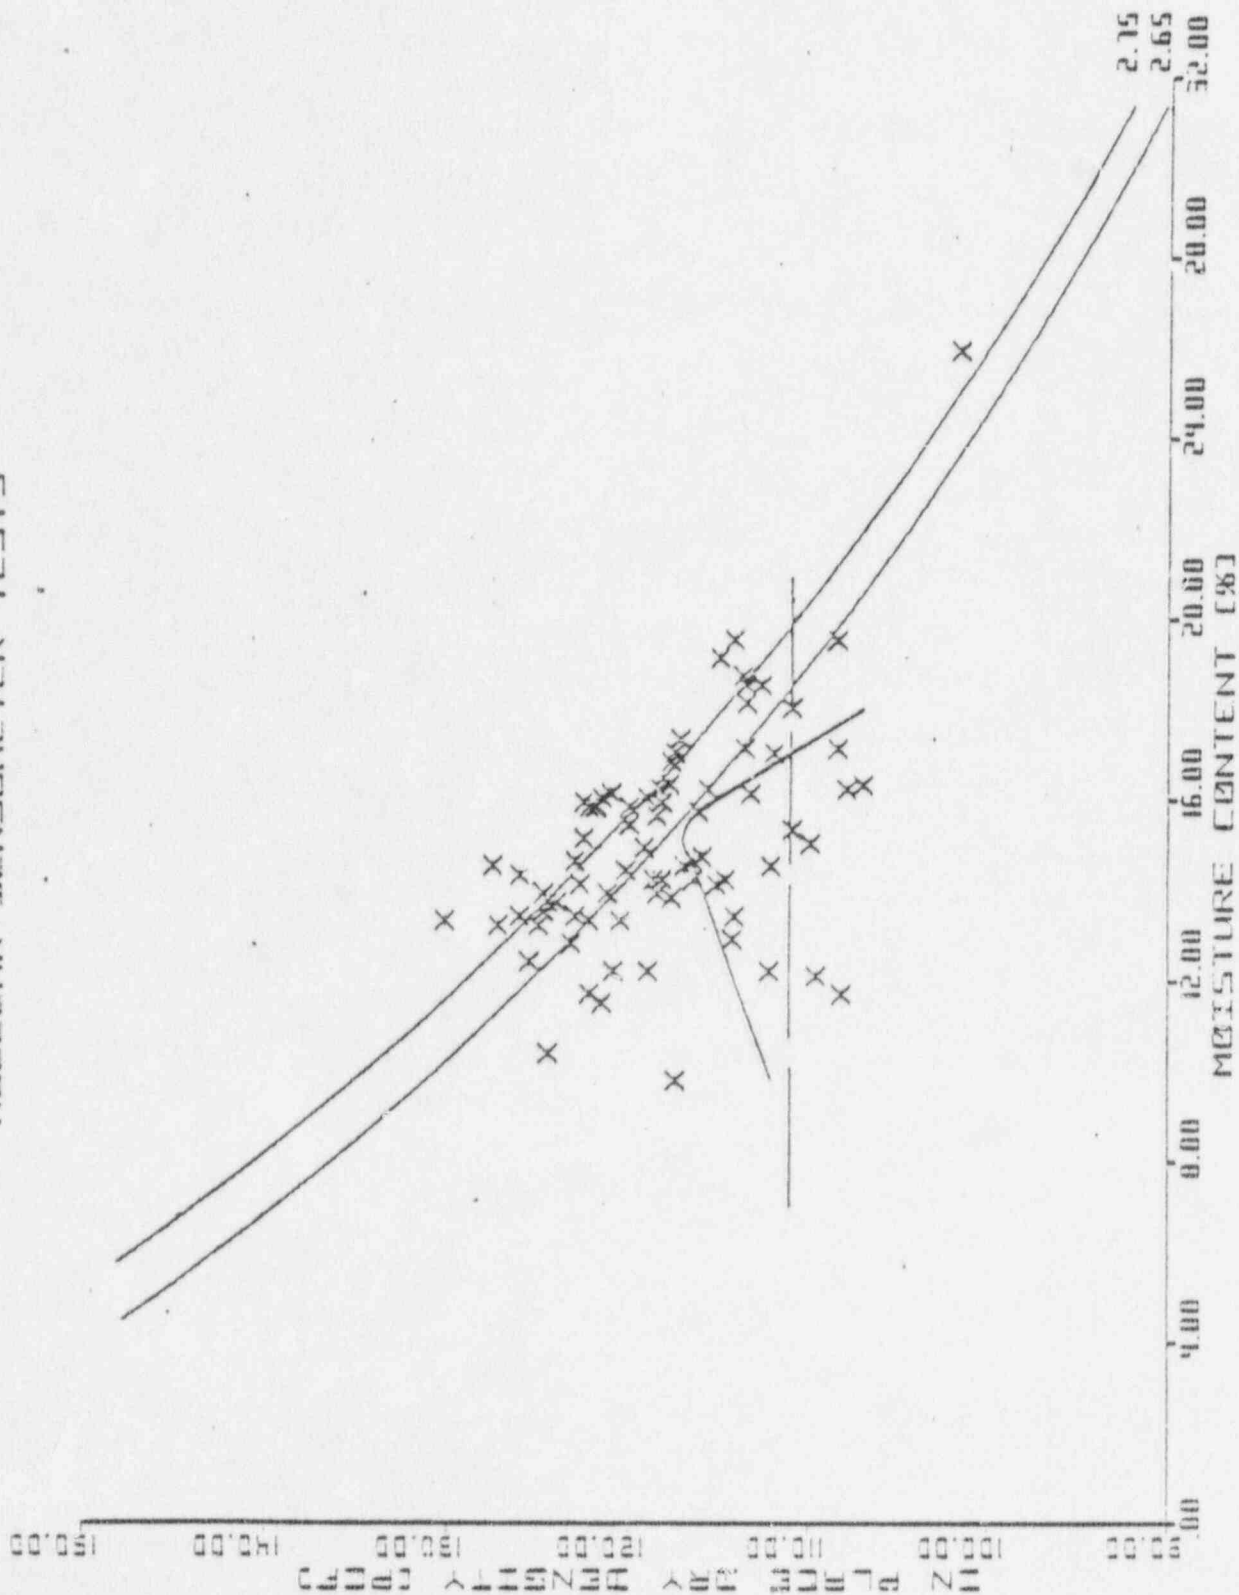
FIGURE 3

However, it is clear that a large number of the nuclear density tests are wrong. This can be explained by considering the wet unit weight may have been wrong or both the moisture content and unit weight may have been wrong. A reliable correlation with properly conducted sand cone tests should have revealed this, but it was not apparently done.

MOISTURE-DENSITY FOR BMP 278

SPECIFIC GRAVITY = 2.65
NUCLEAR DENSOMETER TESTS

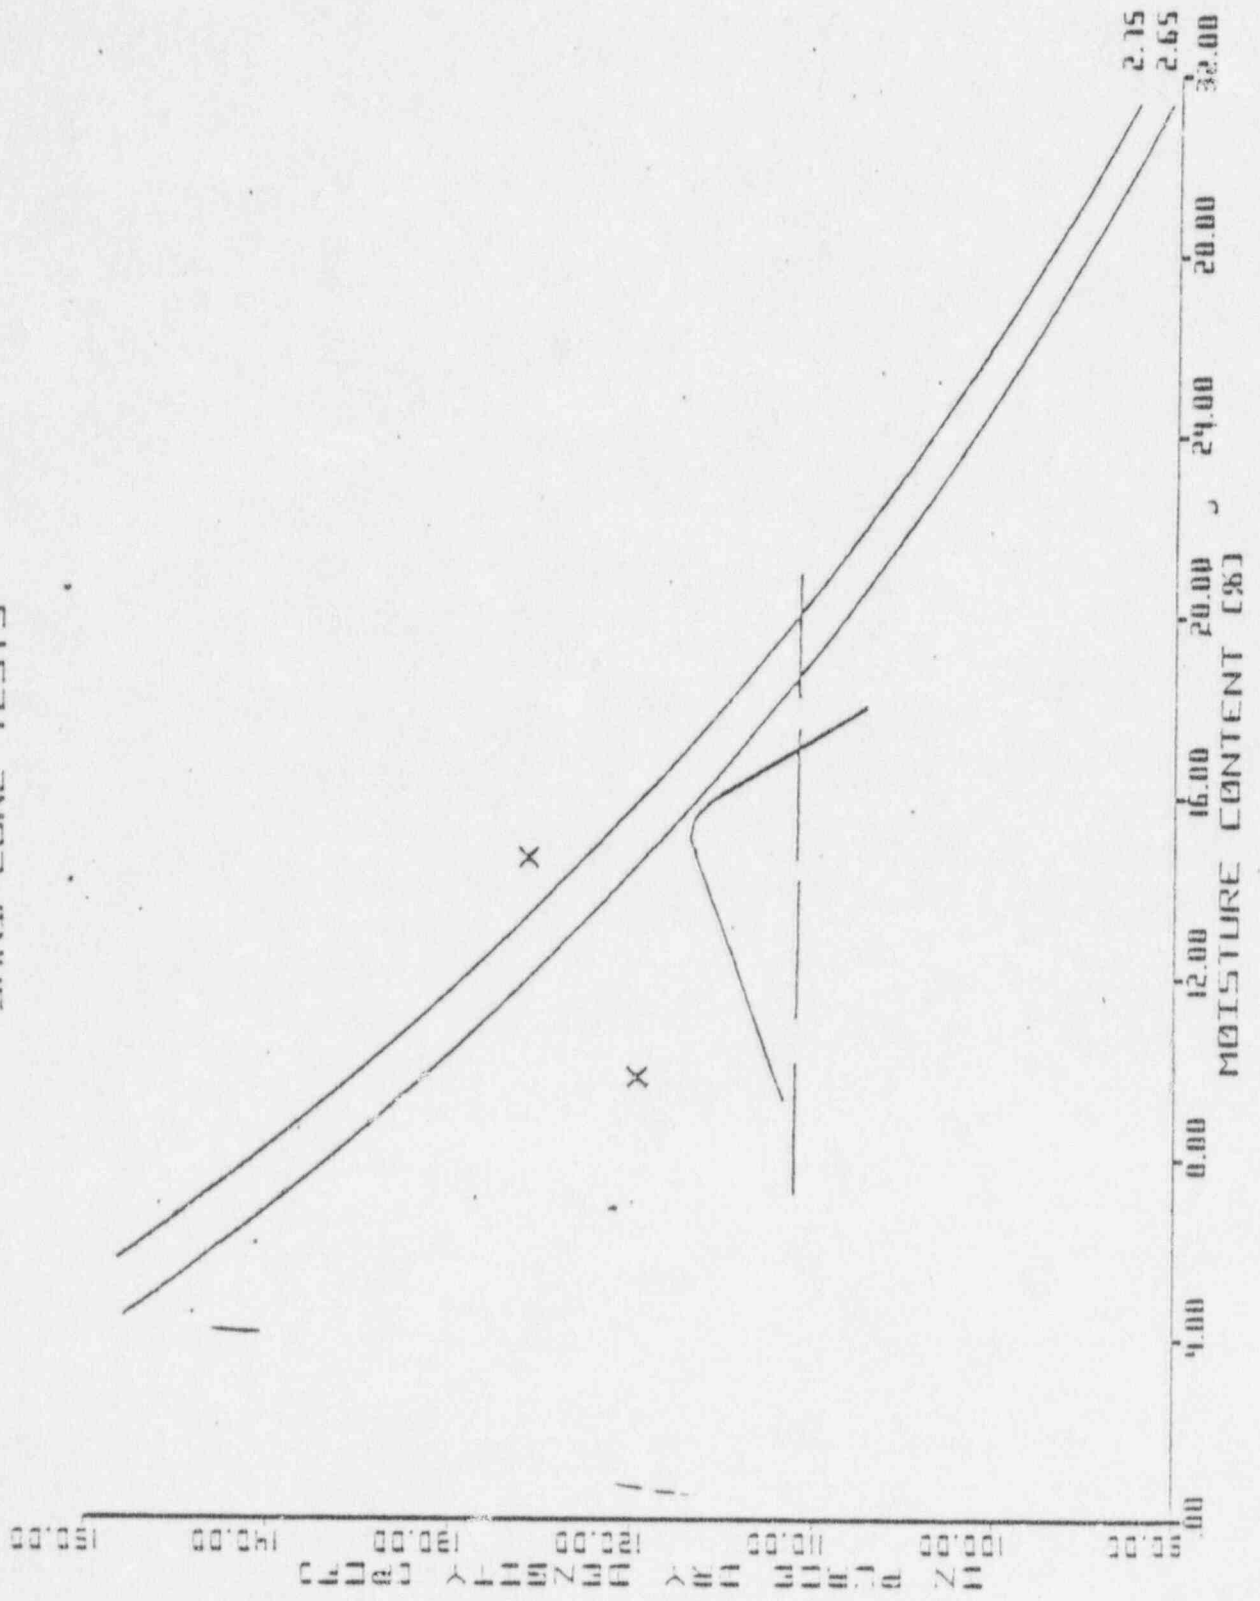
FIGURE 4

MOISTURE-DENSITY FOR BMP 27L
 SPECIFIC GRAVITY = 2.65
 SAND-CONE TESTS

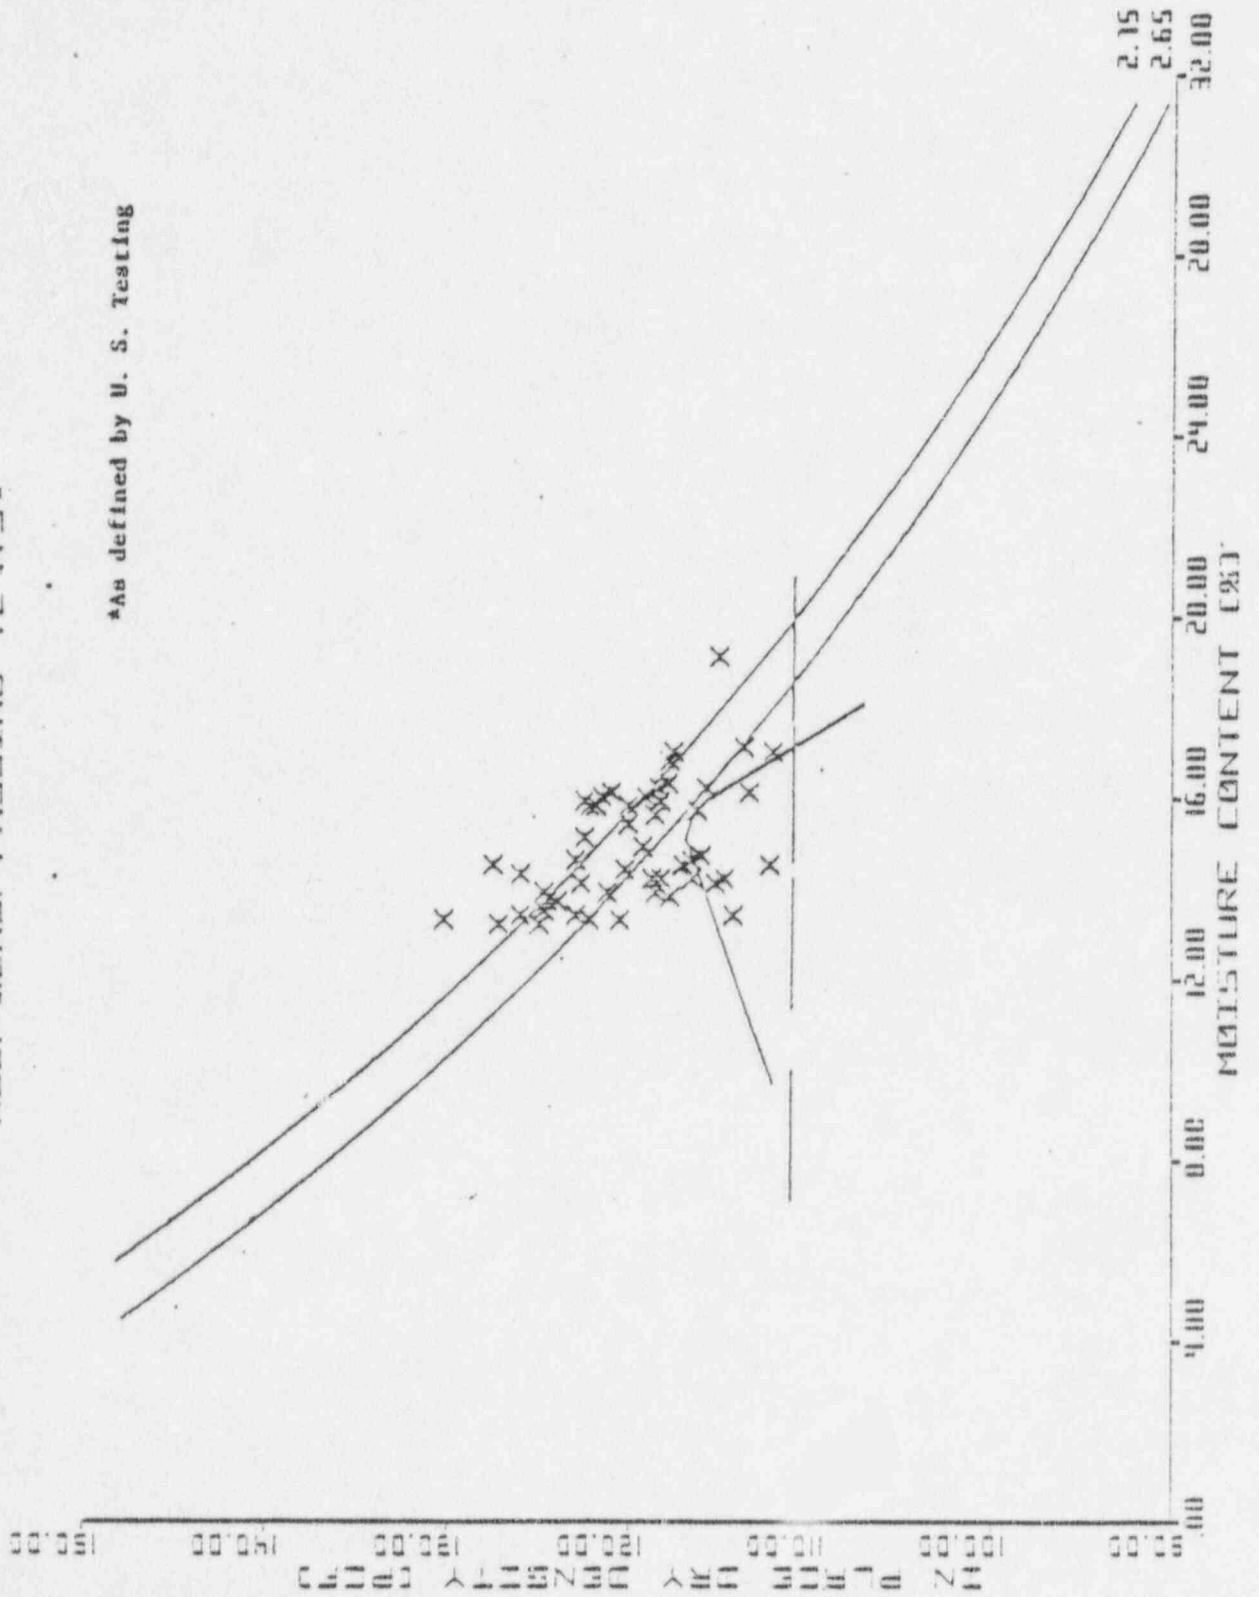
FIGURE 5

MOISTURE DENSITY FOR BMP 278 SPECIFIC GRAVITY = 2.65 NUC. DENS. PASSING TESTS*

*As defined by U. S. Testing

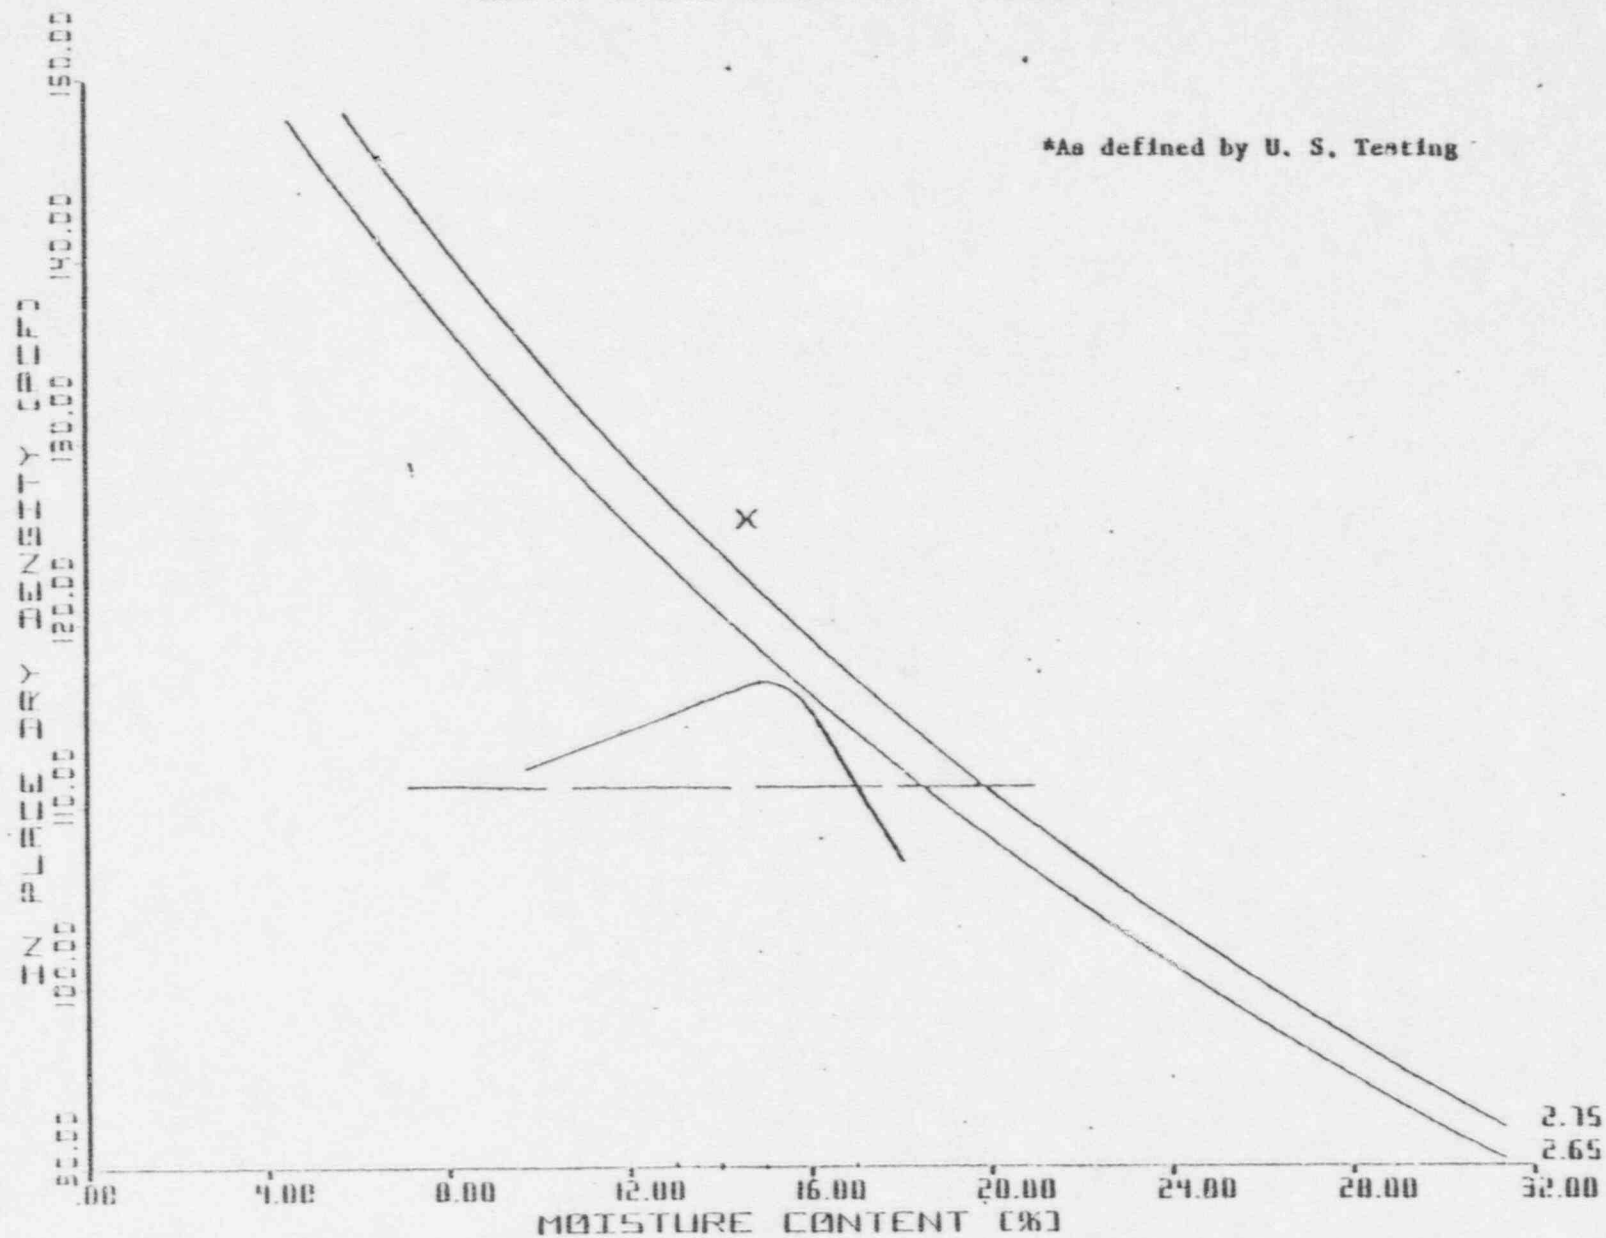
FIGURE 6

MOISTURE-DENSITY FOR BMP 27L SPECIFIC GRAVITY = 2.65 SAND-CONE PASSING TESTS *

*As defined by U. S. Testing

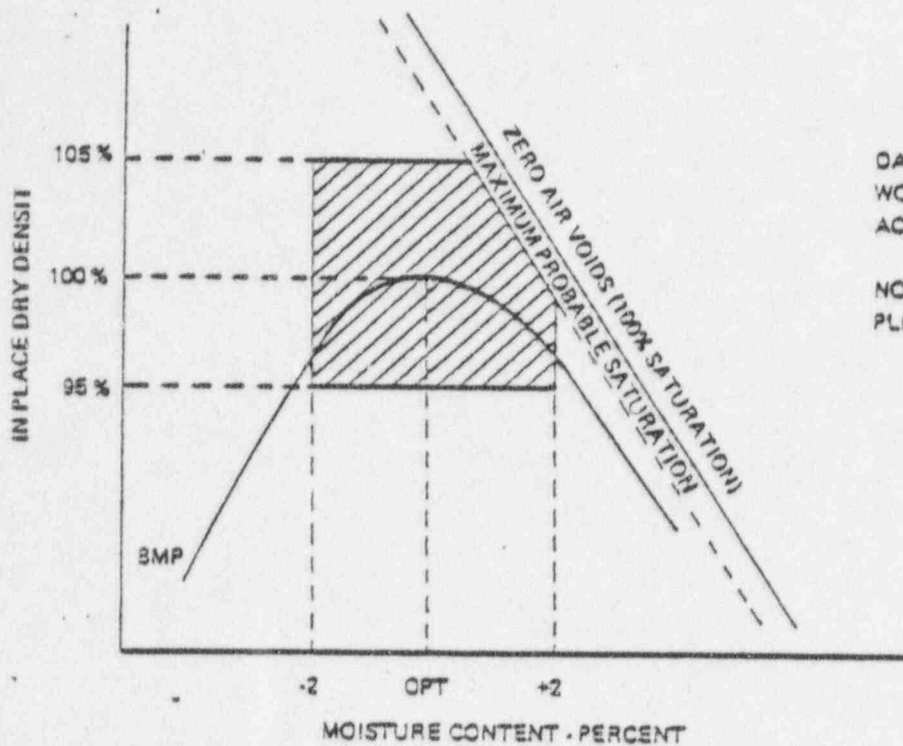
FIGURE 7-A

For a field test result to be valid as well as "Passing" it must fall within a well defined area on the plot containing the laboratory compaction curve. This area or window of acceptability is shown for a hypothetical compaction curve on Figure 7a that would meet requirements of Specification 7220-C-210. It is defined by horizontal lines at 95 percent and 105 percent of specified density, vertical lines through ± 2 percent of optimum moisture content, and a line parallel to the zero voids line indicating saturation about half way between the compaction curve and 100 percent saturation (zero air voids curve). The practical upper limit of 105 percent of specified density is not defined in the specifications. It was arbitrarily chosen as numbers greater than this give increasingly invalid comparisons between field test results and the specified laboratory compaction test curve. Therefore, if all data points fall within the defined window there would be no reason to assume that they are wrong. However, when many data points fall outside the designated area there is something wrong with the information and then all data points become suspect. A review of all data indicates that about 25 percent of the cohesive soil test results fall within this area.

DATA POINTS THAT PLOT IN SHADED AREA WOULD BE GENERALLY ACCEPTABLE ACCORDING TO SPECIFICATIONS

NOTE: ABOUT 25% OF ALL FIELD DATA PLOTS IN THE SHADED AREA

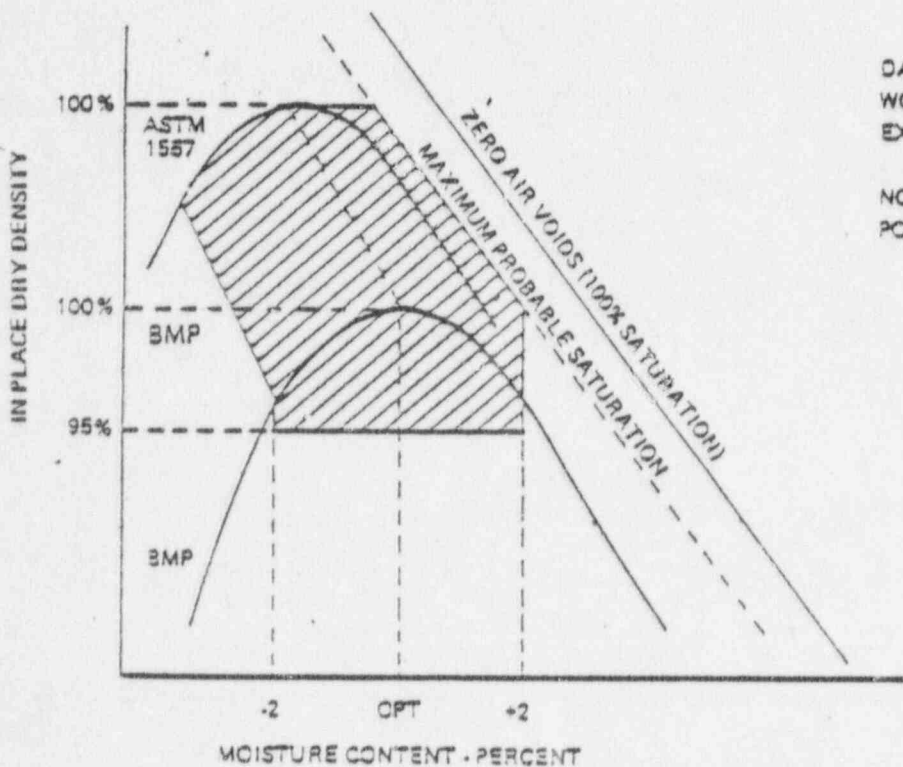
DATA POINTS THAT PLOT IN SHADED AREA WOULD BE ACCEPTABLE REGARDLESS OF EXACT SPECIFICATION WORDING

NOTE: ABOUT 40% OF ALL FIELD DATA POINTS PLOT IN THE SHADED AREA

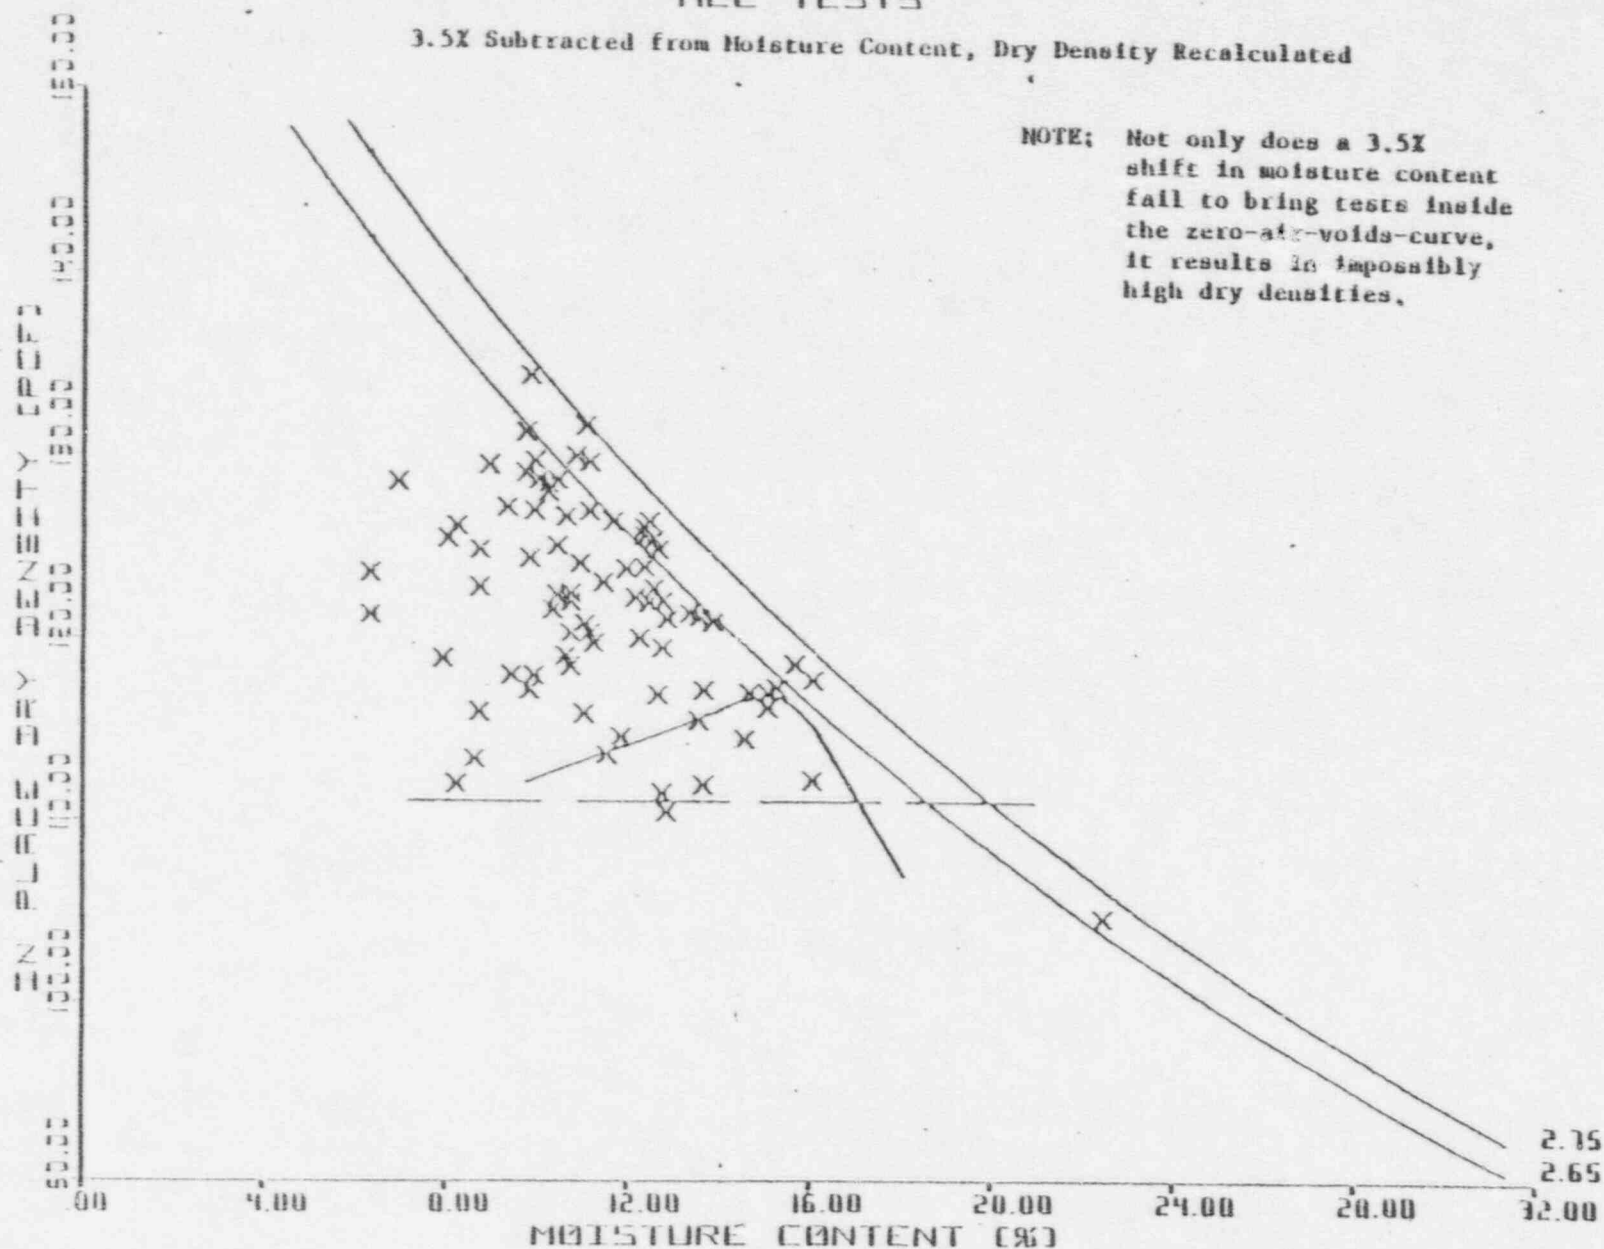
FIGURE 9

In a letter from U. S. Testing to Bechtel (dated May 30, 1974), the average deviation of the nuclear device from oven-dry moistures was $\pm 1.12\%$ for a set of 30 tests. However, the standard error of estimate is 1.6% for the data with the range of differences being from -3.2% to $+3.9\%$. Thus, accuracy of the nuclear device is questionable, and could translate into errors of about ± 4 pcf in the dry density calculation. (It should be noted that errors in the moisture content tend to shift the position of test results on a moisture density plot approximately parallel to the zero air voids curve, assuming the in-place wet density is correct, and thus do not explain the large number of points which plot outside the zero air voids. Compare Figures 1 and 9).

MOISTURE-DENSITY FOR BMP 27

3.5% Subtracted from Moisture Content, Dry Density Recalculated

NOTE: Not only does a 3.5% shift in moisture content fail to bring tests inside the zero-air-voids-curve, it results in impossibly high dry densities.

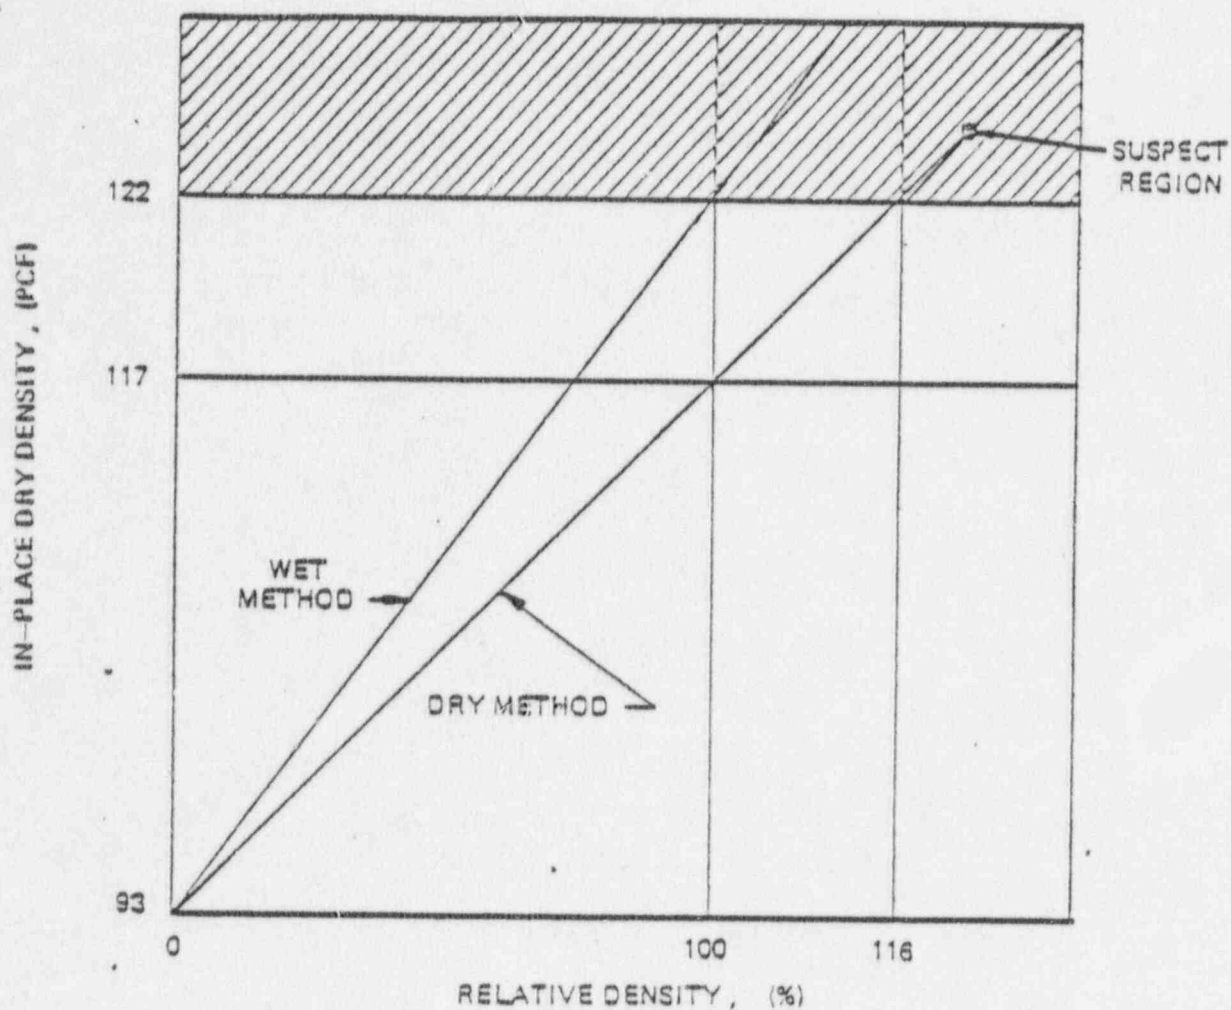
FIGURE 10
CHANGE IN RELATIVE DENSITY SCALE FROM DRY TO WET METHODS
OF OBTAINING MAXIMUM DENSITY, BASED ON RECENT LAB RESULTS

NOTE: VALUES FOR DRY DENSITY ARE TYPICAL OF A RANDOM FILL SAND. ANY TESTS SHOWING MORE THAN 117% RELATIVE DENSITY WOULD BE SUSPECT IN THIS EXAMPLE. STRUCTURAL SANDS TEND TO SHOW ONLY 2 OR 3 PCF INCREASE IN MAXIMUM DENSITY AND THUS RESULTS AT MUCH LOWER RELATIVE DENSITY WOULD BE SUSPECT, SAY 105 - 110 PERCENT
