Draft Radiological and Engineering Assessment

Vicinity Property No. SLC 206

SL-206

April 19, 1985

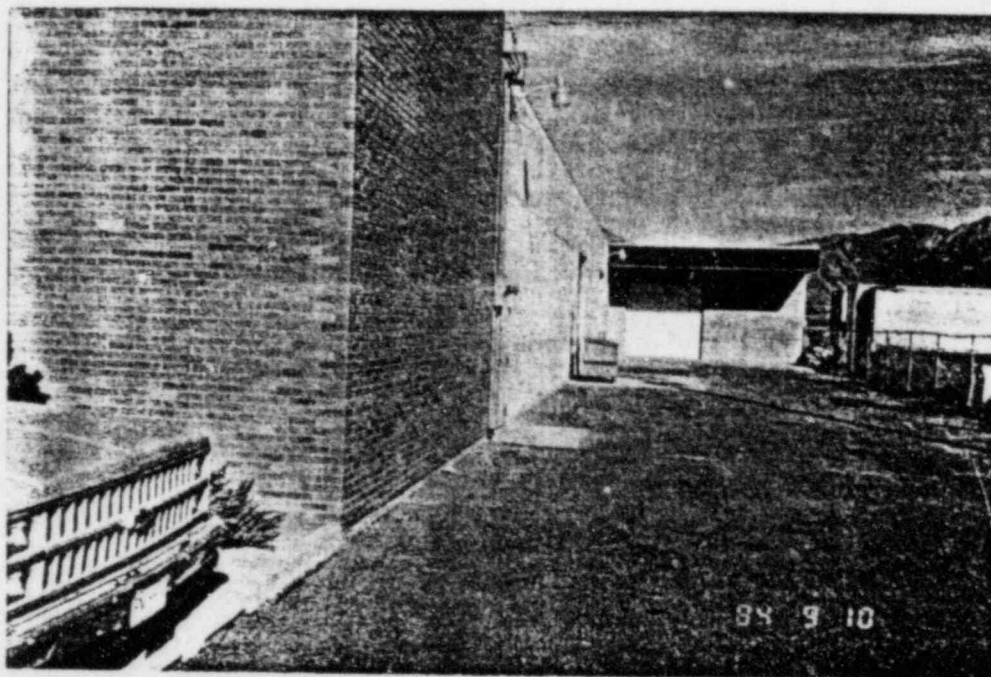
Figure 2.3 Property Photos

South Side of Property Looking East

There is one area of minor contamination on SL-206. These findings concur with those of the inclusion survey. The area is located along the south side of the building. The depth of contamination in this area is 6 inches.
