# **Radiological and Engineering Assessment**

Vicinity Property No. SLC 017

FINAL  
THE RADIOLOGICAL AND ENGINEERING ASSESSMENT  
AND FINAL DESIGN

SL-017

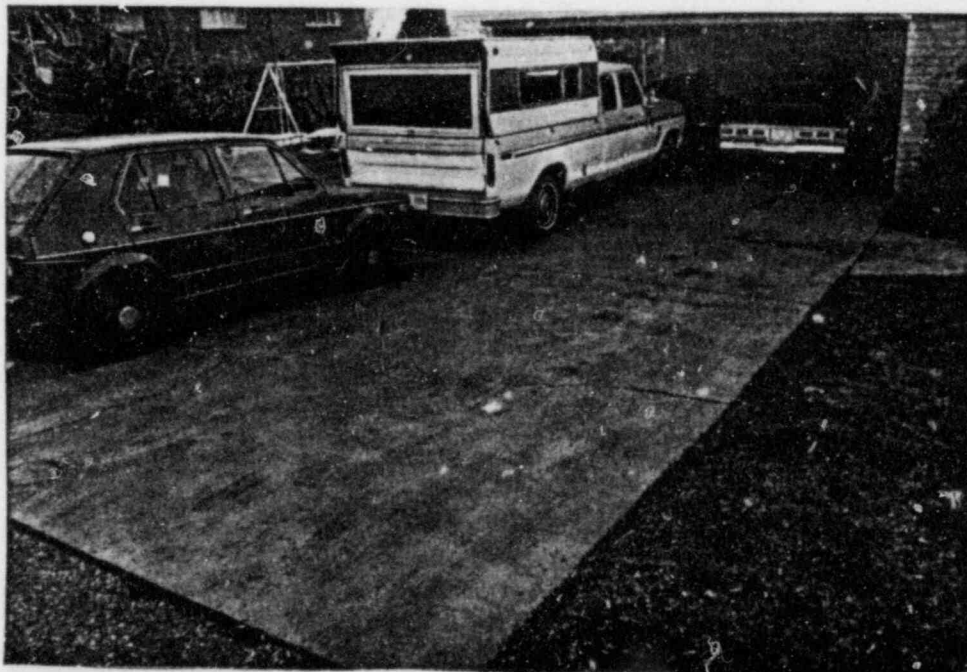
Front of House, Driveway and Carport Looking West

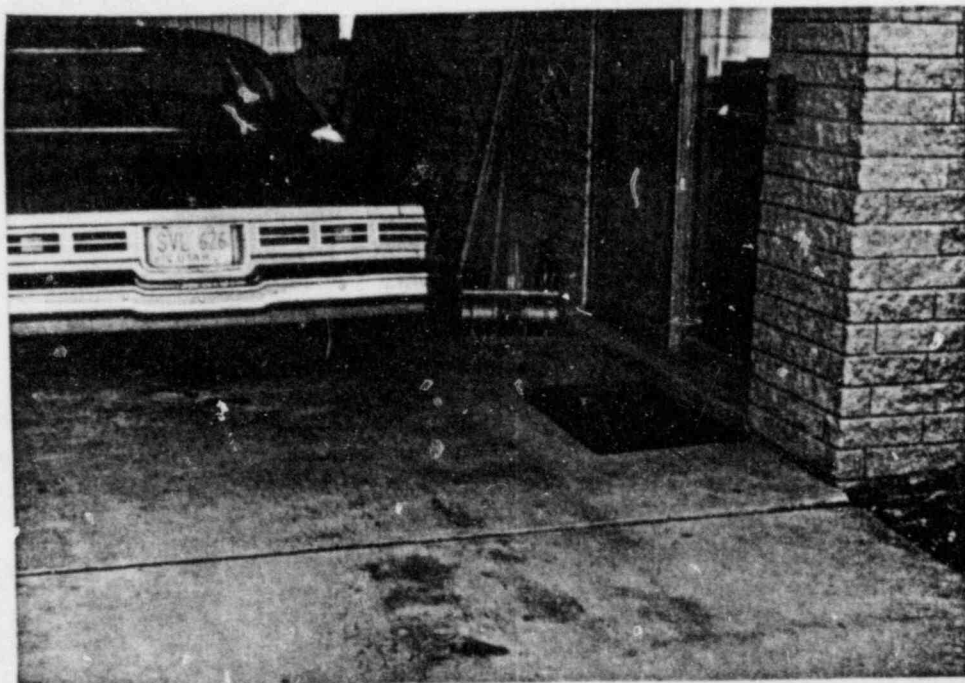
House and Carport Looking West

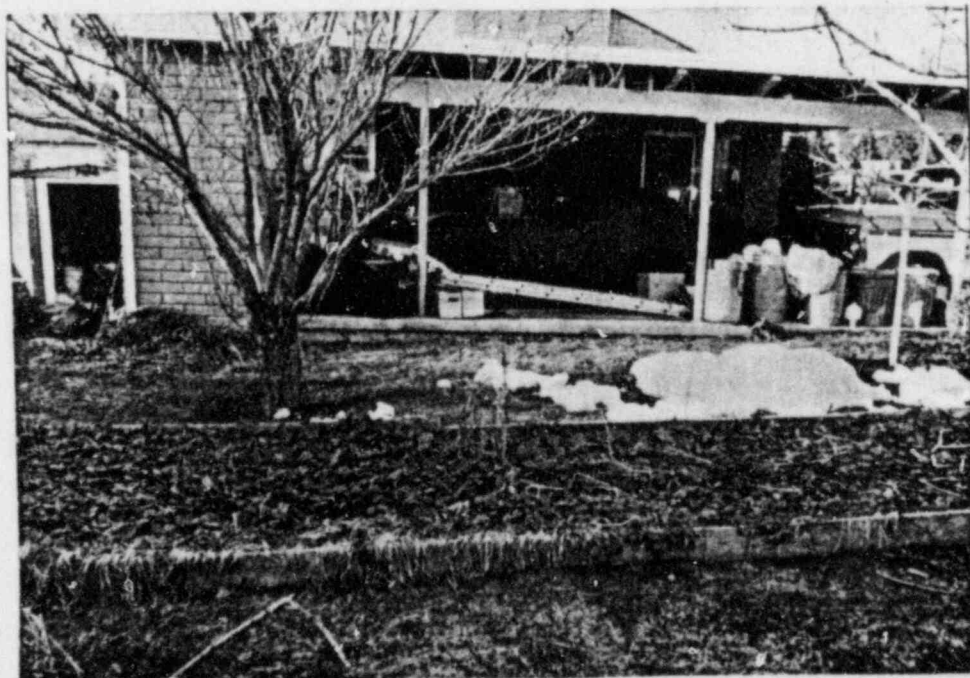
House and Carport Looking North

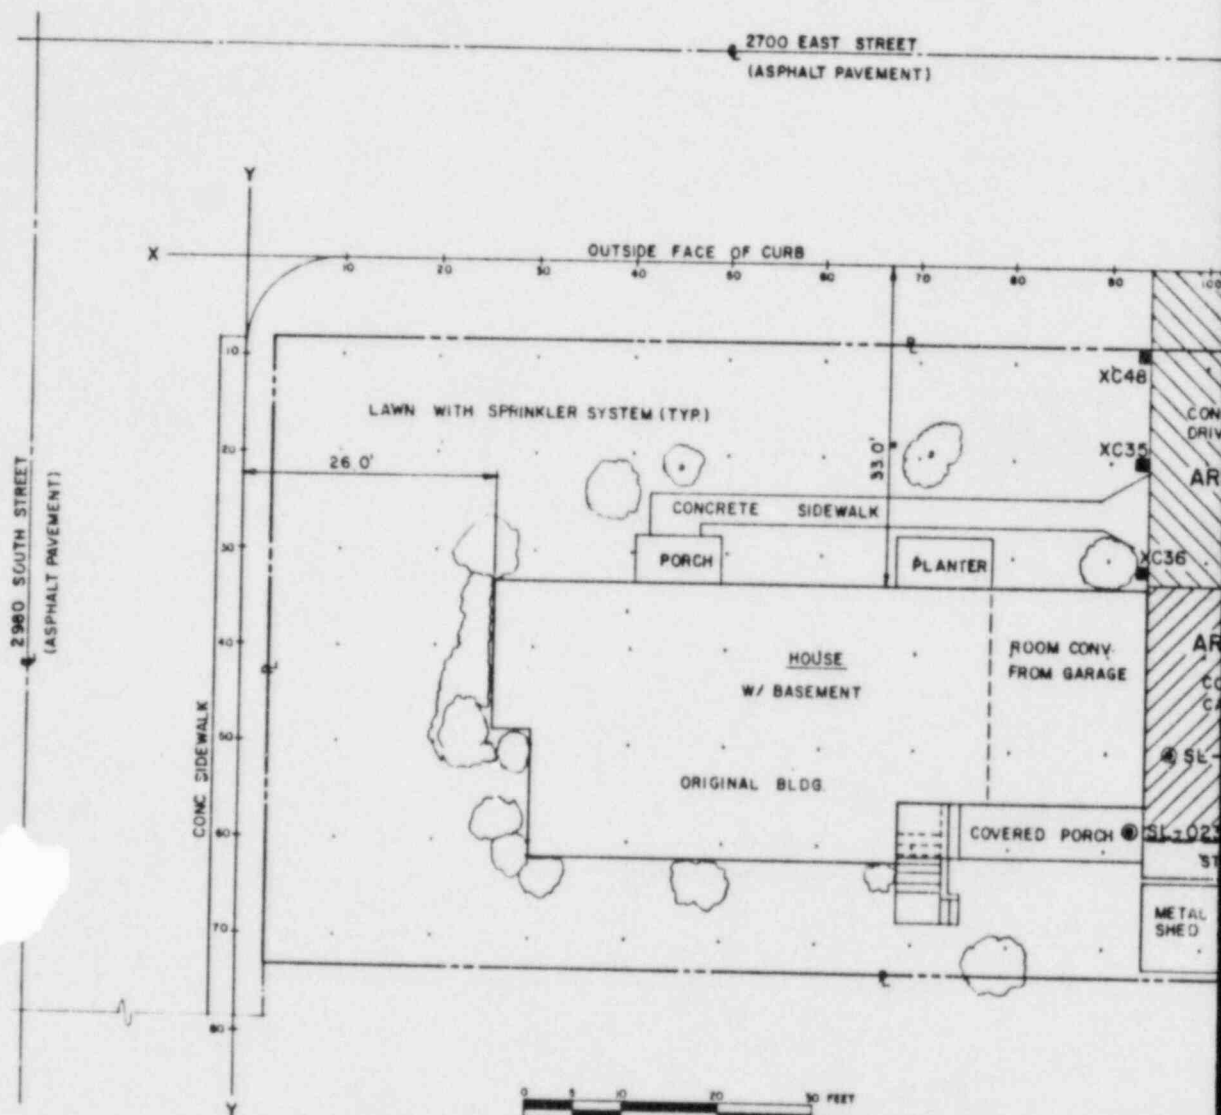
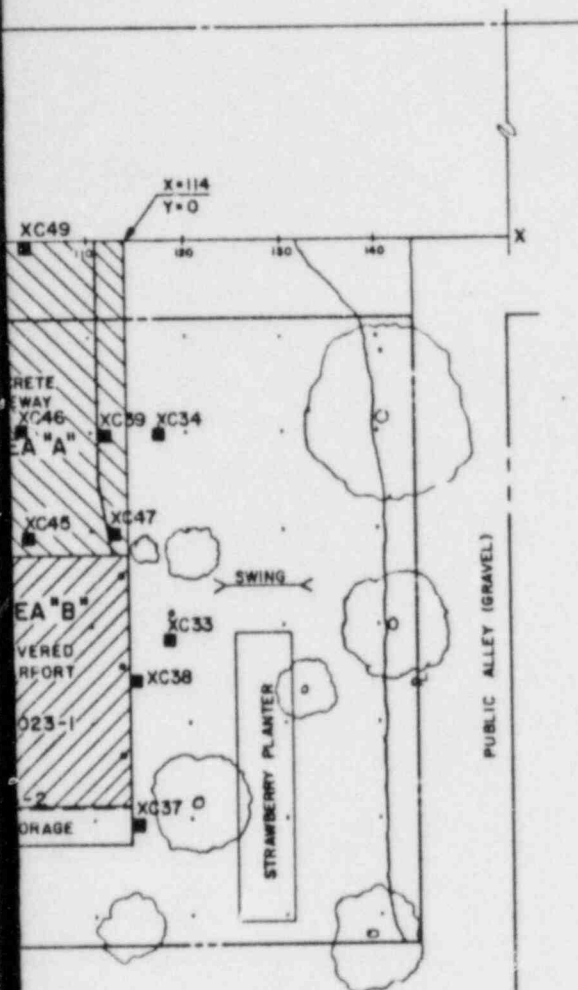
Contamination was found in the hole drilled in the carport but not in the hole drilled in the porch. The location and depth of the contamination is described in Table 3.2 and is shown in Figure 3.1.

Borehole soil samples collected by ORNL during the inclusion survey indicated the presence of contamination in the driveway. Since these holes give a good characterization of this contamination and demonstrate the boundary around the carport, their locations are shown on Figure 3.1 of this assessment and the results are found in Table 3.2.

One area of contamination was identified in the survey. This area consists of the covered carport, the concrete driveway, and a 3-foot wide strip immediately south of the driveway. The estimated depth of the contamination is 12 inches in the driveway and about 36 inches in the carport.

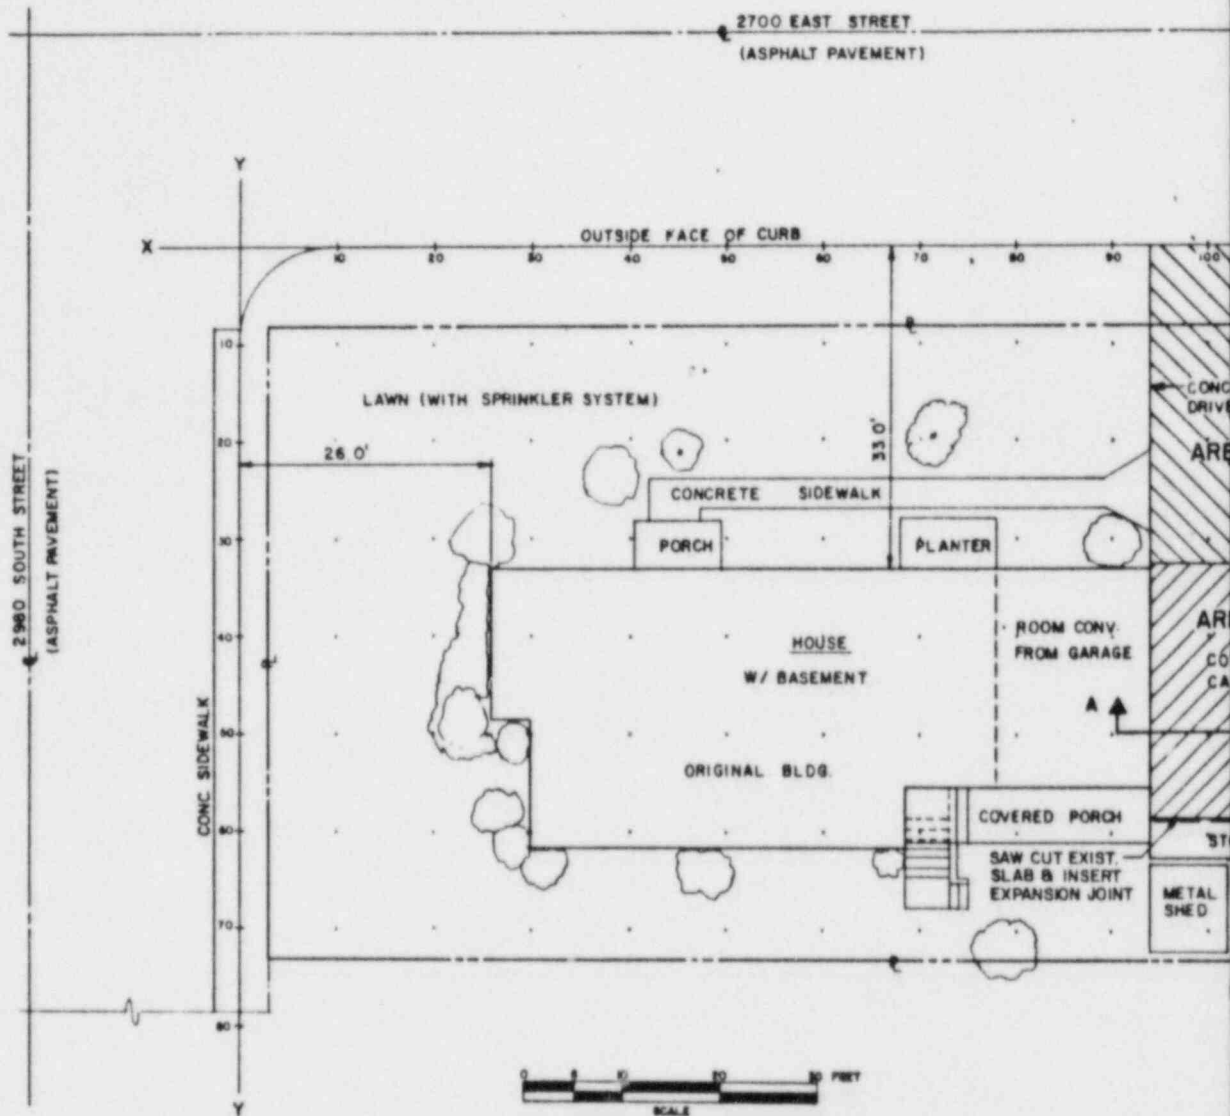
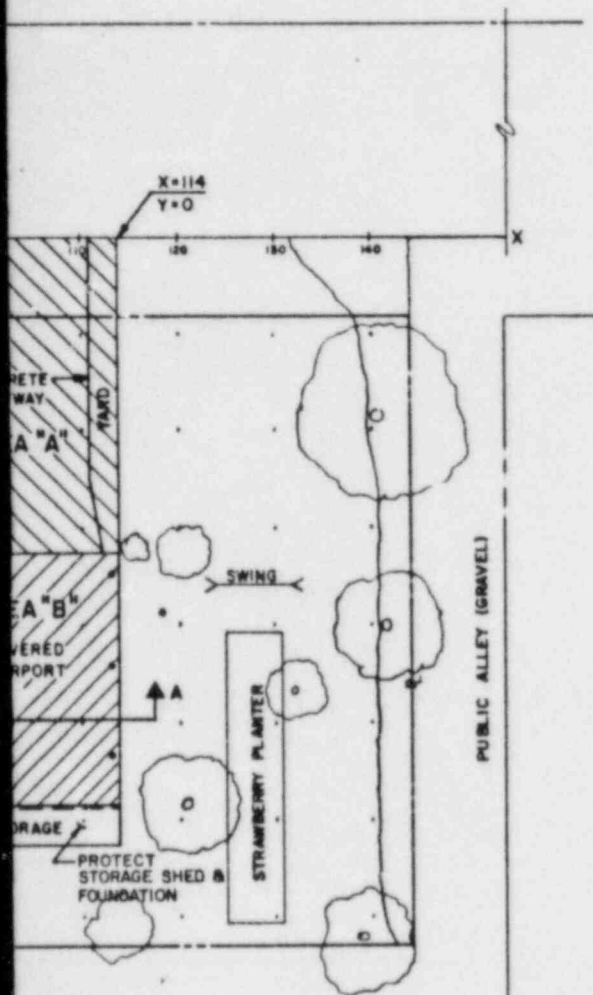
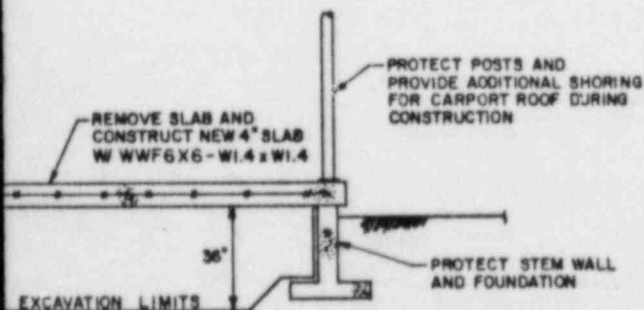
SL-017-120

DEPTH OF ESTIMATED  
CONTAMINATION  
LEGEND

AREA "A"

= 12"

AREA "B"

= 36"

- DEMOLISH AND REMOVE EXISTING CONCRETE SLAB
- EXCAVATE CONTAMINATED SOIL
- PLACE AND COMPACT STRUCTURAL FILL PER SPEC.
- CONSTRUCT NEW 4 INCH THICK CONCRETE SLAB WITH 6" X 6" WWF
- BACKFILL LAWN AREA WITH COMMON FILL, TOP WITH 6 INCHES OF TOPSOIL AND SOG

- DEMOLISH AND REMOVE EXISTING CONCRETE SLAB
- EXCAVATE CONTAMINATED SOIL
- PLACE AND COMPACT STRUCTURAL FILL PER SPEC.
- CONSTRUCT NEW 4 INCH THICK CONCRETE SLAB WITH 6" X 6" WWF
