Vicinity Property No. SLC 001

FINAL
THE RADIOLOGICAL AND ENGINEERING ASSESSMENT
AND FINAL DESIGN
FOR
SALT LAKE CITY PROPERTY
SL-001

April 3, 1985

PREPARED BY
MORRISON-KNUDSEN COMPANY, INC.

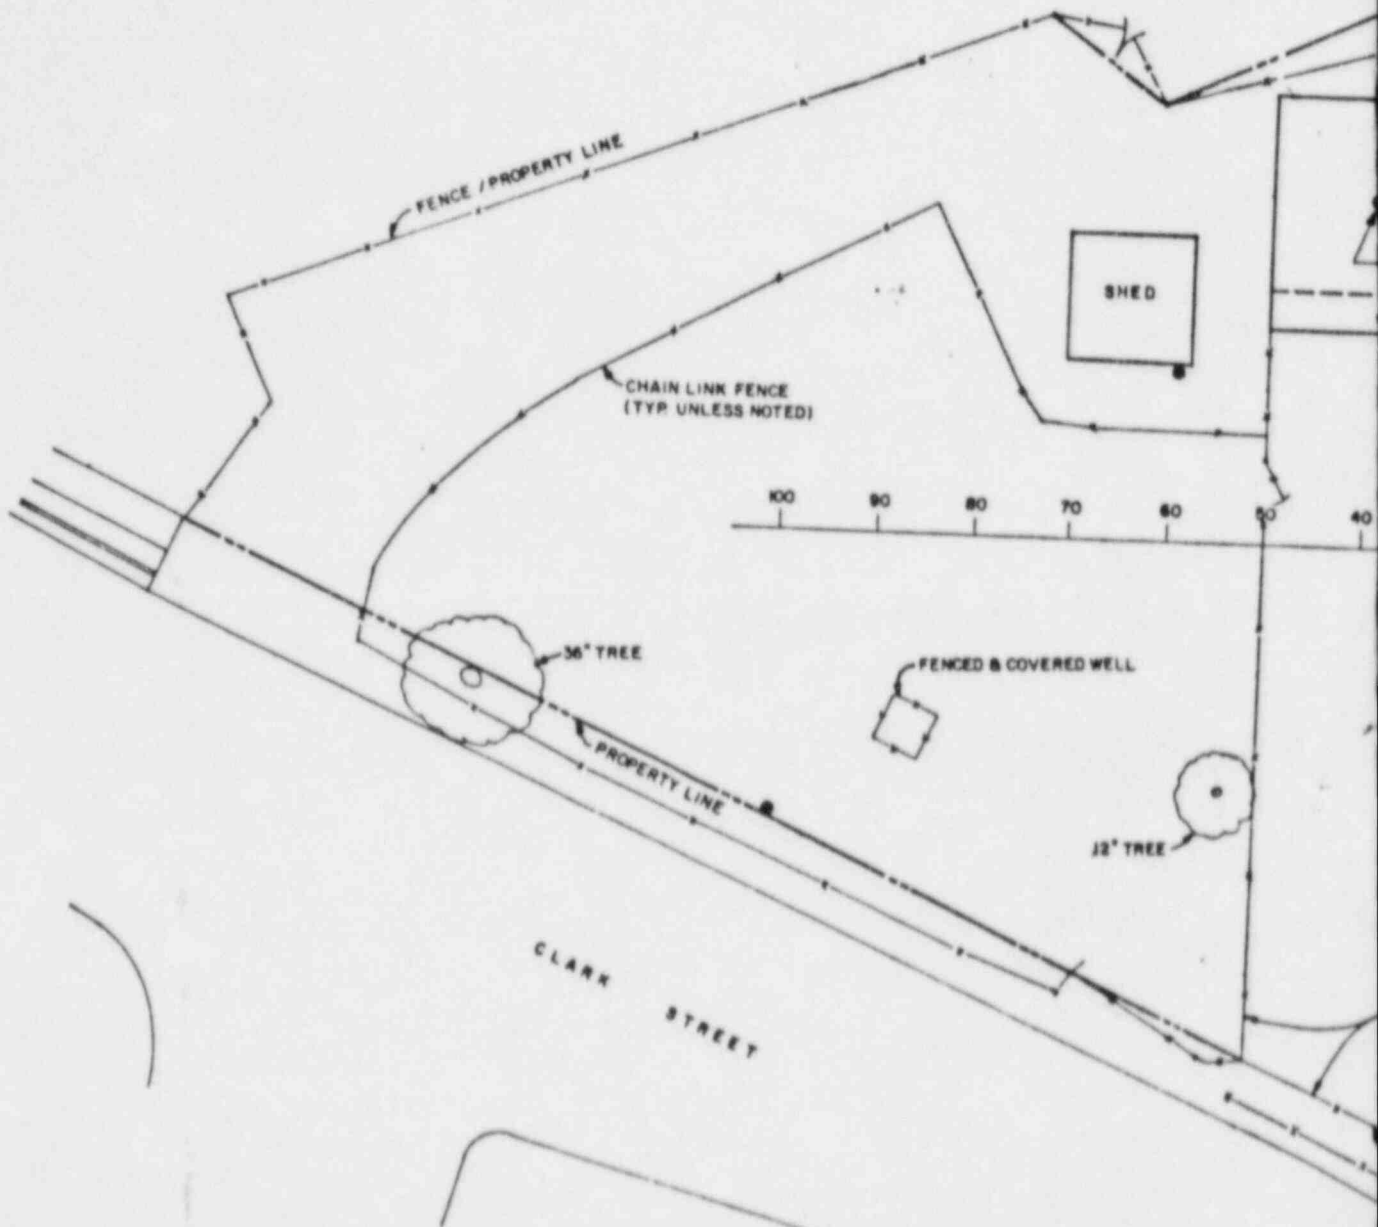
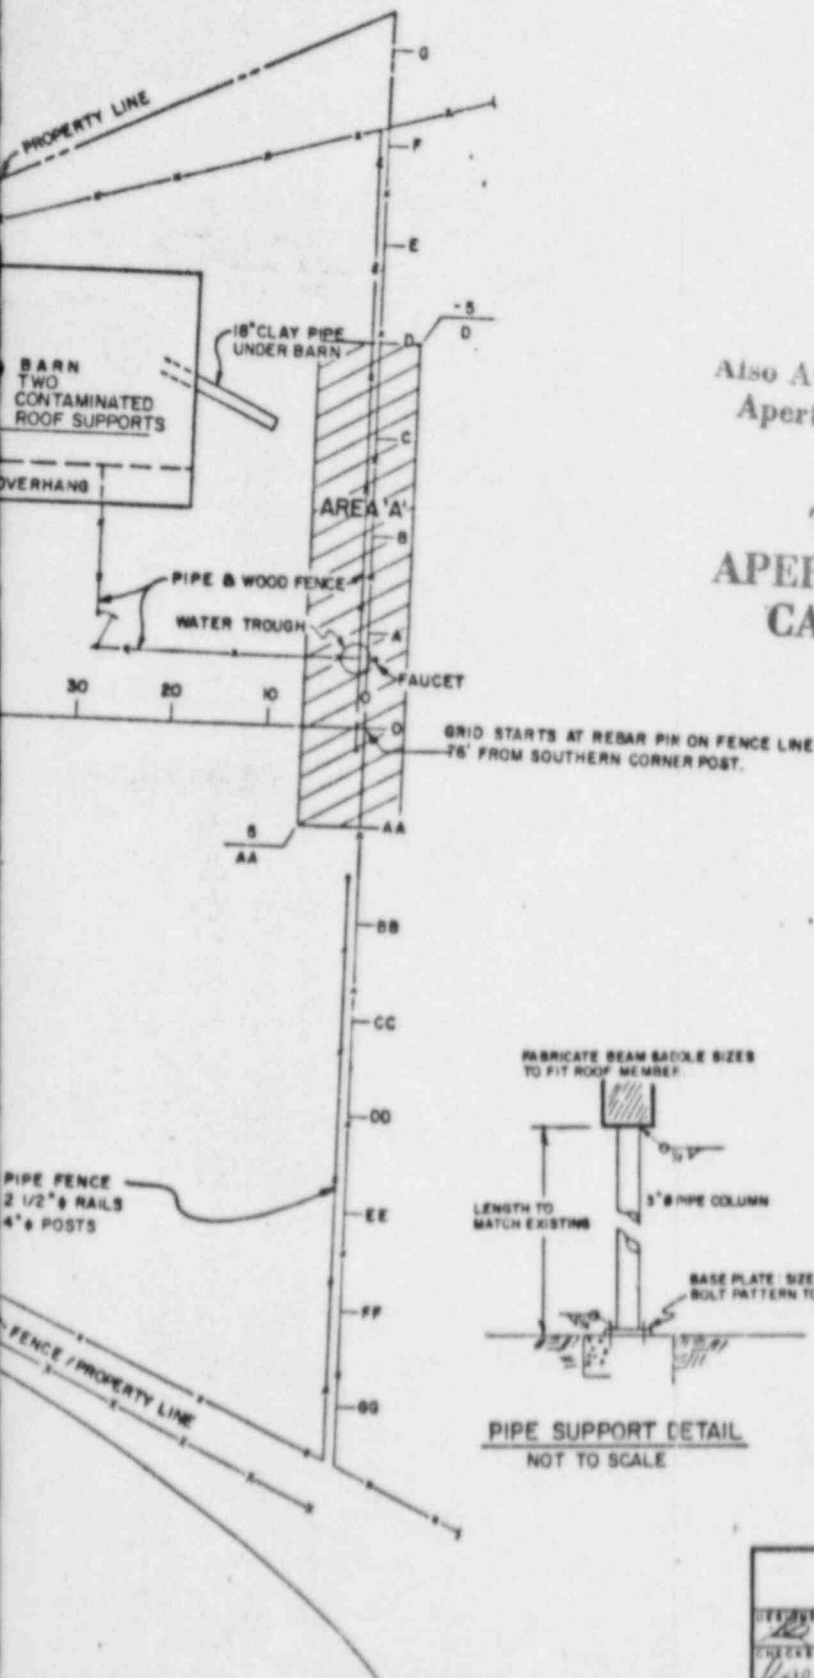
FIGURE 4.1
EXCAVATION & RESTORATION PLAN SL-001

ESTIMATED DEPTH OF CONTAMINATION

• 12"

- * EXCAVATE AND REMOVE CONTAMINATED MATERIAL TO A DEPTH OF 12 INCHES AND BACKFILL WITH COMMON FILL.
- * REMOVE FENCE AND REPLACE WITH CORRAL LINE FENCE AS SELECTED BY THE CONTRACTOR'S REPRESENTATIVE AND APPROVED BY OWNER.
- * REMOVE AND REPLACE PIPE COLUMNS.
- * PRIOR TO EXCAVATION, SOIL SAMPLES SHALL BE TAKEN TO VERIFY CONTAMINATION.

Option 2 - Complete decontamination of the property including retrieval of the contaminated material and restoration of the property. See Figure 4.1 for excavation and restoration plan. Remove approximately 75 linear feet of contaminated fence and replace with a three rail wood corral fence. Replace contaminated pipe roof supports in barn. Excavate twelve inches of soil in the area of the fence removal and replace with common fill.

Prior to excavation, soil samples shall be taken to verify contamination.

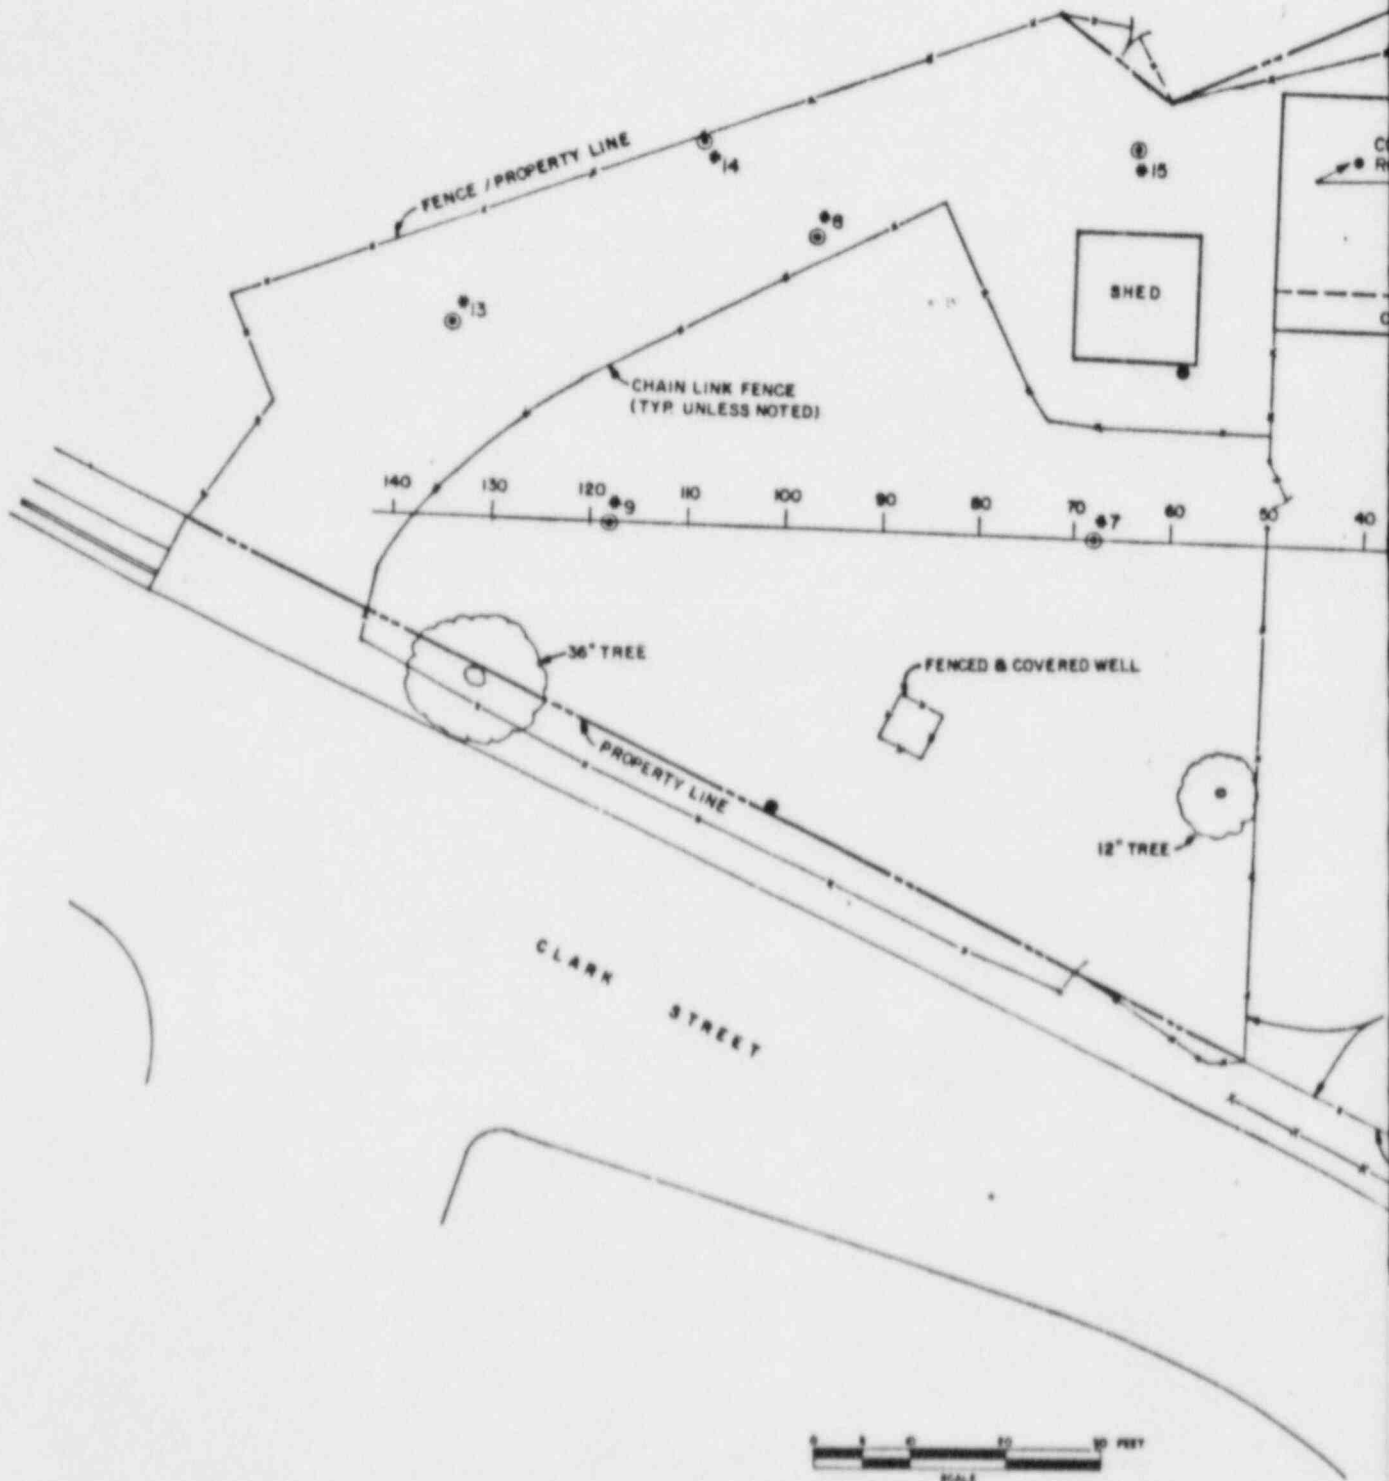
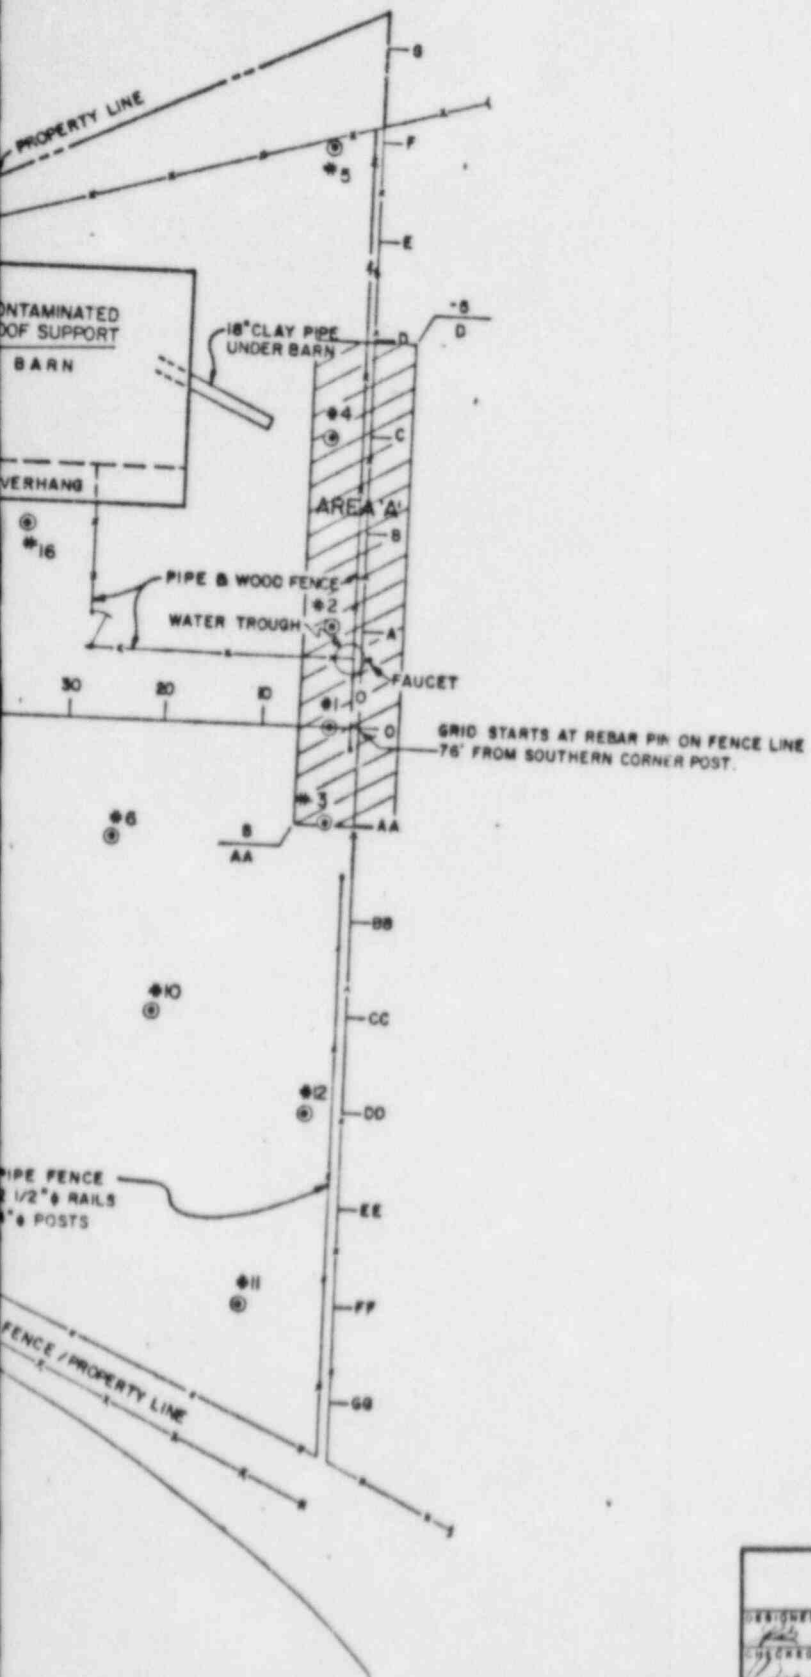
FIGURE 3.1

Contamination was found in 2 of the 16 outdoor holes augered. The location and depth of the contamination is described in Table 3.2 and is shown in Figure 3.1.

There is one area of contamination on SL-001. The area is identified as Area A on Figure 3.1 and corresponds to the area noted on the inclusion survey.

The fence in the center of Area A is constructed of pipes taken from the Vitro site. This piping is reading as high as 300 micro R/hr. It is not possible to determine if the high gamma reading and high borehole surveys taken in this area are due to contaminated soil or the pipe fence.

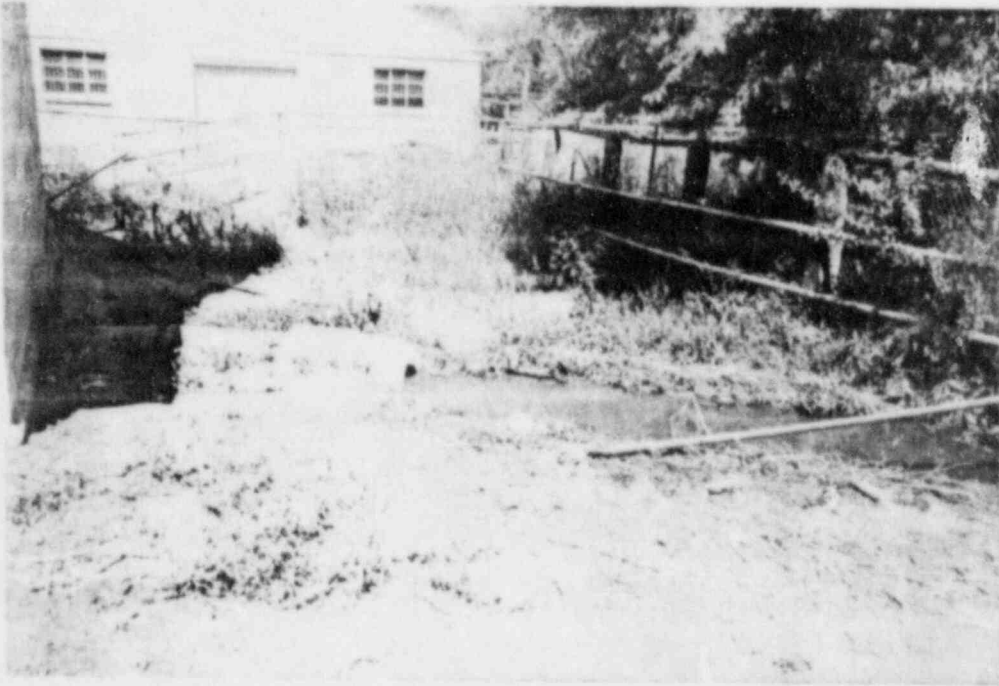
View of Contaminated Fence Looking North

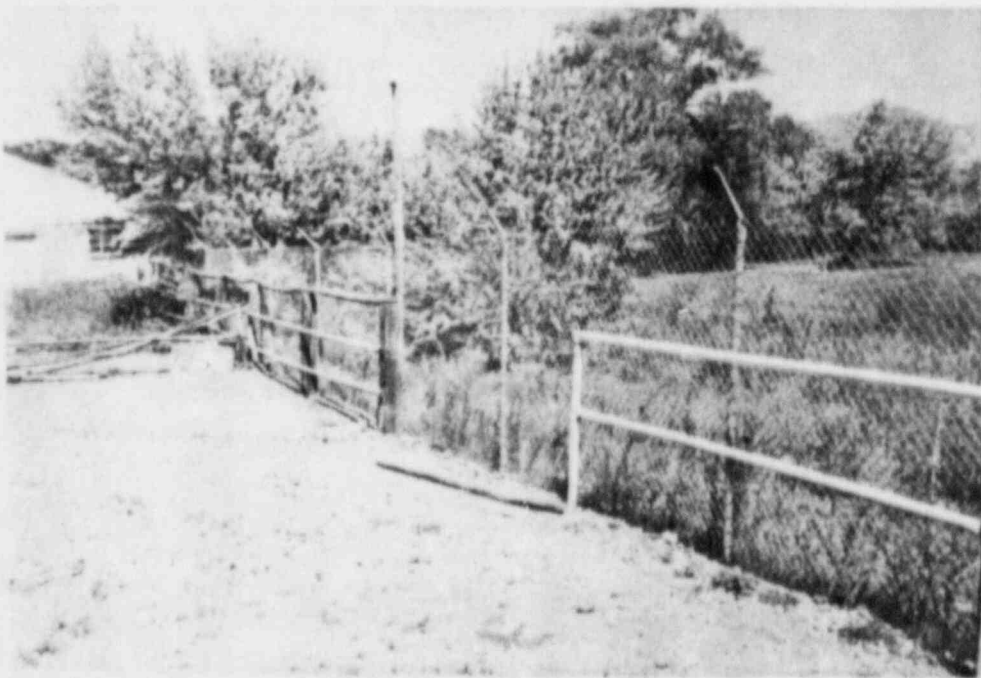
View of Contaminated Fence Looking North
