Subject: PROJECT NOS. 3 AND 5
NRC INSPECTION OF WNP-3 AND WNP-5
DOCKET NUMBERS 50-508 AND 50-509
FINAL REPORT OF POTENTIAL 10CFR50.55(e)
HYDROGEN EMBRITTLEMENT OF 3/4 INCH
LOCKWASHERS

SUBJECT: DETERMINE CAUSE OF FRACTURE OF
3/4-INCH PLATED LOCK WASHERS

Memorandum Report

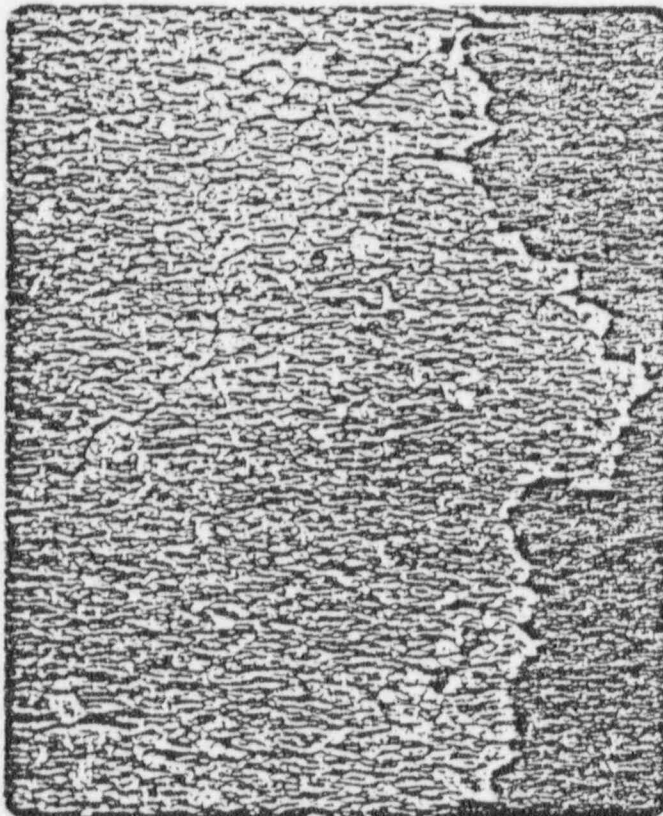
FIGURE 3
(66600)

Figure 3 (66600) 100X Etchant: Picric Hydrochloric Acid

This photomicrograph shows the microstructure along the fracture surface of the washer. This portion of the fracture was dark in color. The embrittled structure was found to be intergranular in its progression and coincided with a high degree of secondary intergranular cracks adjacent to the fracture surface.

The fracture characteristic of the bright crystalline structure was primarily a transgranular cleavage type of cracking as a result of overload on the remaining section. The fracture occurred because of the presence of the incipient embrittled structure.

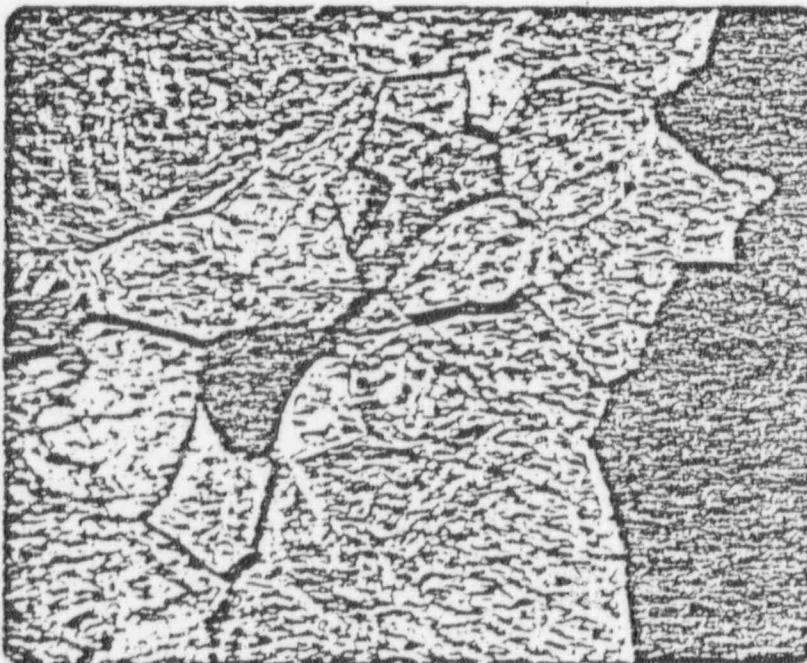
FIGURE 4
(66602)

Figure 4 (66602) 500X Etchant: Picric Hydrochloric Acid

This photomicrograph shows more detail of the microstructure in the fractured washer. The fracture plane along the darkened area of the fracture was primarily intergranular as was the secondary cracking adjacent to this fracture surface. Close examination of these cracks indicated no evidence of significant oxidation or decarburization, as would have been present from the last heat treating process applied to the washers as they were manufactured. The characteristics of these cracks were highly indicative of a hydrogen type embrittlement due to the pickling process which would have occurred at the time the washers were plated.
