Draft Radiological and Engineering Assessment

Vicinity Property No. SLC 092

THE RADIOLOGICAL AND ENGINEERING ASSESSMENT

SALT LAKE CITY PROPERTY

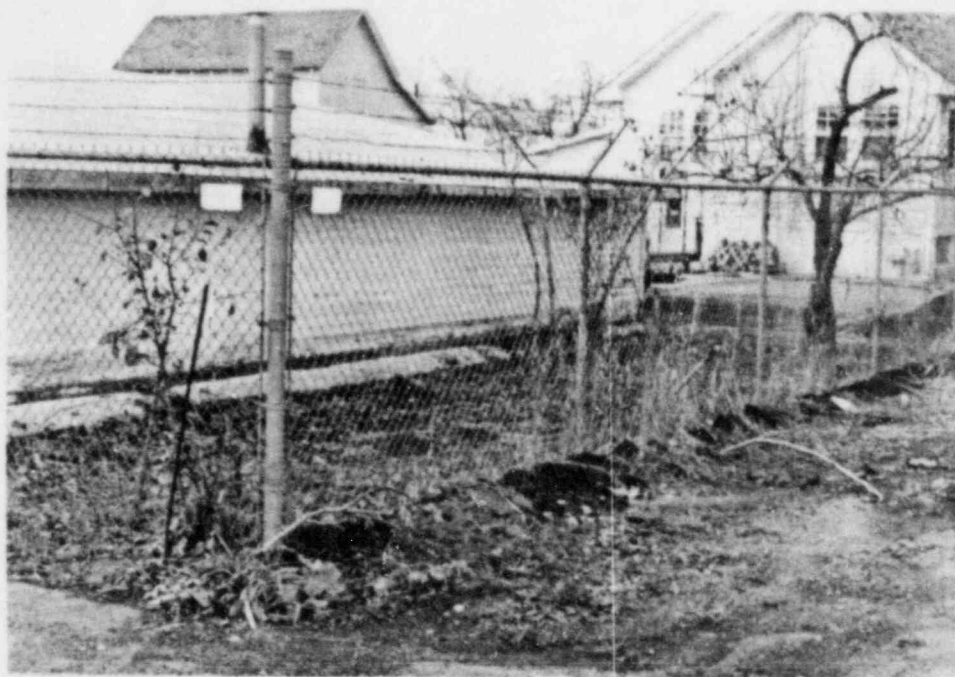
North Side of Property Looking Southwest

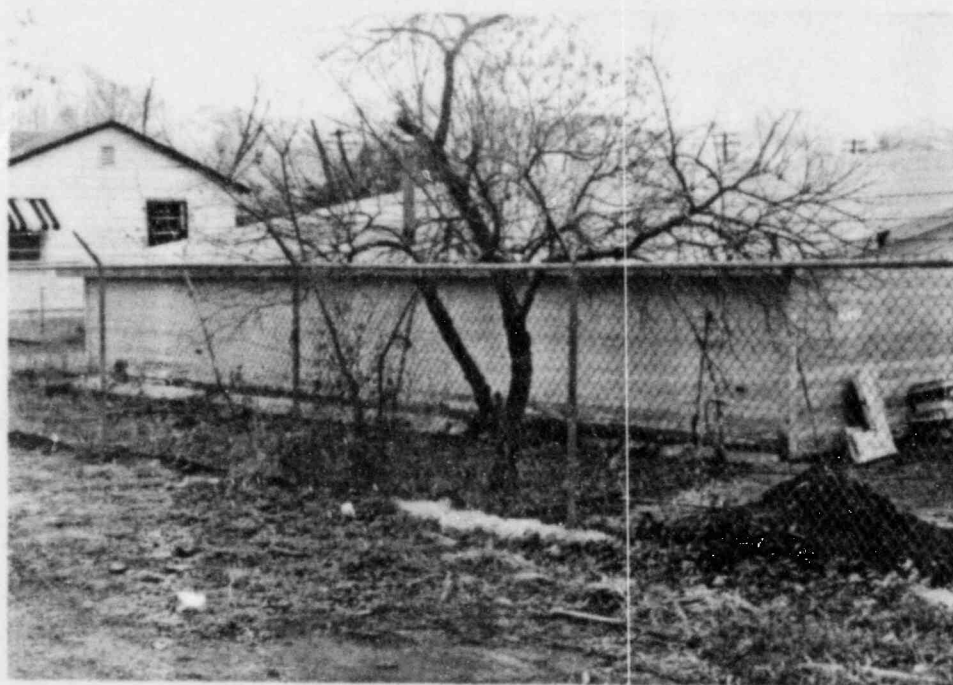
North Side of Property Looking Southeast

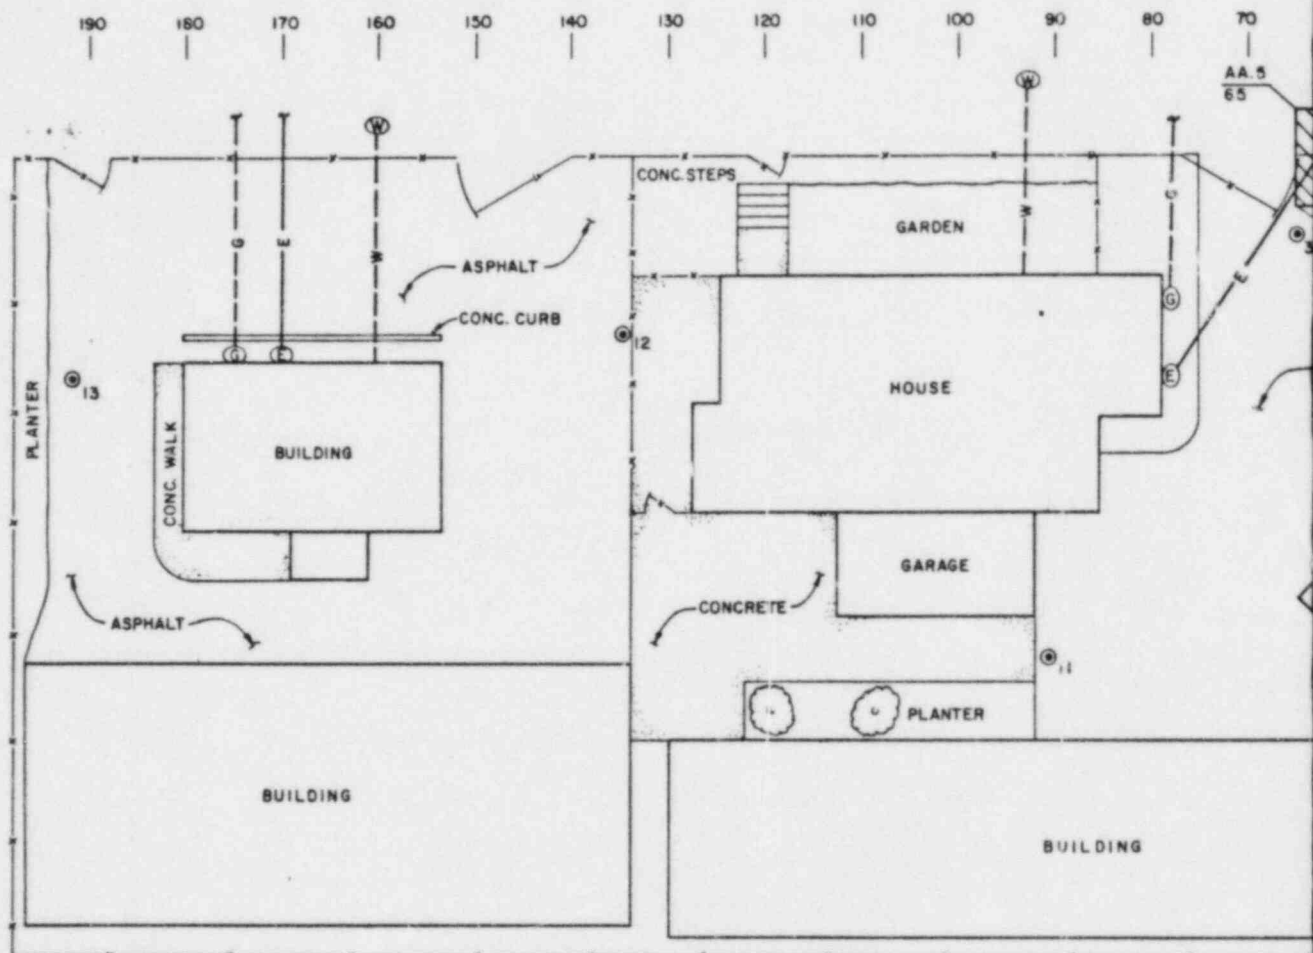
FIGURE 3.1

Contamination concentration readings on the property range from 1 to 120 pCi/g, as described in Table 3.1 and shown in Figure 3.1.

Contamination was found in 3 of the 13 outdoor holes augered. The location and depth of the contamination is described in Table 3.2 and is shown in Figure 3.1.

The area is contaminated to approximately 24 inches in depth. These findings concur with those of the inclusion survey.

24"

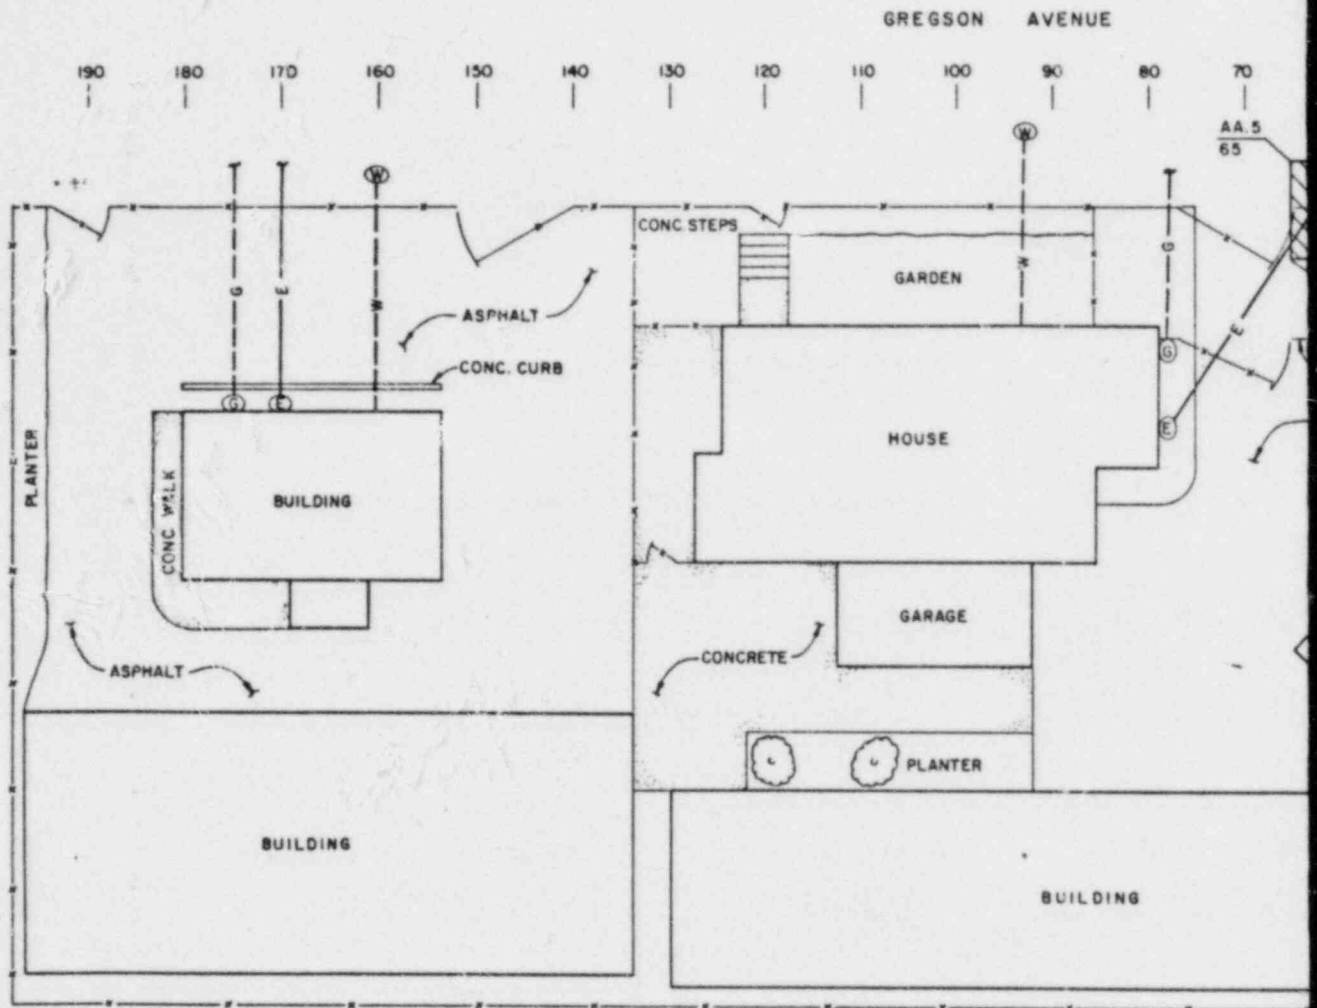
EXCAVATION & RESTORATION PLAN SL-092

3. THE EXCAVATION LIMITS AND DEPTHS ARE BASED ON A LIMITED NUMBER OF BORINGS TAKEN DURING THE RADIOLOGICAL SURVEYS OF THIS PROPERTY. ADDITIONAL RADIOLOGICAL SURVEYS PERFORMED DURING REMEDIAL ACTION MAY REQUIRE MORE OR LESS EXCAVATION TO BE TAKEN FROM THE DESIGNATED AREAS. ALL CHANGES TO THE LIMITS AND DEPTHS OF EXCAVATION AS SHOWN ON THE DESIGN DRAWINGS SHALL BE AS DIRECTED BY THE CONTRACTORS REPRESENTATIVE.

- REMOVE AND SALVAGE CHAIN LINK FENCING.
- INSTALL TEMPORARY SECURITY FENCING WITH GATE AS SHOWN.
- REMOVE TREES WITHIN CONTAMINATED AREA.
- REMOVE ASPHALT PAVING.
- EXCAVATE TO A DEPTH OF 24 INCHES.
- BACKFILL WITH CLEAN COMMON FILL.
- PLACE 12 INCHES OF CLEAN TOPSOIL IN GARDEN AREA.
- REPLACE TREES WITH SIMILAR TYPE AND SIZE SUBJECT TO APPROVAL OF CONTRACTOR'S REPRESENTATIVE.
- PLACE AND COMPACT 6 INCHES OF AGGREGATE BASE COURSE IN PAVED AREA.
- REPAVE WITH 3 INCHES OF ASPHALT PAVING.
- REPLACE CHAIN LINK FENCING.
- REMOVE TEMPORARY SECURITY FENCING.
