## LICENSEE EVENT REPORT (LER)

FACILITY NAME (1)  
La Crosse Boiling Water Reactor (LACBWR)DOCKET NUMBER (2)  
0 5 0 0 0 4 0 9 1 OF 0 3TITLE (4)  
Reactor Partial Scram due to Lower Control Rod Drive Mechanism

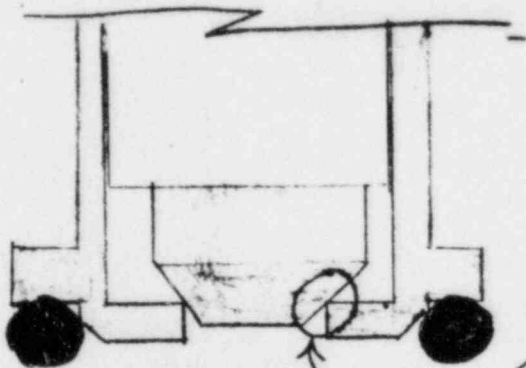
An internal oil leak on the CRDM in position 12 was found to be due to a small metal chip imbedded in 1 of the 2 scram solenoids' valve seat, which allowed oil flow past the seat. This condition could have caused a CRDM low oil level partial scram, but is considered a less likely scram cause, since a CRD charging pump had been running periodically to maintain system pressure. The spare mechanism was installed in position 12.

Low oil level in any one of the 29 CRDMs accumulators also causes a partial scram. During operation, an internal leak in the CRDM in position 12 was causing the hydraulic charging pumps (P) to periodically run to maintain system pressure. It is possible, but considered less likely, that low oil level in CRDM 12 caused the partial scram. A small metal chip (see next page) was found imbedded in the sealing edge of the seat of one of its scram solenoids. This chip would have allowed a small amount of internal hydraulic fluid leakage, causing the charging pump to run periodically to maintain system pressure and hence oil level in CRDM 12's accumulator. Since the

Metal chip found  
imbedded in valve  
seat.

hydraulic charging system was operating properly, low oil level in CRDM 12 is a less likely cause of the partial scram. The spare lower CRDM was installed in position 12 and the scram solenoid was replaced in the mechanism which had been removed.
