APPLICANT: Northeast Nuclear Energy Company  
FACILITY: Millstone Nuclear Power Station, Unit 3  
SUBJECT: SUMMARY OF MILLSTONE 3 SEISMIC II/I MEETING

The purpose of this meeting was to discuss the non-seismic/seismic interaction program for Millstone 3.

**THE APPLICATION OF EXPERIENCE DATA  
TO SEISMIC INTERACTION AT THE  
MILLSTONE III NUCLEAR POWER PLANT**

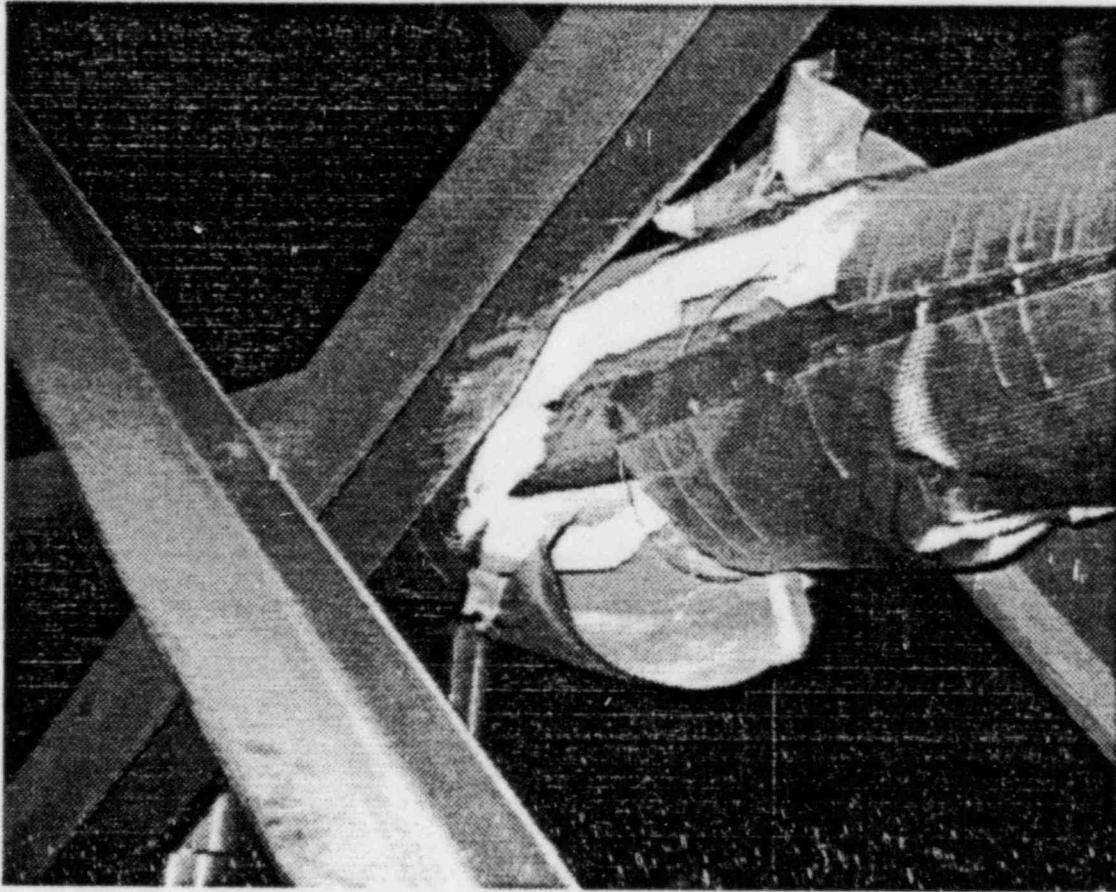
INSULATION AND BRACING DAMAGE AT  
LAS VENTANAS POWER PLANT, CHILE  
PHOTOGRAPHED ON MARCH 8, 1985  
NO DAMAGE TO PRESSURE BOUNDARY

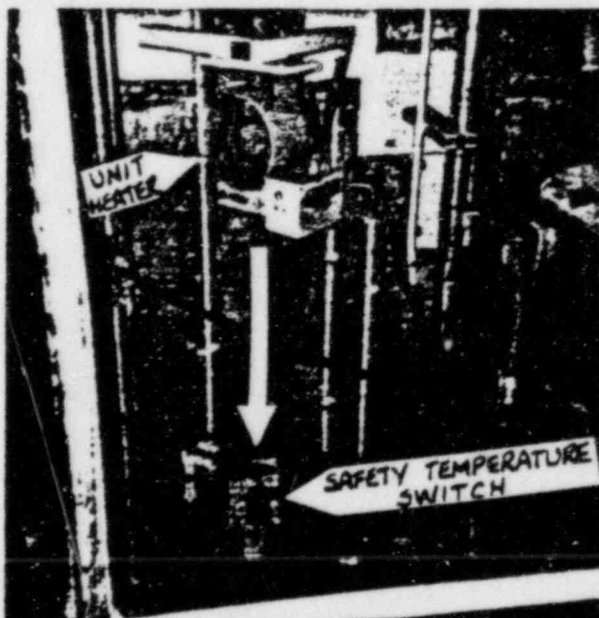
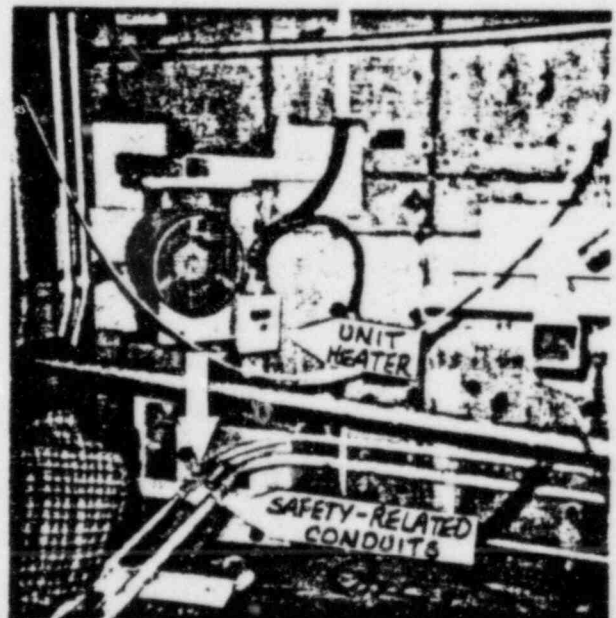
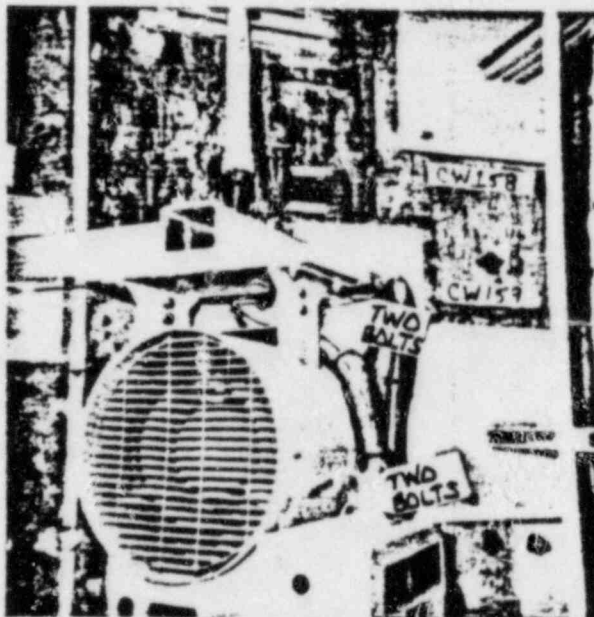
No credible singular failure mechanism is present in the support configuration. In the unlikely case of one of the bolts failing during a seismic event, adequate load path redundancy provided by the

Unit heaters will not become detached during a seismic event since adequate anchorage is provided. Subsequently, no functional impairment of nearby safety-related components will occur.

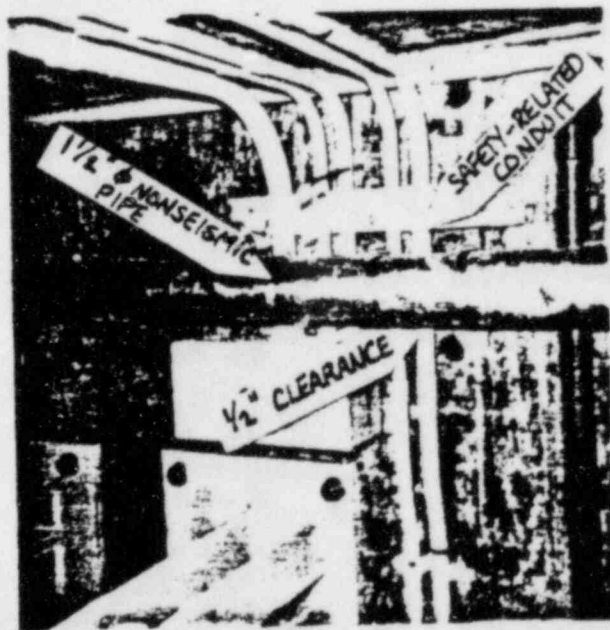
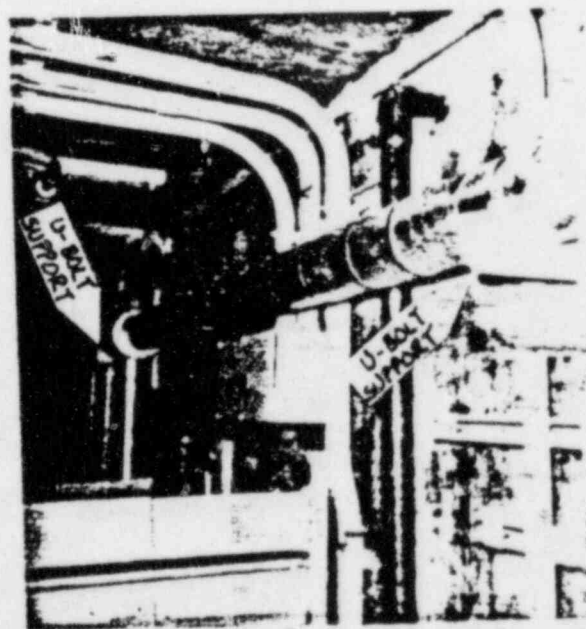
Evaluation: The safety-related conduit is restricted from movement towards the nonseismically supported 1 1/2" water pipe by a seismic U-strap/unistrut support located 7" from the potential point of interaction. The 1 1/2" water pipe is restricted from movement towards the safety-related conduit by U-bolts which secure the pipe to angle iron cantilever supports located on either side of the potential point of interaction (see Photo No. 2).

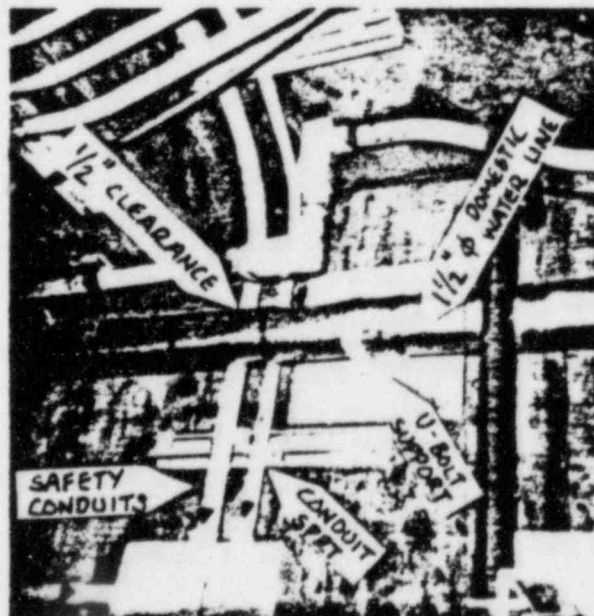
Photo No. 1

Evaluation: The 1 1/2" diameter nonseismic water pipe is restricted from movement towards the safety-related conduits by a U-bolt support located 10" and 13" respectively from the potential point of interaction. The conduits are well-supported against movement towards the nonseismically supported pipe by a U-strap/unistrut support located 9" from the potential point of interaction. Due to the close proximity and adequacy of the supports, the relative seismic movement between the components will be very small and adequate

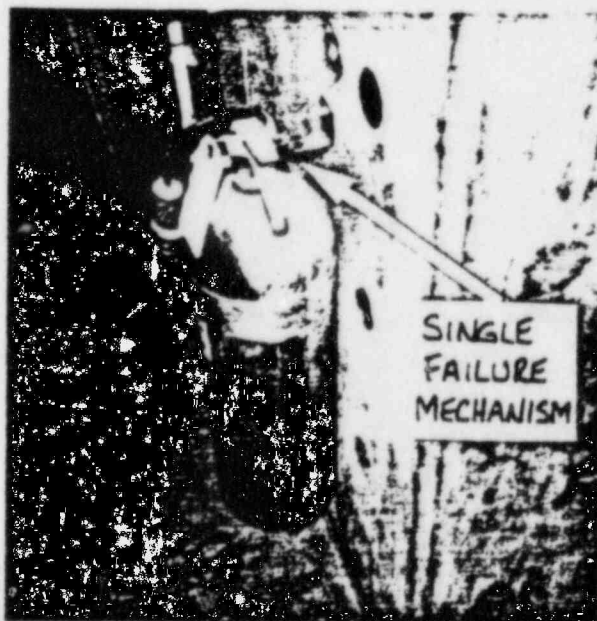
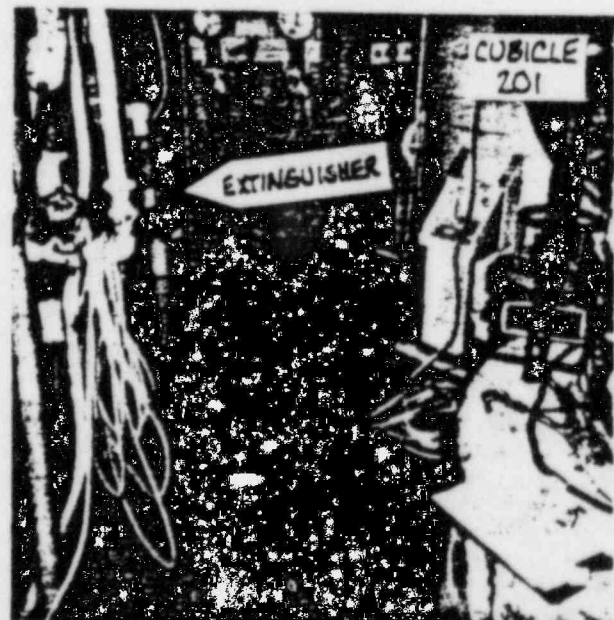
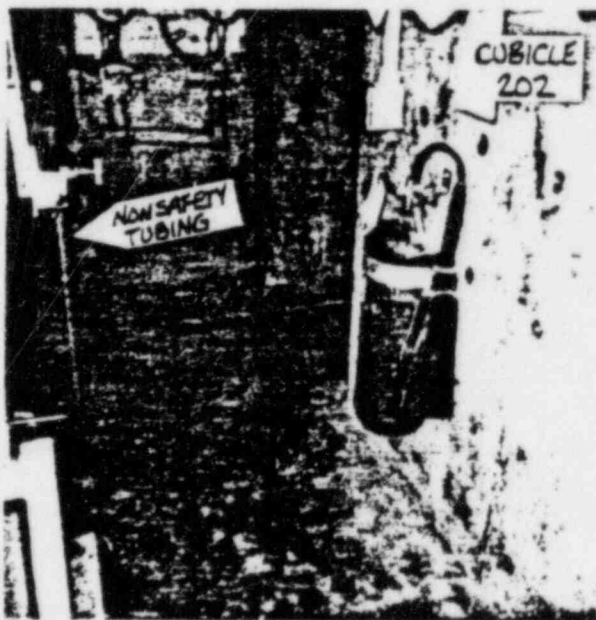
Description: Portable fire extinguishers in both safety-related service water cubicles (one in each cubicle) are gravity hung onto supports mounted to the wall (see Photo No. 1). Vertical excitation from a seismic event will cause the fire extinguishers to become completely detached from their supports.

The fire extinguishers will not fall onto any safety-related components since all safety-related components susceptible to damage from the falling fire extinguishers are remotely located from the area (see Photos 2 and 3). In addition, the ability for

Resolution: The fire extinguishers are expected to lose their anchorage during a seismic event, however, no functional impairment of safety-related components will occur.

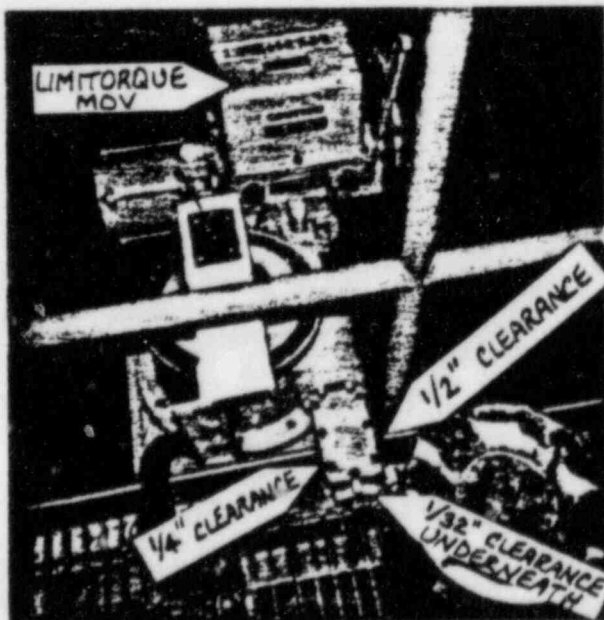
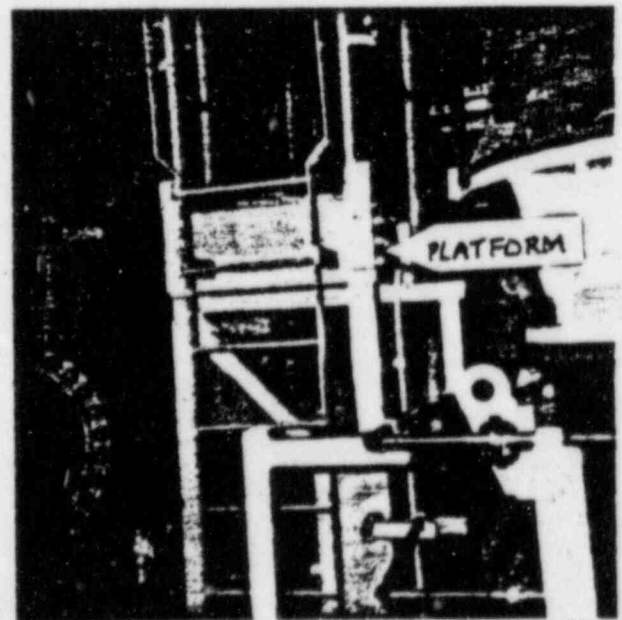
Nevertheless, the acceptability of this configuration cannot be determined by a visual/judgemental assessment because of the

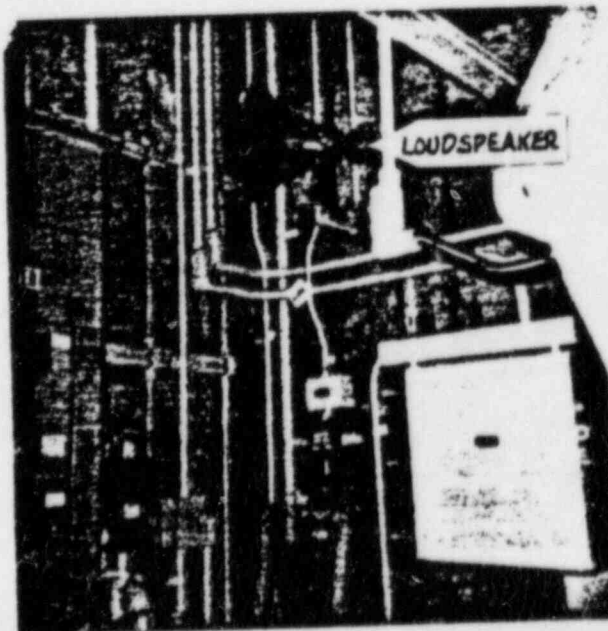
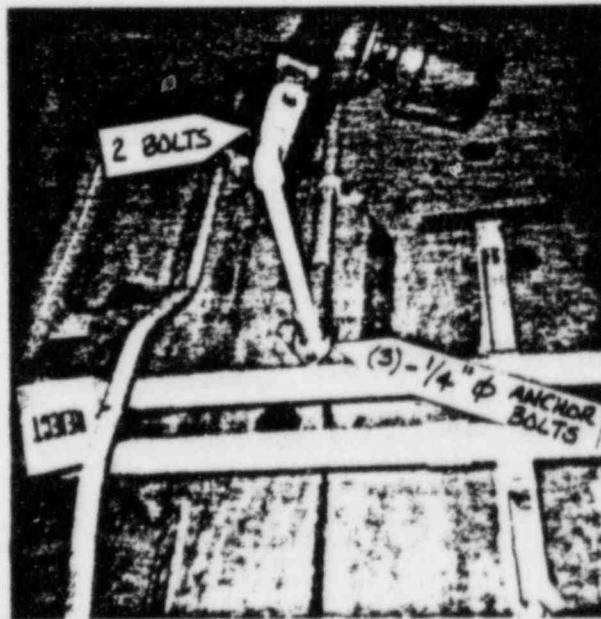
No credible singular failure mechanism is present in the support. If one of the bolts should fail during a seismic event, adequate load path redundancy provided by the remaining bolts precludes a complete loss of anchorage of the unit.

Loudspeakers will not become detached during a seismic event since adequate anchorage is provided. Subsequently, no functional impairment of safety-related components will occur.

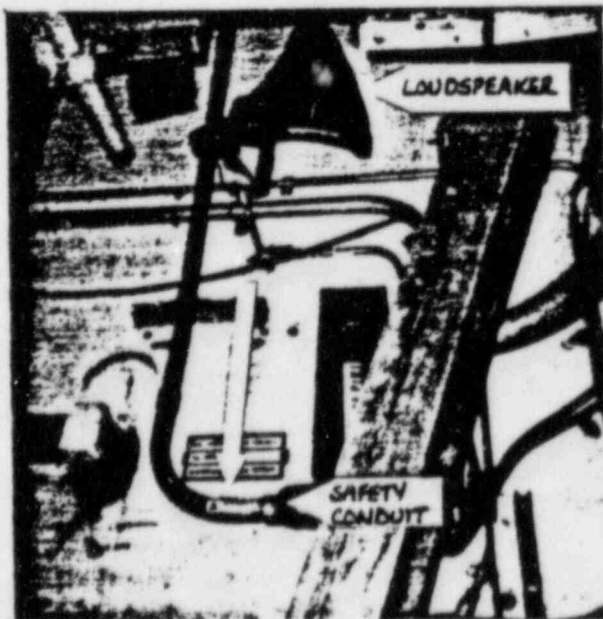
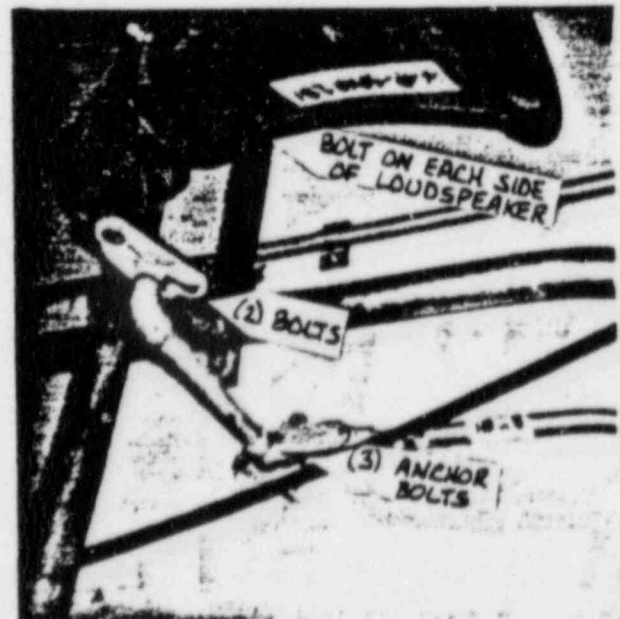
No credible singular failure mechanism is present in the loudspeaker's support configuration. If one of the bolts should fail during a seismic event, adequate load path redundancy provided by the remaining bolts precludes a complete loss of anchorage of the unit.

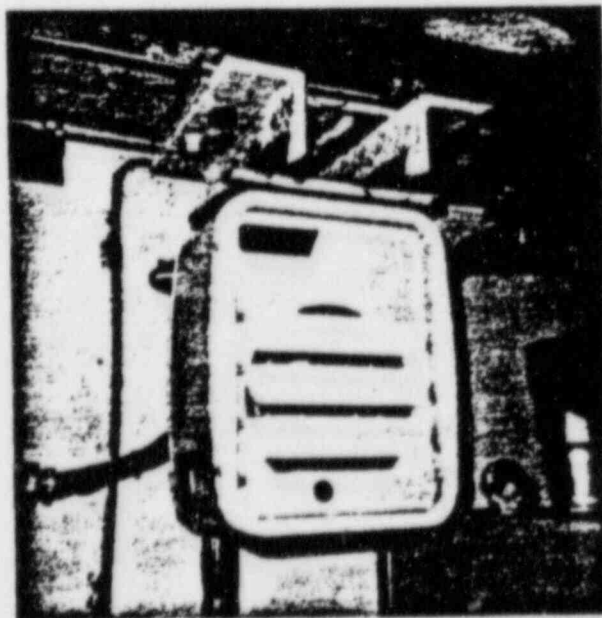
Photo No. 1

No credible singular failure mechanism is present in the unit heater's support configuration. If one of the bolts should fail during a seismic event, adequate load path redundancy provided by the

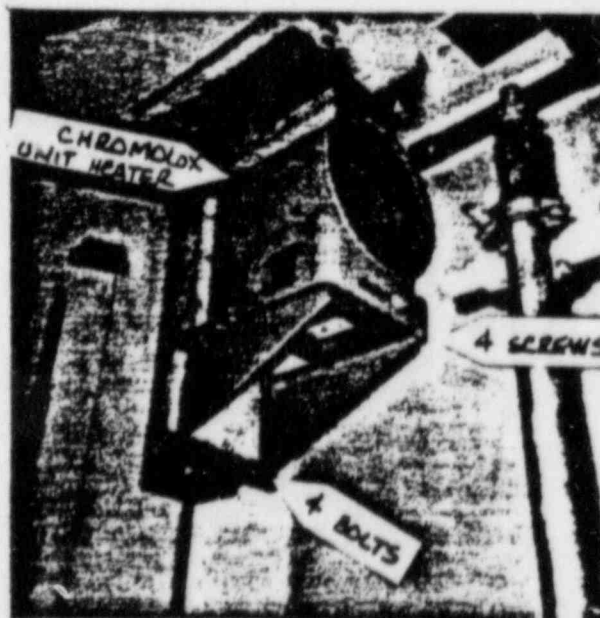
Photo No. 1

Description: A chromolox unit heater is mounted in the sample room which contains safety-related components (see Photo No. 1). A loss of anchorage would cause the unit heater to become a gravity missile possibly targeting safety-related components.

No credible singular failure mechanism is present in the unit heater's support configuration. If one of the bolts or screws should

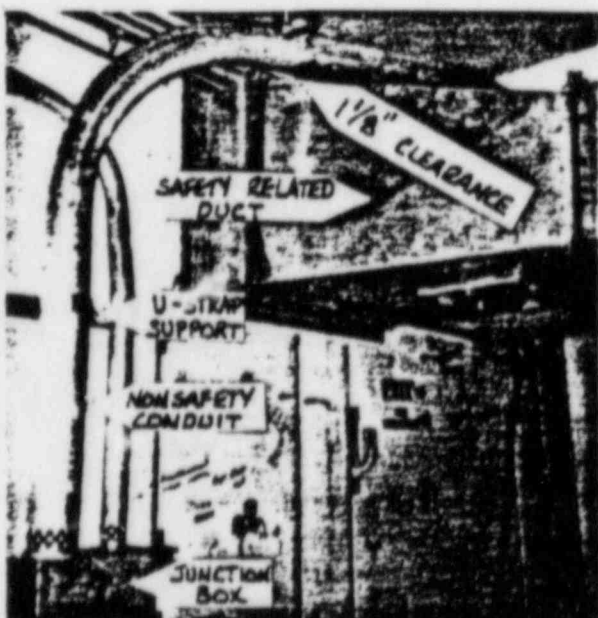
Due to the adequate anchorage and inherent stiffness characteristics of both components, the relative seismic displacements between the two components will not exceed the 1-1/8" available clearance between them.
