RADIOLOGIC AND ENGINEERING ASSESSMENT

DOE ID NO.: GJ-03999-RS
ADDRESS: 1930 Kennedy Avenue

JULY 1985

BENDIX FIELD ENGINEERING CORPORATION
P.O. Box 1569
Grand Junction, Colorado 81502

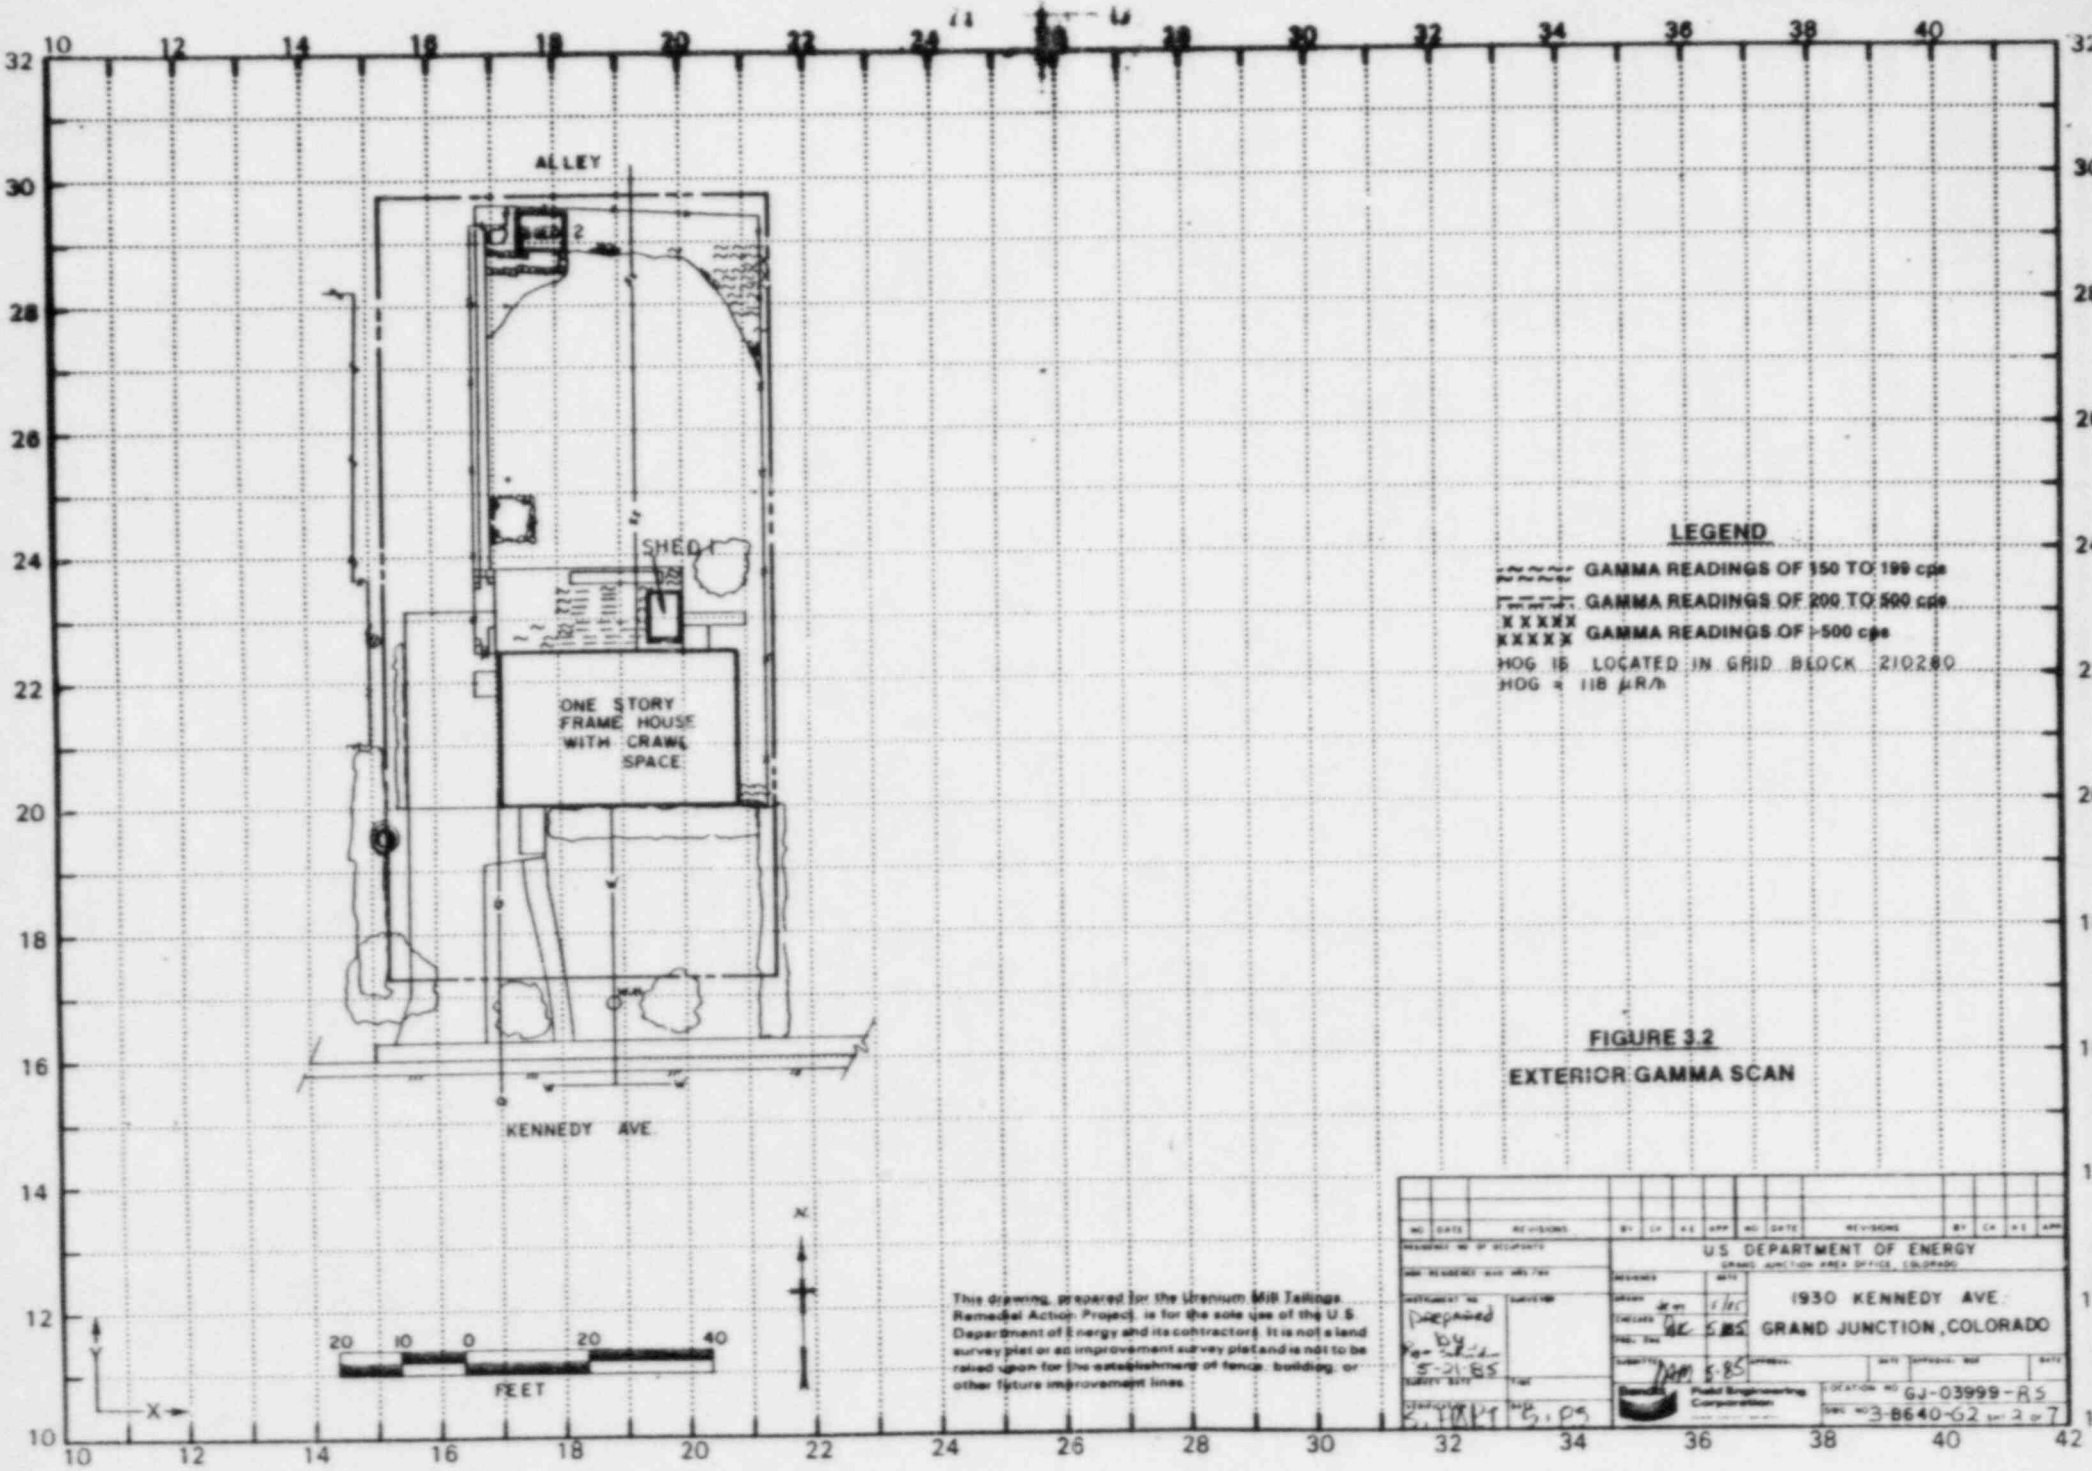
FIGURE 3.2
EXTERIOR GAMMA SCAN

Exterior radium-concentration measurements are presented in Appendix Table 3.1. Grid-point survey results are shown in Appendix Figure 3.1. Appendix Figure 3.2 presents the ranges of elevated gamma readings and indicates areas of possible contamination.

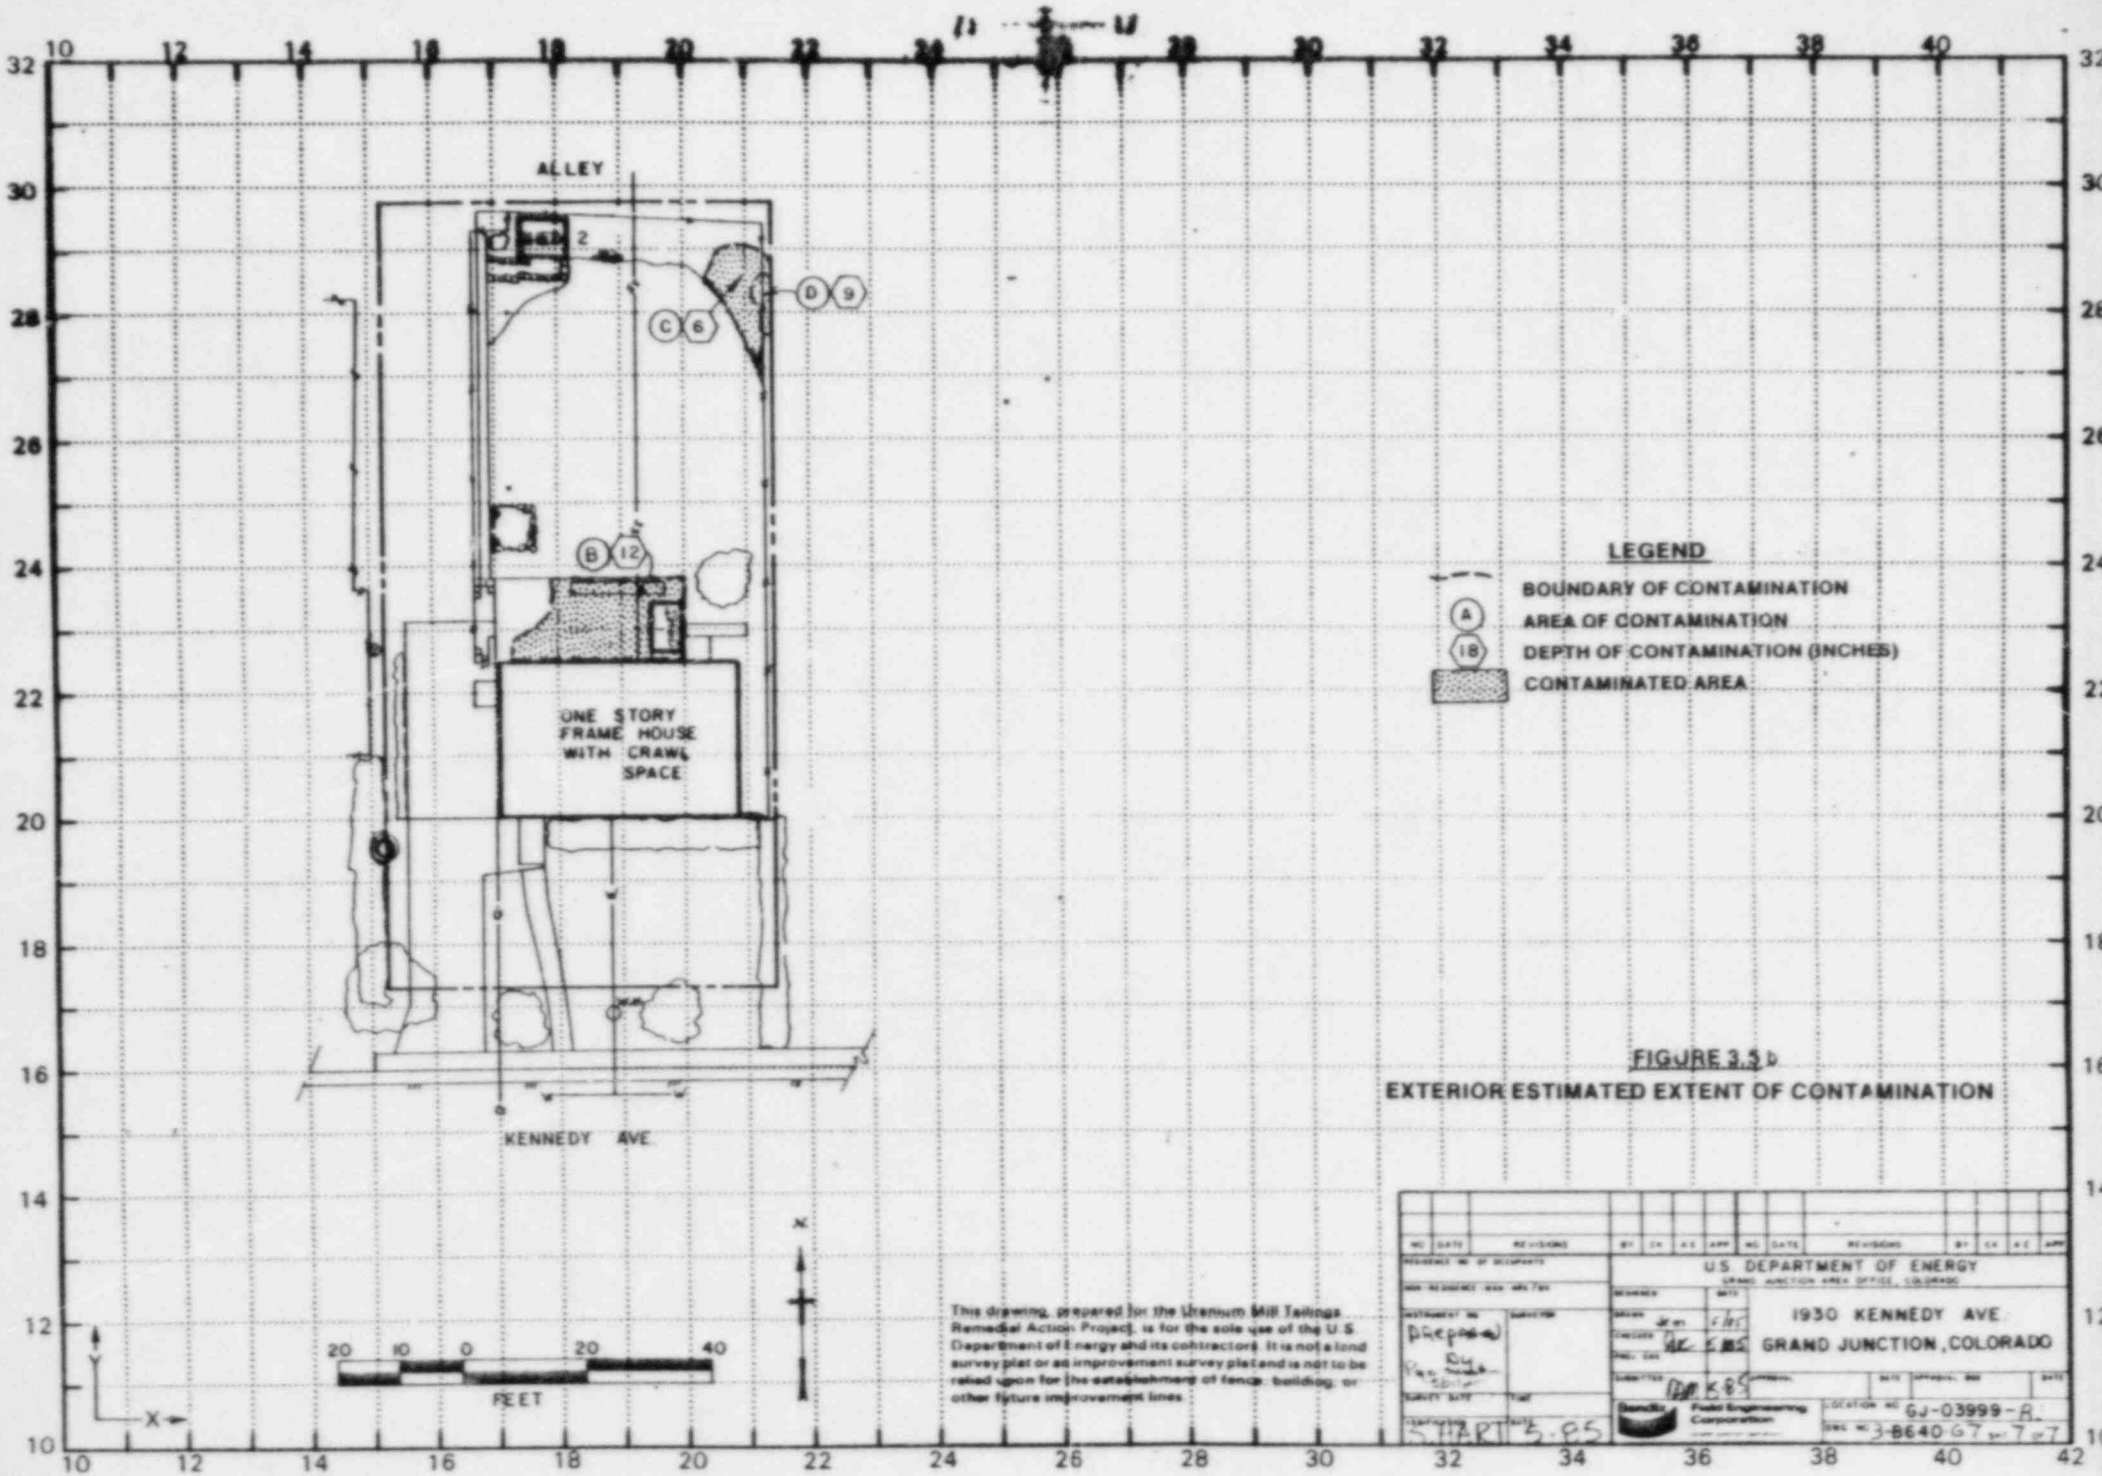
Appendix Figures 3.5a and 3.5b show identified areas and estimated depths of contamination on this property, based on assessments of all measurements taken. As noted in these figures, areas recommended for remedial action that contain identified residual radioactive materials are:

- (AREA A) Under the shed (Shed 1) on the covered patio north of the primary structure, there is an 8-inch layer of contaminated soil under a 4-inch-thick concrete slab. The total depth of contamination is 12 inches. (NOTE: Shed 1 is portable and shall be considered as exterior involvement and part of Area B. For combined square footage, see under Area B.)
- (AREA B) The covered patio north of the primary structure is contaminated. There is an 8-inch layer of contaminated soil under the 4-inch-thick concrete slab. The total depth of contamination is 12 inches (approximately 390 sf).
- (AREA C) In the northeast corner of the property, there is a contamination in the rock garden. The depth of contamination is 6 inches (approximately 75 sf).
- (AREA D) In the rock garden, a strip of soil along the east fence line is contaminated to a depth 9 inches (approximately 30 sf).

The recommended remedial action for this property, DOE ID No. GJ-03999-RS, includes removal of all areas identified as containing radioactive material (as discussed in Section 3.5 and shown in Appendix Figures 3.5a and 3.5b) and transport of removed material to the disposal site.

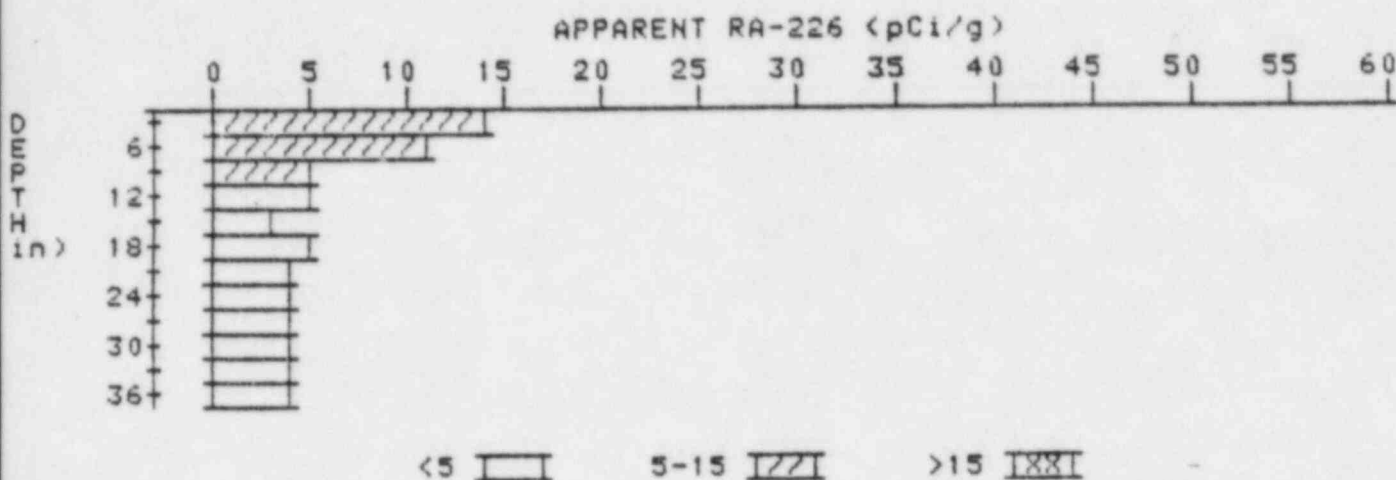
HOLE NUMBER: 11

| Loc # | Grid Location | Depth (in.) | Meas. Type | In Situ Ra-226 (pCi/g) | | Chem Ra-226 (pCi/g) | Comments |
|---|---|---|---|---|---|---|---|
| | | 03 | TC | 13.7 | | * | On patio |
| | | 06 | TC | 10.8 | | * | Next to sewer line |
| | | 12 | TC | 6.0 | | * | DC = 12 inches |

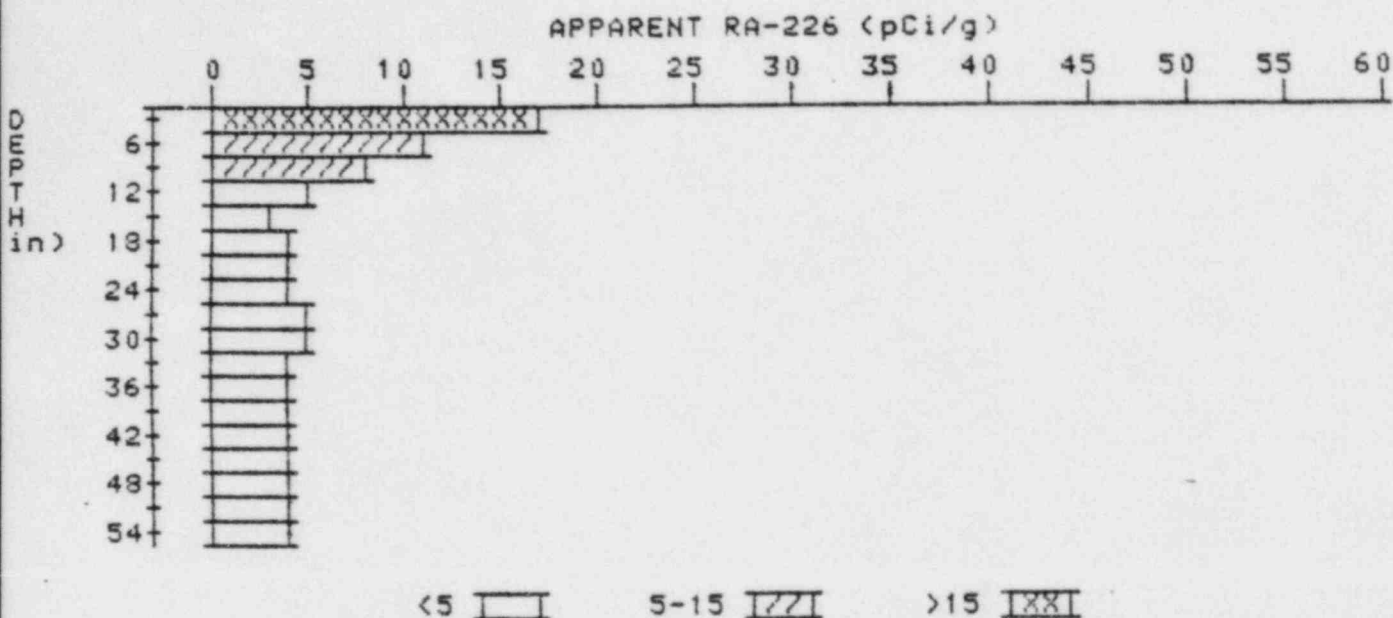
HOLE NUMBER: 20

| Loc # | Grid Location | Depth (in.) | Meas. Type | In Situ Ra-226 (pCi/g) | | Chem Ra-226 (pCi/g) | Comments |
|---|---|---|---|---|---|---|--|
| 20 | 212285 | 03 | TC | 16.6 | | * | Northeast rock garden DC = 9 inches Based on the deconvolution graph |
