**RADIOLOGIC AND ENGINEERING ASSESSMENT**

DOE ID NO.: GJ-03494-RS  
ADDRESS: 174 LITTLE PARK ROAD

JULY 1985

BENDIX FIELD ENGINEERING CORPORATION  
P.O. Box 1569  
Grand Junction, Colorado 81502

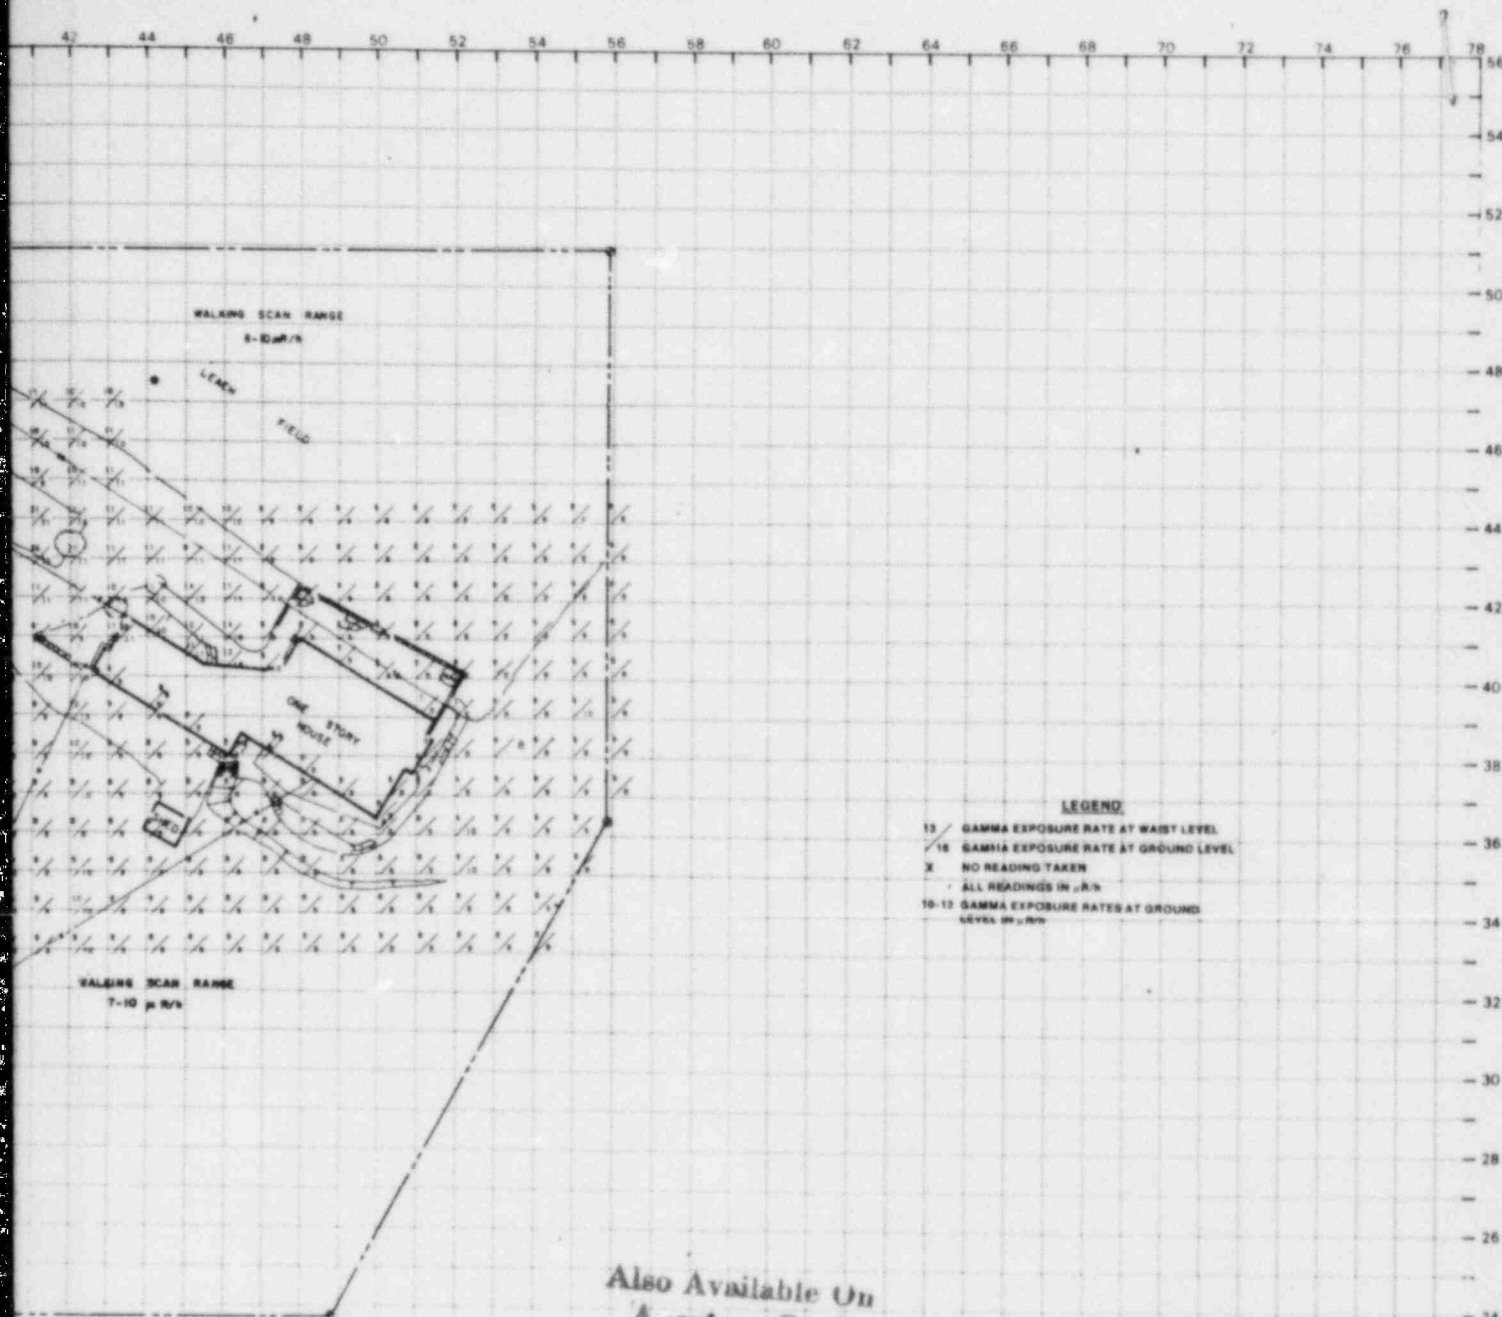
FIGURE 3.1  
EXTERIOR GRID-POINT EXPOSURE RATES

Exterior radium-concentration measurements are presented in Appendix Table 3.1. Grid-point survey results are shown in Appendix Figure 3.1. Appendix Figure 3.2 presents the ranges of elevated gamma readings and indicates areas of possible contamination.

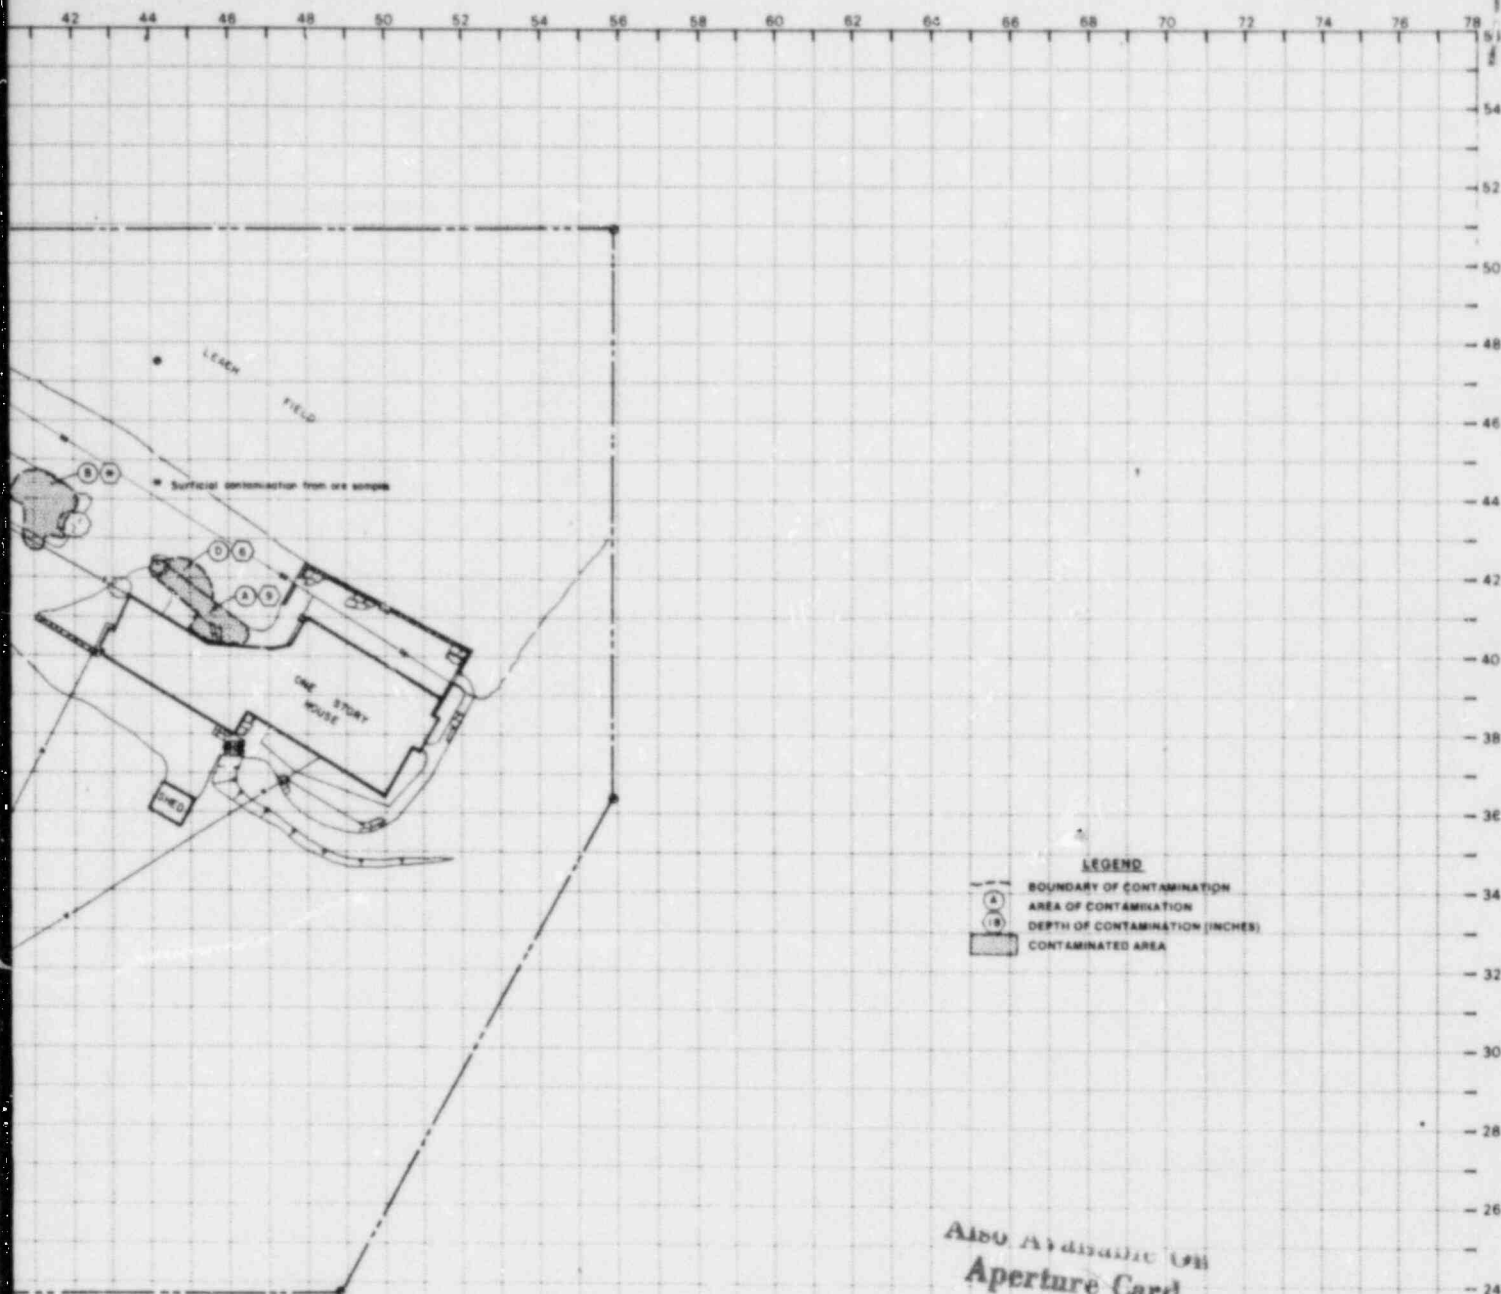
FIGURE 33  
ESTIMATED EXTENT OF CONTAMINATION

Area B, as discussed in Section 3.5 and shown on Appendix Figure 3.5, will not be included in this remedial action for the following reasons:

1. High readings in this area are the result of rock and mineral samples which have been collected by the property owners. These samples do not originate from the millsite, therefore do not fall under the scope of the UMTRA Program.

Appendix Figure 3.5 shows identified areas and estimated depths of contamination on this property, based on assessments of all measurements taken. As noted in this figure, areas recommended for remedial action that contain identified residual radioactive materials are:

- (AREA A) The fill material below the 3-inch-thick flagstone sidewalk is contaminated. The total depth of contamination is 9 inches (approximately 210 sf).
- (AREA B) The eastern one-third of the rock garden, adjacent to the driveway, is contaminated. The contamination is ore related, with several specimens lying on the surface (excluded).
- (AREA C) A small area located south of the driveway is contaminated to a depth of 30 inches (approximately 35 sf).
- (AREA D) A section of soil adjacent to the flagstone sidewalk is contaminated to a depth of 6 inches (approximately 68 sf).

The recommended remedial action for this property, DOE ID No. GJ-03494-RS, includes removal of all areas identified as containing radioactive material (as discussed in Section 3.5 and shown in Appendix Figure 3.5) and transport of removed material to the disposal site.

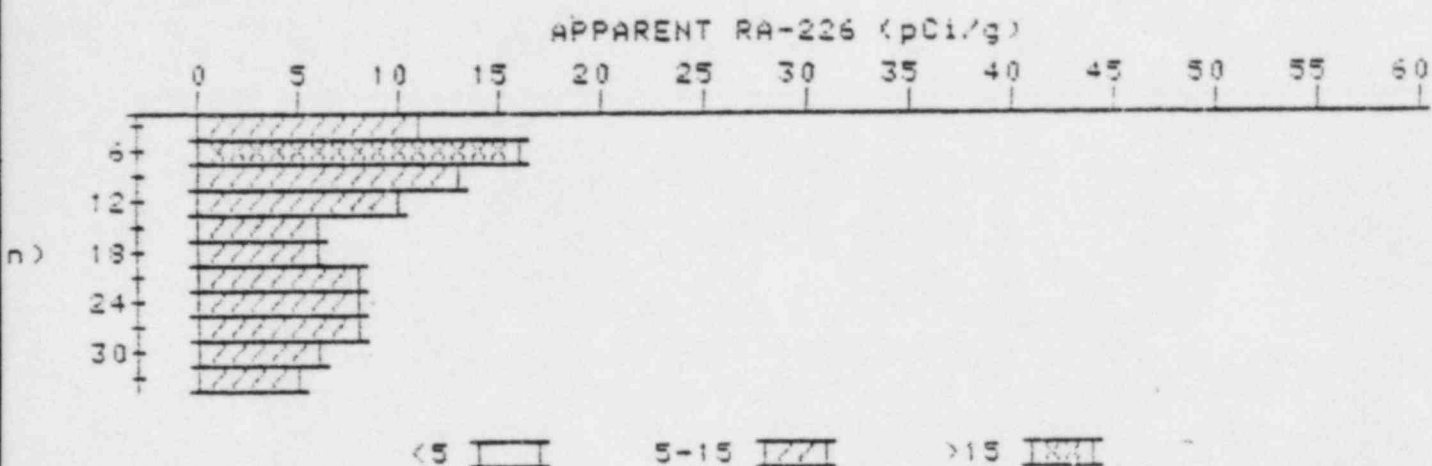
HOLE NUMBER: 3

Depth (in)	Apparent Radium-226 (pCi/g) Undeconvolved	Apparent Radium-226 (pCi/g) Deconvolved
3	10.9	10.9
6	12.2	15.8
9	11.5	13.3
12	9.8	9.8
15	8.1	6.1
18	7.5	6.1
21	7.7	8.2
24	7.6	8.3
27	7.1	8.2
30	6.0	6.8
33	5.0	5.0

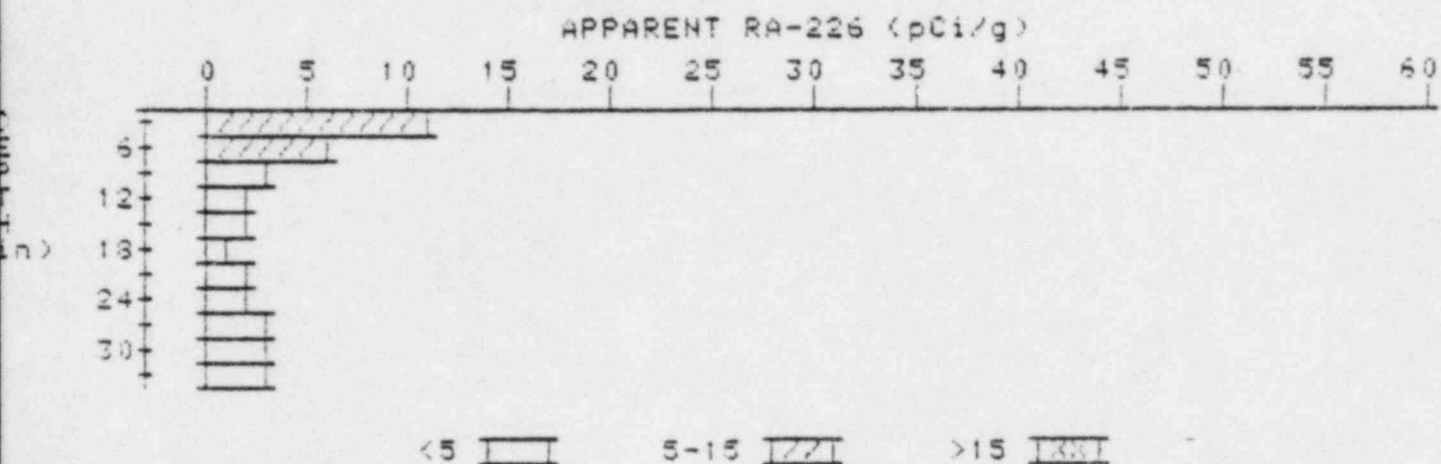
HOLE NUMBER: 12

Depth (in)	Apparent Radium-226 (pCi/g) Undeconvolved	Apparent Radium-226 (pCi/g) Deconvolved
3	10.6	10.6
6	7.3	6.1
9	4.7	2.9
12	3.1	1.5
15	2.4	1.9
18	2.0	1.1
21	2.1	2.1
24	2.2	2.0
27	2.4	2.6
30	2.5	2.5
33	2.6	2.6

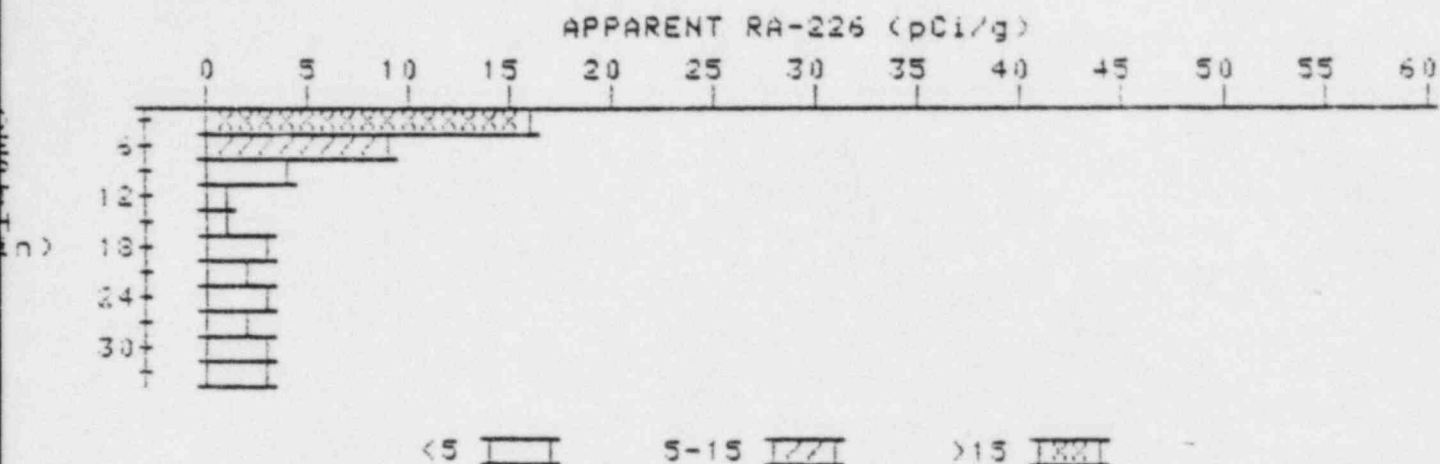
PROPERTY NUMBER: GJ-03494-RS  
HOLE NUMBER: 16  
LOCATION: 462406

Depth (in)	Apparent Radium-226 (pCi/g) Undeconvolved	Apparent Radium-226 (pCi/g) Deconvolved
3	15.7	15.7
6	10.5	9.5
9	6.4	3.9
12	3.7	.7
15	2.7	1.3
18	2.5	2.5
21	2.3	1.6
24	2.5	2.9
27	2.5	2.3
30	2.6	2.8
33	2.6	2.6
