Modified to Fit Waterford Unit #3

Concrete Phase I Construction

POP-N-713
USE OF DISCREPANCY REPORTS

WATERFORD III SES
ANALYSIS OF CRACKS AND WATER SEEPAGE
IN FOUNDATION MAT
LOUISIANA POWER & LIGHT COMPANY
REPORT NO. 8304-1
SEPTEMBER 19, 1983

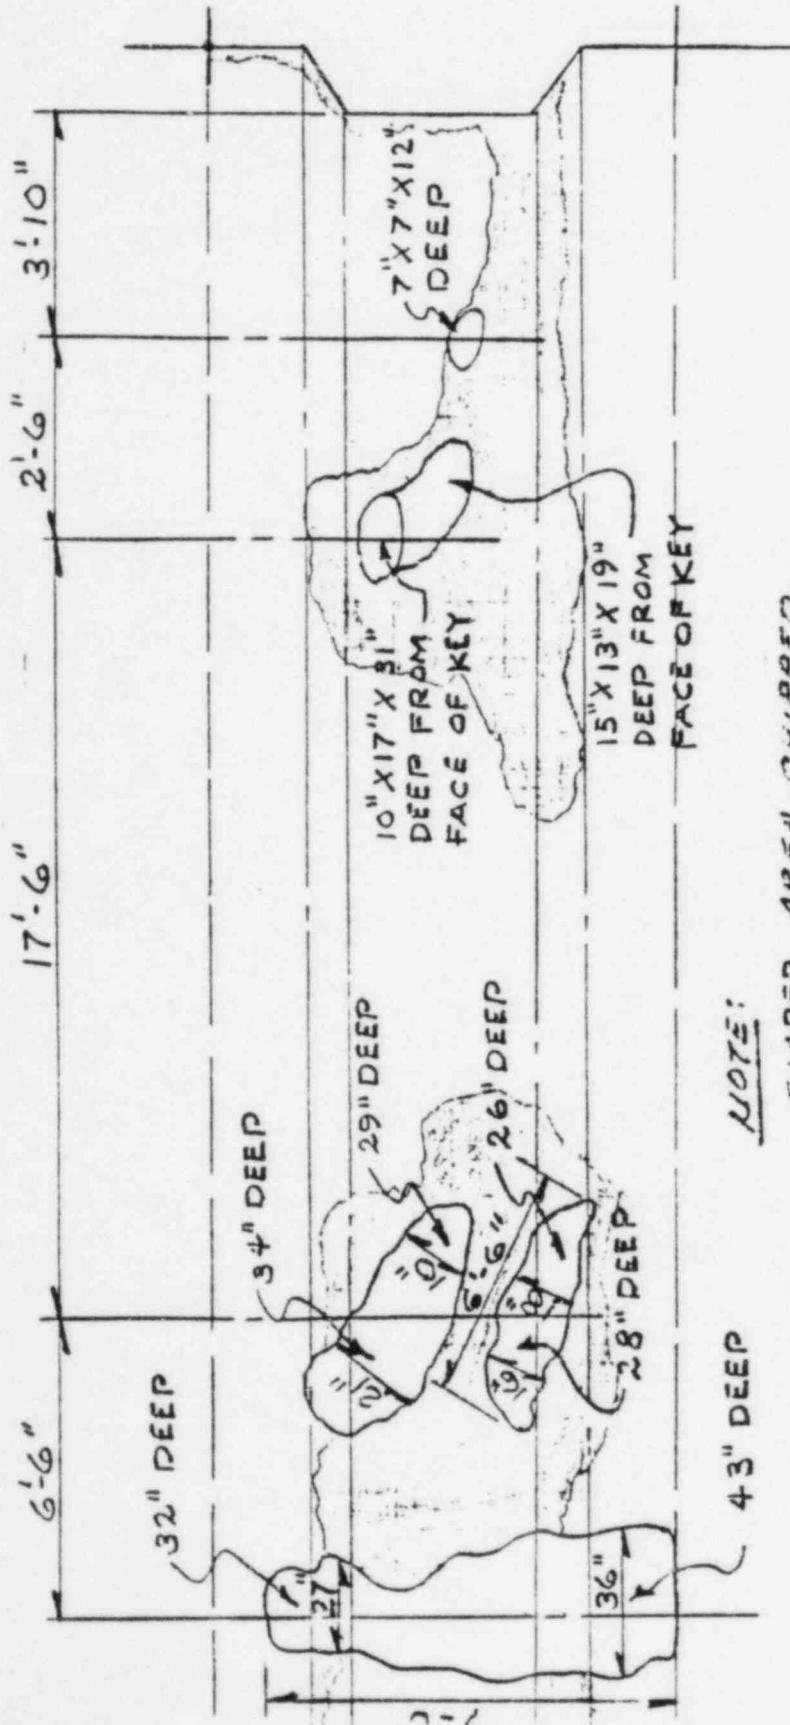
SUBJECT EAST FACE
PLACEMENT NO. 16

SHADED AREA CHIPPED
FROM 2" TO 4" DEEP

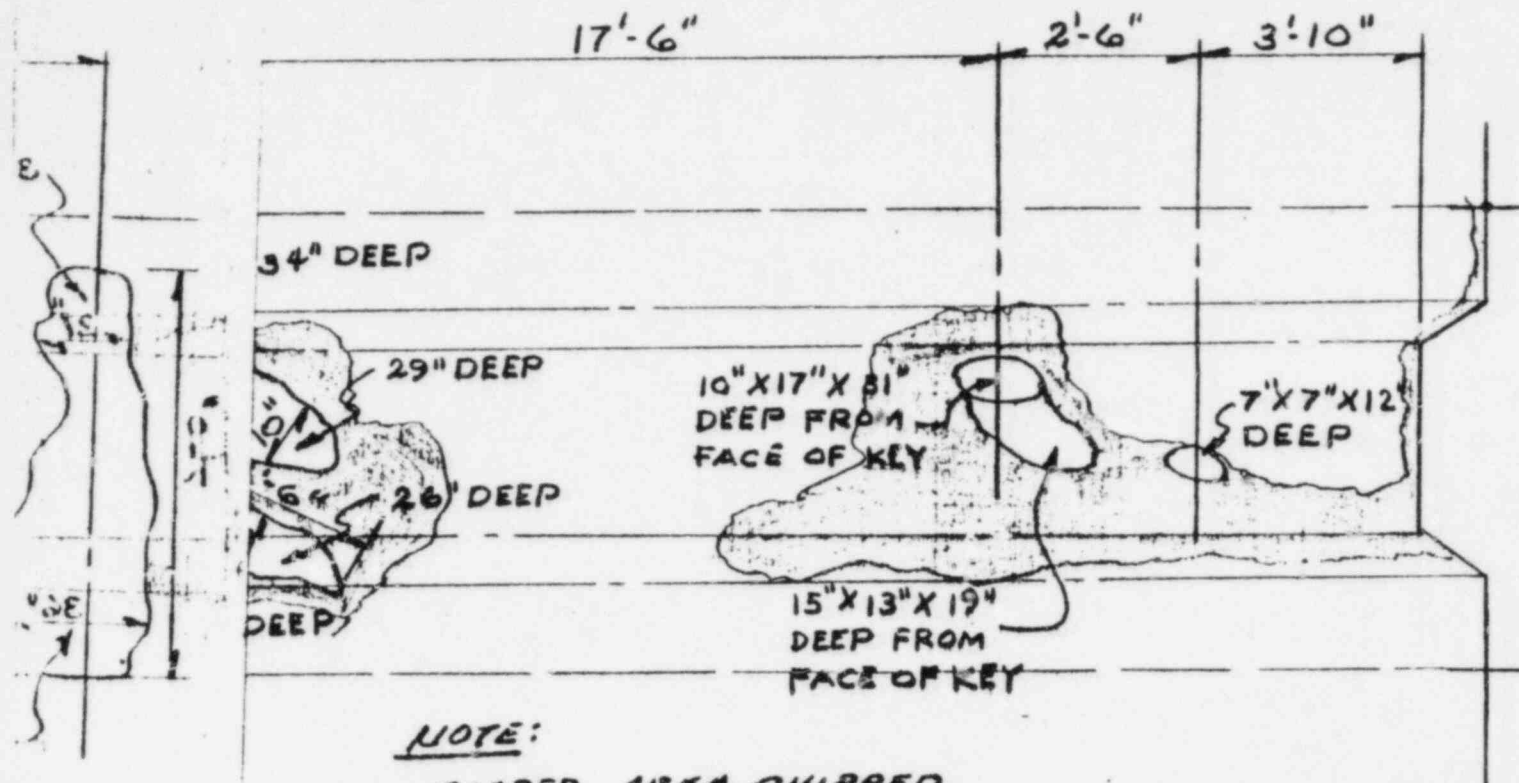
SHADED AREA CHIPPED
FROM 2" TO 4" DEEP

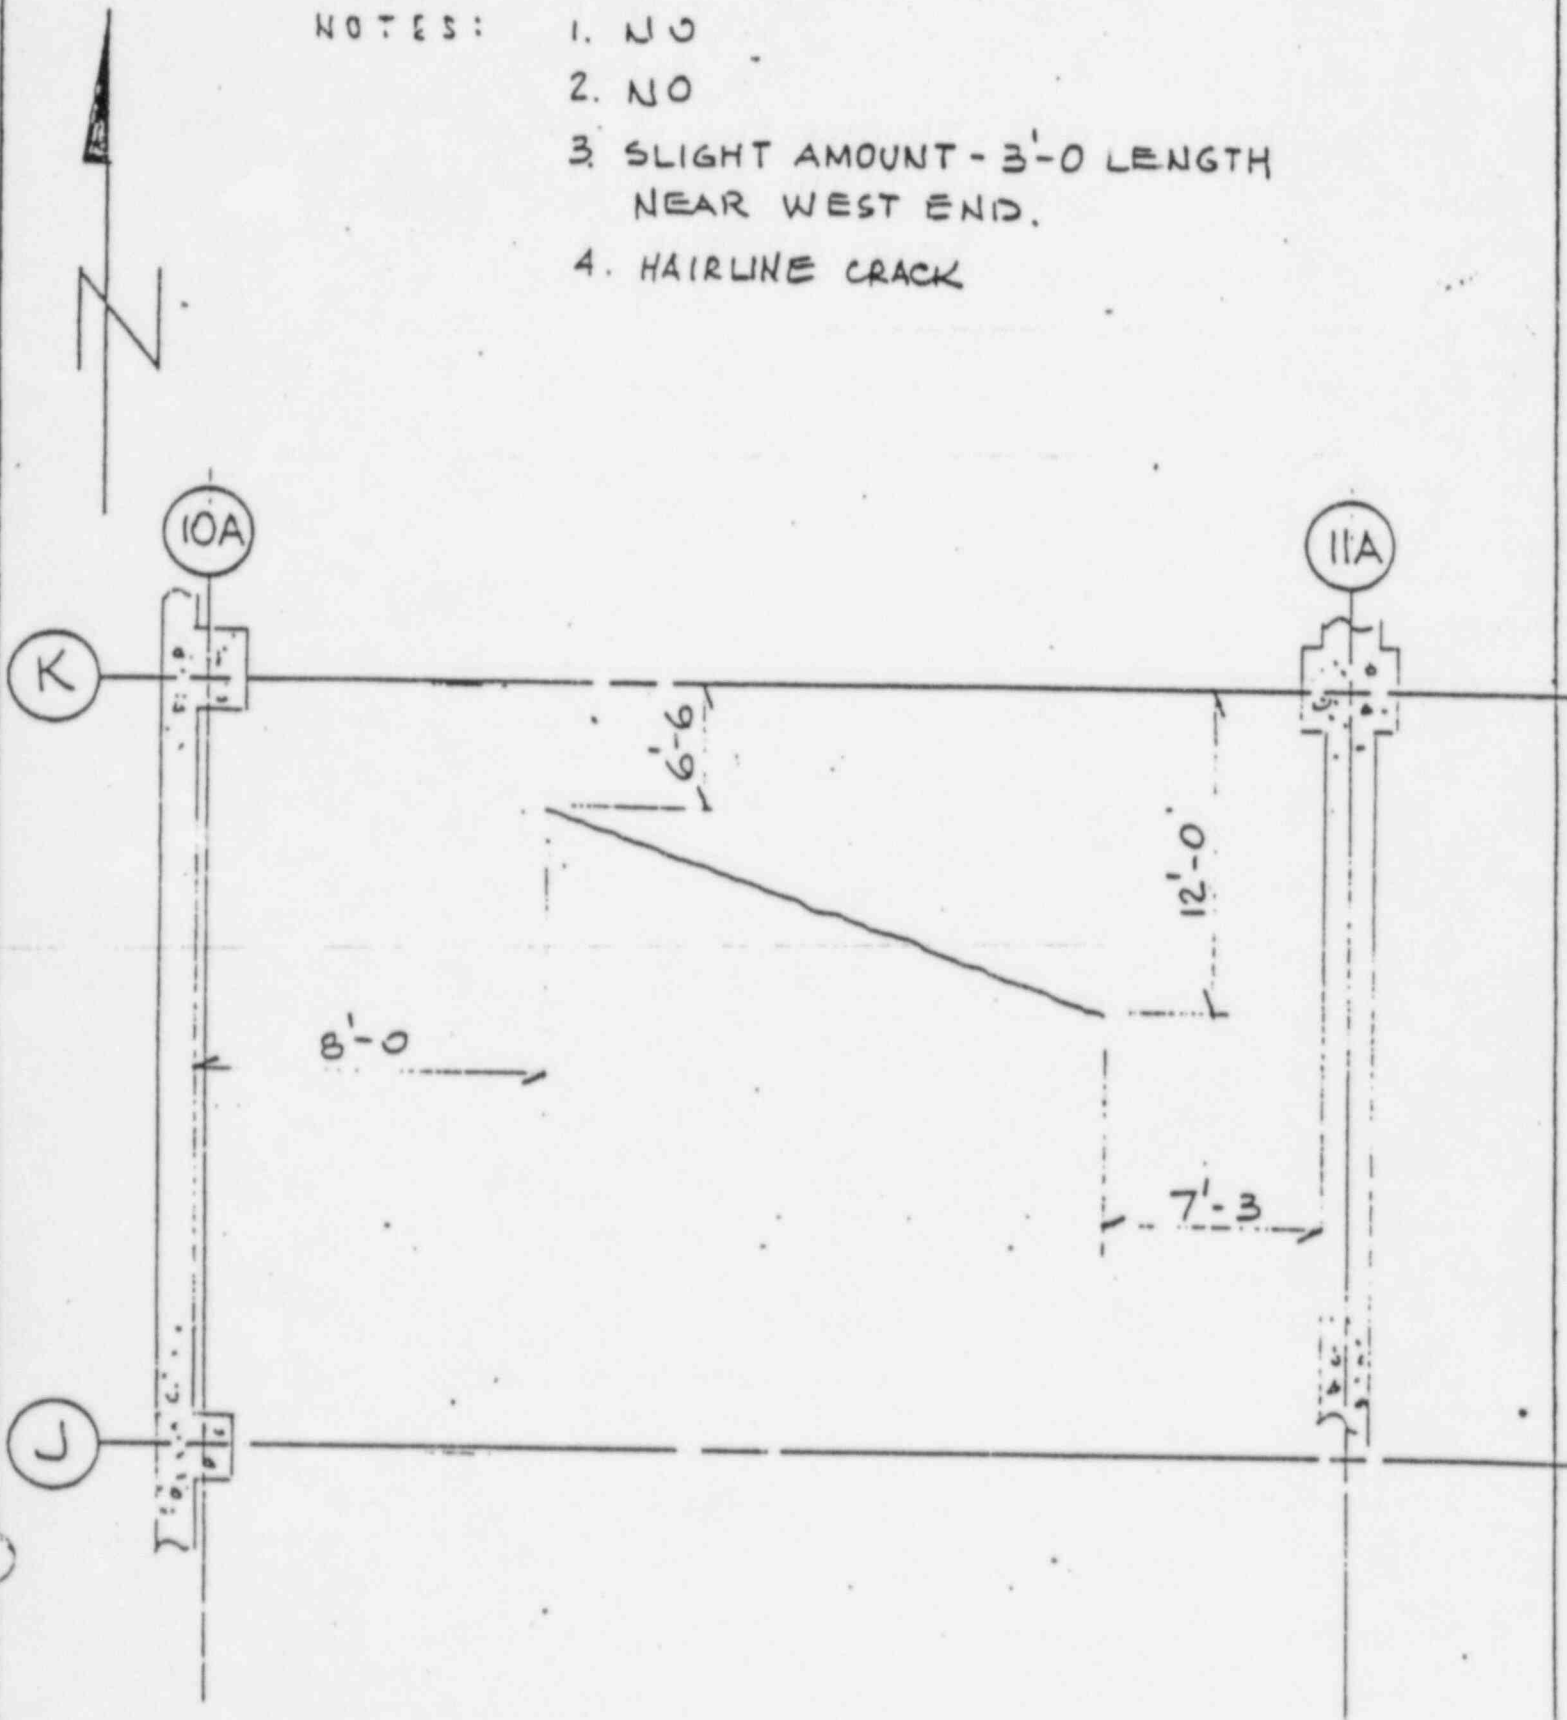
1. NO
2. NO
3. SLIGHT AMOUNT - 3'-0 LENGTH
NEAR WEST END.
4. HAIRLINE CRACK

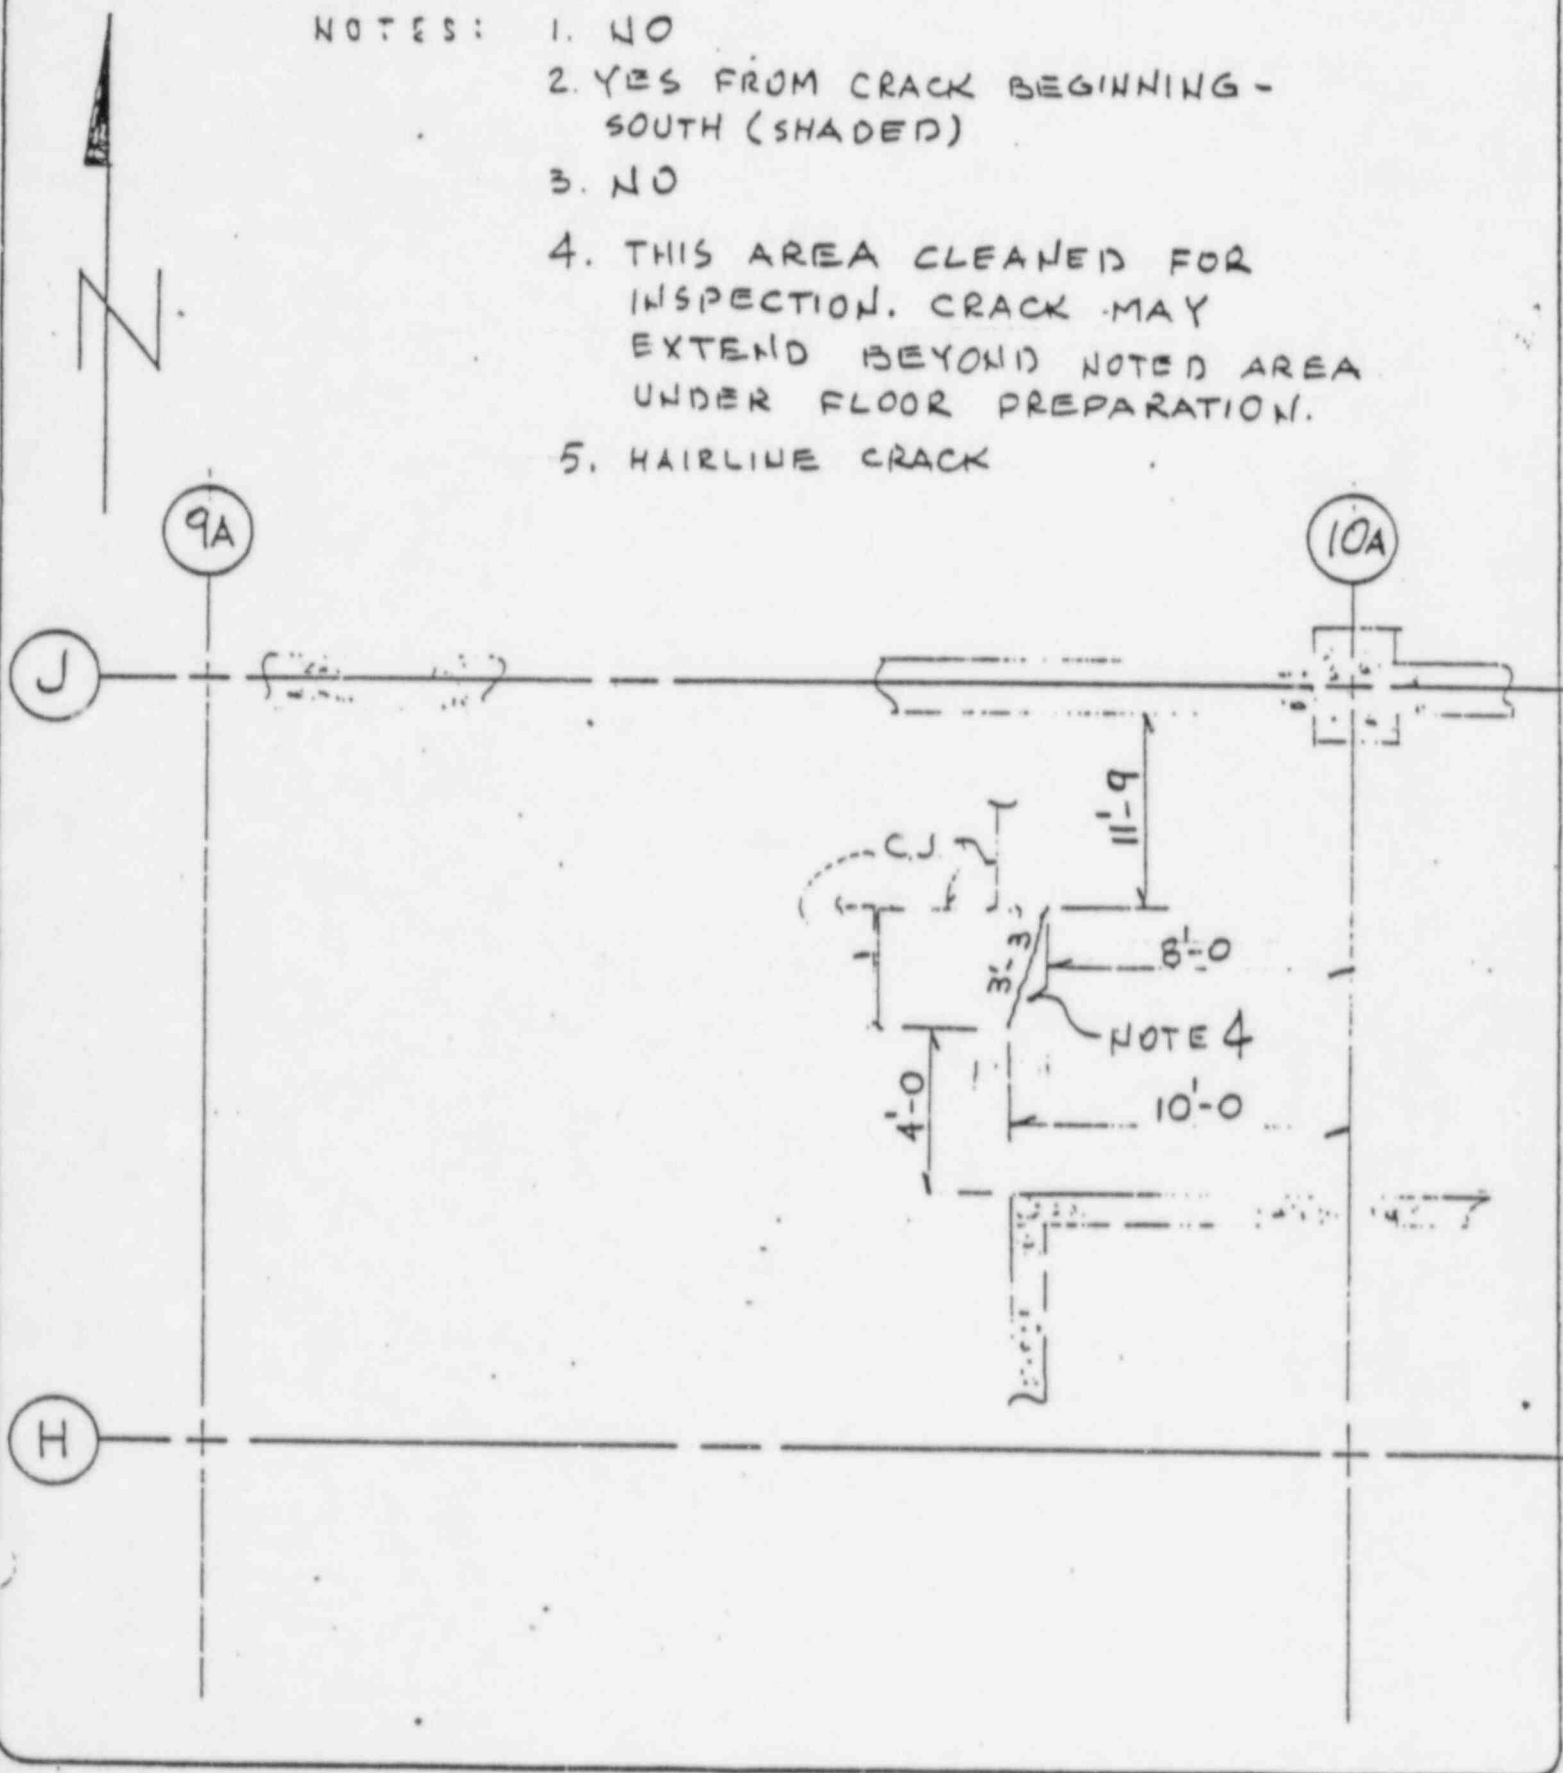
1. NO
2. YES FROM CRACK BEGINNING - SOUTH (SHADED)
3. NO
4. THIS AREA CLEANED FOR INSPECTION. CRACK MAY EXTEND BEYOND NOTED AREA UNDER FLOOR PREPARATION.
5. HAIRLINE CRACK

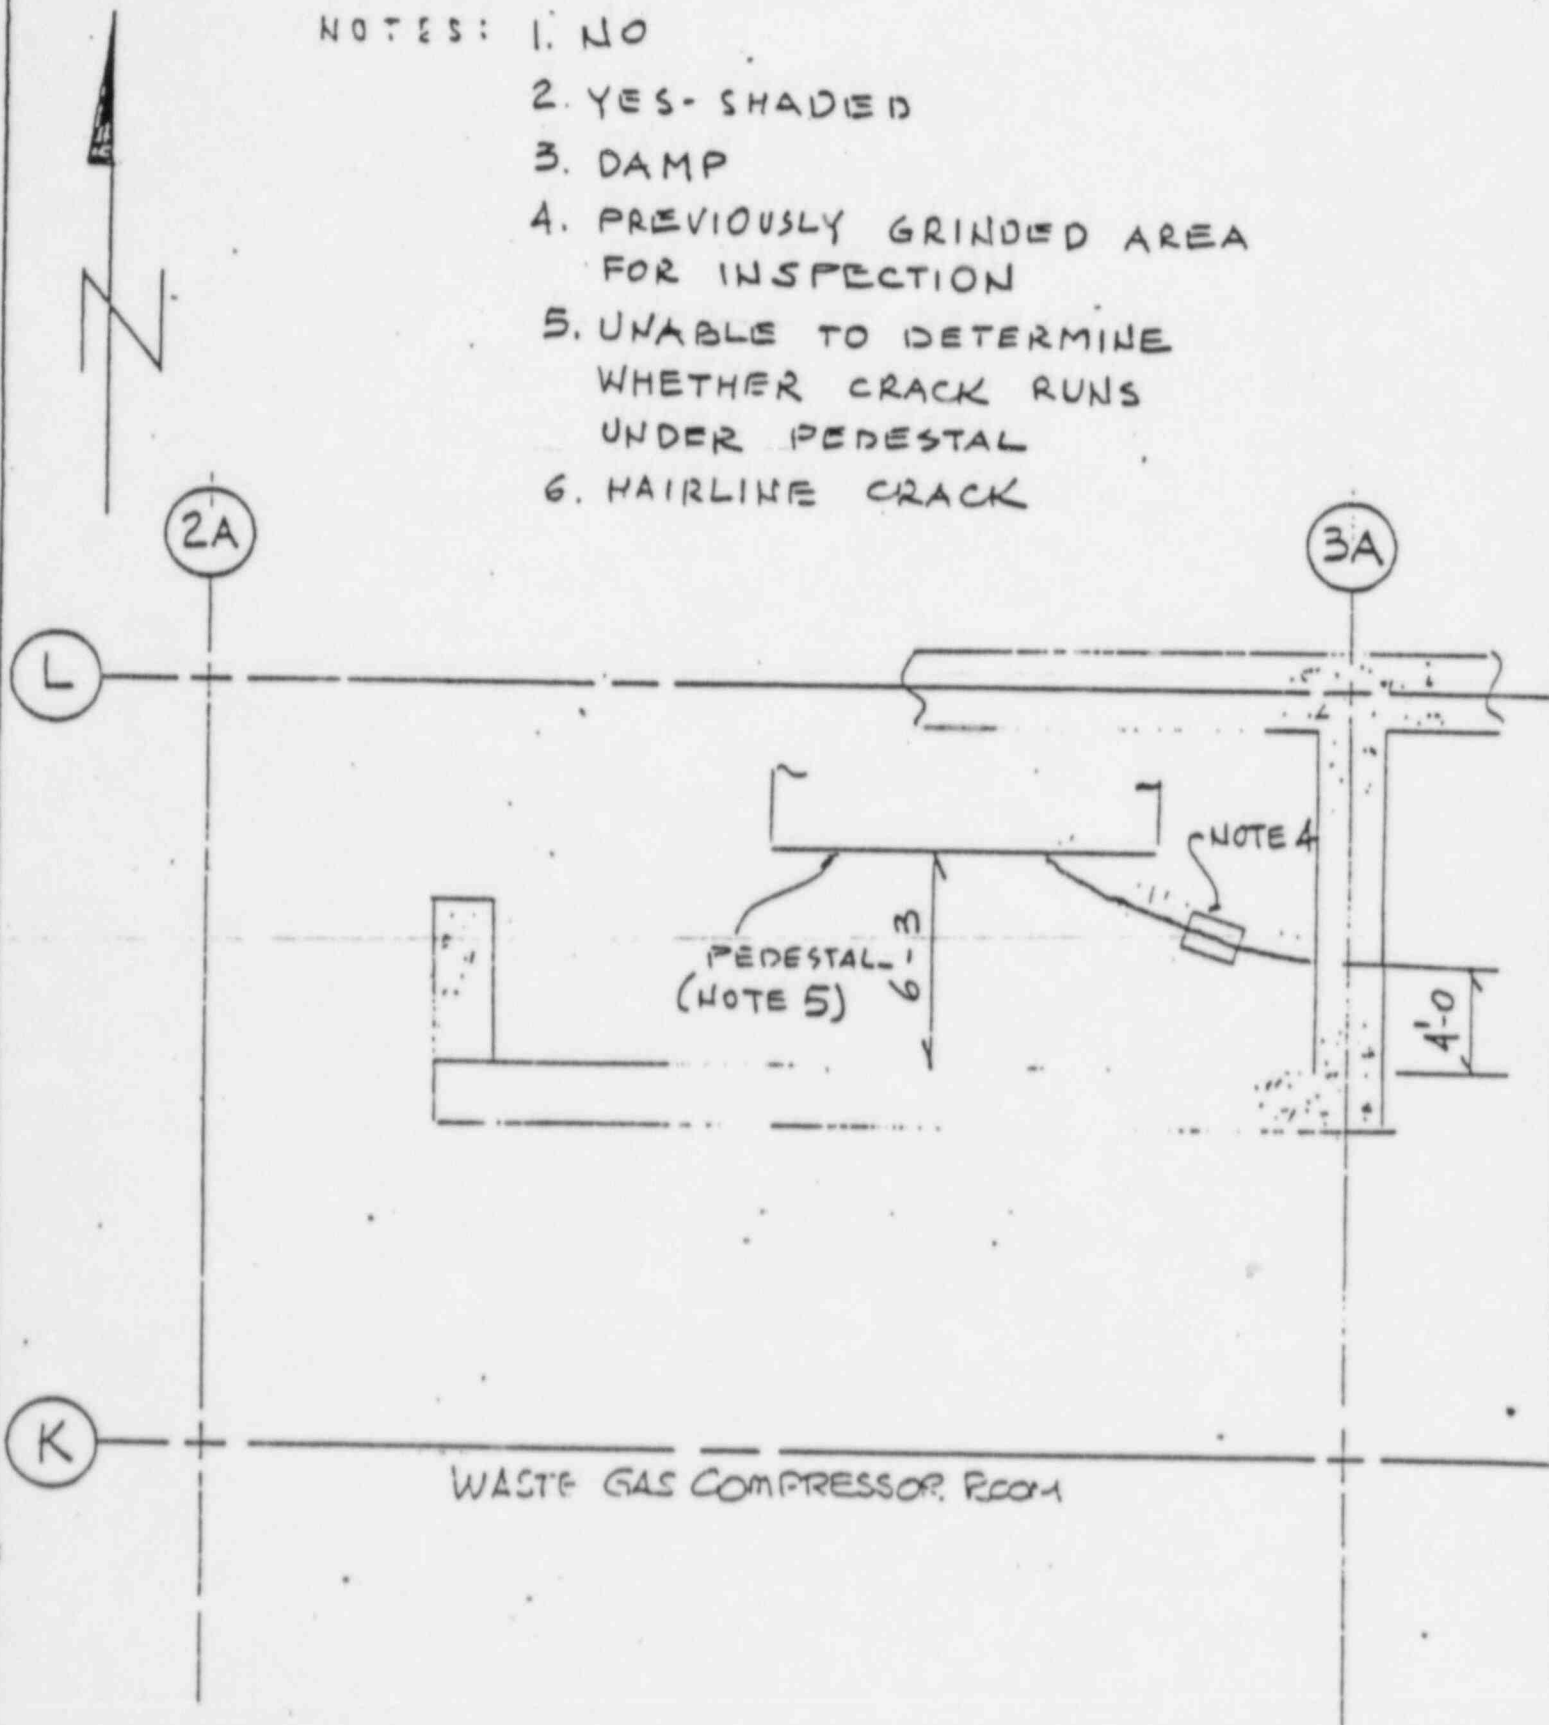
5. UNABLE TO DETERMINE
WHETHER CRACK RUNS
UNDER PEDESTAL

6. HAIRLINE CRACK

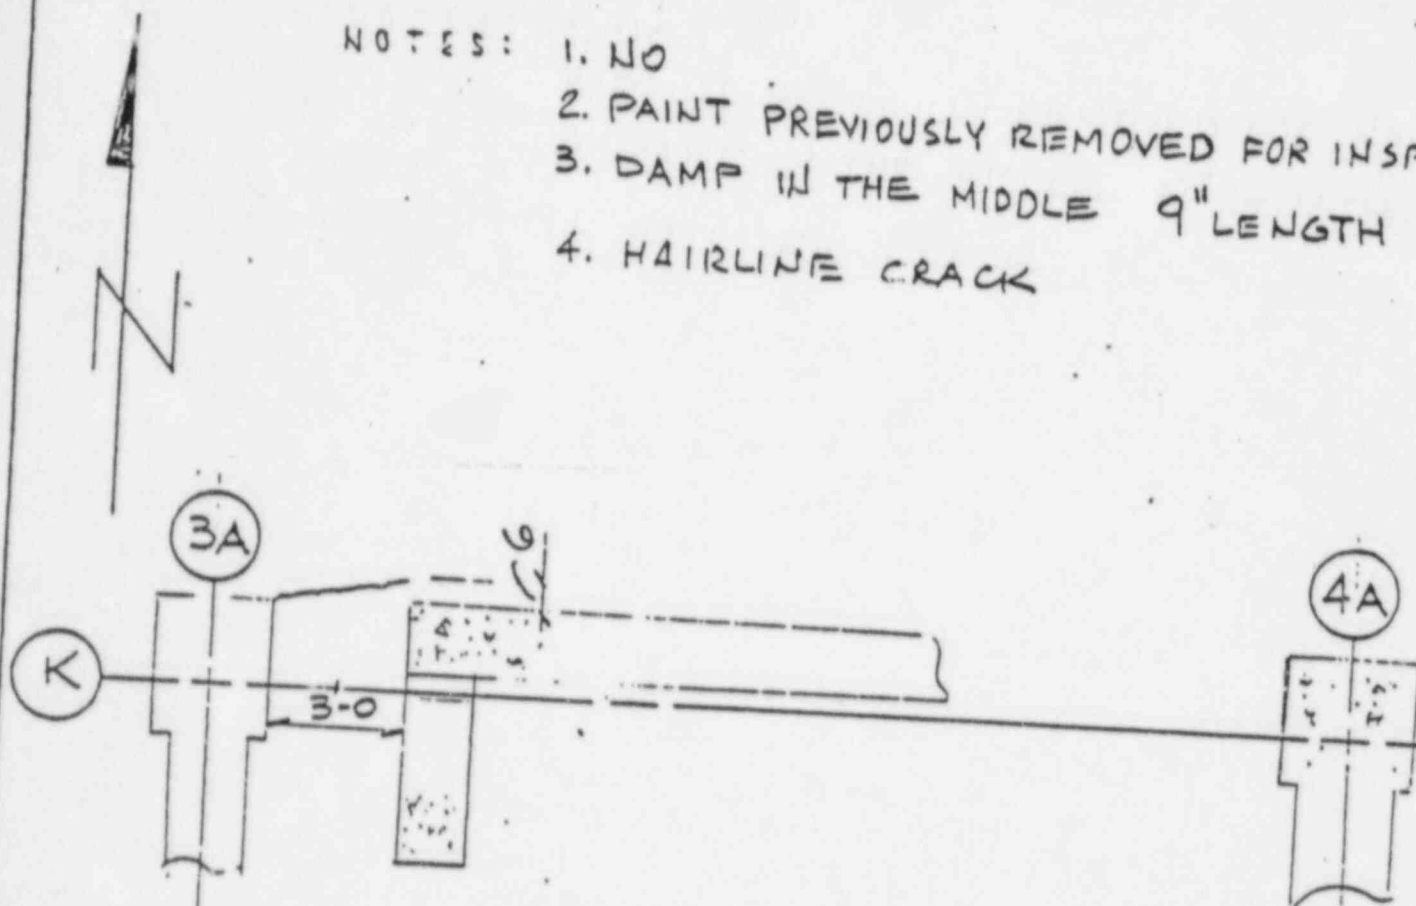
- NOTES:
1. NO
 2. PAINT PREVIOUSLY REMOVED FOR INSPECTION
 3. DAMP IN THE MIDDLE 9" LENGTH
 4. HAIRLINE CRACK

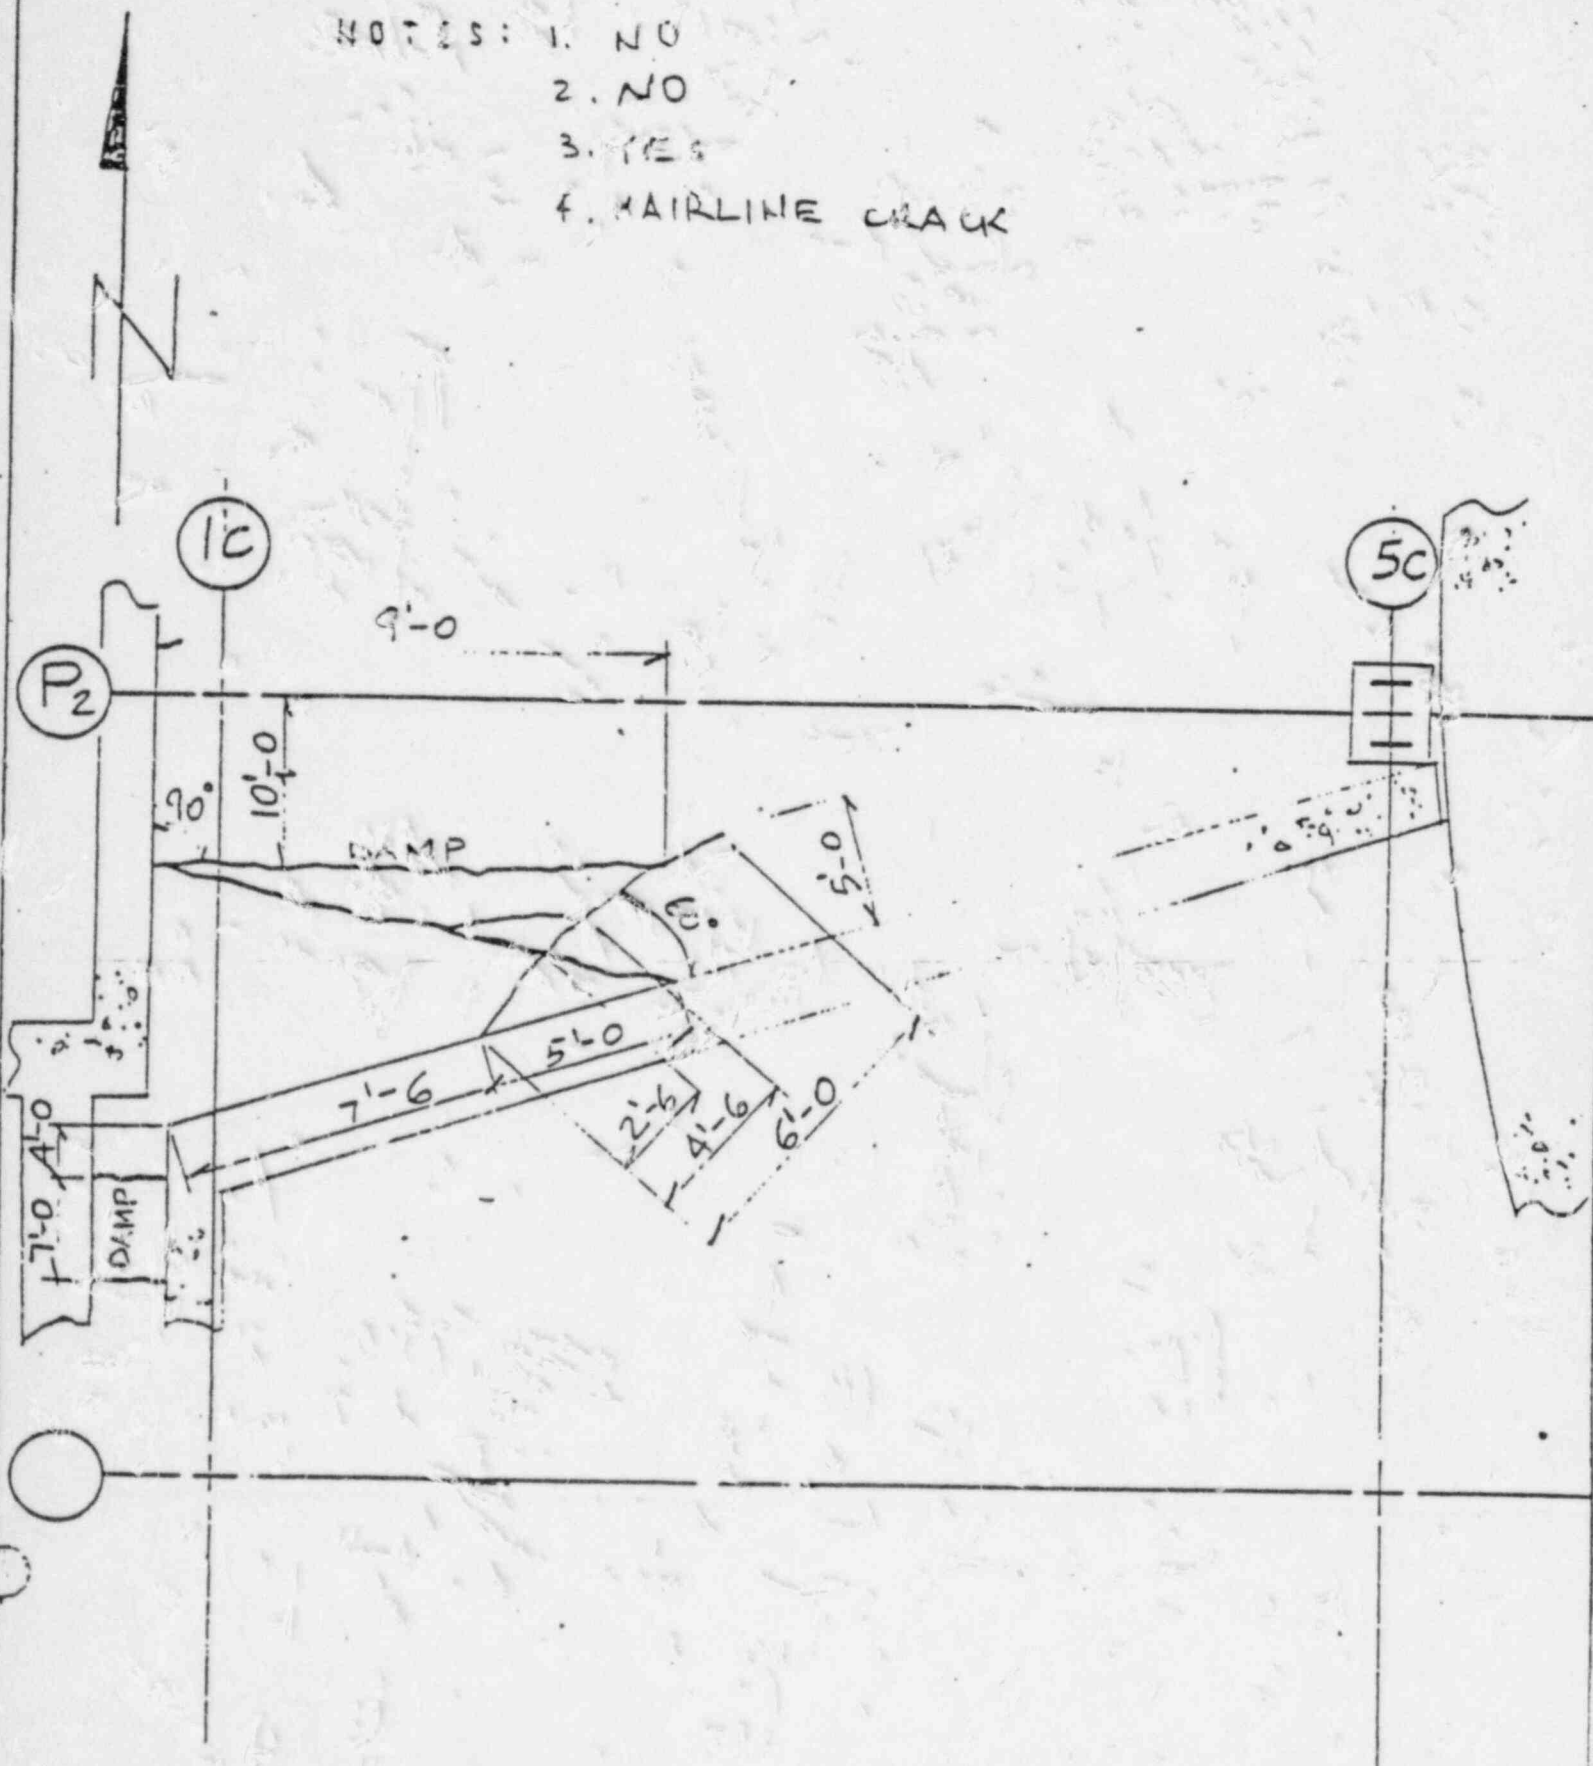
NOTES: 1. NO
2. NO
3. YES
4. AIRLINE CRACK

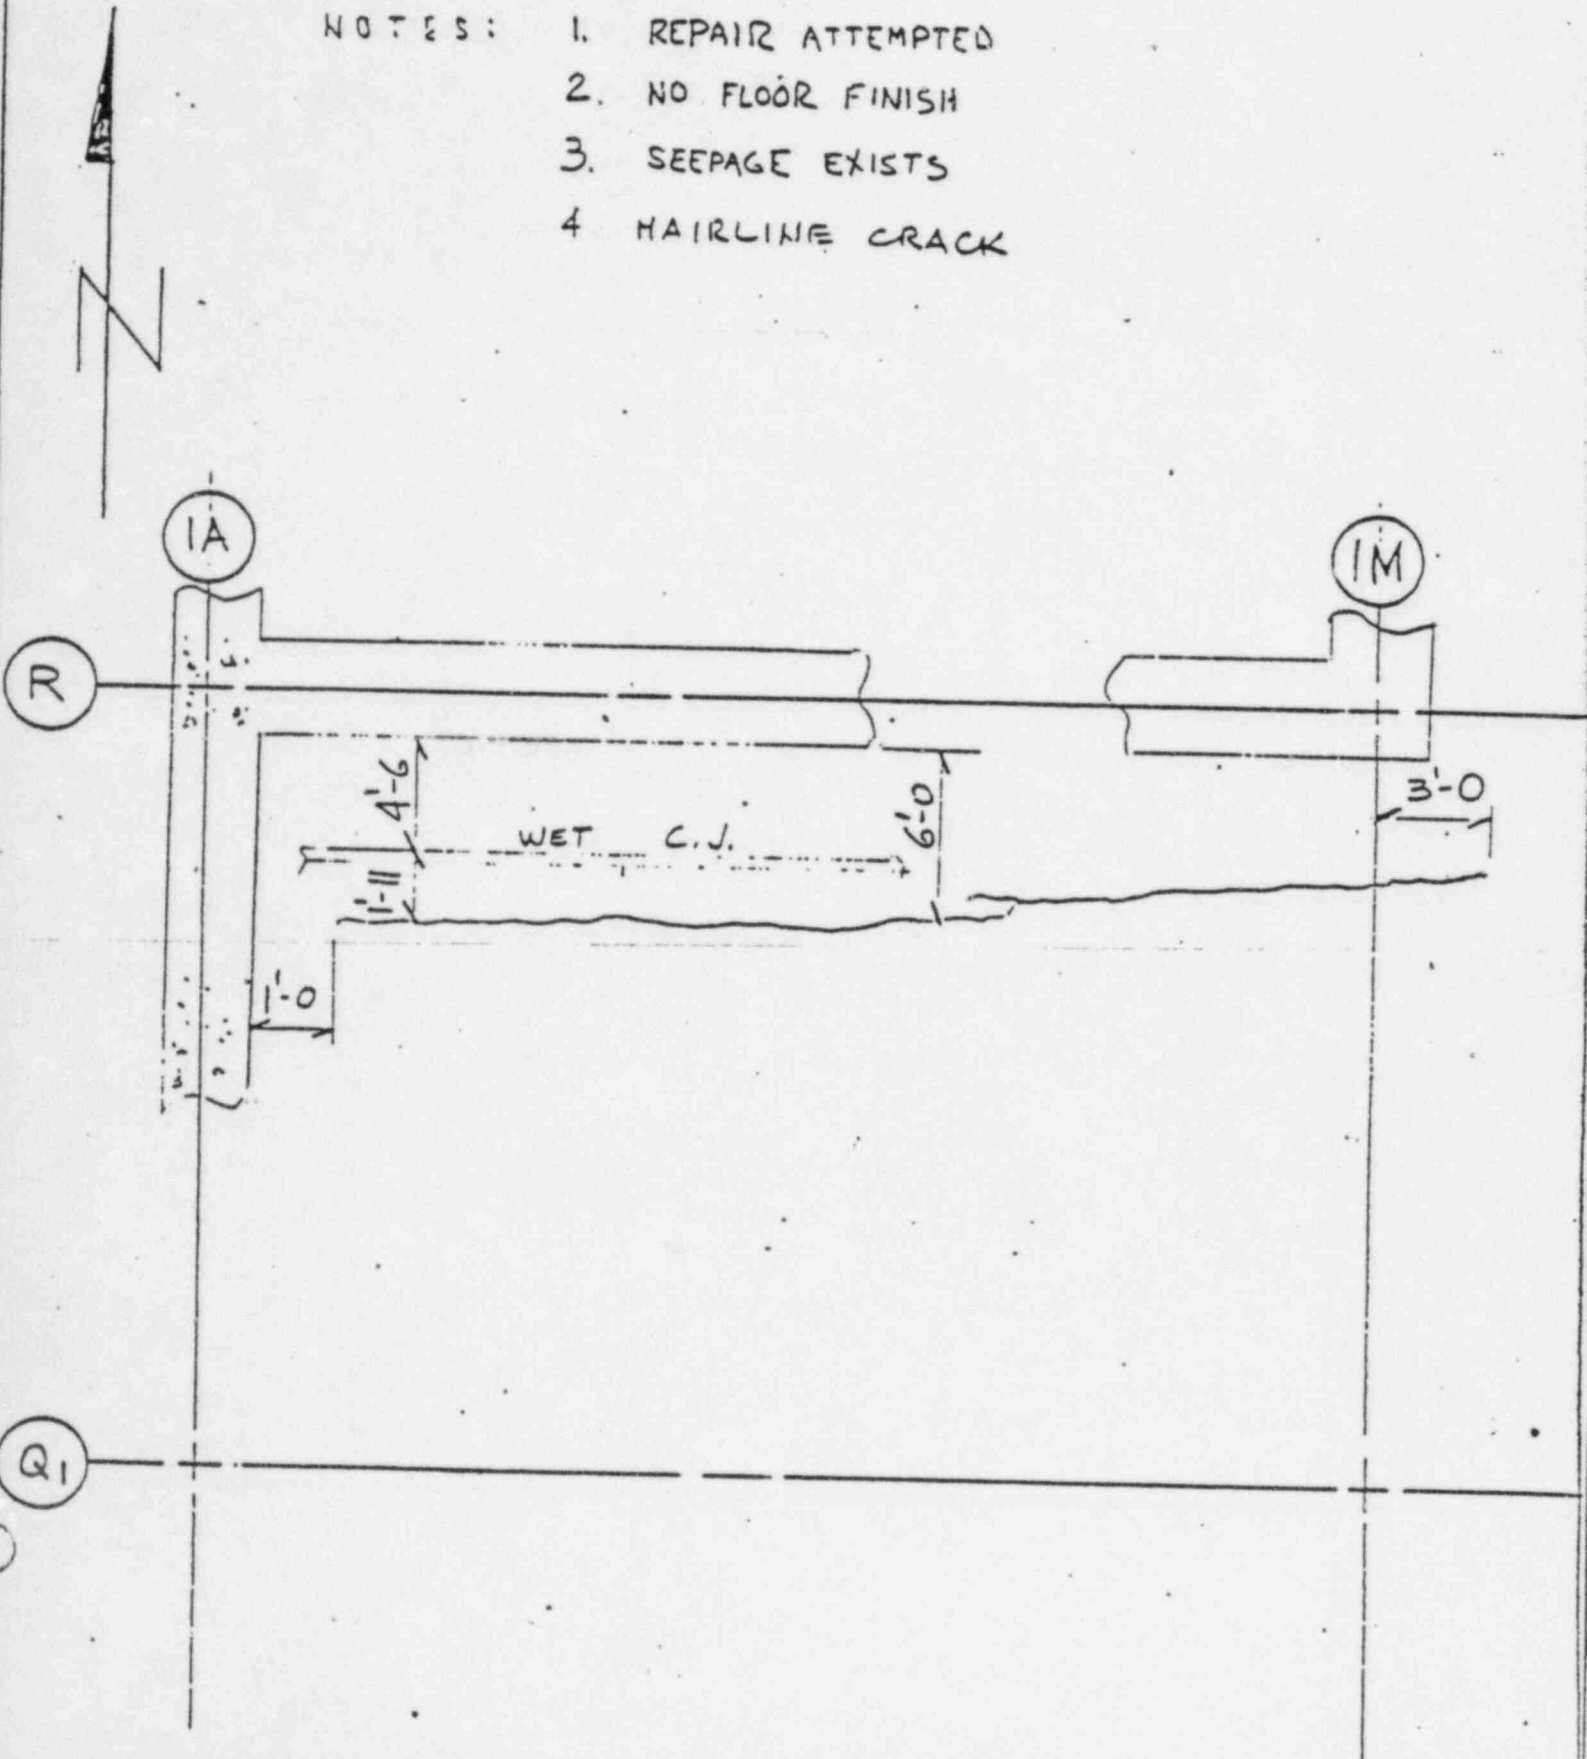
- NOTES:
1. REPAIR ATTEMPTED
 2. NO FLOOR FINISH
 3. SEEPAGE EXISTS
 4. HAIRLINE CRACK

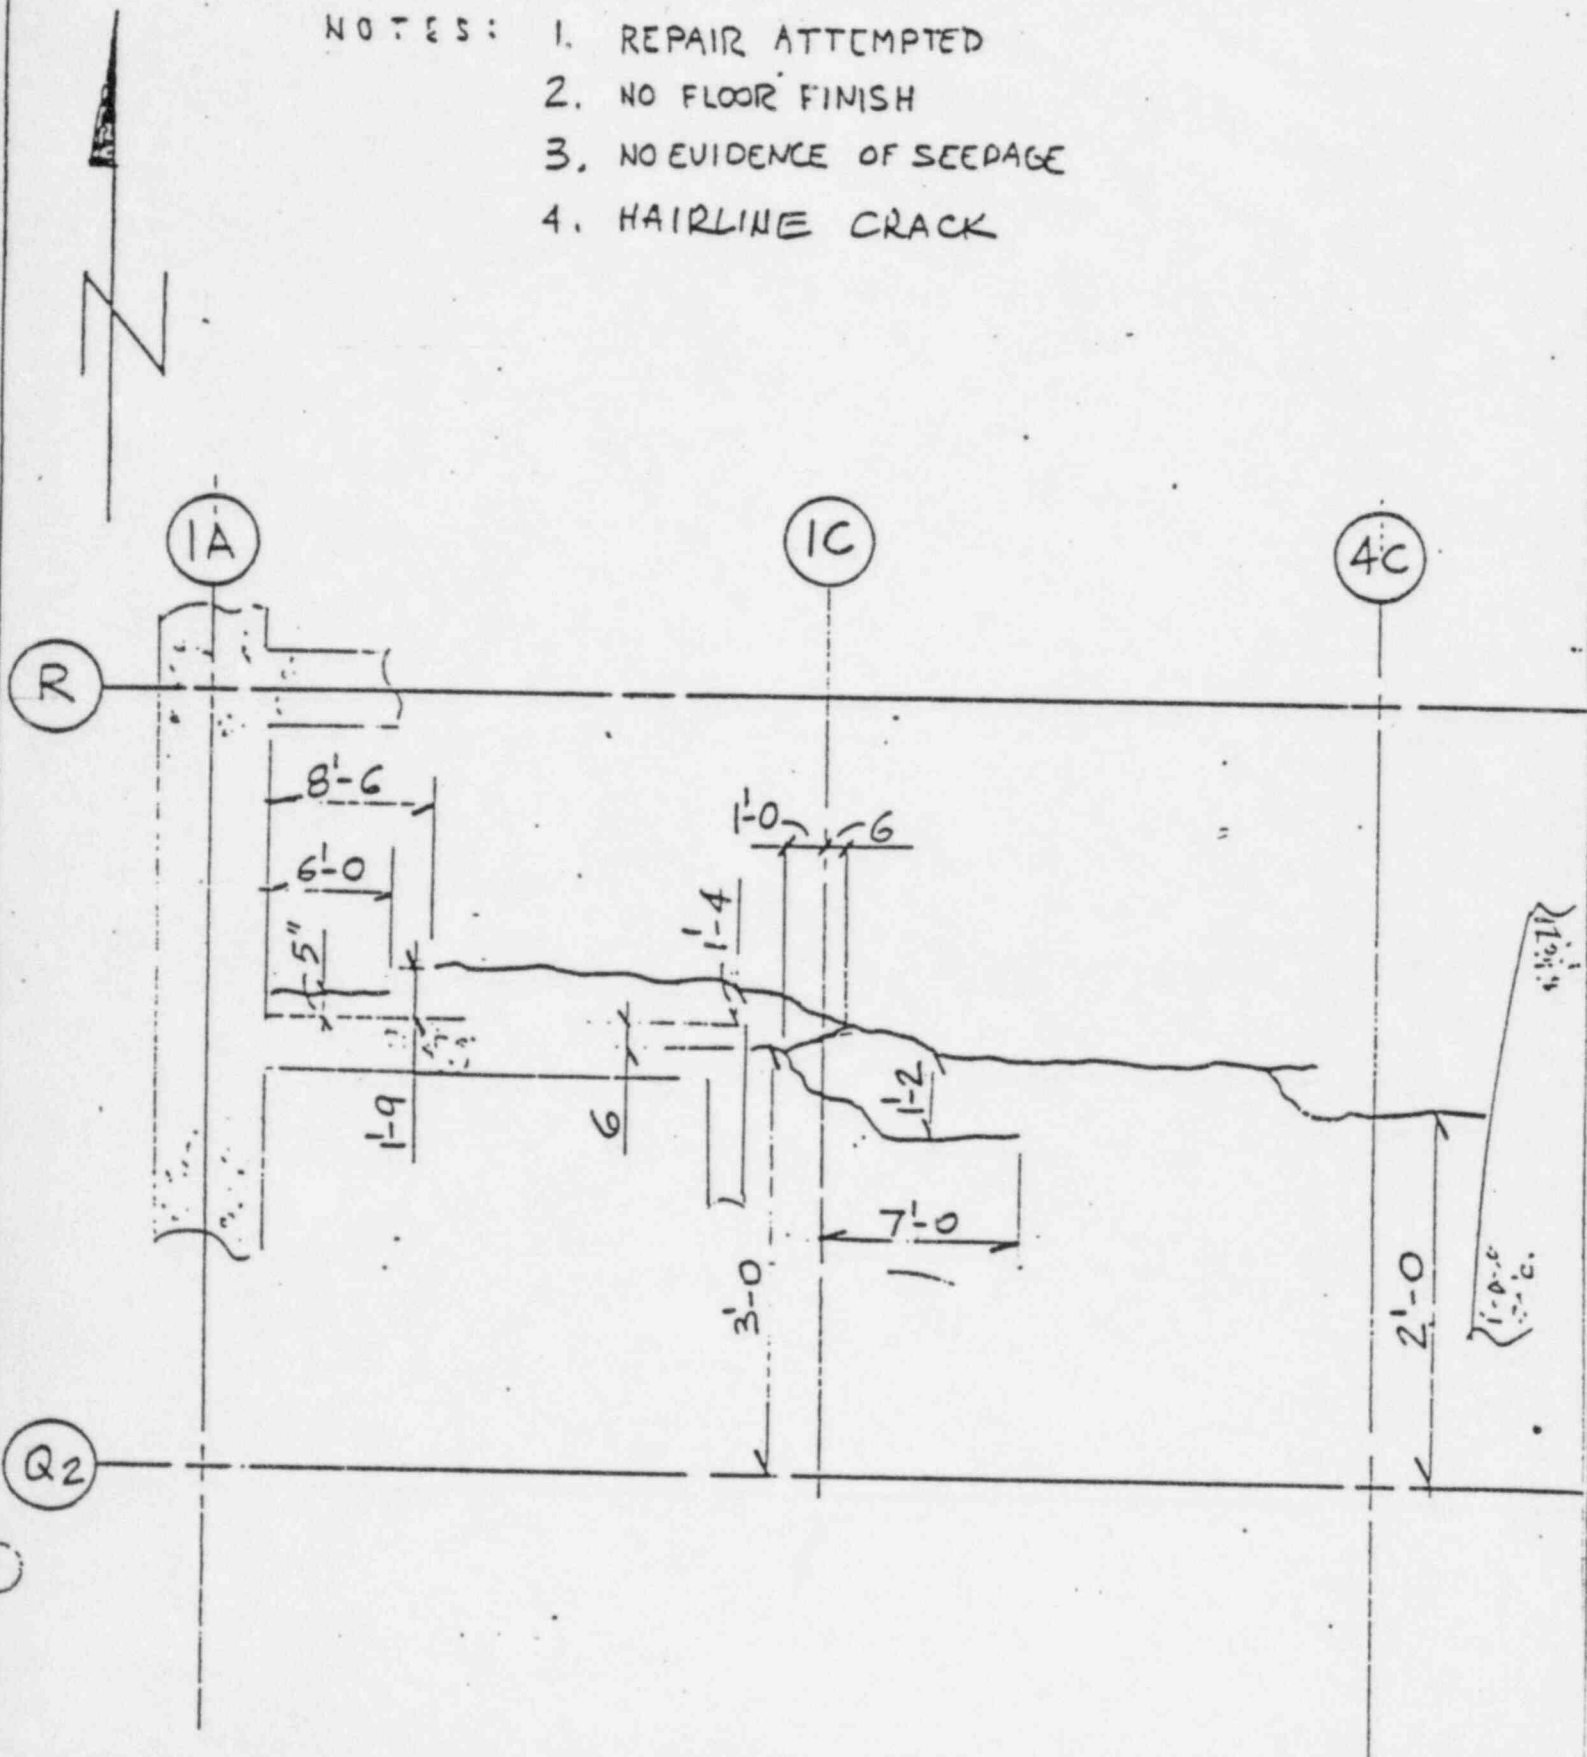
- NOTES:
1. REPAIR ATTEMPTED
 2. NO FLOOR FINISH
 3. NO EVIDENCE OF SEEPAGE
 4. HAIRLINE CRACK

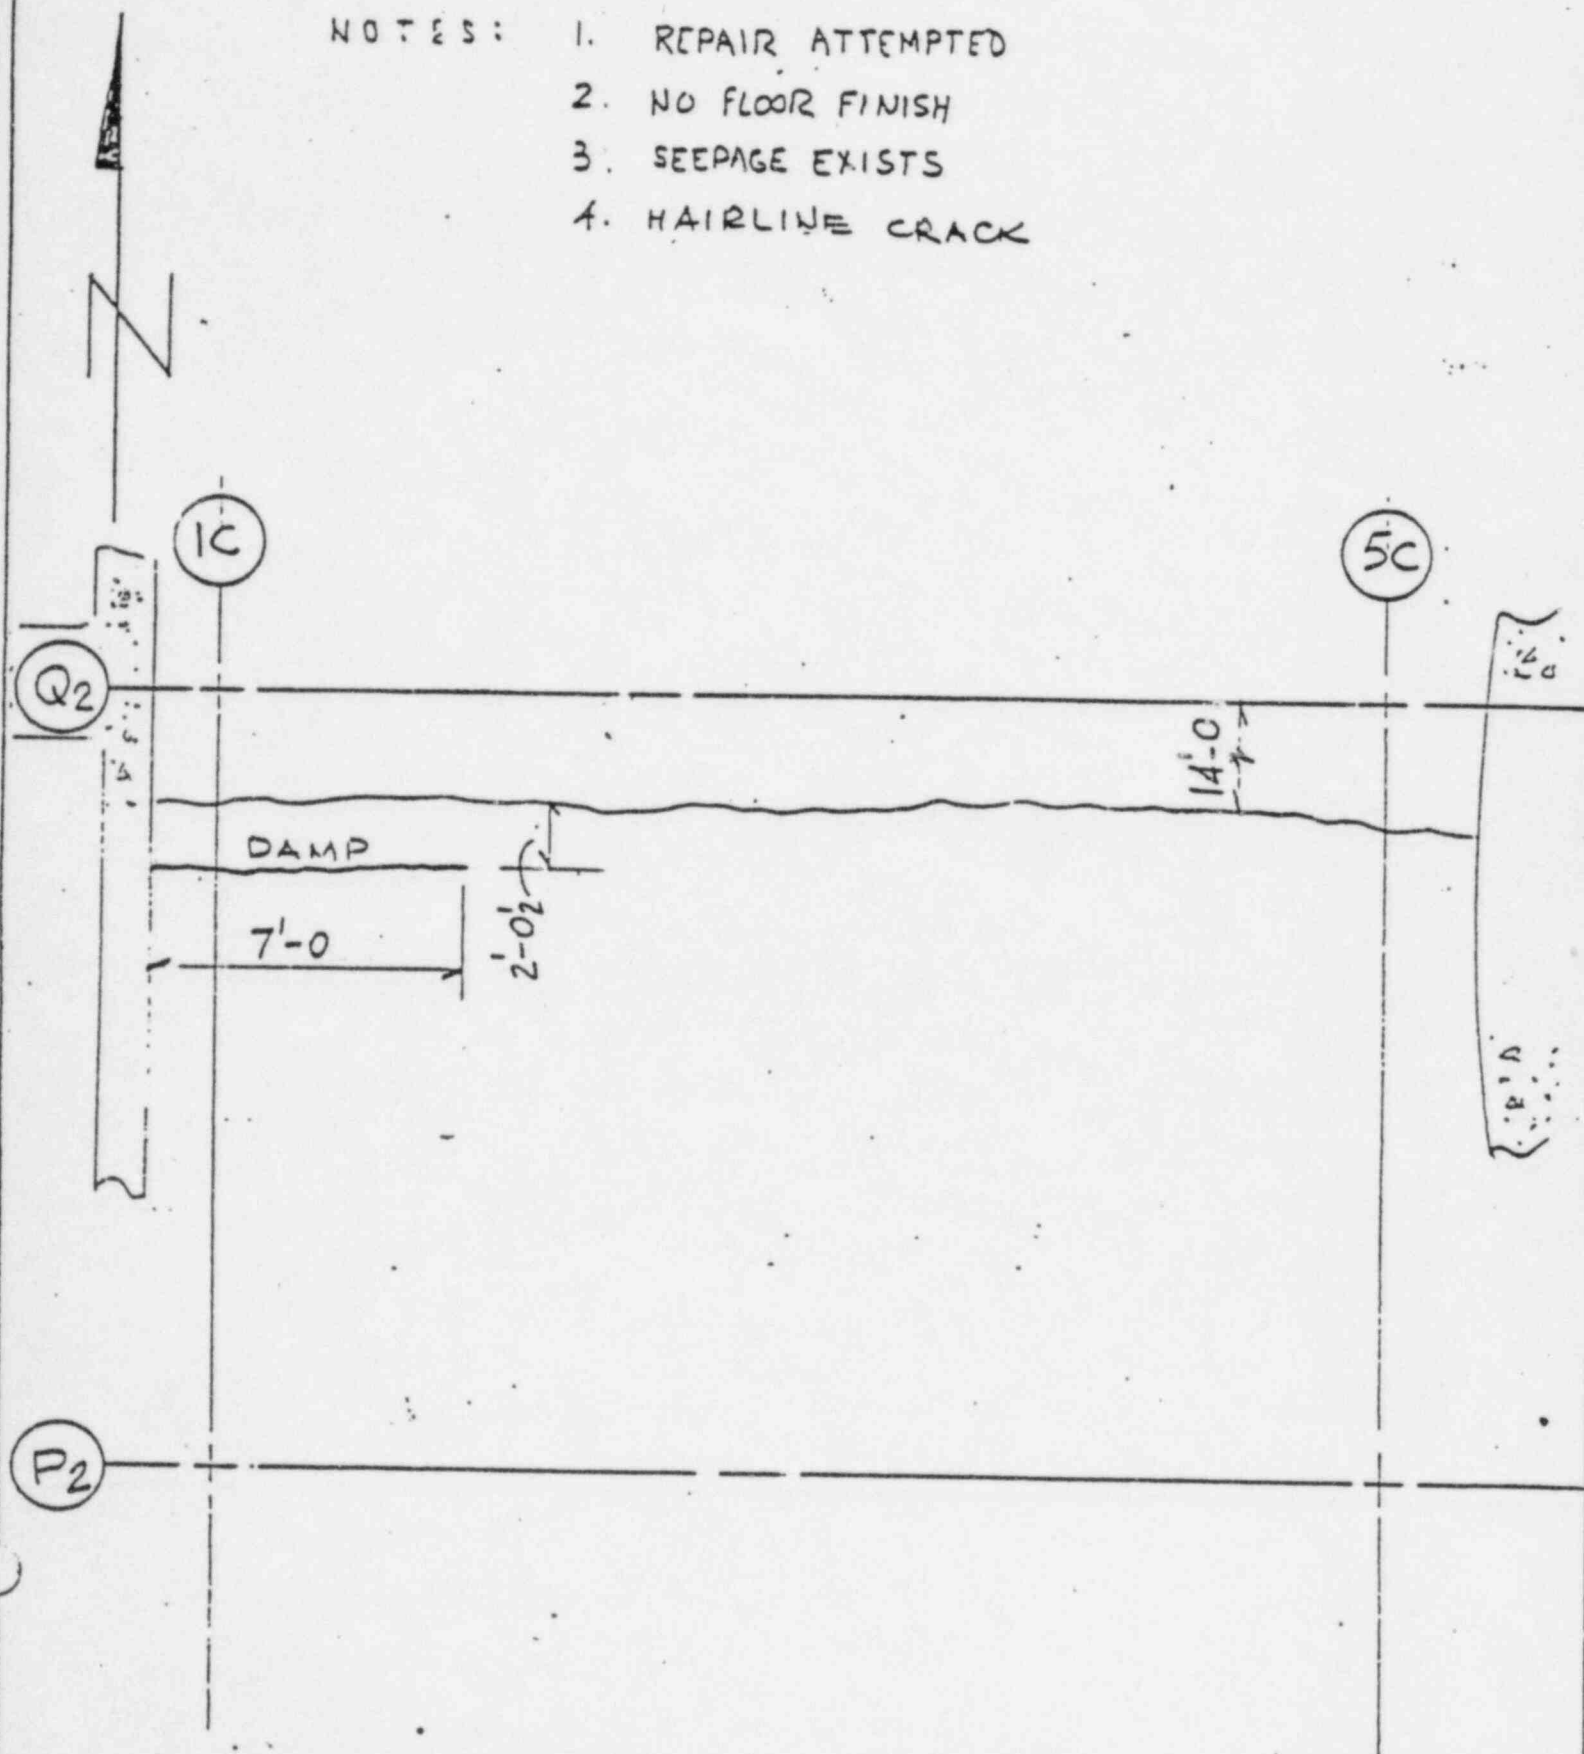
- NOTES:
1. REPAIR ATTEMPTED
 2. NO FLOOR FINISH
 3. SEEPAGE EXISTS
 4. HAIRLINE CRACK
