Modified to Fit Waterford Unit #3

Concrete Phase I Construction

POP-N-713
USE OF DISCREPANCY REPORTS

WATERFORD III SES
ANALYSIS OF CRACKS AND WATER SEEPAGE
IN FOUNDATION MAT
LOUISIANA POWER & LIGHT COMPANY
REPORT NO. 8304-1
SEPTEMBER 19, 1983

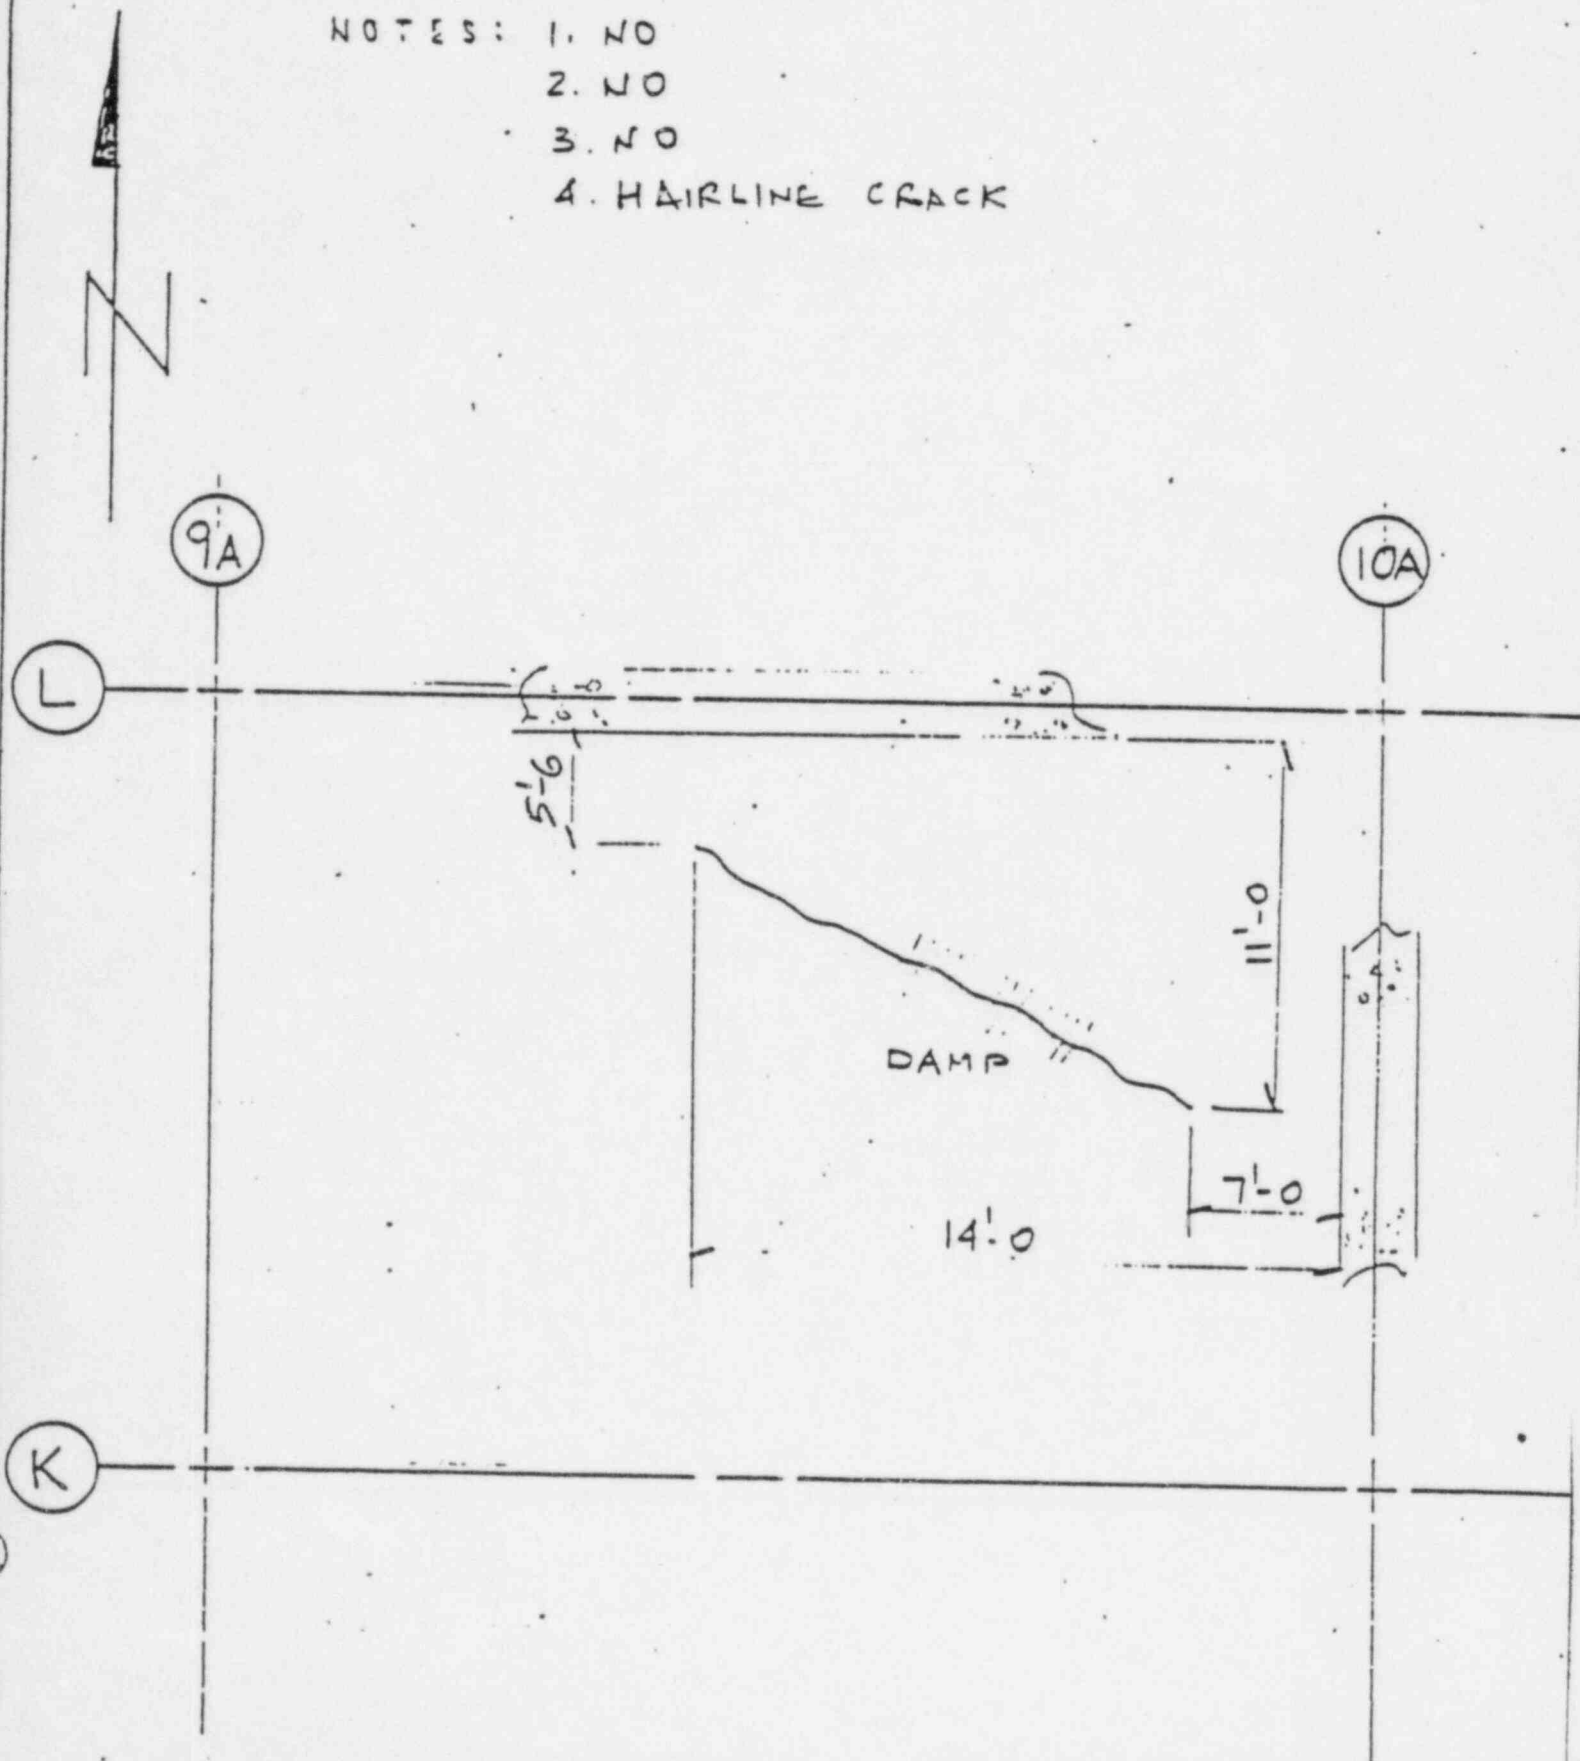
- NOTES:
1. NO
 2. NO
 3. NO
 4. HAIRLINE CRACK

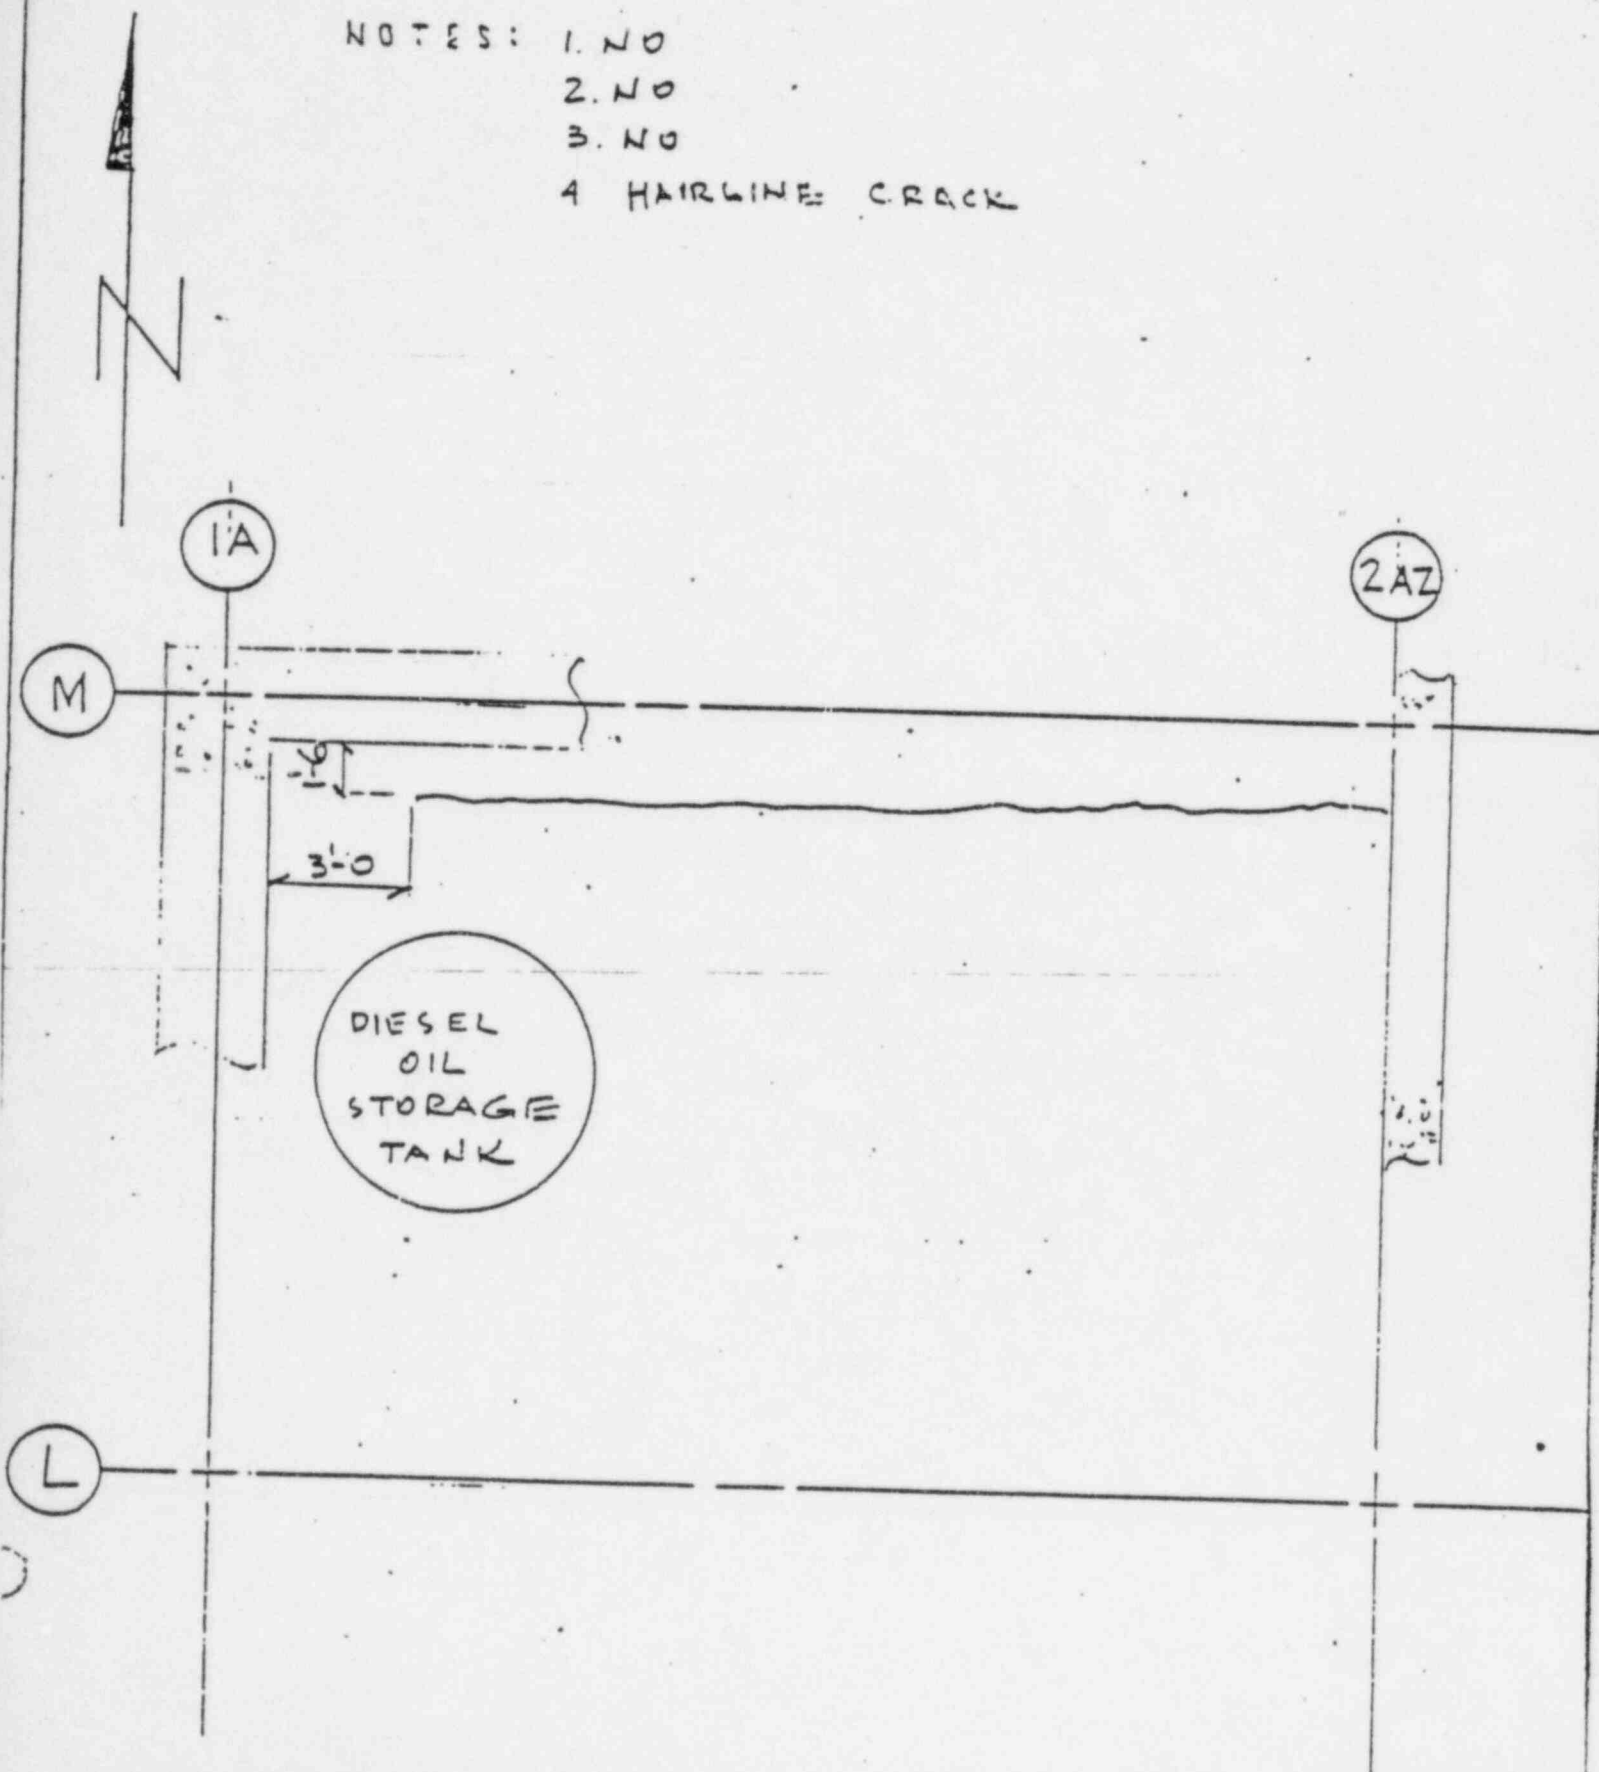
NOTES: 1. NO
2. NO
3. NO
4. HAIRLINE CRACK

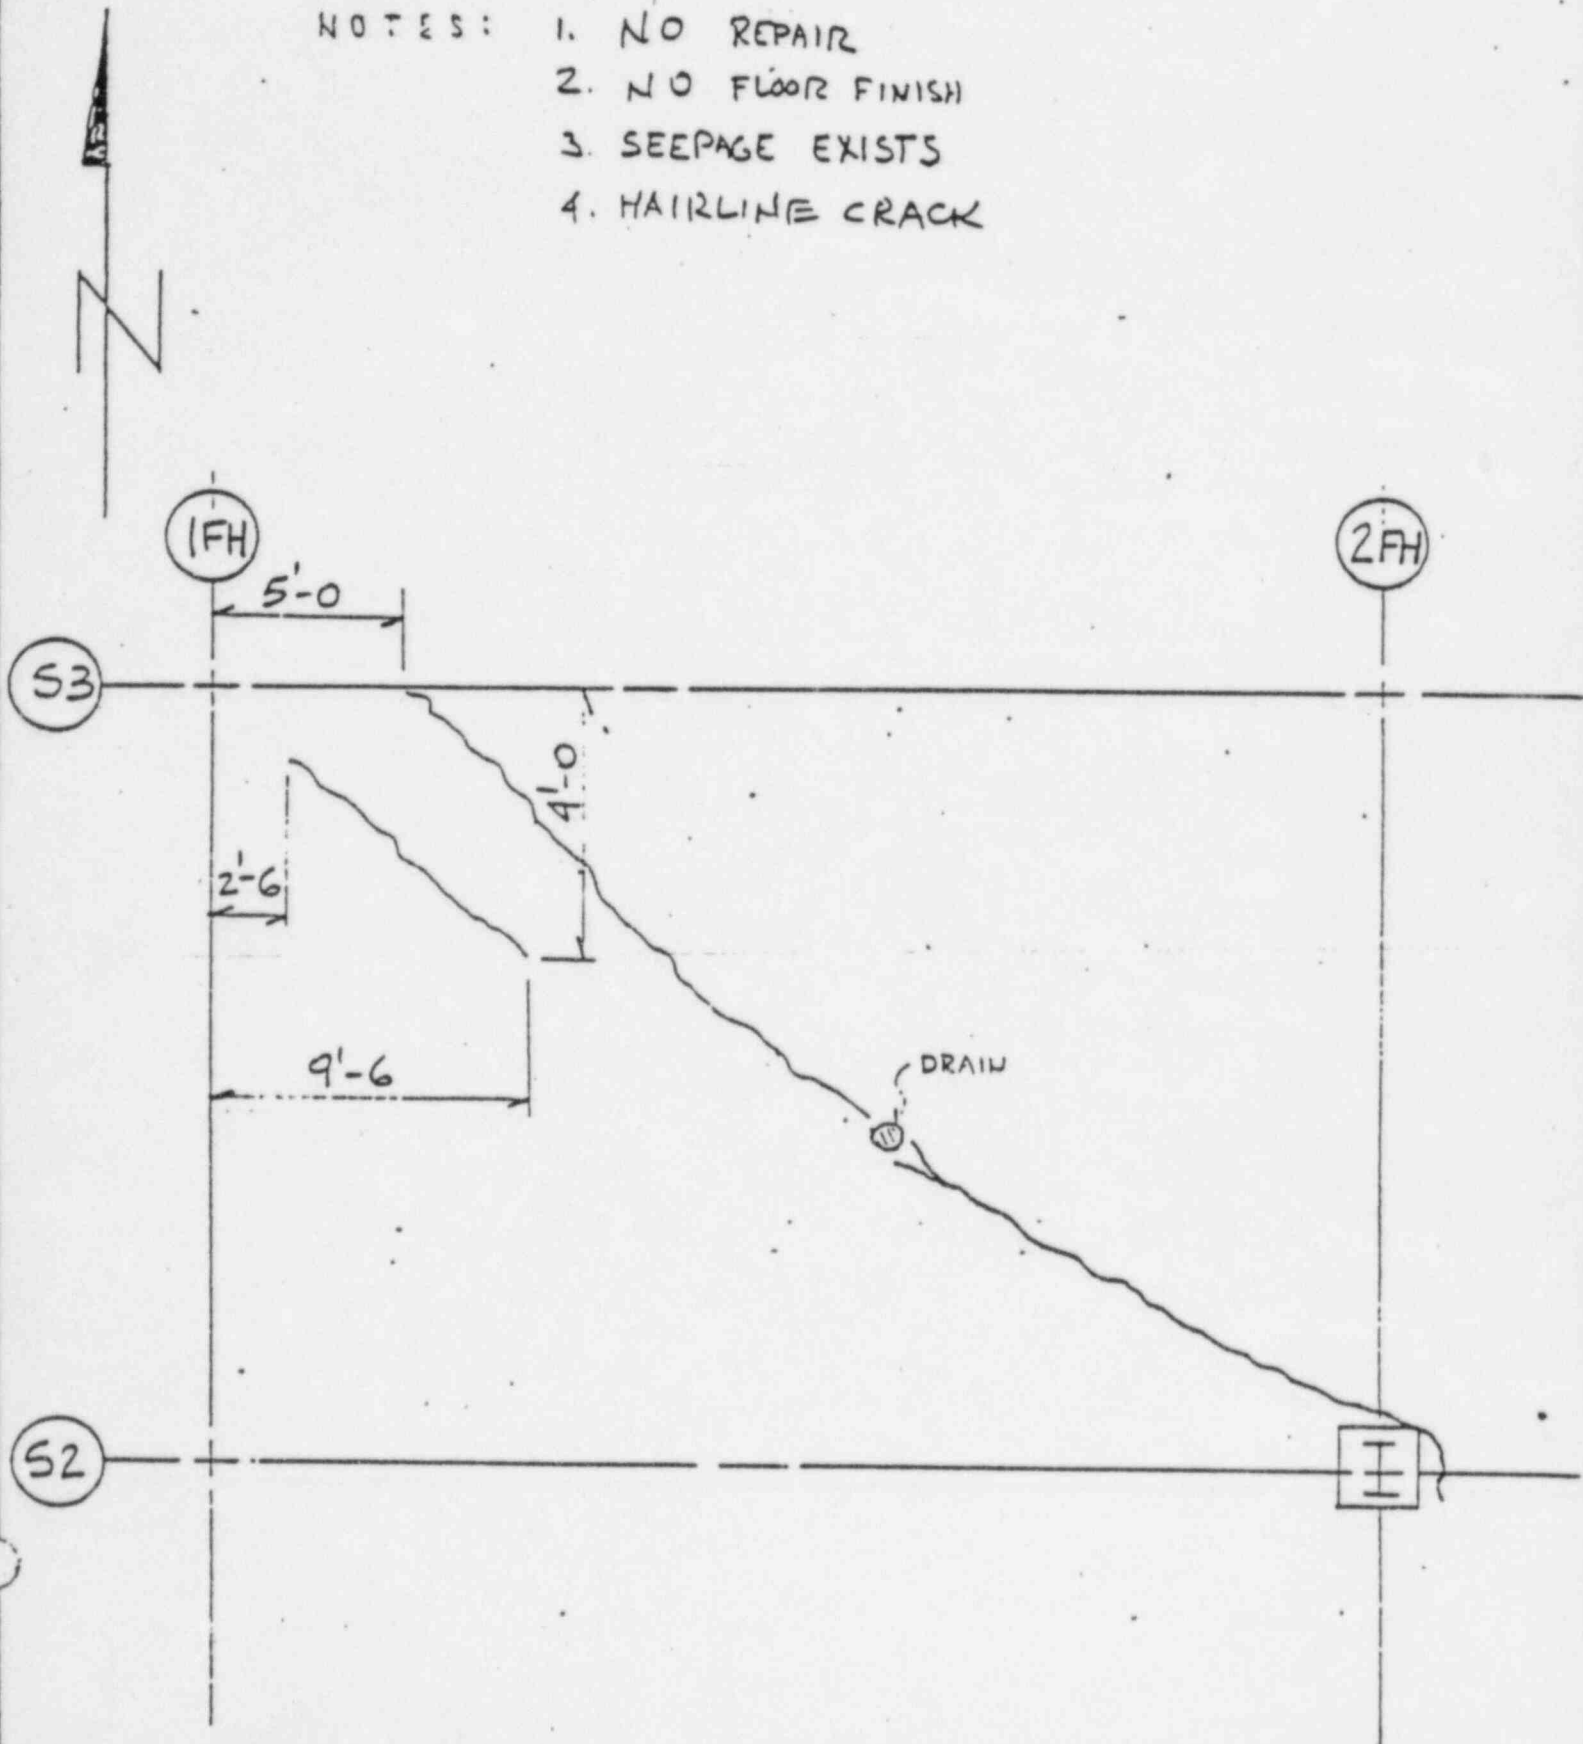
- NOTES:
1. NO REPAIR
 2. NO FLOOR FINISH
 3. SEEPAGE EXISTS
 4. HAIRLINE CRACK

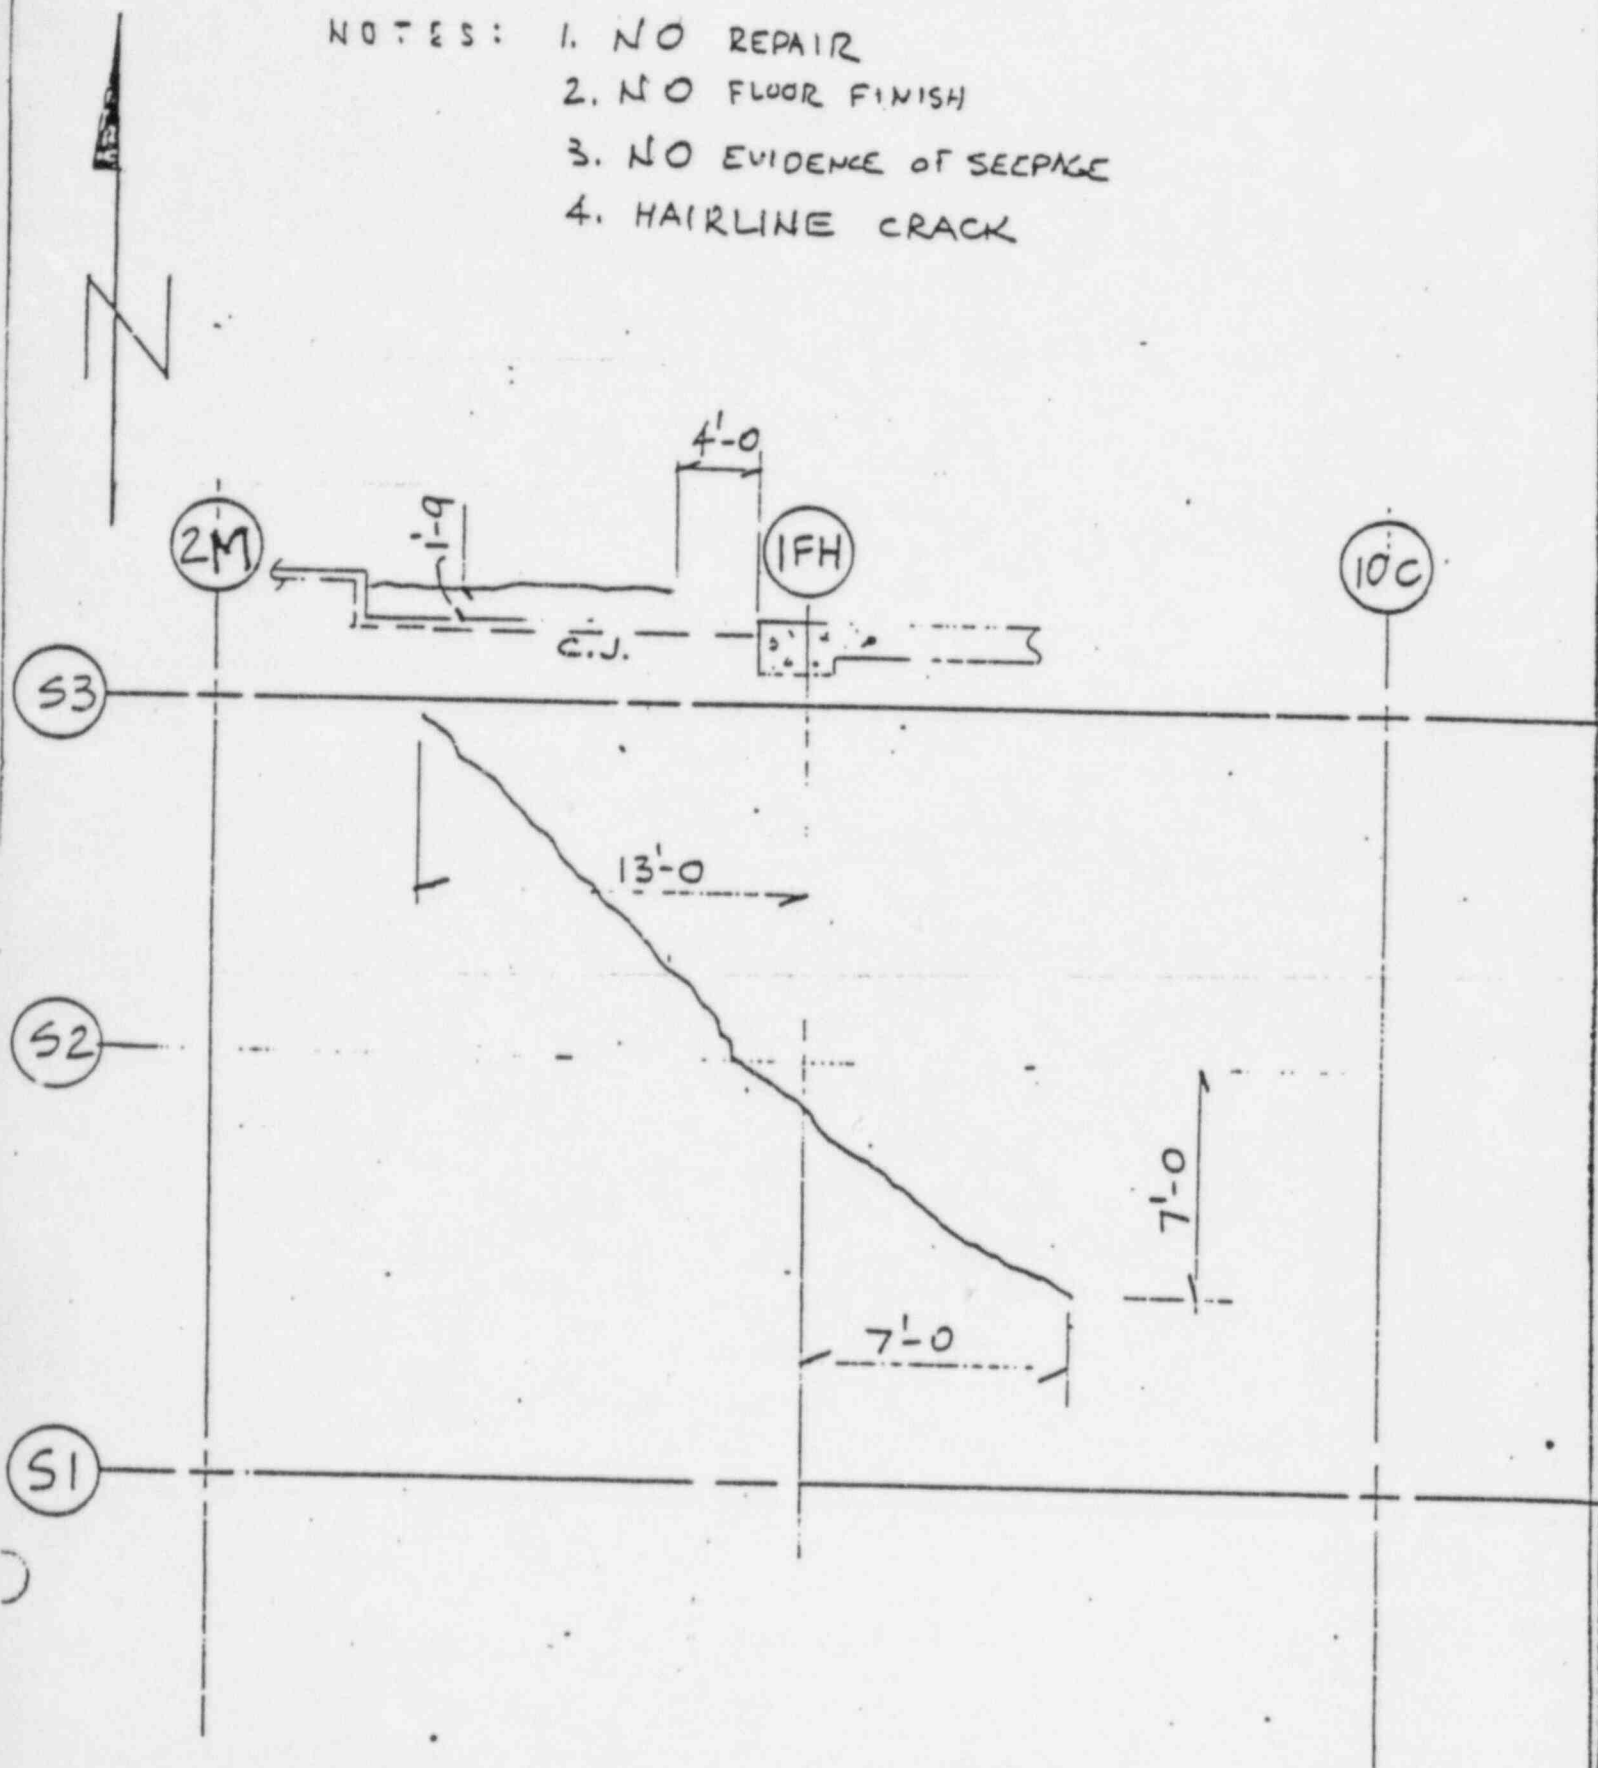
- NOTES:
1. NO REPAIR
 2. NO FLOOR FINISH
 3. NO EVIDENCE OF SEEPAGE
 4. HAIRLINE CRACK

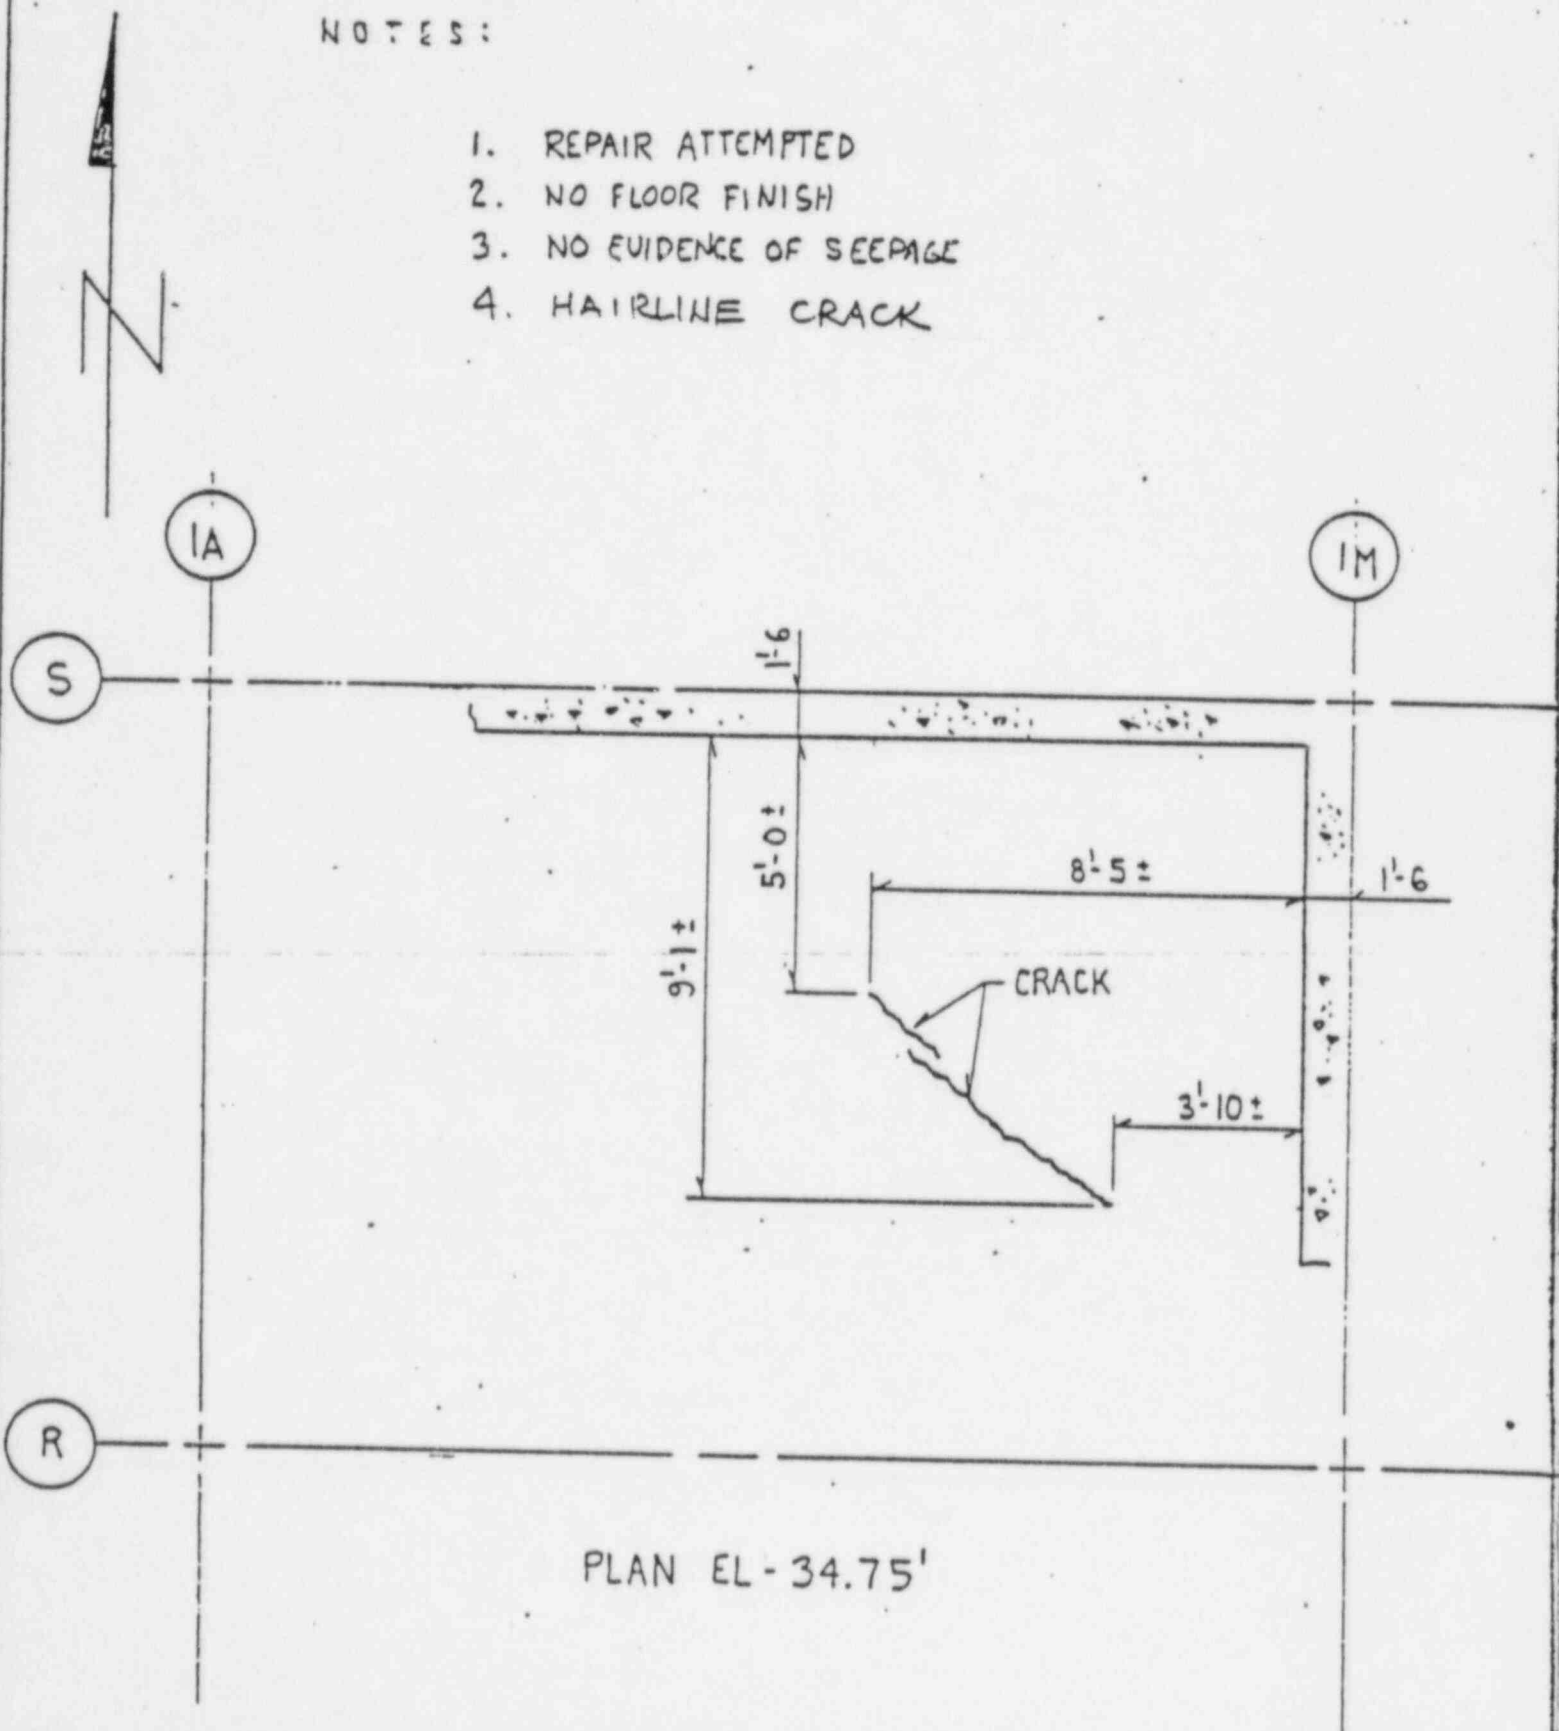
1. REPAIR ATTEMPTED
2. NO FLOOR FINISH
3. NO EVIDENCE OF SEEPAGE
4. HAIRLINE CRACK

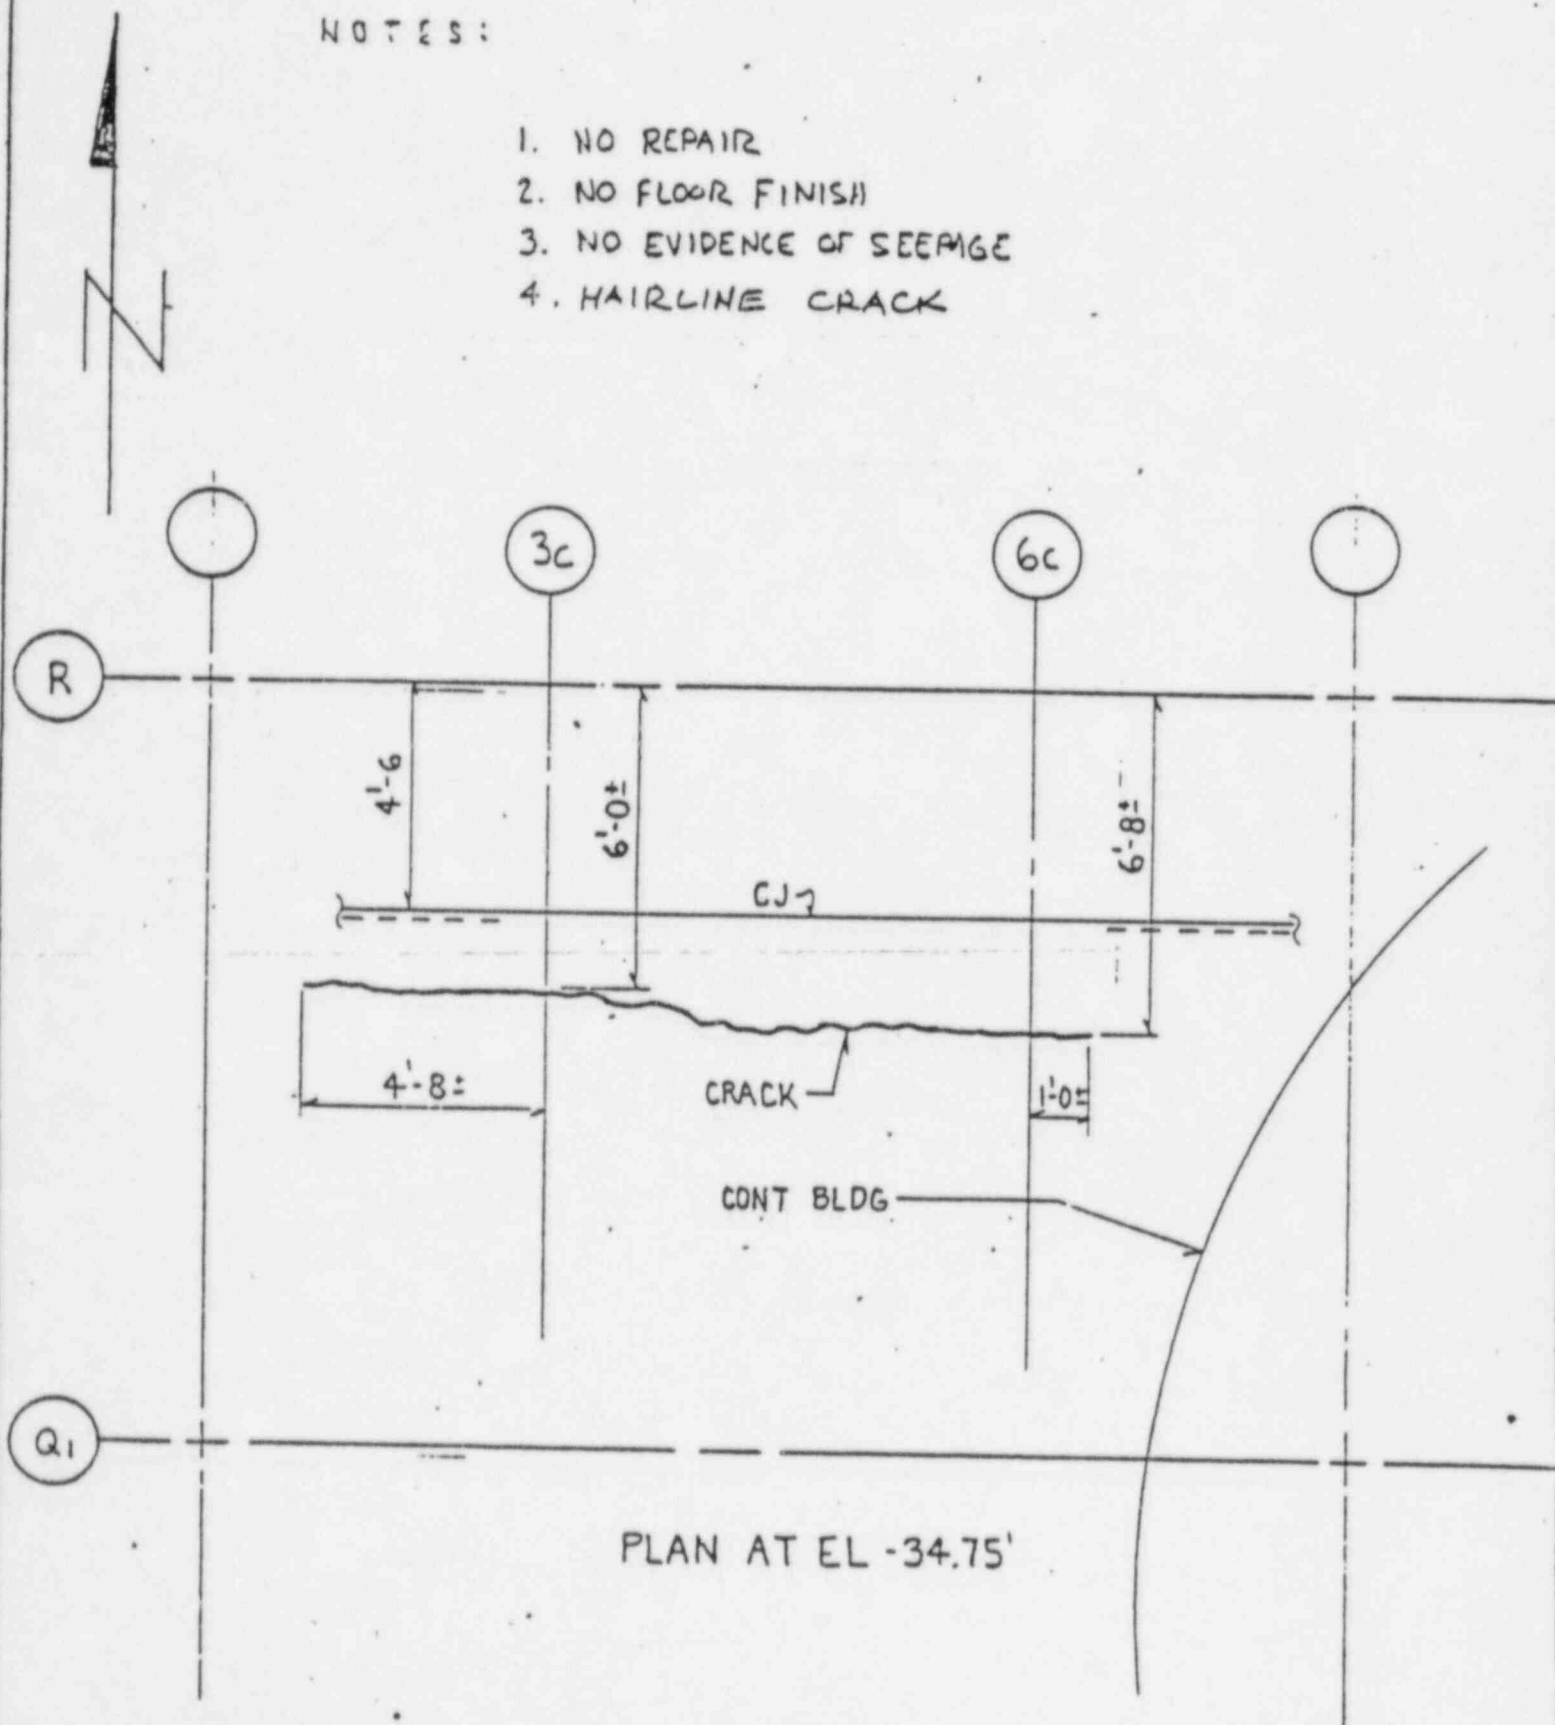
1. NO REPAIR
2. NO FLOOR FINISH
3. NO EVIDENCE OF SEEPAGE
4. HAIRLINE CRACK

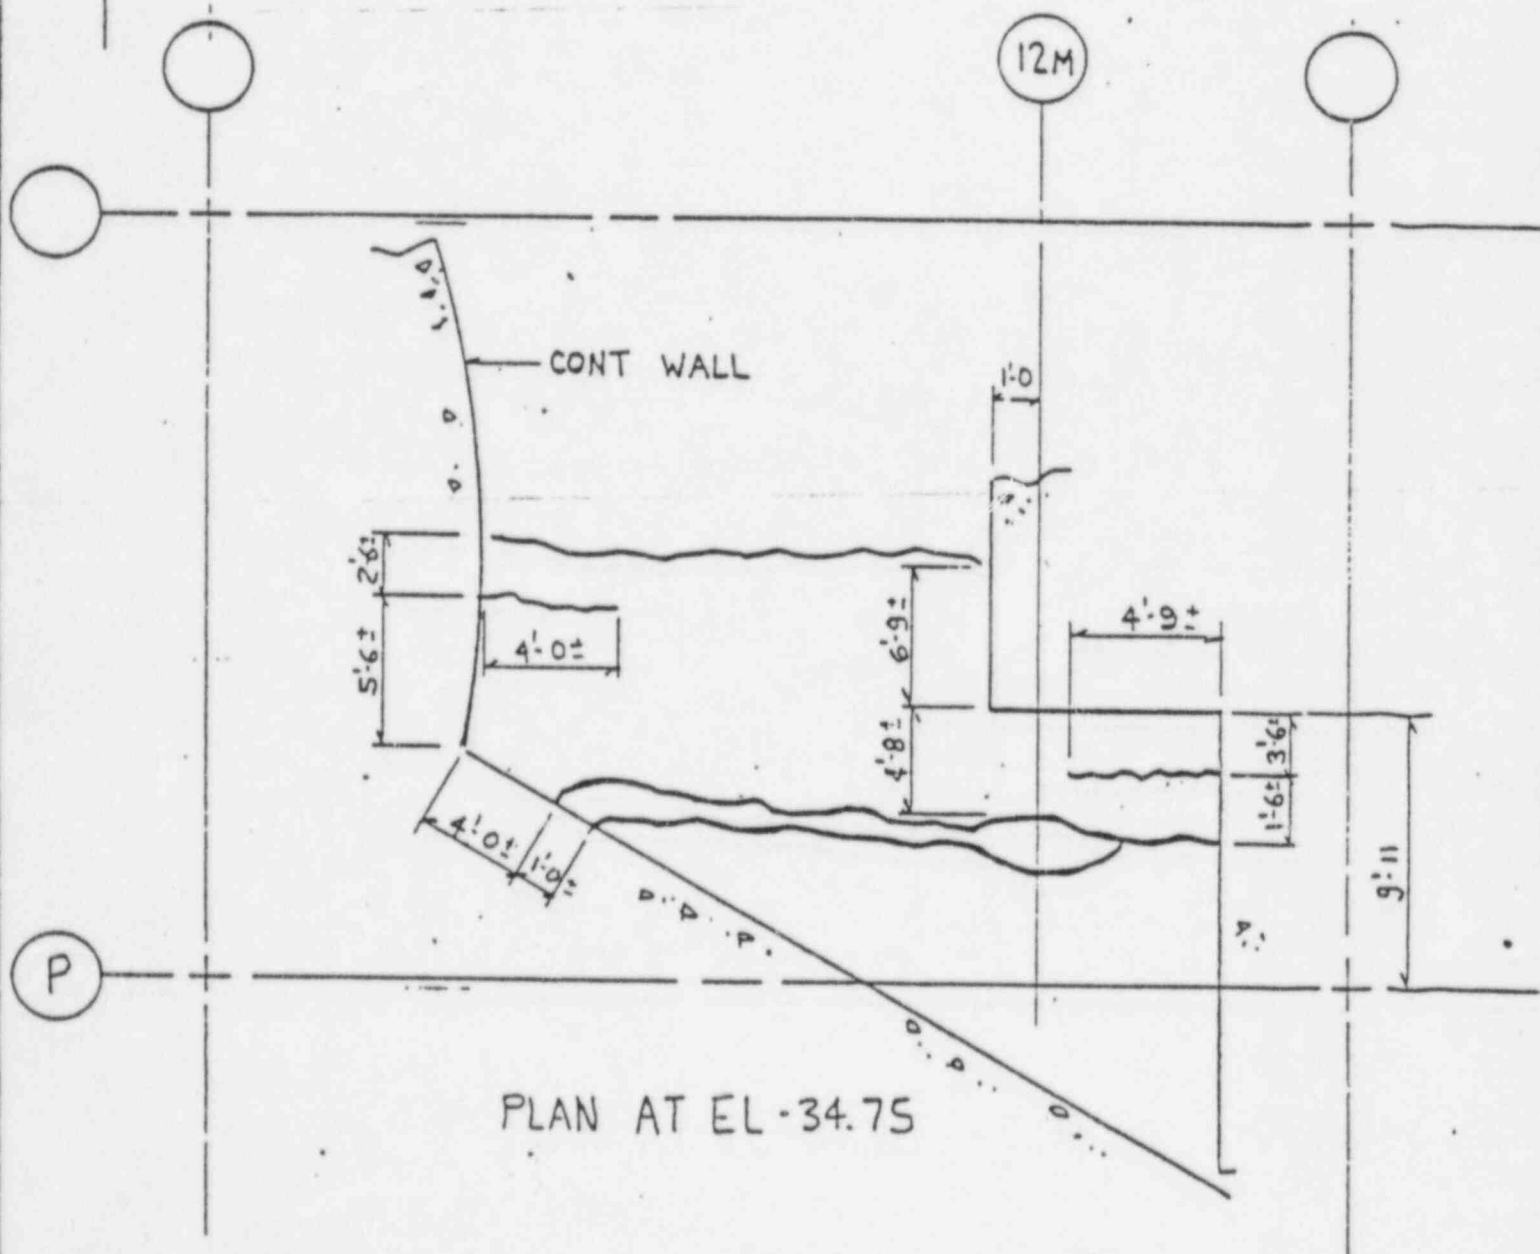
PLAN AT EL - 34.75

- 1 NO REPAIR
- 2 NO FLOOR FINISH
- 3 SOME SEEPAGE
4. HAIRLINE CRACK.

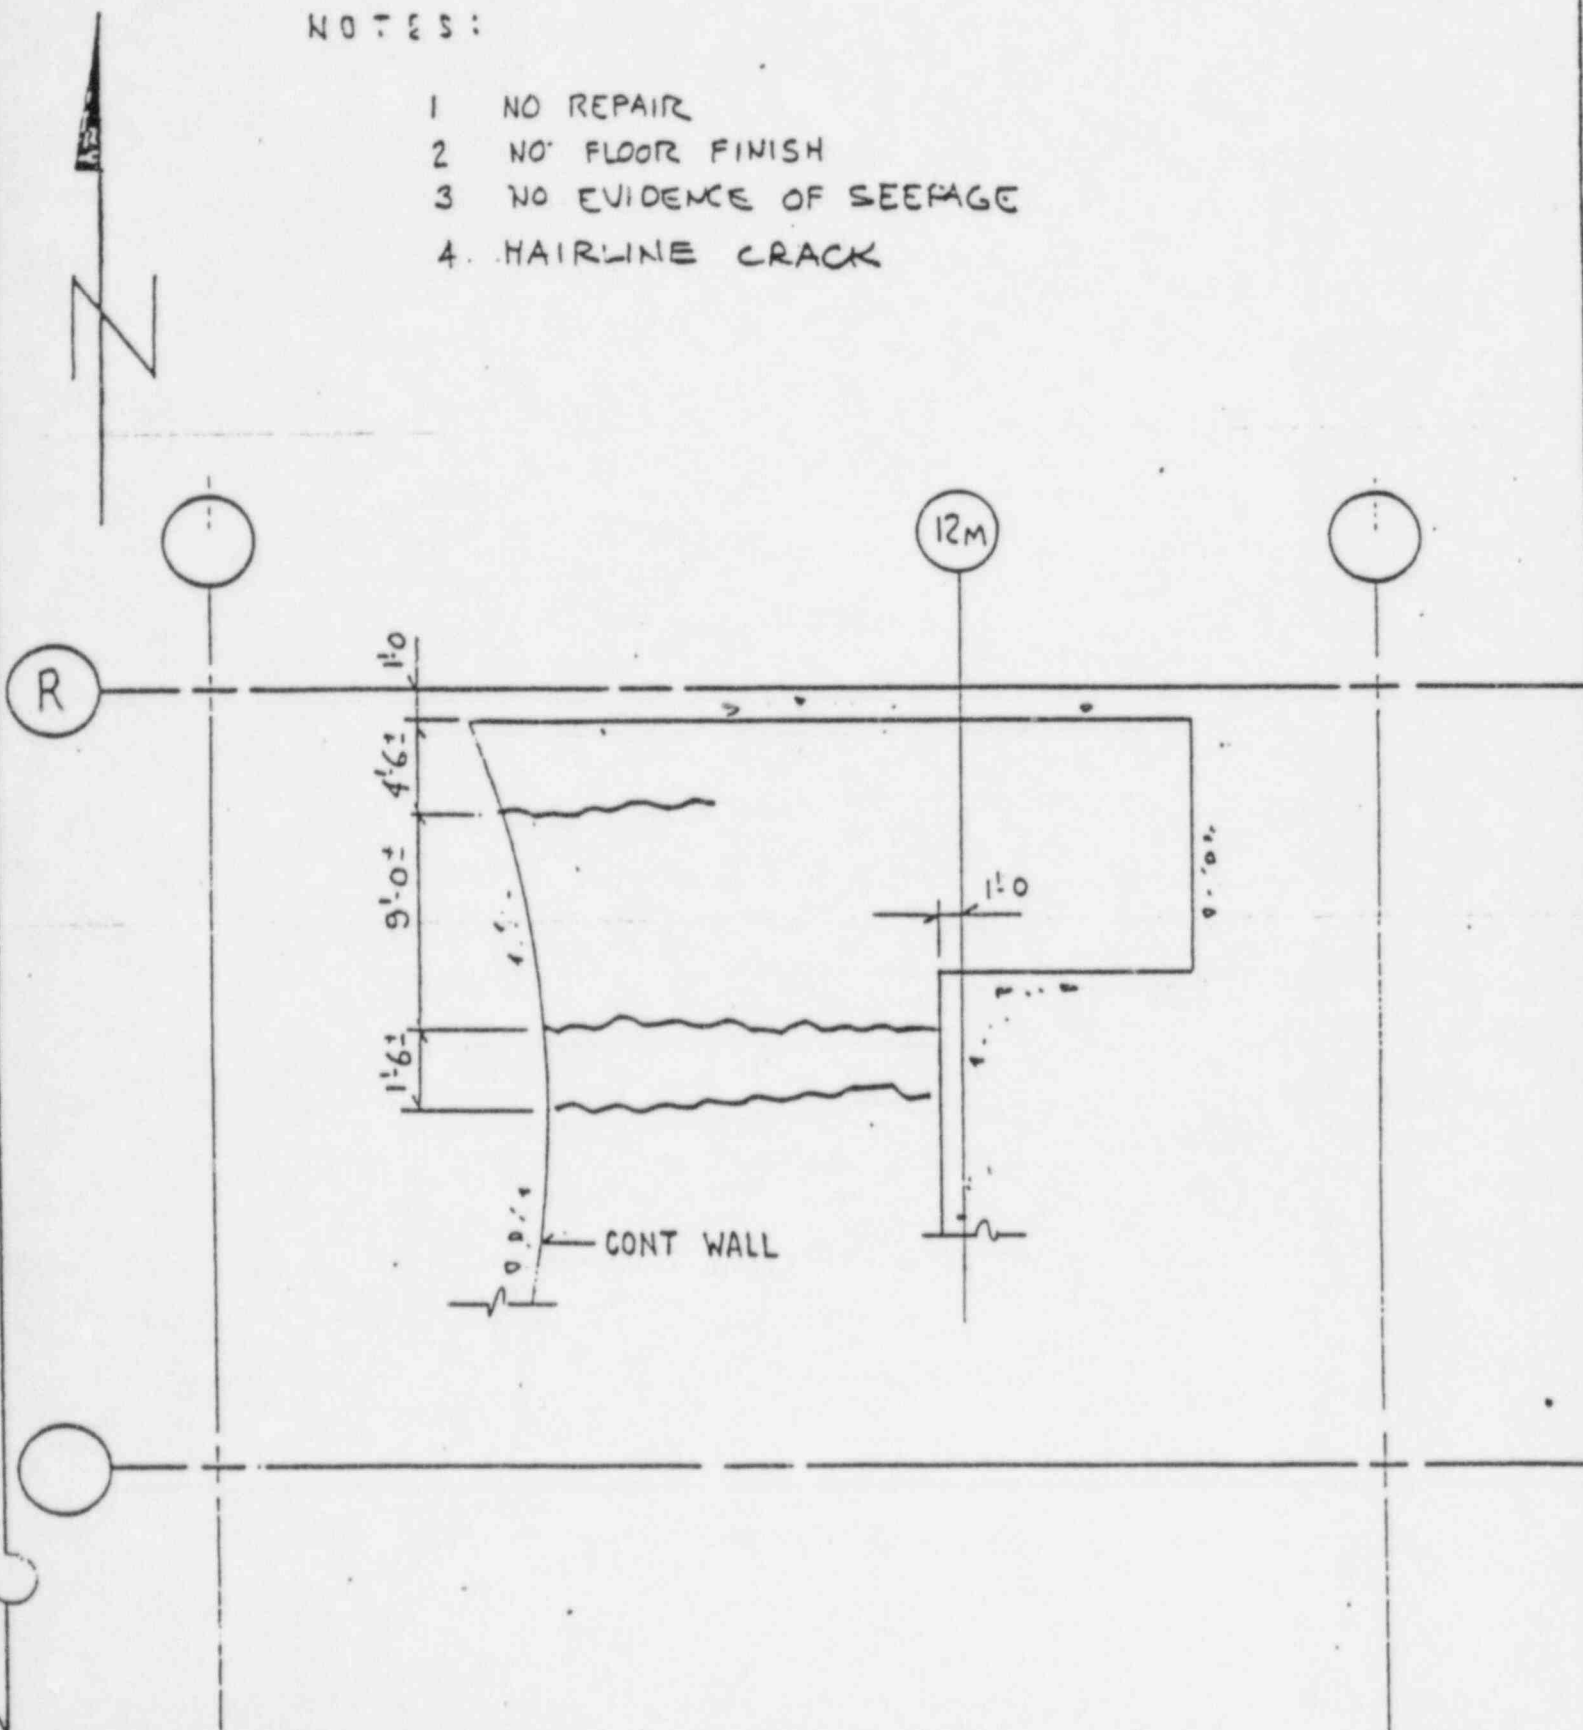
- 1 NO REPAIR
- 2 NO FLOOR FINISH
- 3 NO EVIDENCE OF SEEPAGE
4. HAIRLINE CRACK
