Modified to Fit Waterford Unit #3

Concrete Phase I Construction

POP-N-713
USE OF DISCREPANCY REPORTS

WATERFORD III SES
ANALYSIS OF CRACKS AND WATER SEEPAGE
IN FOUNDATION MAT
LOUISIANA POWER & LIGHT COMPANY
REPORT NO. 8304-1
SEPTEMBER 19, 1983

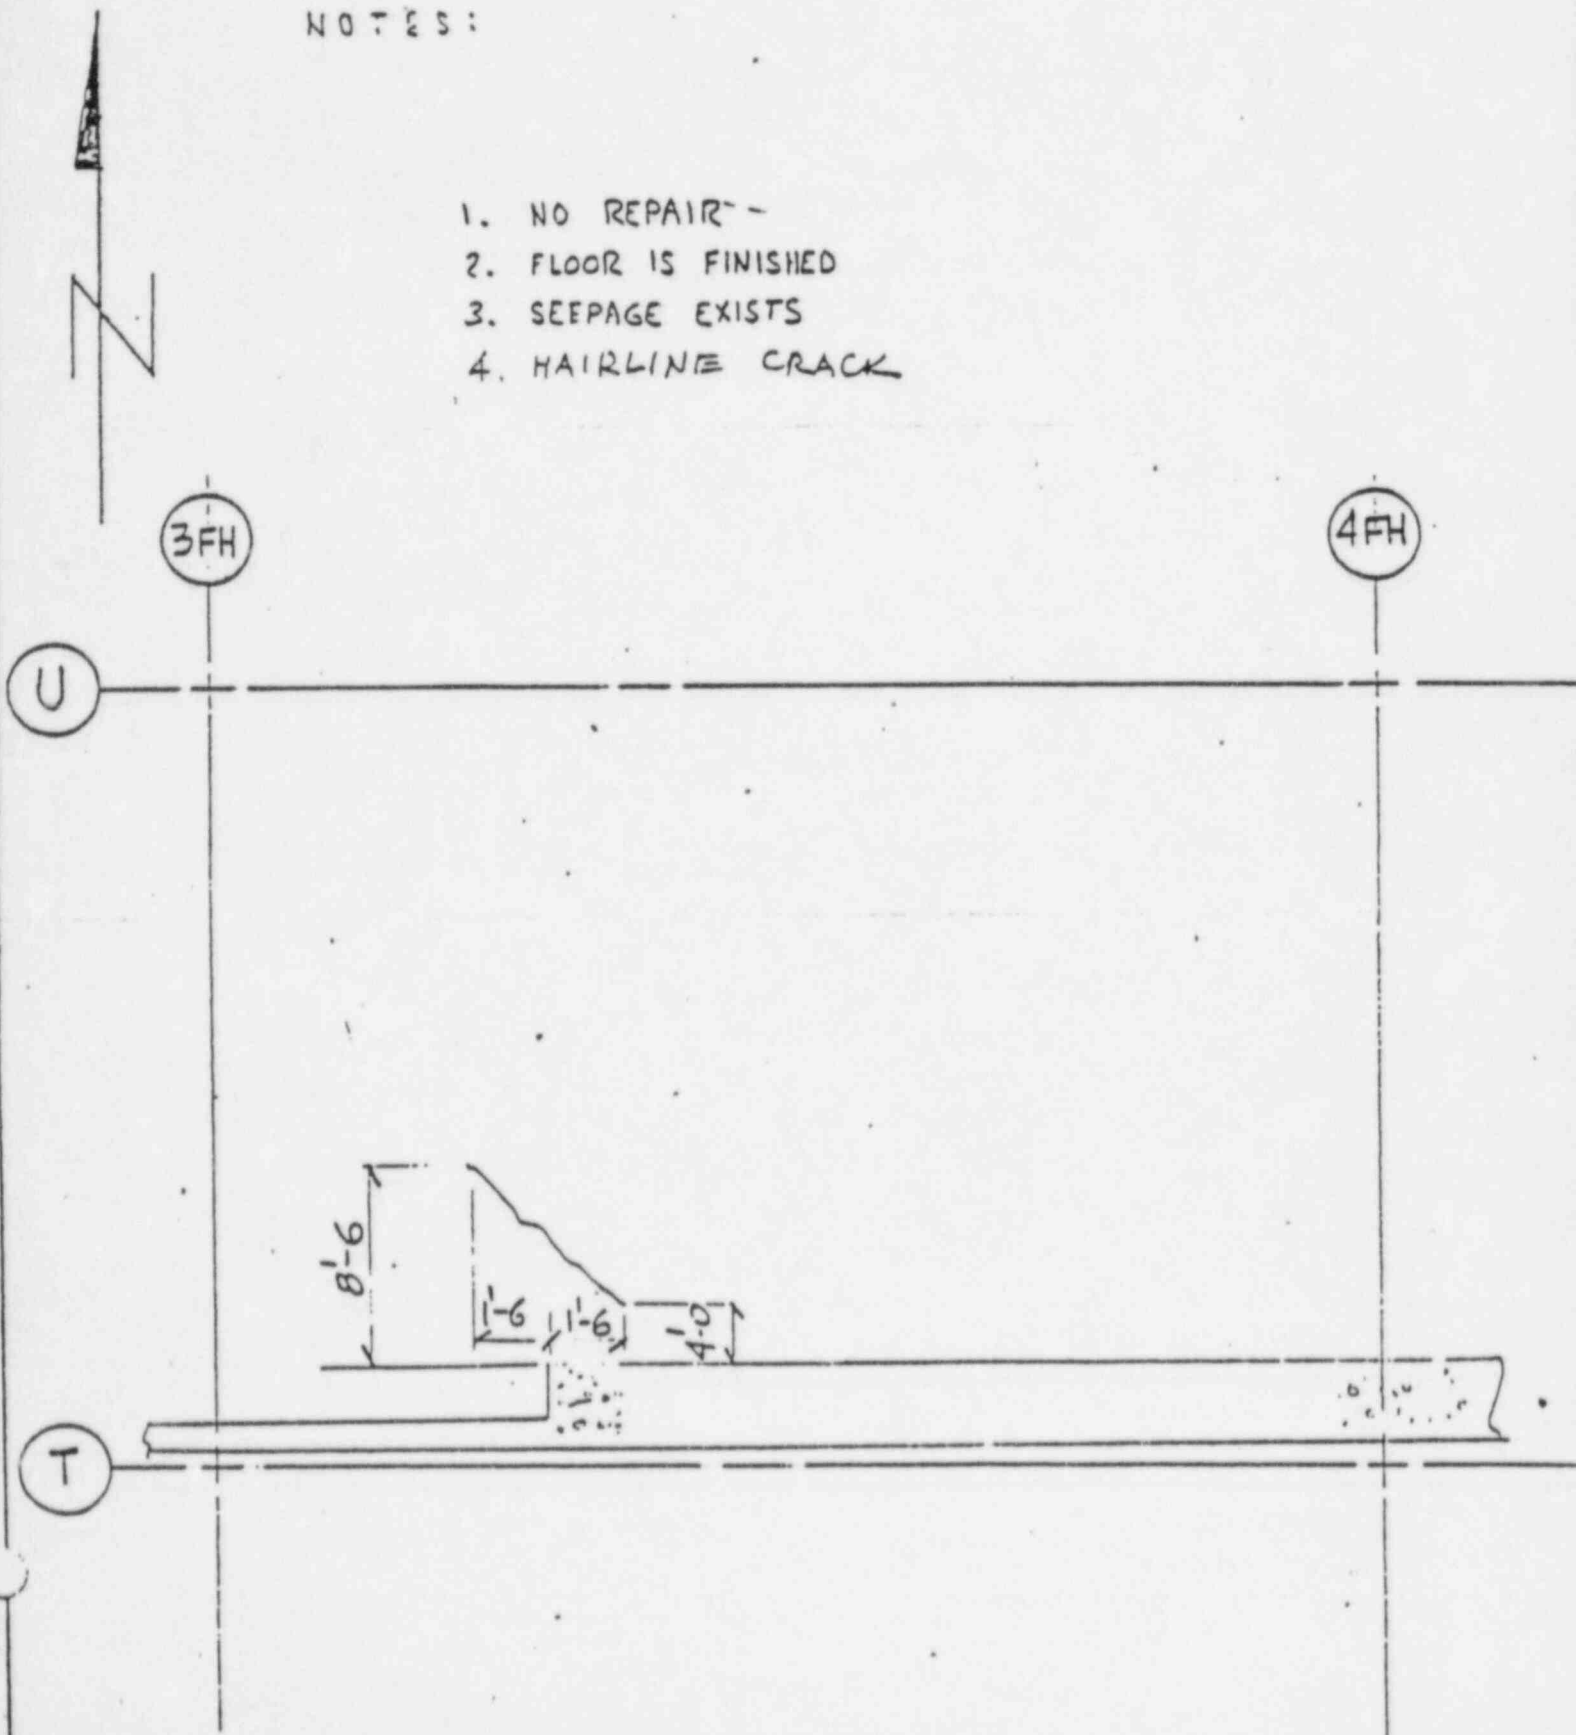
1. NO REPAIR -
2. FLOOR IS FINISHED
3. SEEPAGE EXISTS
4. HAIRLINE CRACK

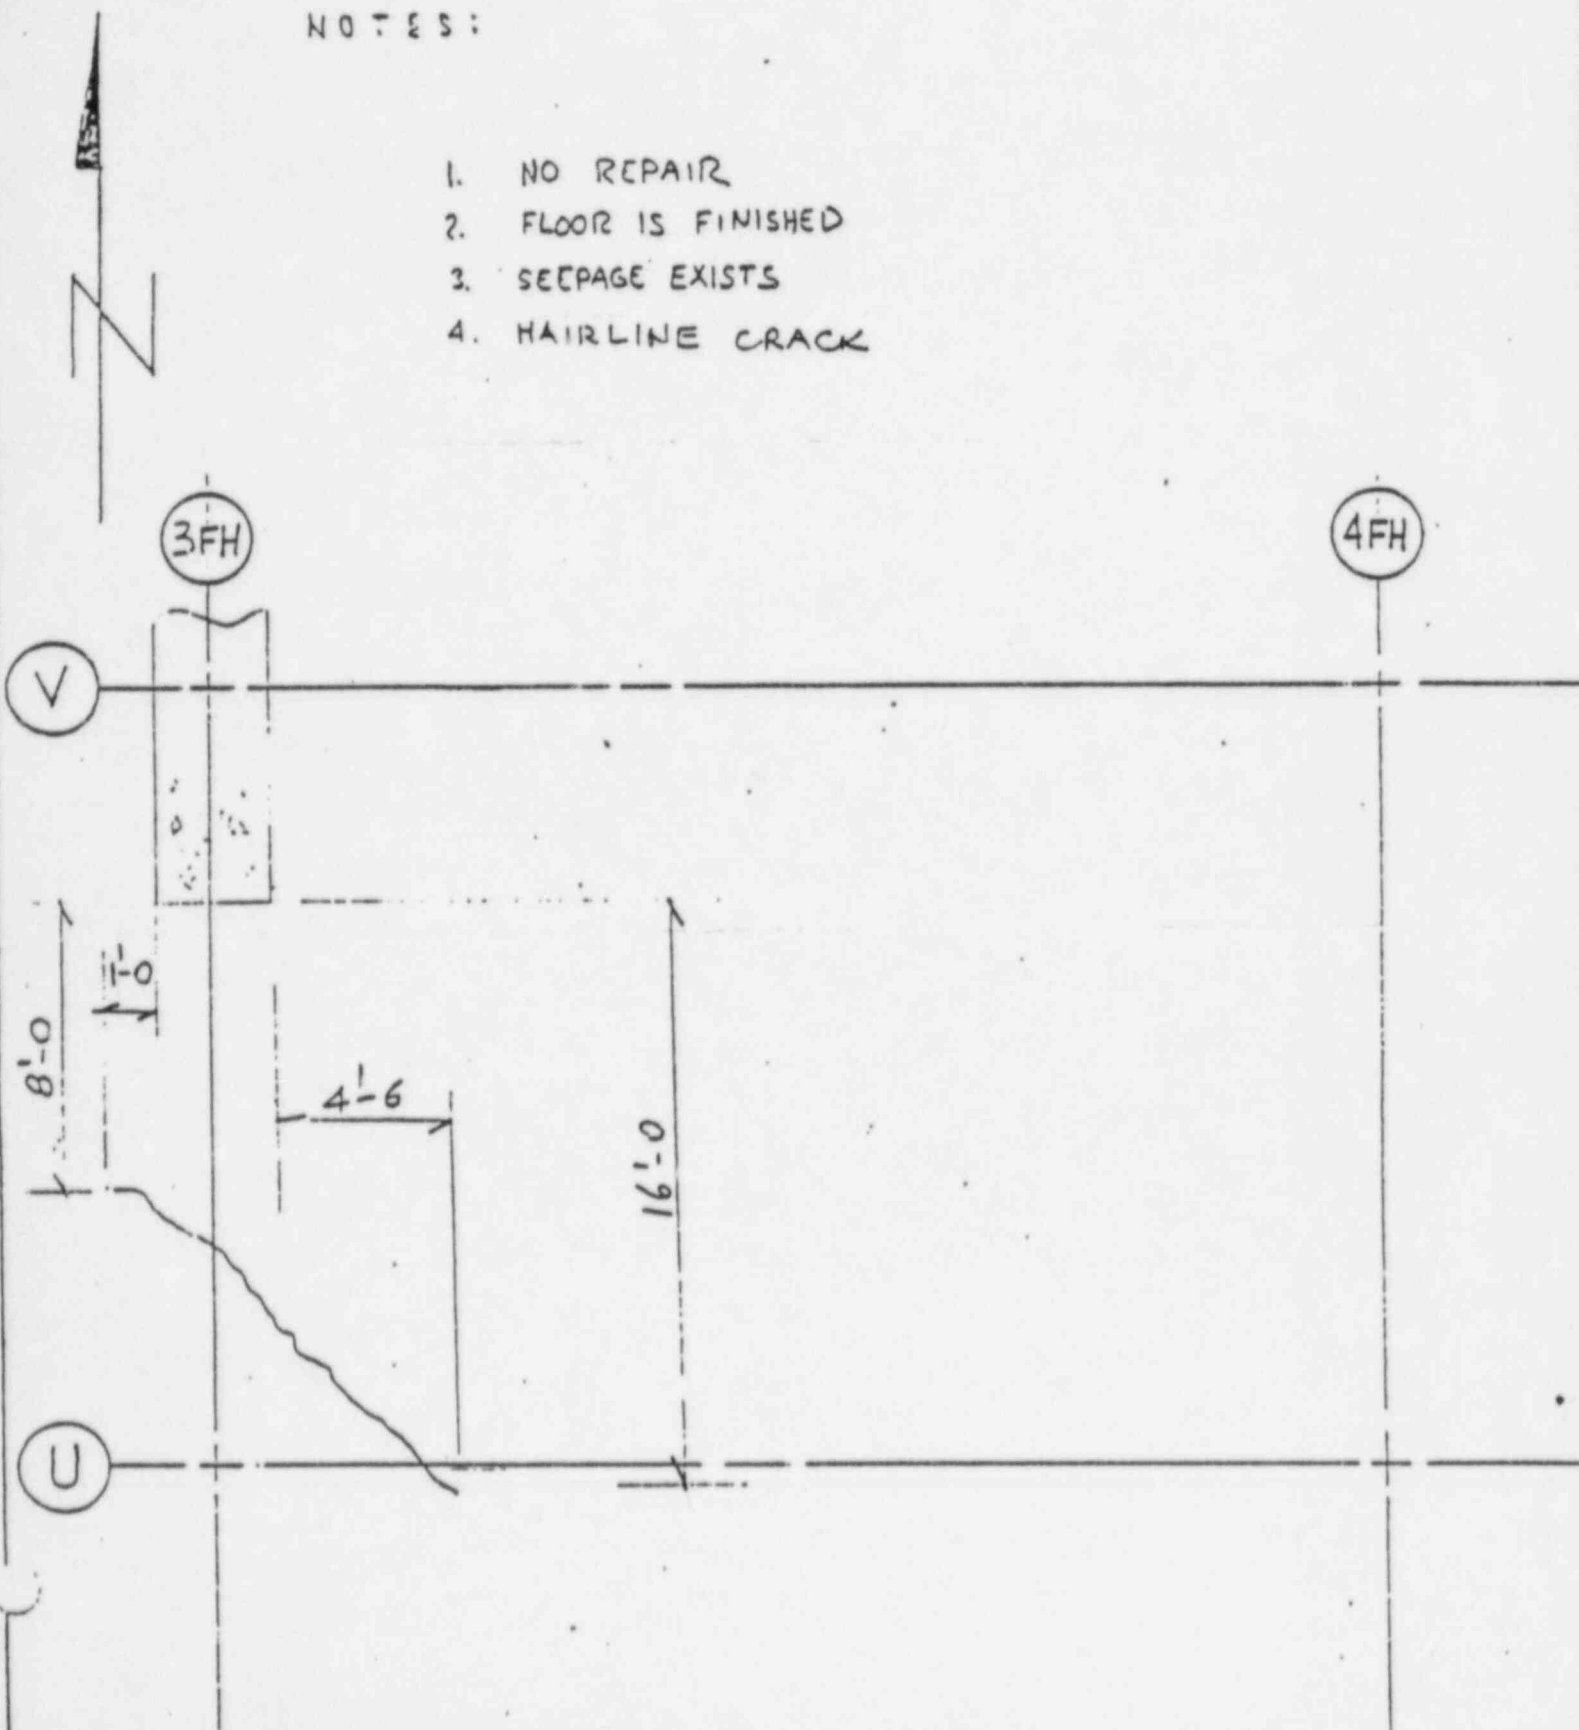
1. NO REPAIR
2. FLOOR IS FINISHED
3. SEEPAGE EXISTS
4. HAIRLINE CRACK

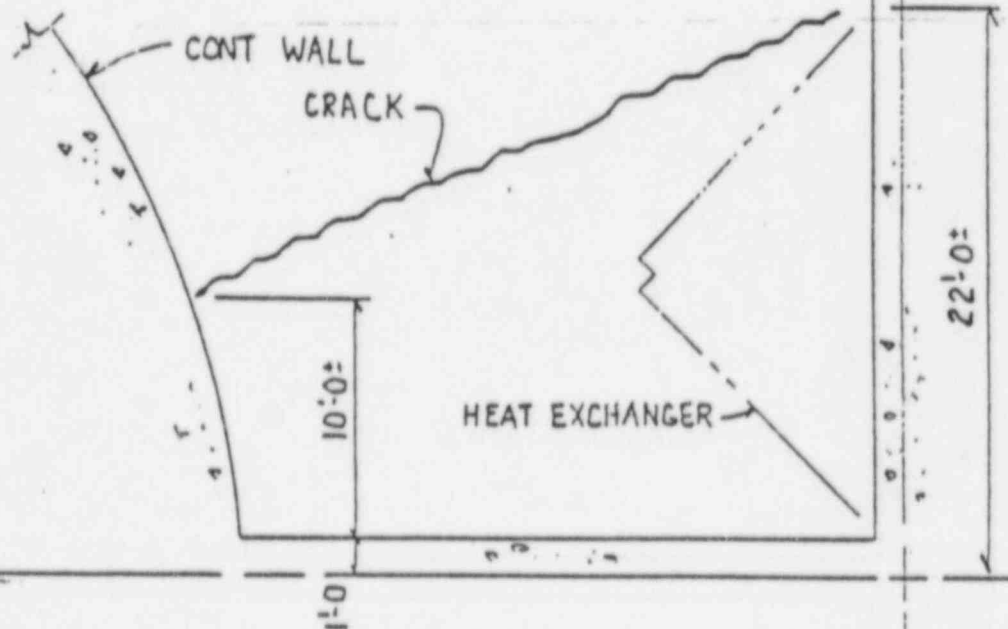
PLAN AT EL -34.75'

- 1 NO REPAIR
- 2 NO FINISH
- 3 NO SEEPAGE
4. HAIRLINE CRACK

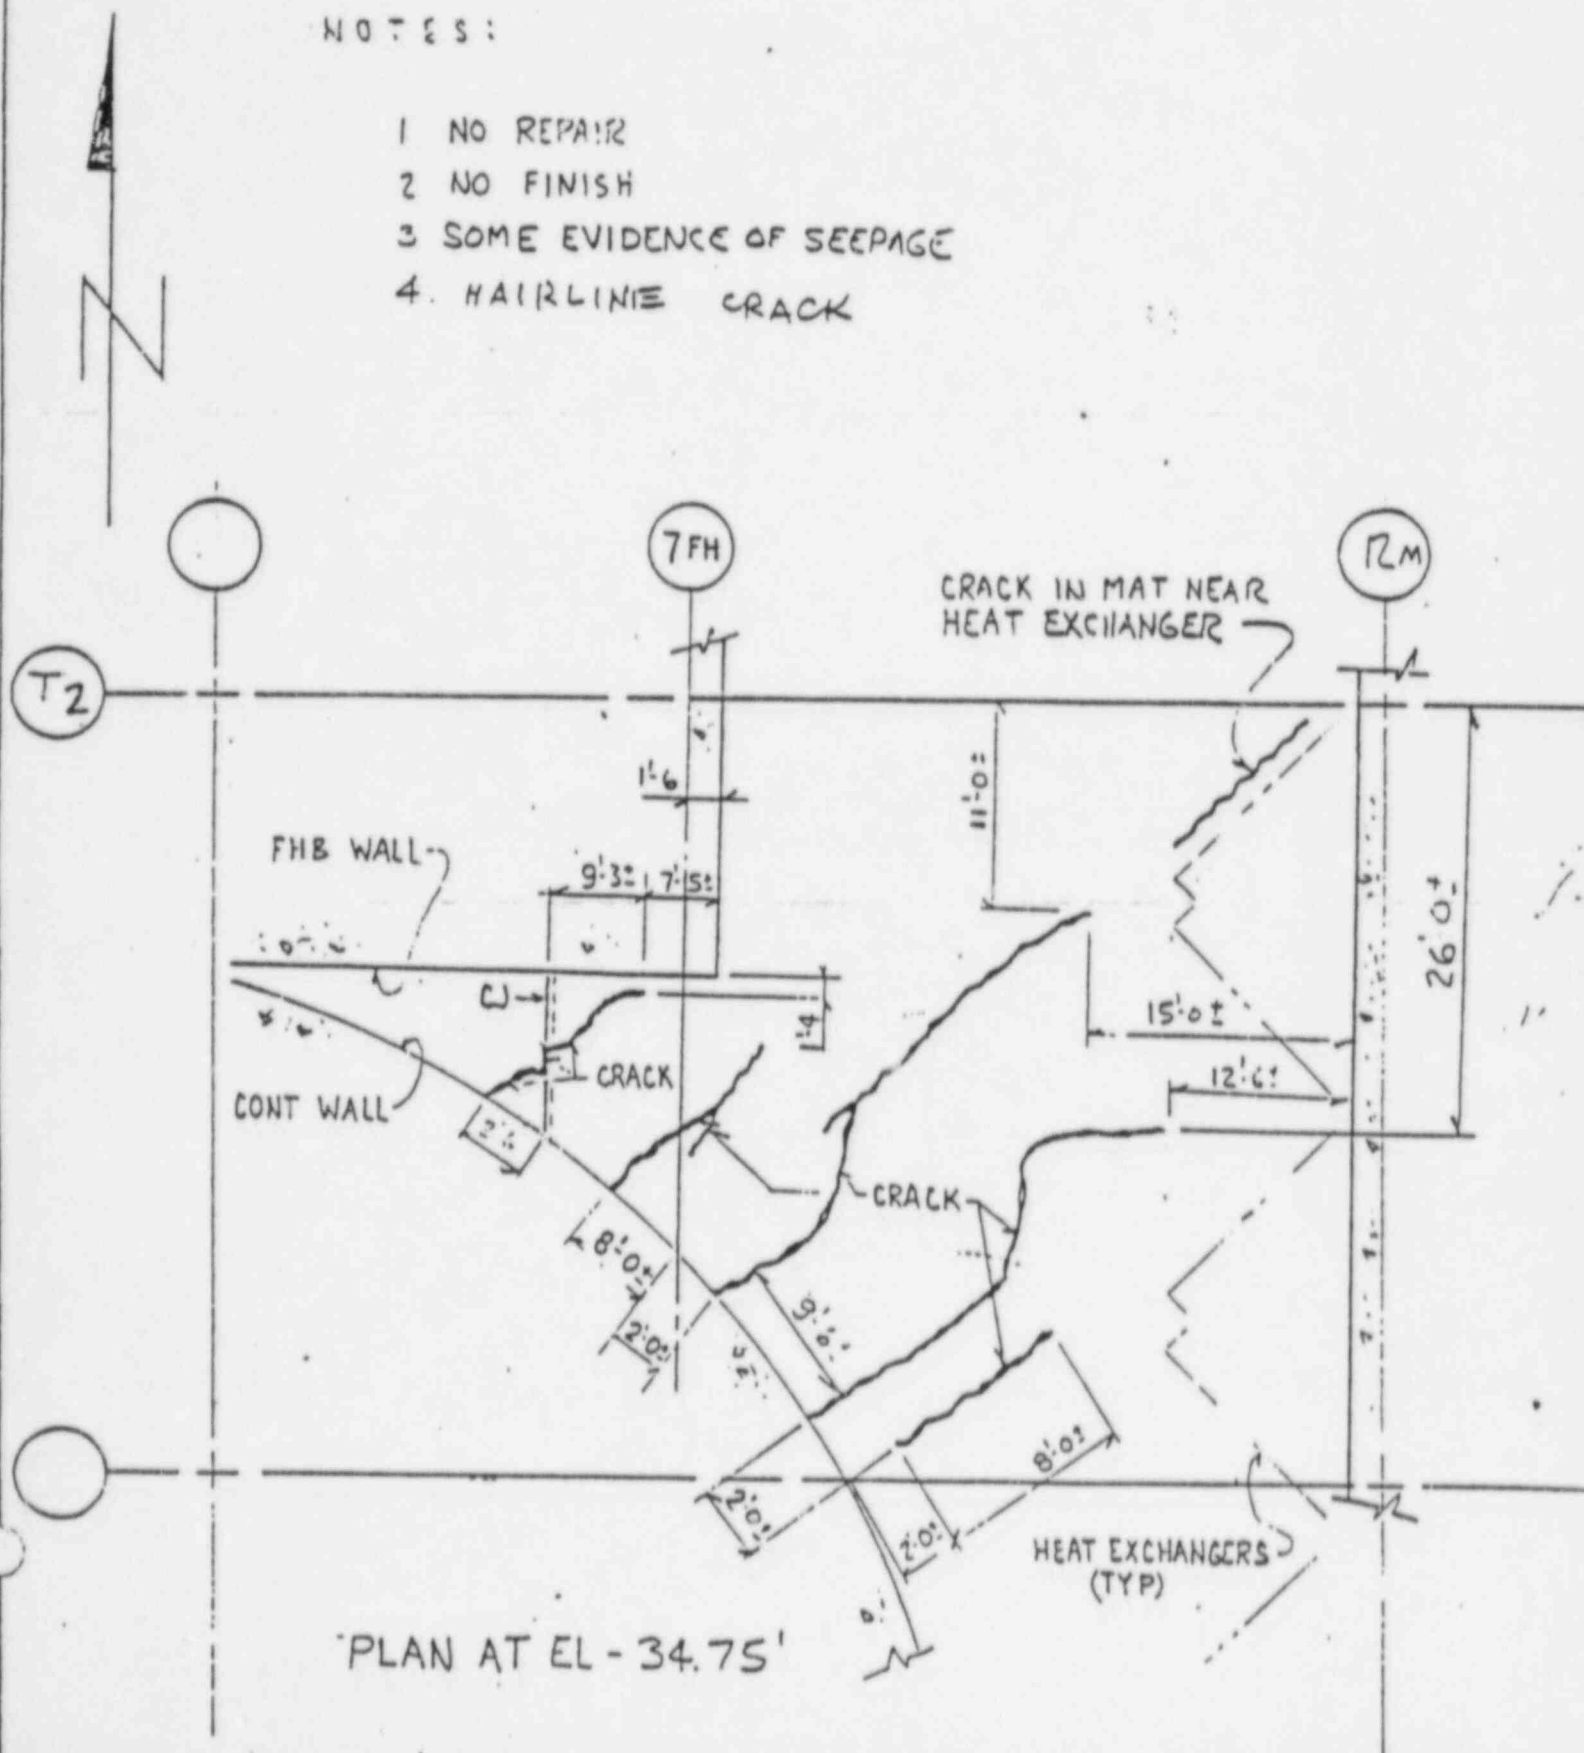
- 1 NO REPAIR
- 2 NO FINISH
- 3 SOME EVIDENCE OF SEEPAGE
4. HAIRLINE CRACK

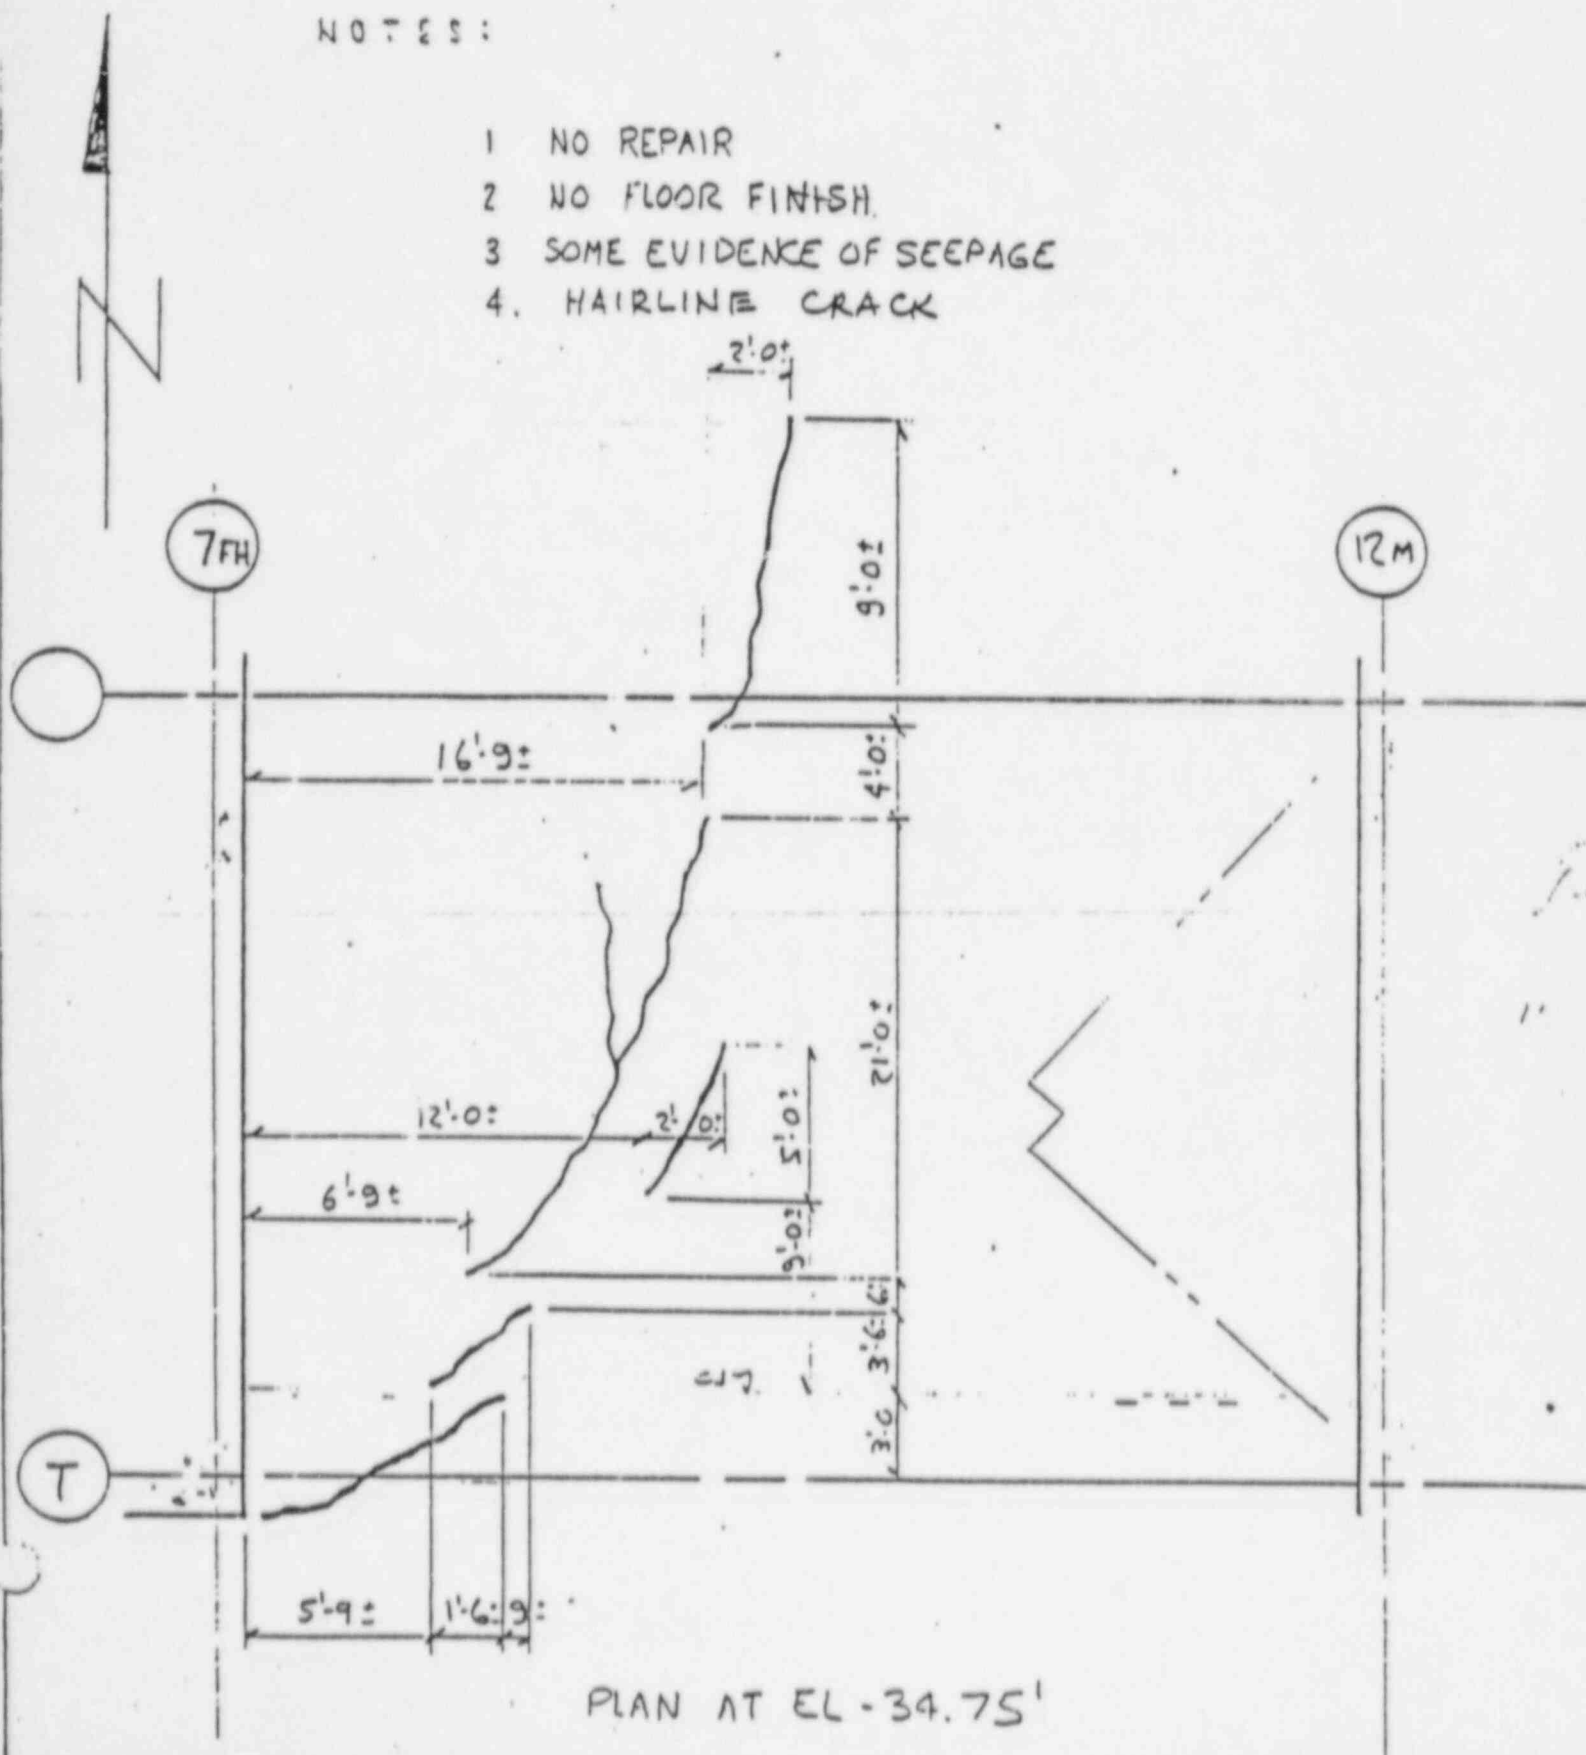
PLAN AT EL - 34.75'

- 1 NO REPAIR
- 2 NO FLOOR FINISH
- 3 SOME EVIDENCE OF SEEPAGE
4. HAIRLINE CRACK

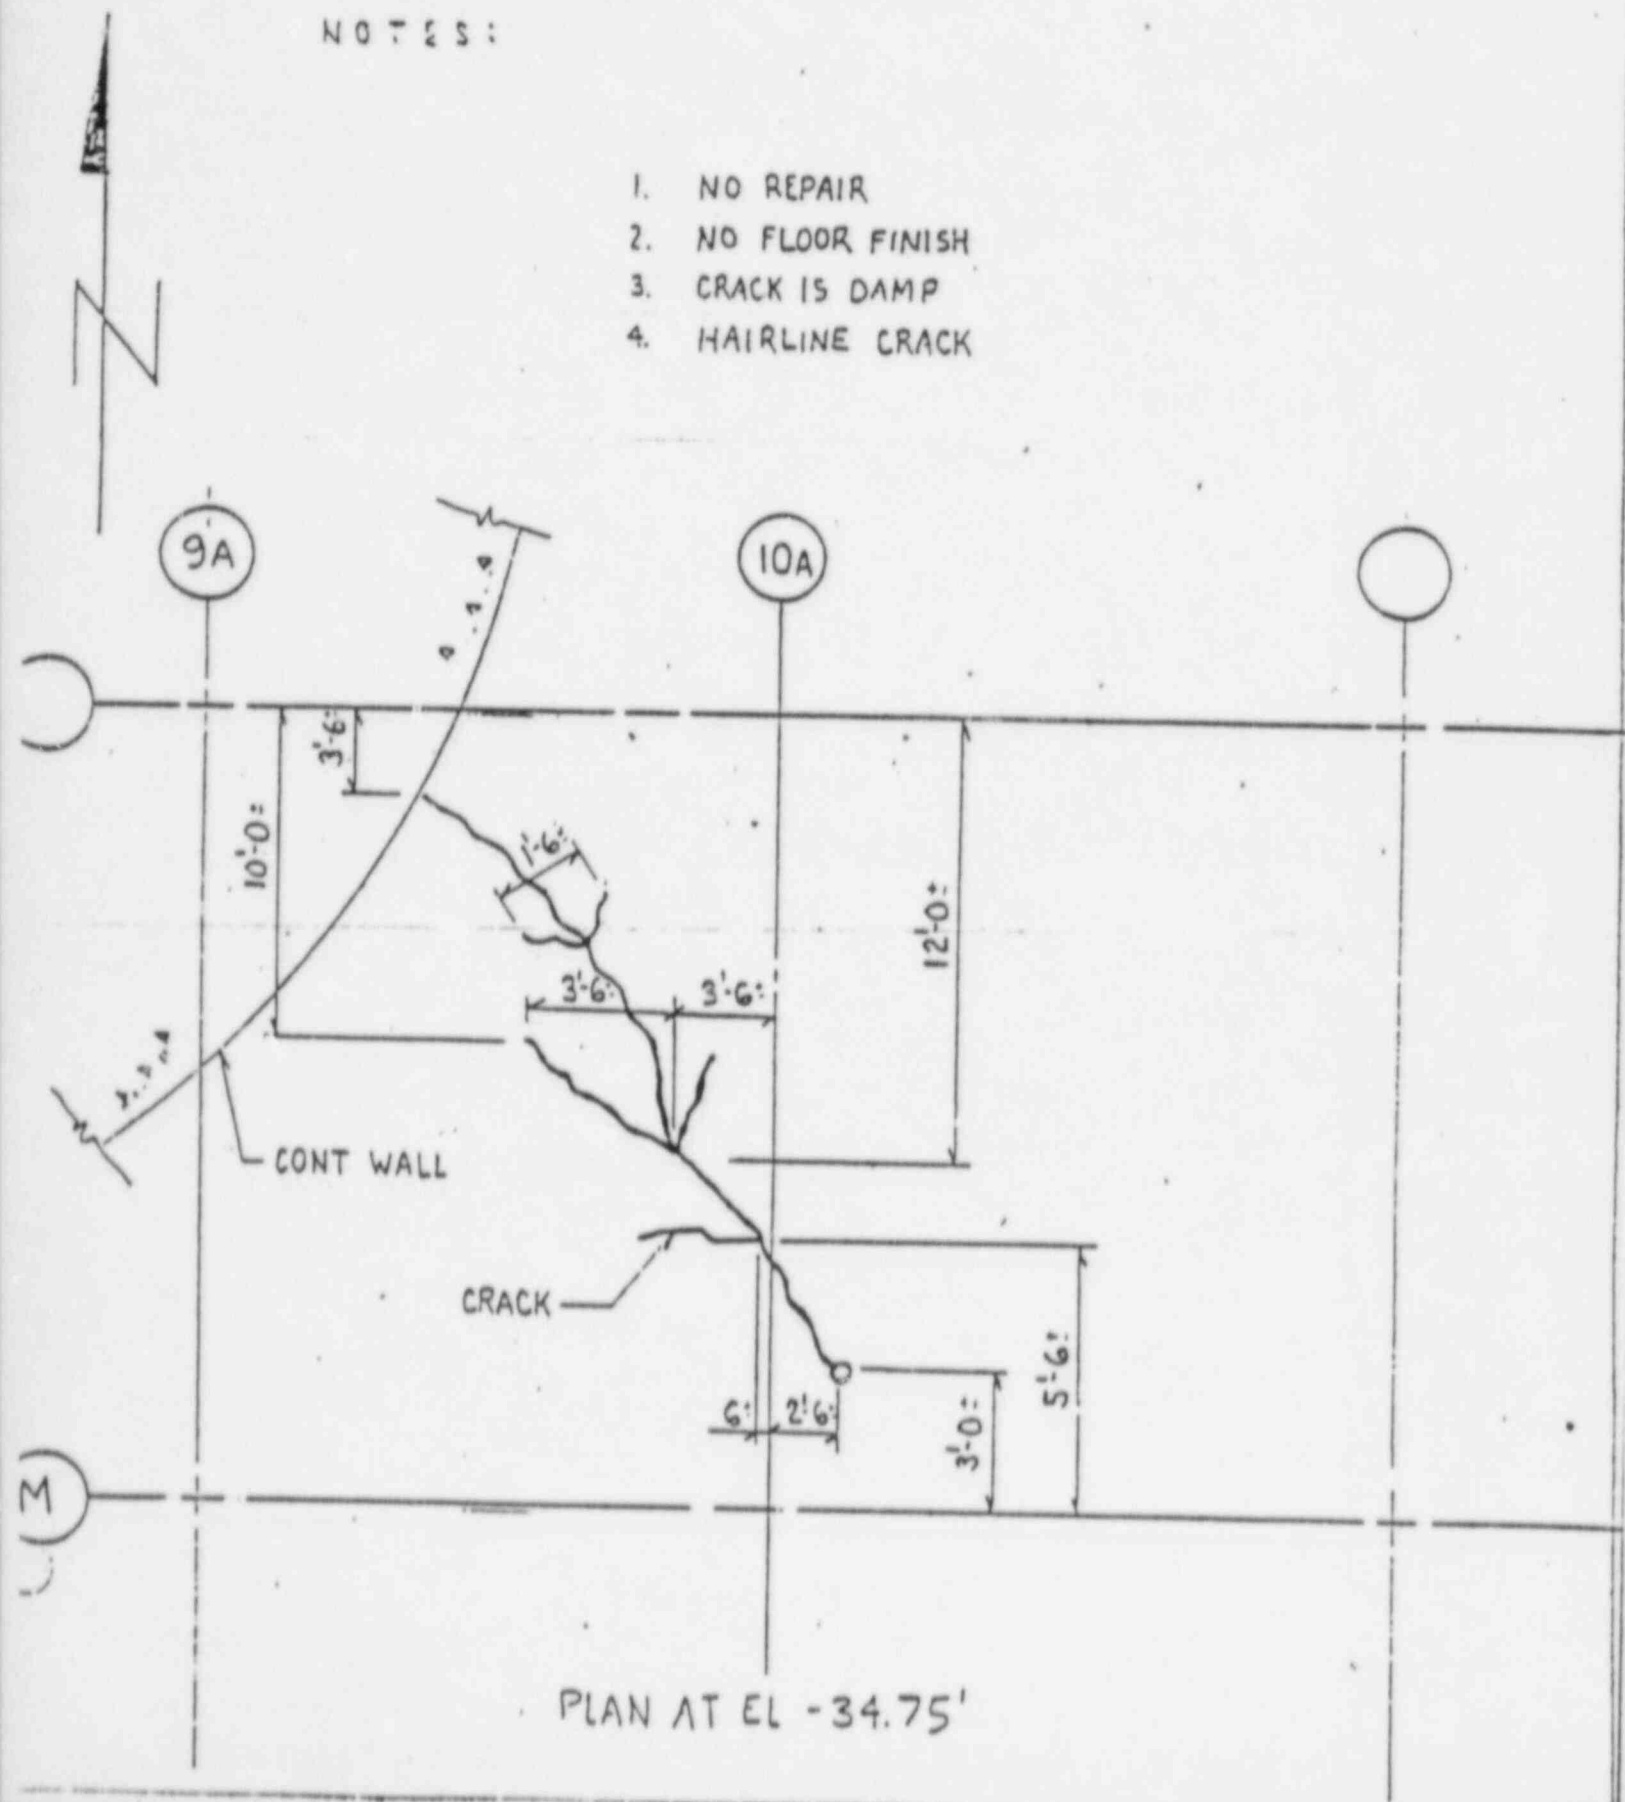
1. NO REPAIR
2. NO FLOOR FINISH
3. CRACK IS DAMP
4. HAIRLINE CRACK

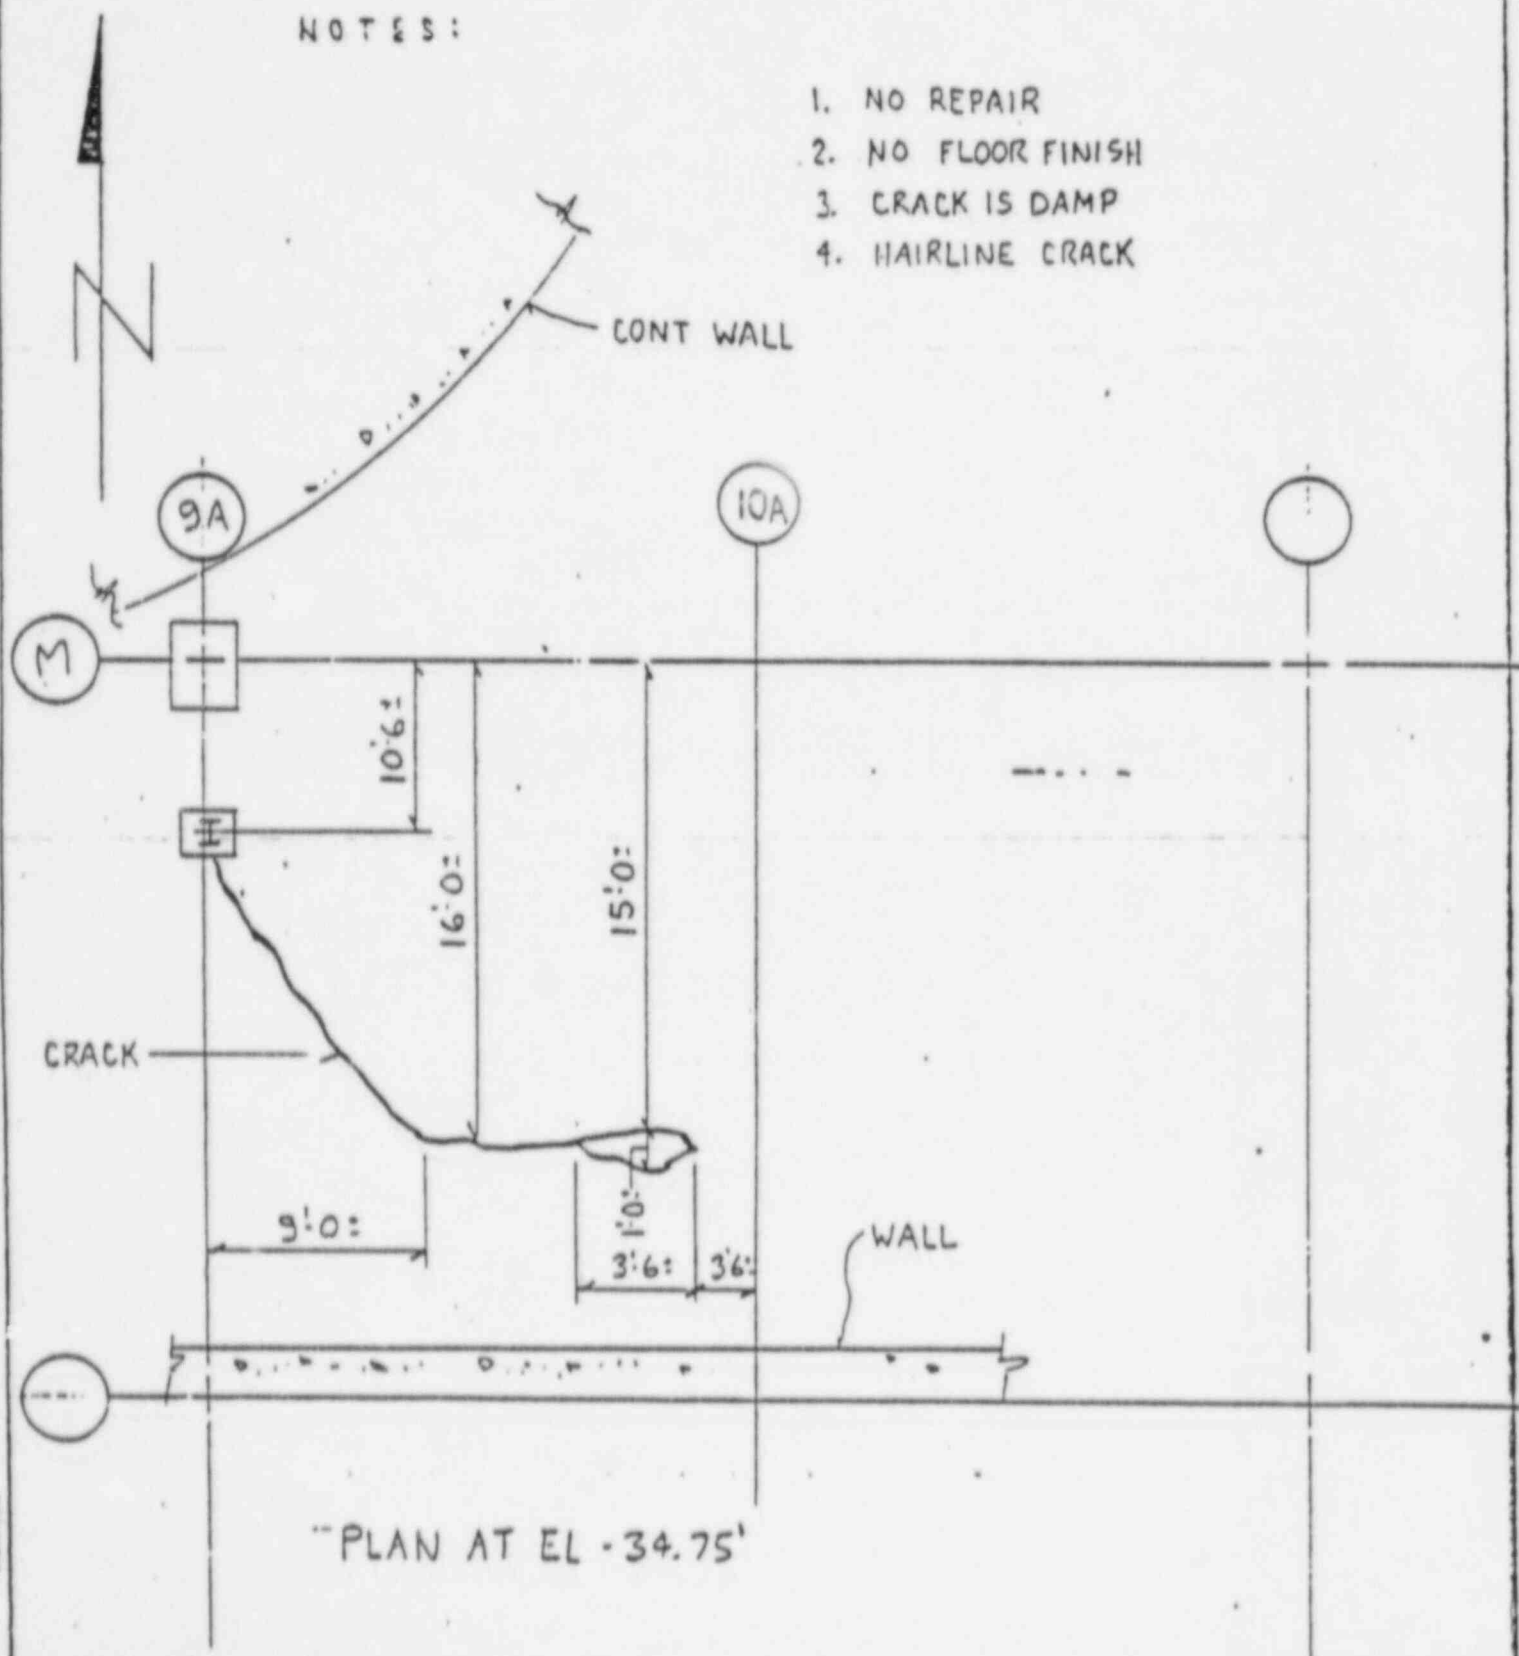
1. NO REPAIR
2. NO FLOOR FINISH
3. CRACK IS DAMP
4. HAIRLINE CRACK

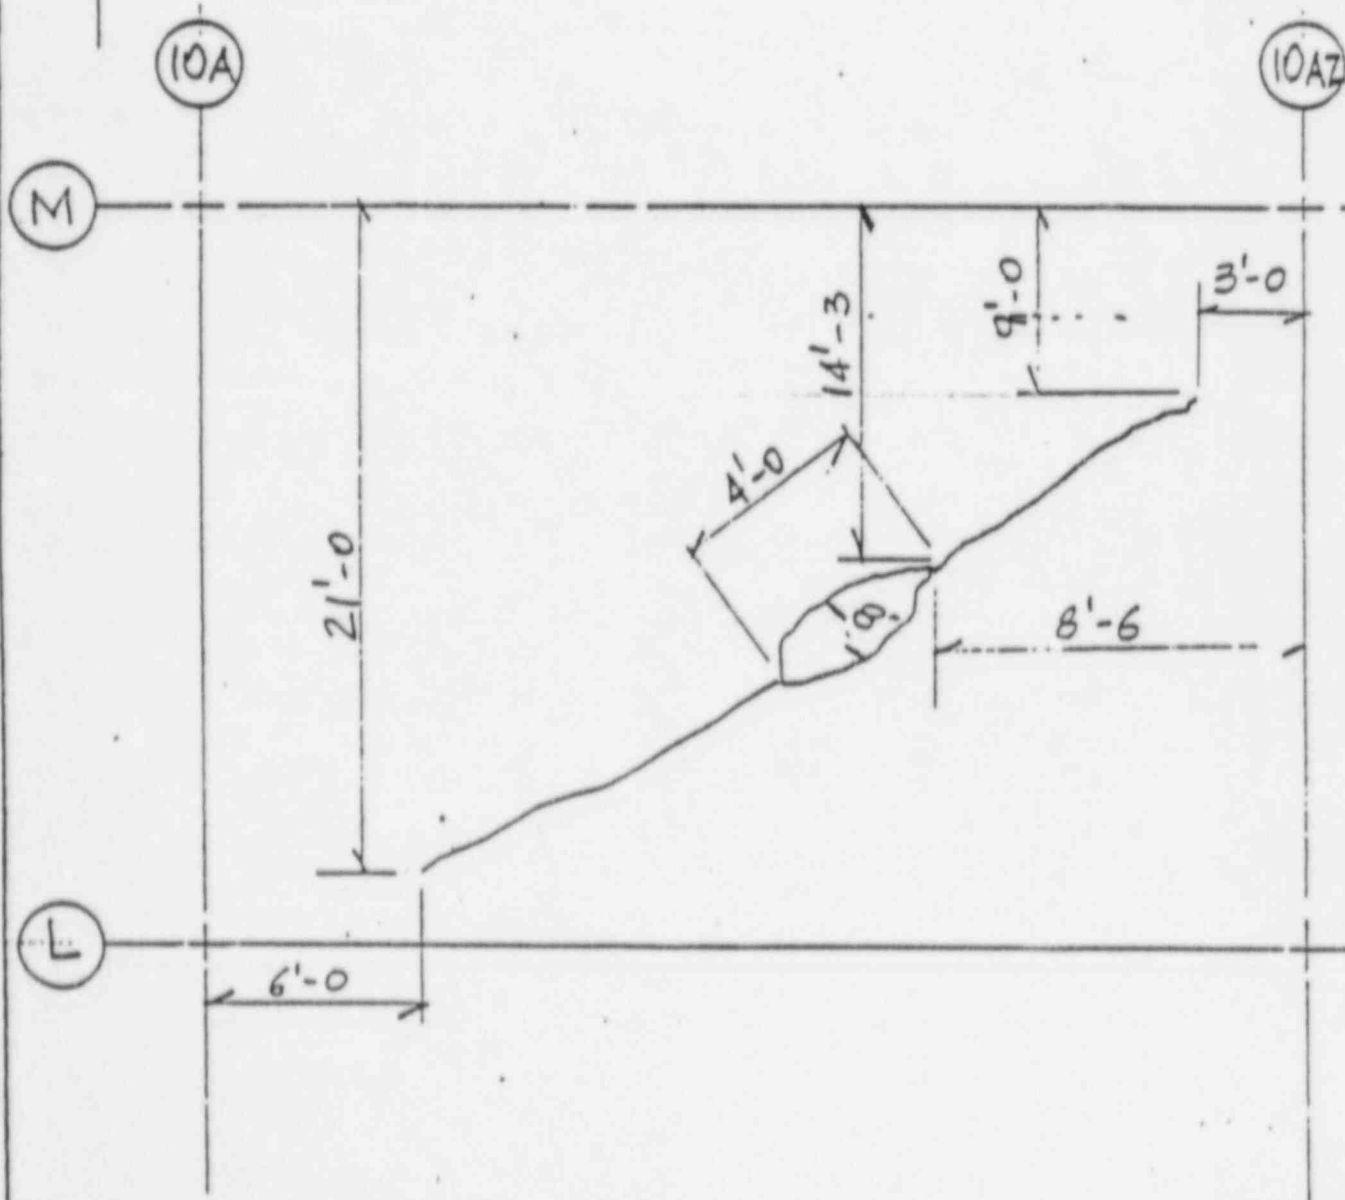
- NOTES: 1. NO
2. NO
3. YES - DAMP
4. HAIRLINE CRACK

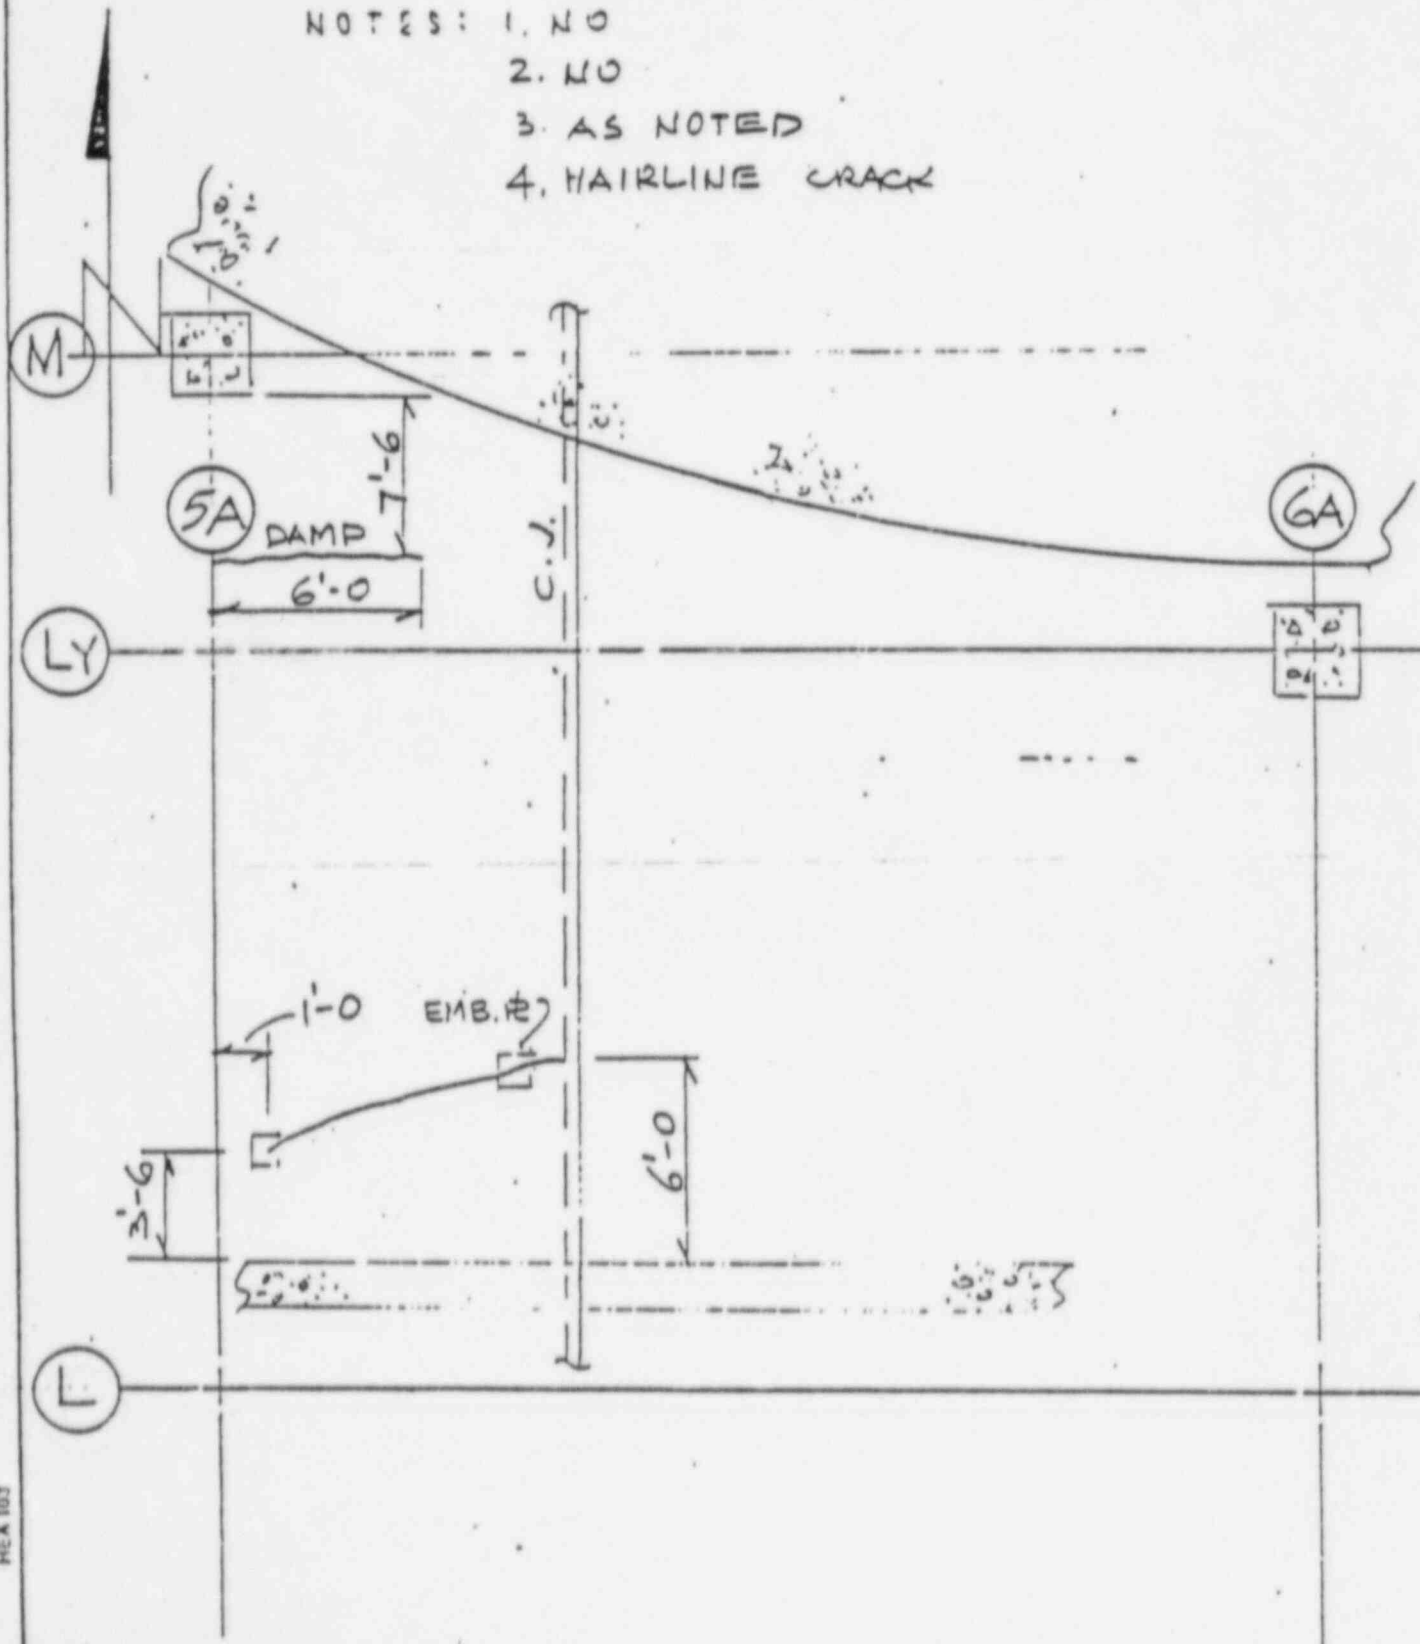
- NOTES: 1. NO
2. NO
3. AS NOTED
4. HAIRLINE CRACK
